# **Arboricultural Assessment, Arboricultural Impact and Tree Protection Report**

## **St. Vincent's Hospital, Fairview, Dublin 3**

<b>Project No.</b>	TSTV001	<b>Date</b>	22/03/23
<b>Project Name</b>	St. Vincent's Hospital Redevelopment	<b>Revision</b>	F

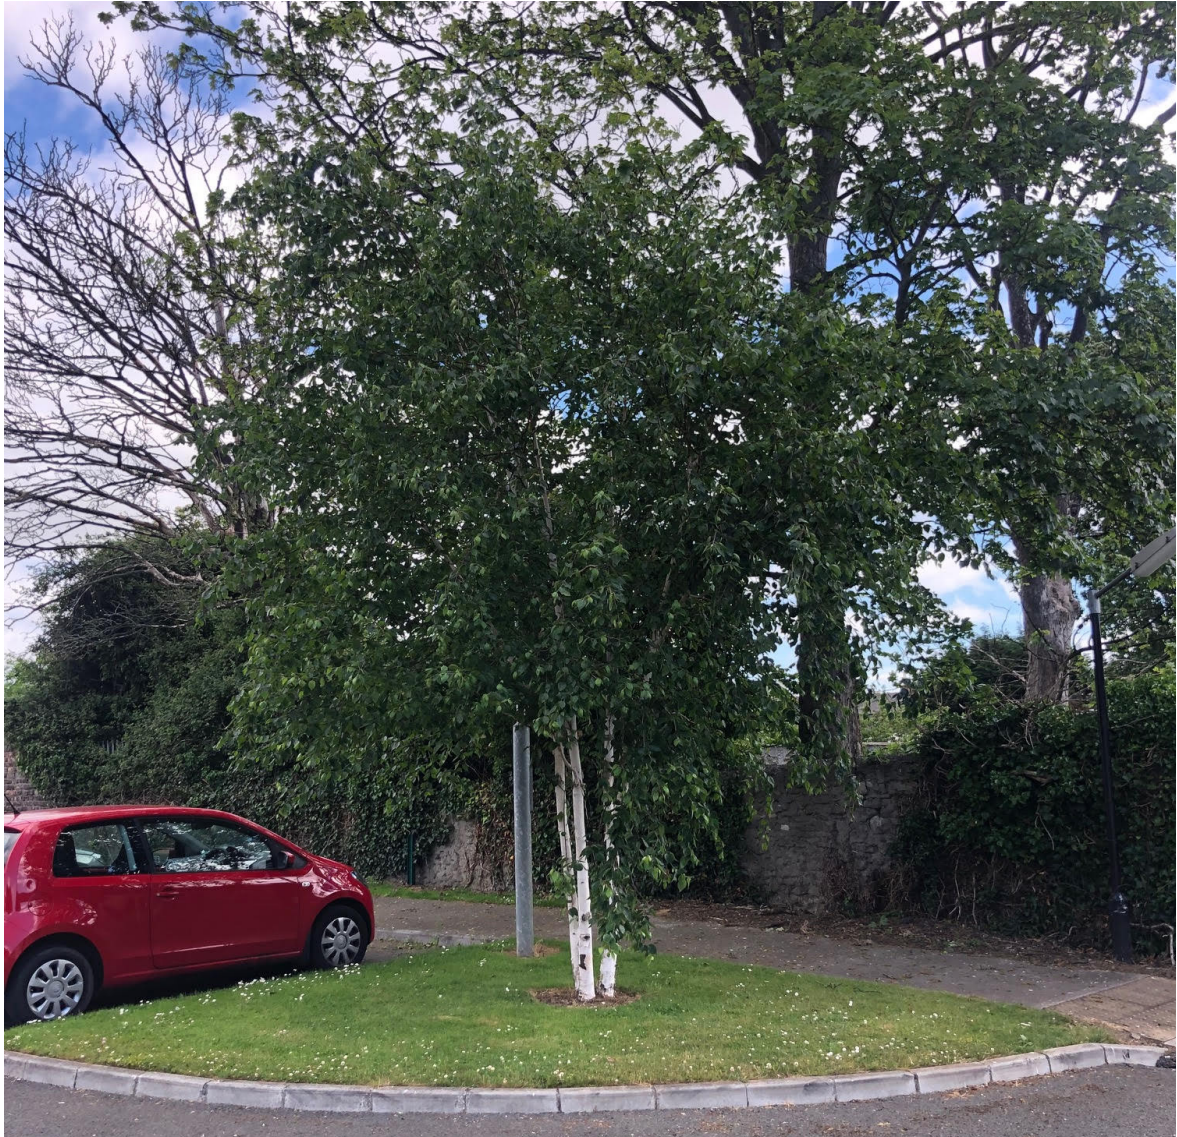
Image 2. Birch within the car park and the immediate vicinity of St.Vincent's Hospital near the north eastern survey boundary.

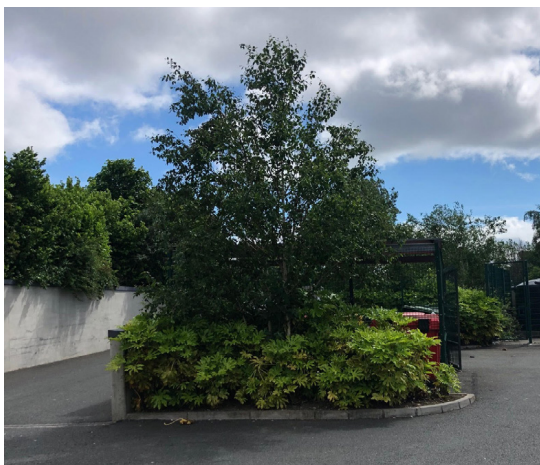
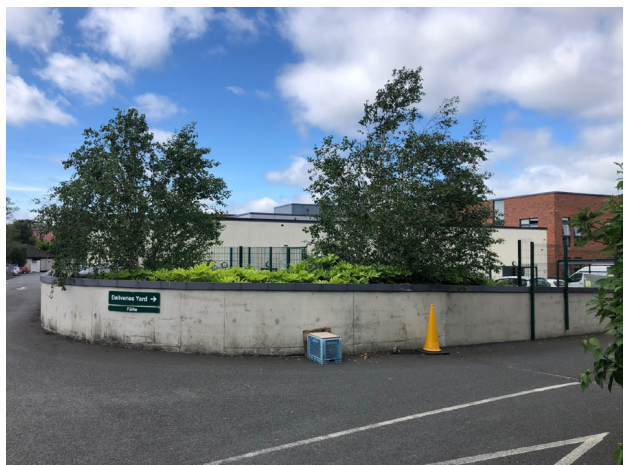
Images 3/4. Birch within the car park and the immediate vicinity of St.Vincent's Hospital near the north eastern survey boundary.

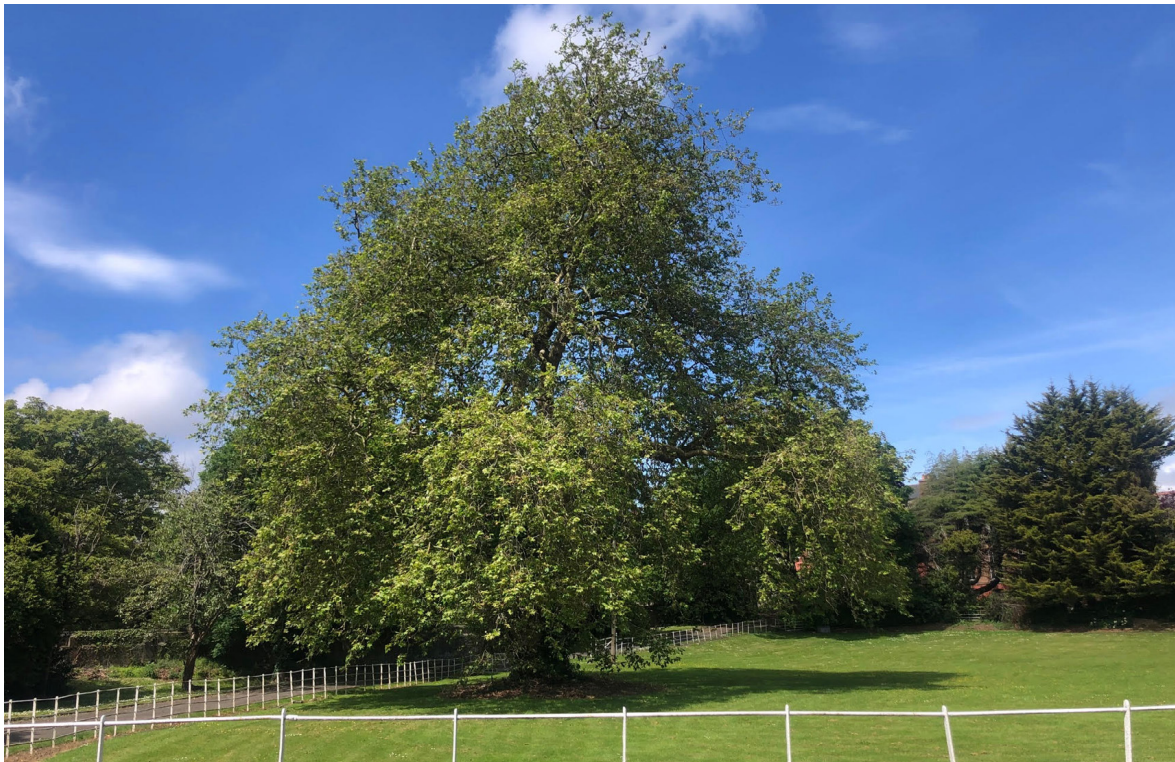
Image 5. London plane (#1792) within an open area north of the Convent Avenue entrance way. Line of Monterey cypress (#1765) in background right.

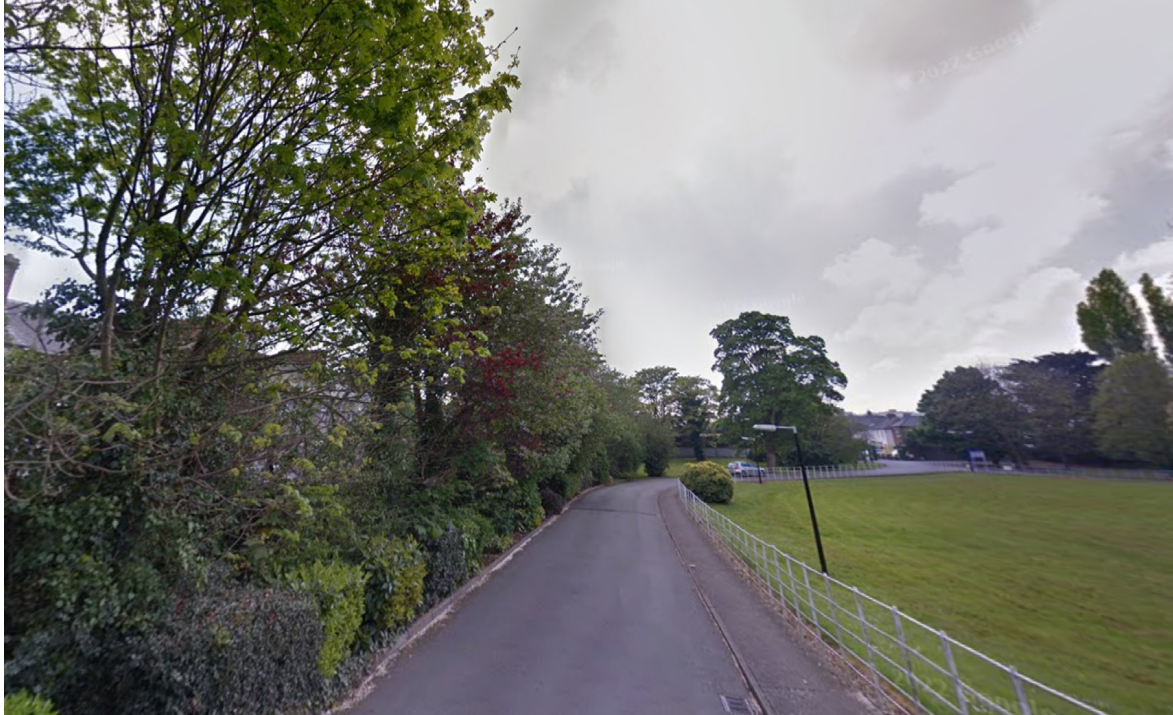
Along the eastern boundary are a single line of early mature trees for approx. 110m (image 6). This planted line contains many smaller form species including whitebeam (*Sorbus intermedia*), holly (*Ilex*), willow (*Salix alba*) and elm (*Ulmus glabra*).

Image 6. Single line of early mature trees along the eastern boundary.

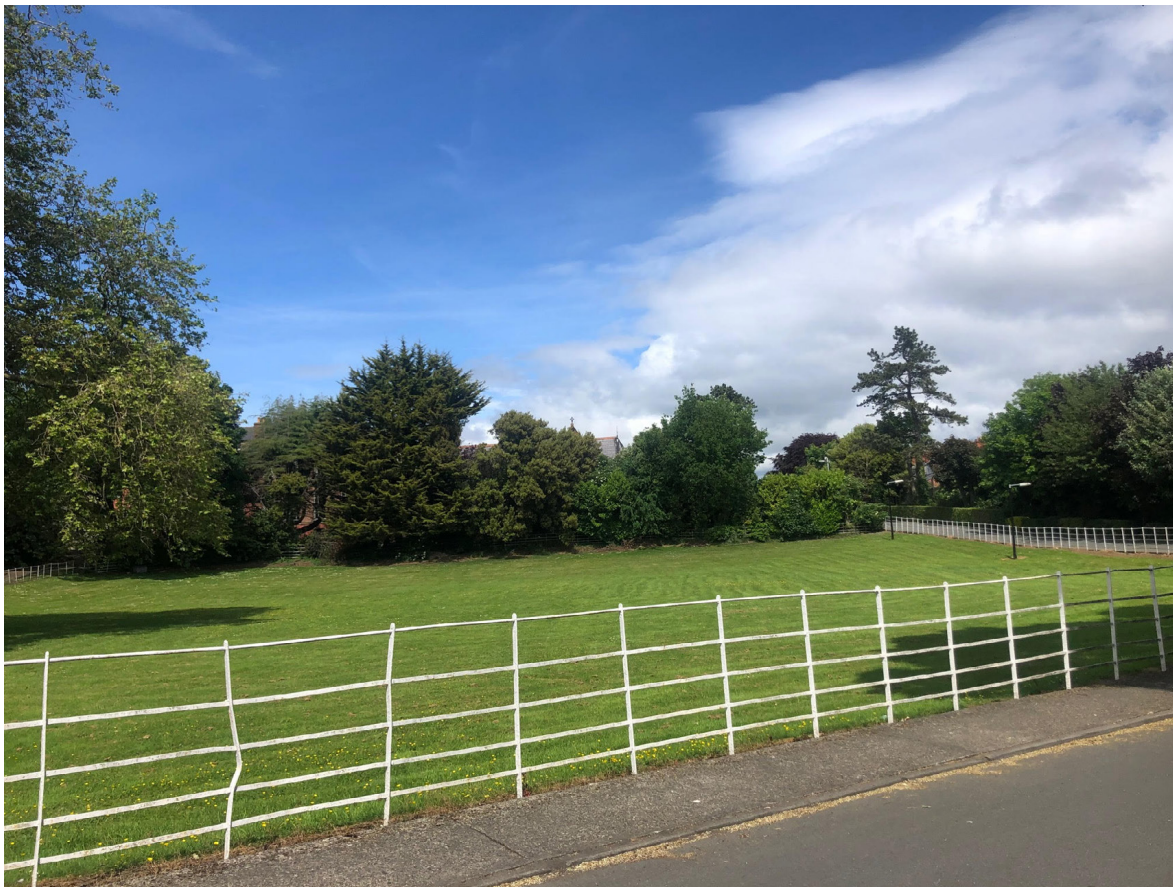
Image 7. Holm and sessile oak at the northern boundary of area 2 (refer to image 1).

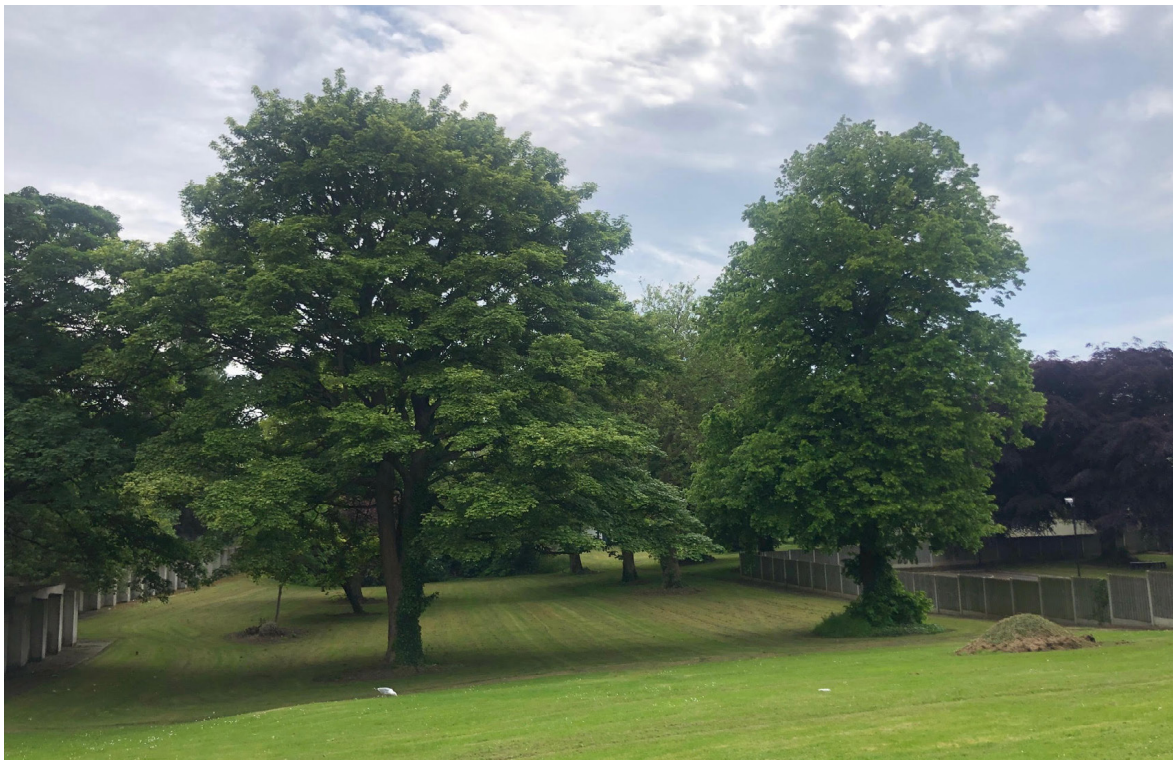
Image 8. Well developed high value trees within the walled garden area (#1689 & #1690).

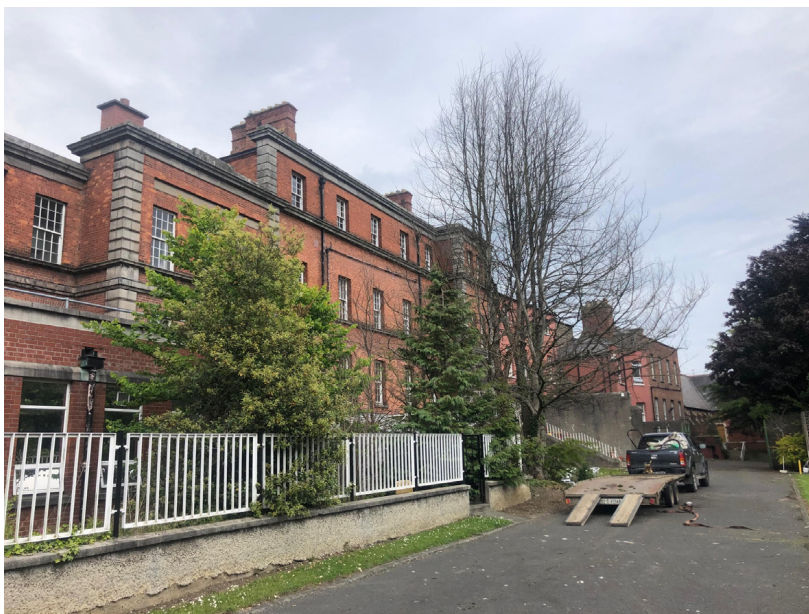
The general condition of these trees is good with few exhibiting any significant decay or structural issues (save for two that have failed #1691 and #1693; image 9).

Image 9. Dead elm adjacent to St.Vincents hospital (#1693).

Tag Number	Vigour	Species	Age class	Category	Comments	Recommendations	Long Term Potential	DBH (mm)	Height (metre)	Clear Stem (metre)	Crown spread NESW (metre)
1693	Dead	Elm <i>Ulmus glabra</i>	Mature	U	Failed	Fell	0	700	10	NA	4;4;4;4
1694	Good	Norway maple <i>Acer platanoides</i> 'crimson king'	Mature	A2	Bars embedded on base. Well developed. No visible defects.	No action necessary	40	420	14	4e	6;6;5;4
1695	Poor	Cherry cultivar <i>Prunus</i> cv	Mature	U	Becoming shaded out by neighbouring tree with extensive deadwood in crown.	Fell	<10	370	11	NA	3;5;5;3
1696	Good	Norway maple <i>Acer platanoides</i>	Early Mature	B2	Relatively well developed. Congestion in crown. Not significant at present.	No action necessary	30-40	370	12	2w	5;4;5;6
1697	Good	Sycamore <i>Acer pseudoplatanus</i>	Mature	A2	Cavity at base to north but Unlikely to be significant at present. Very heavy ivy. Minor deadwood in lower crown. Canopy well developed. No visible defects.	Cut ivy and re-assess	40	1020	24	4w	10;10;6;10

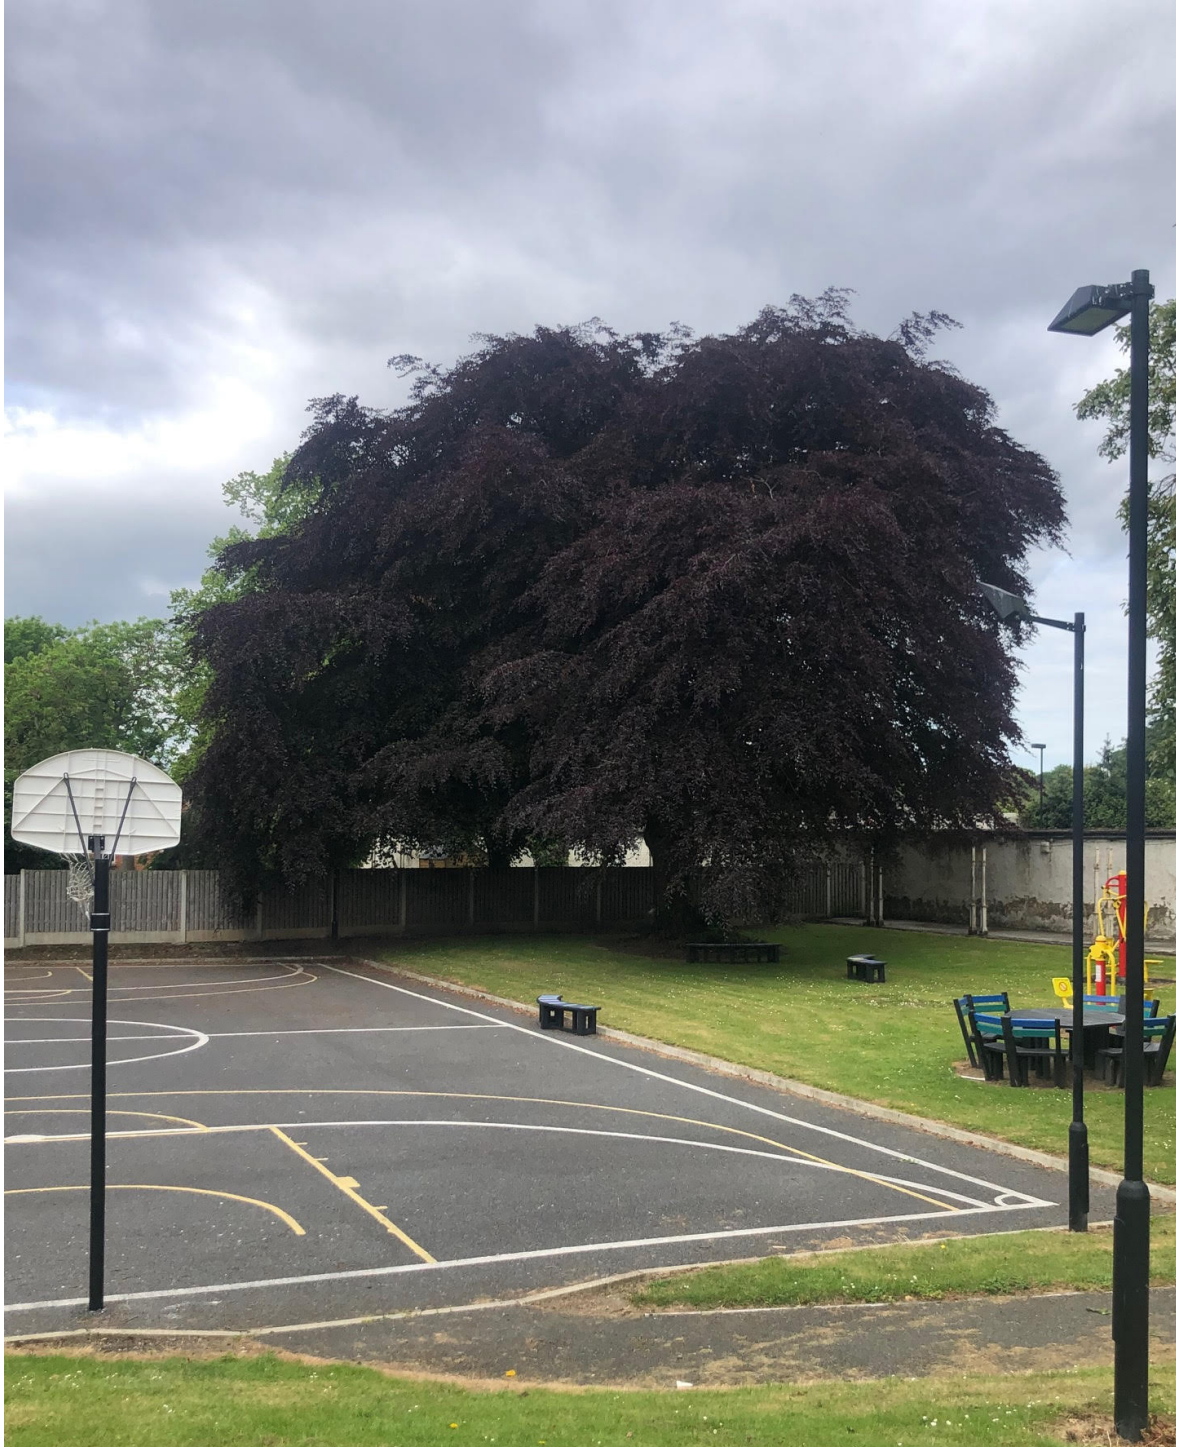
Image 10. Copper beech #1787 on the western boundary of the wall garden.

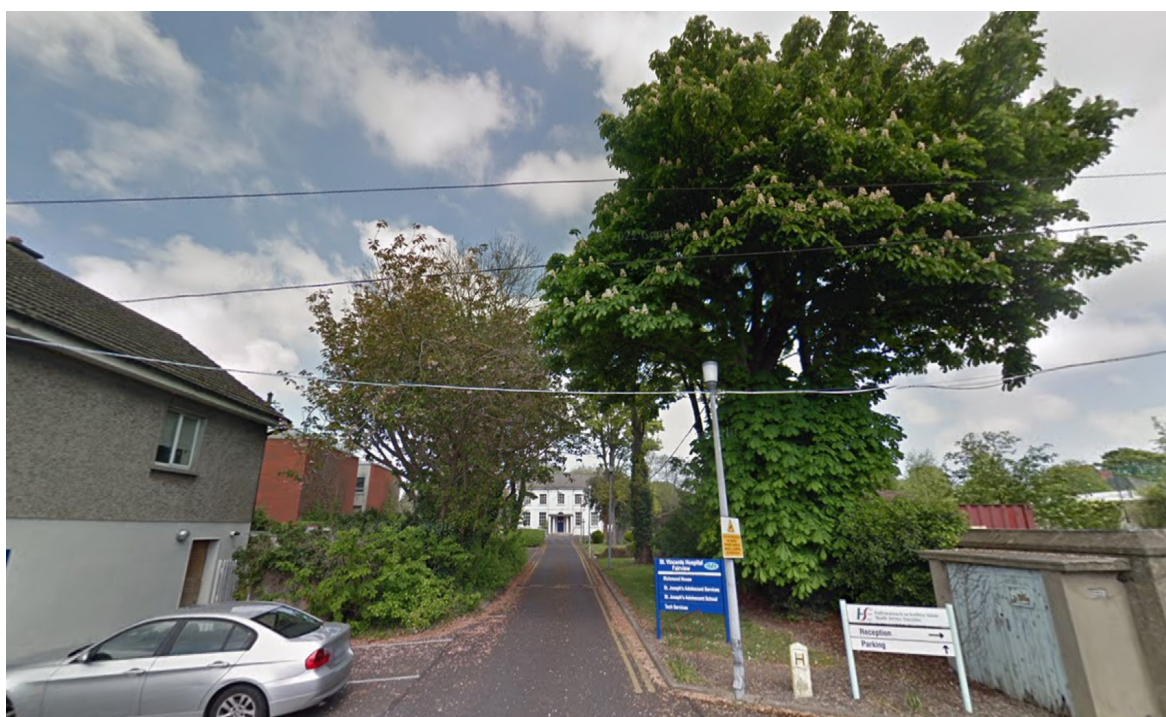
Image 11. Horse chestnut (right #1834) with sycamore, Norway maple and ash at the entrance to Richmond House.

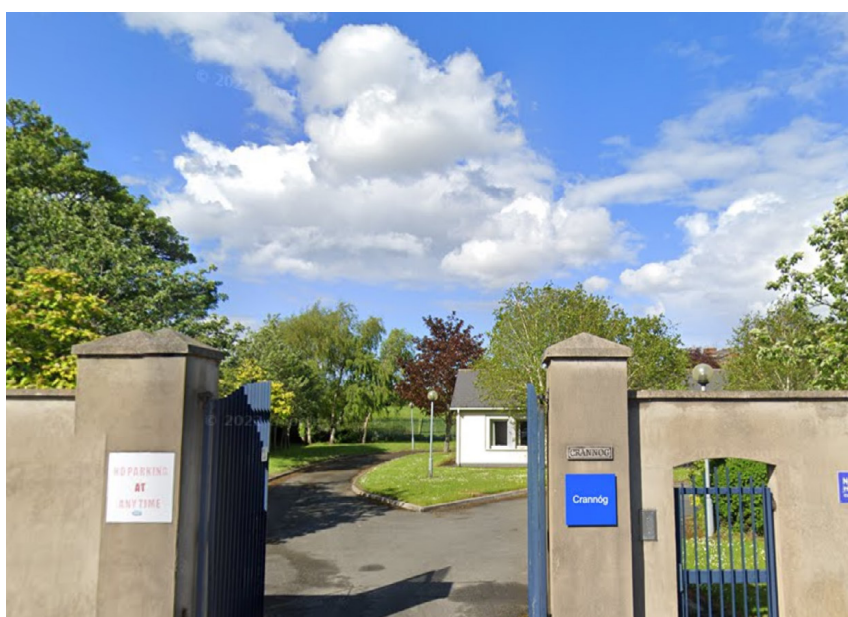
The grounds of Crannog house (images 1 & 12) contains 44 trees. The majority are early-mature birch and rowan. Seven trees have bark damage at base, the cause of which is most likely due to mower impact.

Image 12. Early mature birch and rowan within the grounds of Crannog.
