# ST. VINCENT'S HOSPITAL FAIRVIEW REDEVELOPMENT Demolition Works Justification Report

Revision: 02

Date: 23.03.2023

### JUSTIFICATION REPORT

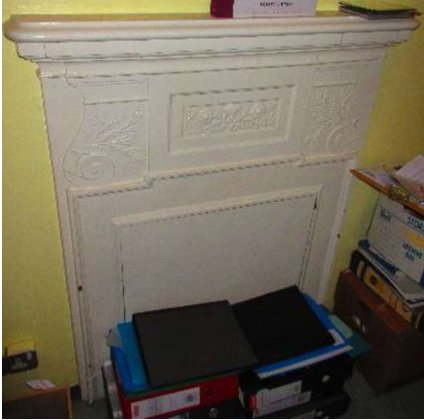
### 6.5.1 FIREPLACES

| | <b>Description</b> | Painted cast-iron fireplace. | | |
| | <b>Condition</b> | Good Condition. Where hearthstones have survived, these are to be salvaged and re-installed within relevant fireplace. | | |

| | <b>Current Location</b> | Room G235, G236, G237, 1216, 1217, 1218 | <b>Proposed Location</b> | 4no. Main Hospital Building – Room tbc, and 2no. Rose Cottage – Room tbc |

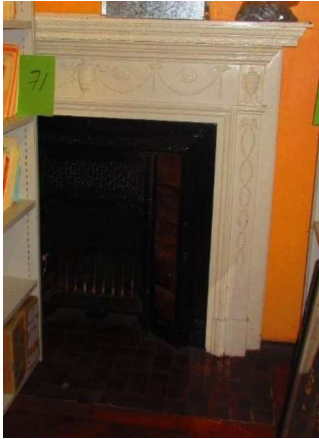
| | <b>Description</b> | Decorated cast Iron inner frame with modest tiled surrounds. Painted timber chimney piece. Tiled hearth slab. | | |
| | <b>Condition</b> | Good Condition. Hearth slab to be salvaged and re-installed within the fireplace. | | |

| | <b>Current Location</b> | Room G238 | <b>Proposed Location</b> | Main Hospital Building – Room tbc |

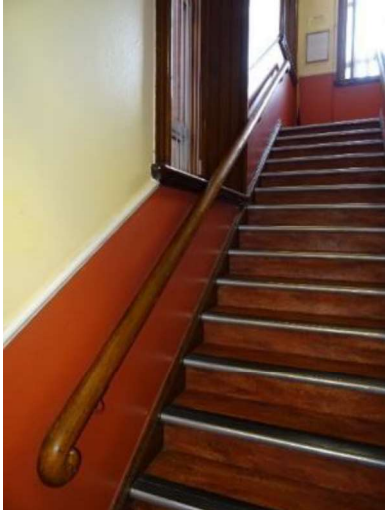
### 6.5.2 HANDRAIL

| | <b>Description</b> | Oak handrail with curved ends is fitted to both walls of main stairwell and east side of the stair in the passageway. | | |
| | <b>Condition</b> | Good Condition. | | |

| | <b>Current Location</b> | Room G230 (Passageway) and Main Stairwell | <b>Proposed Location</b> | Main Hospital Building – Central Staircase |

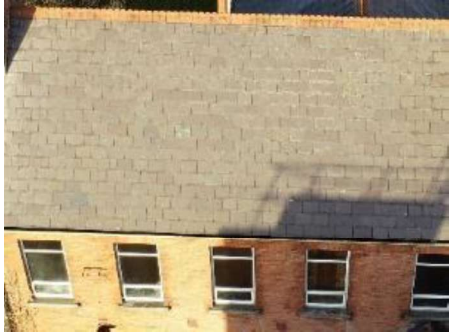
### 6.6.1 SLATES

| | <b>Description</b> | Slates. | | |
| | <b>Condition</b> | Reasonable condition. It is anticipated that a good quantity of the existing slate will be sound and shall be salvaged for reuse. Quantity/Percentage tbc. | | |

| | <b>Current Location</b> | T-building main roof, Passageway roof | <b>Proposed Location</b> | Conservation repair works of the Main Hospital building |

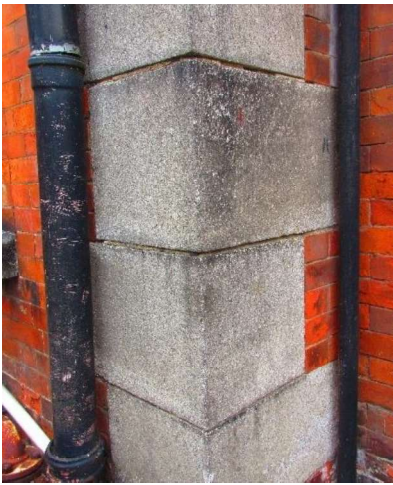
### 6.6.2 QUOIN STONES

| | <b>Description</b> | Granite quoin stones. | | |
| | <b>Condition</b> | Good condition. It is anticipated that most of the existing quoins stones will be sound and shall be salvaged for reuse. Surplus to be salvaged and reused on the landscaping. Quantity/Percentage tbc. | | |

| | <b>Current Location</b> | Façade corners on the T-building.<br>Façade corners on the Concert Hall. | <b>Proposed Location</b> | Conservation repair works of the Main Hospital building. |

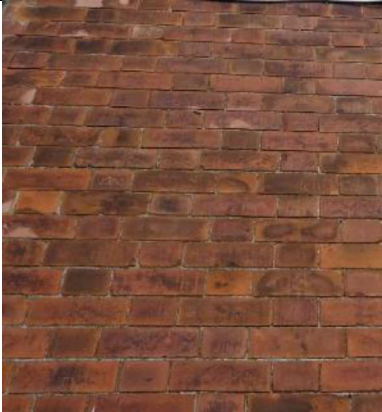
### 6.6.3 BRICKWORK

| | <b>Description</b> | Good quality red brick with fire skin. | | |
| | <b>Condition</b> | Reasonable condition. It is anticipated that 30% (tbc) of the existing brickwork will be sound and shall be salvaged for repairs to scars and replacement of damaged bricks. | | |

| | <b>Current Location</b> | All elevations. | <b>Proposed Location</b> | Conservation repair works of the Main Hospital building. |

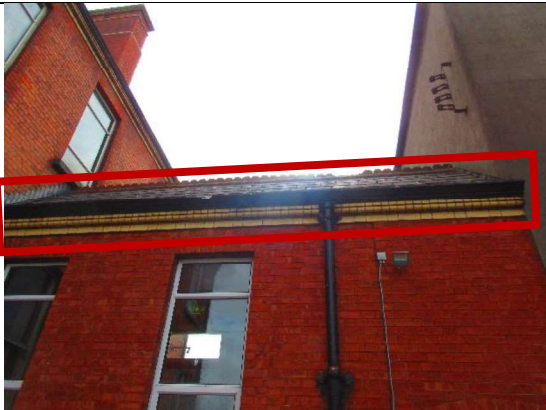
## 6.6.4 RAINWATER GOODS

| | <b>Description</b> | Profiled cast iron gutter. | | |
| | <b>Condition</b> | Reasonable condition. It is anticipated that a fair quantity of the existing gutters sections will be sound and shall be salvaged for repairs/replacement. Estimated 40% for salvage tbc. | | |

| | <b>Current Location</b> | All elevations – on T building, on the passageway. | <b>Proposed Location</b> | Conservation repair works of the Main Hospital building. |

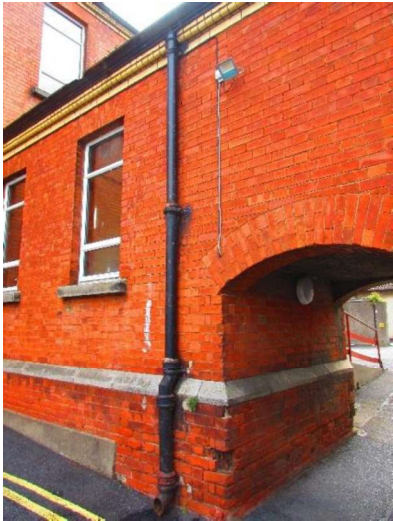
| | <b>Description</b> | Cast iron downpipe + brackets. | | |
| | <b>Condition</b> | Good condition. It is anticipated that a fair quantity of the existing downpipe sections will be sound and shall be salvaged for repairs/replacement. Estimated 80% for salvage tbc. | | |

| | <b>Current Location</b> | West Elevation, East Elevation – on T building. | <b>Proposed Location</b> | Conservation repair works of the Main Hospital building. |

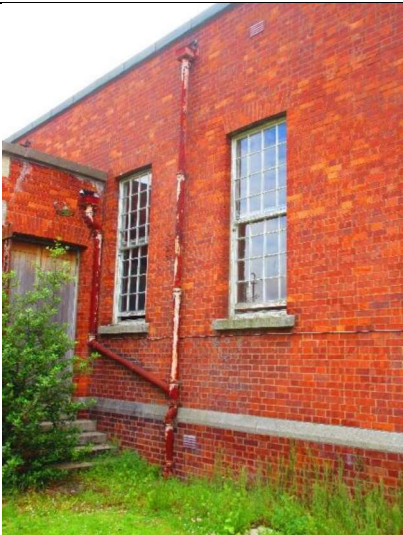
| | <b>Description</b> | Cast iron downpipe + brackets + Hopper. | | |
| | <b>Condition</b> | Good condition. It is anticipated that 80% (tbc) of the existing downpipes and hoppers will be sound and shall be salvaged for repairs/replacement. | | |

| | <b>Current Location</b> | West Elevation, East Elevation – on Concert Hall. | <b>Proposed Location</b> | Conservation repair works of the Main Hospital building. |

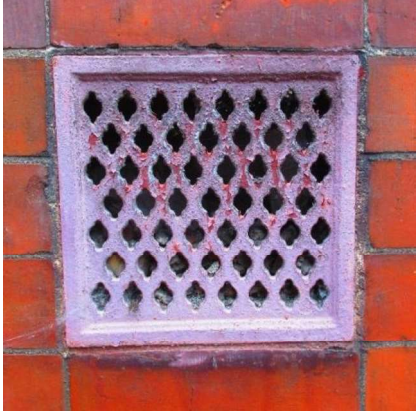
## 6.6.5 EXTERNAL VENT GRILLE PANELS

| | <b>Description</b> | Painted decorative cast-iron vent grille panels. | | |
| | <b>Condition</b> | Reasonable condition. It is anticipated that 50% (tbc) of the existing vent grille panels will be sound and shall be salvaged for replacement. | | |

| | <b>Current Location</b> | Refers to Salvage Strategy Drawings | <b>Proposed Location</b> | Replace poor quality modern vents on the Main Hospital Building |

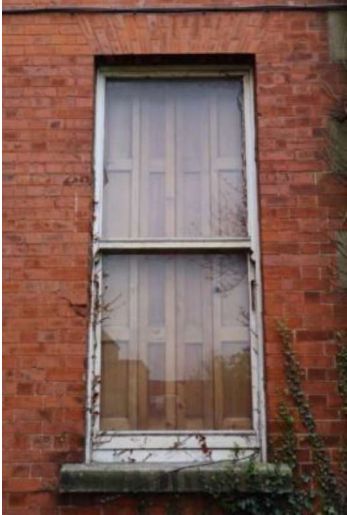
## 6.6.6 WINDOWS

| | <b>Description</b> | Single-pane timber sash window. | | |
| | <b>Condition</b> | Reasonable condition. It is anticipated that 20% (tbc) of the existing windows will be sound and shall be salvaged for reuse on the conservation repair works of windows on the main hospital building. Surplus to be sold to a salvage merchant. | | |

| | <b>Current Location</b> | South Elevation, West Elevation, North Elevation – on T building. | <b>Proposed Location</b> | Conservation repair works of windows on the main hospital building. |

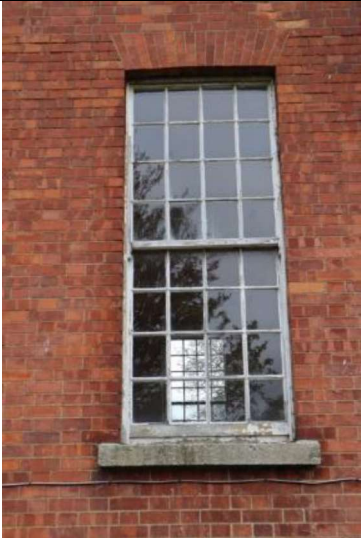
| | <b>Description</b> | 16-over-16 pane timber sash window. | | |
| | <b>Condition</b> | Reasonable condition. It is anticipated that 20% (tbc) of the existing windows will be sound and shall be salvaged for reuse on the conservation repair works of windows on the main hospital building. The remaining could be sold to a salvage merchant. | | |

| | <b>Current Location</b> | West Elevation, and East Elevation | <b>Proposed Location</b> | Conservation repair works of windows on the main hospital building |

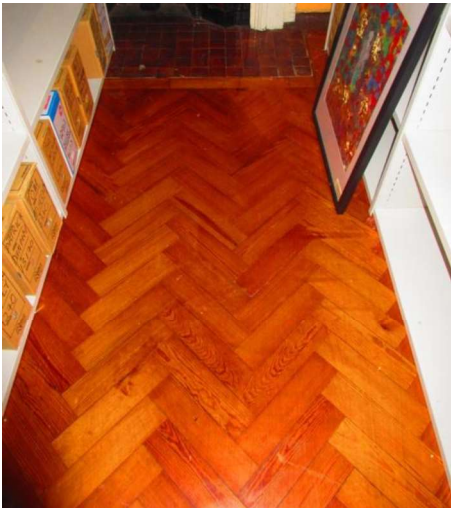
#### 6.6.7 FLOORING

| | <b>Description</b> | Parquet Flooring – Timber Herringbone Floor. | | |
| | <b>Condition</b> | Reasonable condition. It is anticipated that 30% (tbc) of the existing parquet flooring will be sound and shall be salvaged for repairs. The remaining can go to a reputable salvage merchant. | | |

| | <b>Current Location</b> | Room G230, G231, G239, and G238. | <b>Proposed Location</b> | Conservation repair works on the main hospital building. |

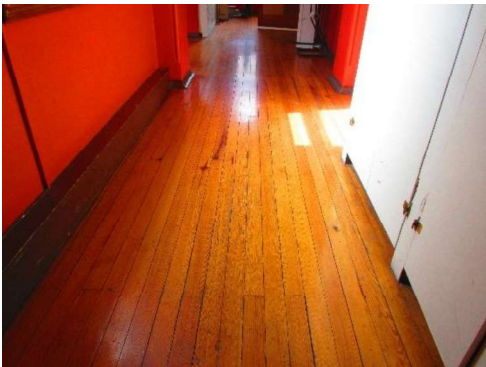
| | <b>Description</b> | Timber floorboards. | | |
| | <b>Condition</b> | Reasonable condition. It is anticipated that 30% (tbc) of the existing timber floorboard will be sound and shall be salvaged for repairs. The remaining can go to a reputable salvage merchant. | | |

| | <b>Current Location</b> | Room G245, G251, G252, G253 and G254. | <b>Proposed Location</b> | Conservation repair works on the main hospital building. |

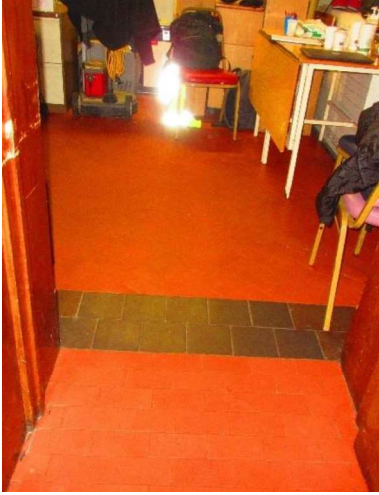
| | <b>Description</b> | Ceramic tiles. | | |
| | <b>Condition</b> | Reasonable condition. It is anticipated that 30% (tbc) of the existing tiles will be sound and shall be salvaged for repairs. | | |

| | <b>Current Location</b> | Room G232 and G233. | <b>Proposed Location</b> | Conservation repair works of the Main Hospital building. |

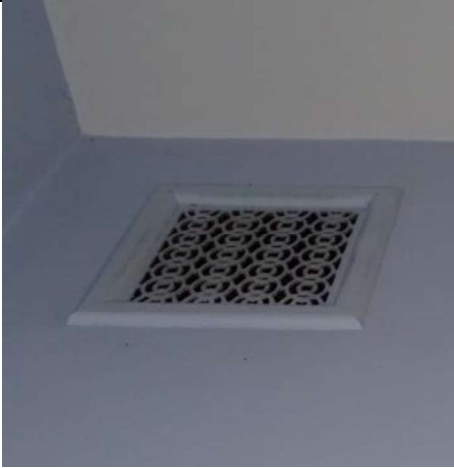
#### 6.6.8 INTERNAL VENT GRILLE PANELS

| | <b>Description</b> | Painted decorative cast-iron vent grille panels. | | |
| | <b>Condition</b> | Reasonable condition. It is anticipated that the existing vent grille panels will be sound and shall be salvaged for reuse. Estimated 60% for salvage tbc. | | |

| | <b>Current Location</b> | Refers to Salvage Strategy Drawings | <b>Proposed Location</b> | Replace poor quality modern vents on the Main Hospital Building |

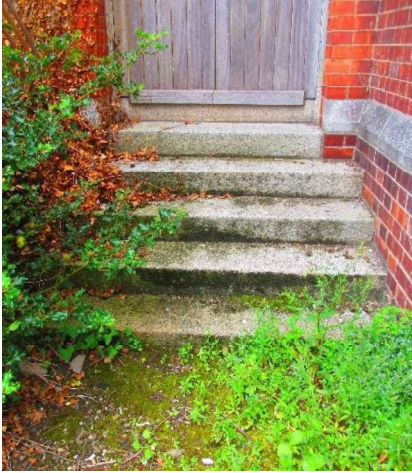
### 6.7.1 GRANITE STEPS AND THRESHOLD

| | <b>Description</b> | Granite steps. | | |
| | <b>Condition</b> | Good Condition. It is anticipated that 90% of the existing granite steps will be sound. These shall be salvaged for reuse on the landscaping. Quantities to salvage TBC with Landscape Architect. | | |

| | <b>Current Location</b> | West Elevation – Concert Hall Entrance. | <b>Proposed Location</b> | Salvage to be reused on the landscaping. |

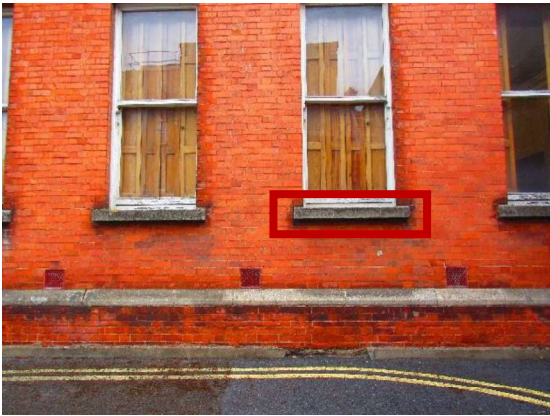
### 6.7.2 GRANITE SILLS

| | <b>Description</b> | Granite sills. | | |
| | <b>Condition</b> | Good Condition. It is anticipated that 90% of the existing granite sills will be sound. Quantities to salvage TBC with Landscape Architect. | | |

| | <b>Current Location</b> | All elevations | <b>Proposed Location</b> | Salvage to be reused in the landscaping. |

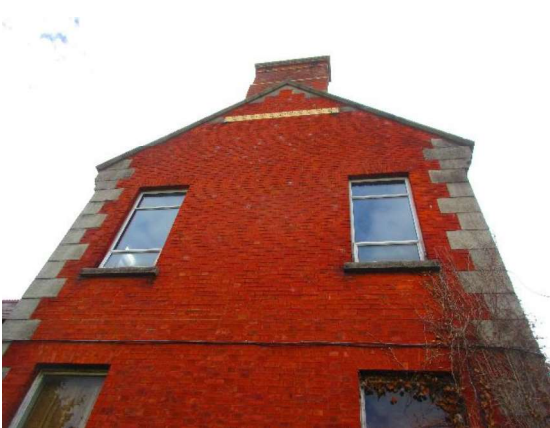
### 6.7.3 GRANITE GABLE CAPPING

| | <b>Description</b> | Granite parapet capping. | | |
| | <b>Condition</b> | Reasonable condition. It is anticipated that 80% of the existing granite capping will be sound. Quantities to salvage TBC with Landscape Architect. | | |

| | <b>Current Location</b> | T-building main roof, passageway roof | <b>Proposed Location</b> | Salvage to be reused in the landscaping. |

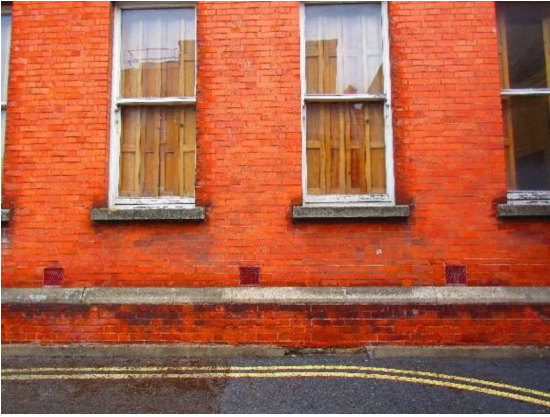
## 6.7.4 GRANITE PLINTH

| | <b>Description</b> | | Chamfered granite plinth. | |
| | <b>Condition</b> | Reasonable condition. It is anticipated that 80% of the granite plinth will be sound. Quantities to salvage TBC with Landscape Architect. | | |

| | <b>Current Location</b> | All elevations. | <b>Proposed Location</b> | Salvage to be reused in the landscaping. |

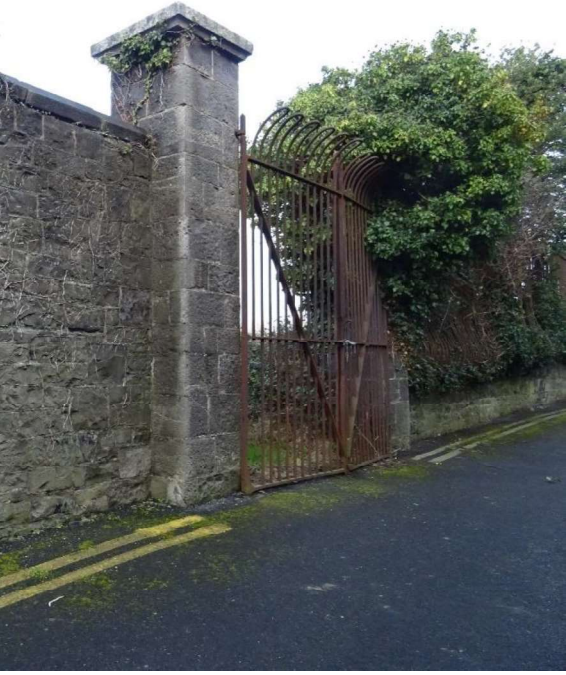
## 6.7.5 GATE PIERS

| | <b>Description</b> | | Cut stone gate piers with granite coping and wrought iron gates. | |
| | <b>Condition</b> | Reasonable condition. It is anticipated that 100% of the feature shall be salvaged for reuse in the landscaping. | | |

| | <b>Current Location</b> | West boundary wall. | <b>Proposed Location</b> | Salvage to be reused at new entrance. TBC by landscape architect. |

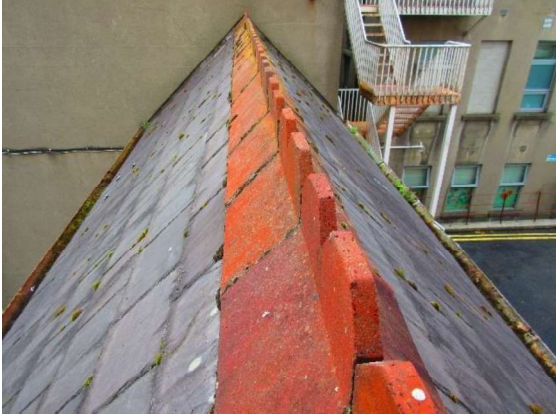
### 6.8.1 RIDGE TILES

| | <b>Description</b> | Crested terracotta ridge tiles. This element is only presented in the St Teresa building. |
| | <b>Condition</b> | Reasonable condition. Small number of cracked/broken ridge tiles. |

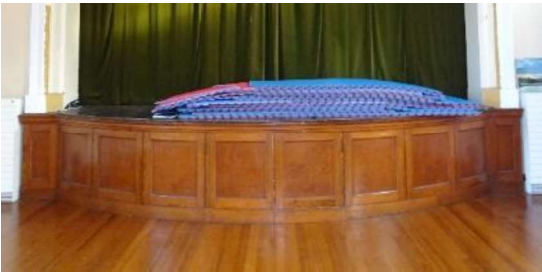
| | <b>Description</b> | Timber structure of the Concert Hall Stage. |
| | <b>Condition</b> | Good condition. |

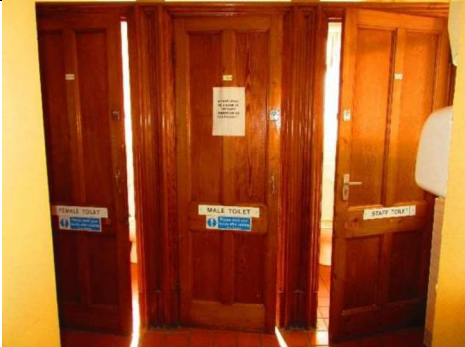
| | <b>Description</b> | Original Timber panelled doors and partitions. |
| | <b>Condition</b> | Good condition. |

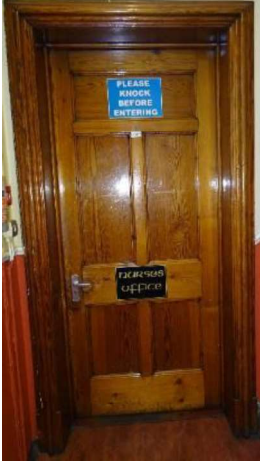
| | <b>Description</b> | Timber panelled door and architrave. |
| | <b>Condition</b> | Good condition. |

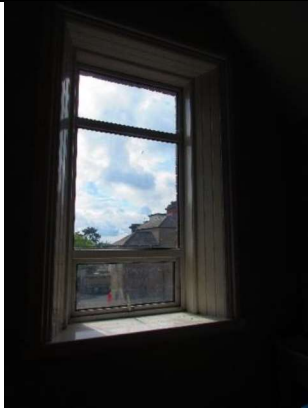
| | <b>Description</b> | Timber window Architraves. |
| | <b>Condition</b> | Good condition. |

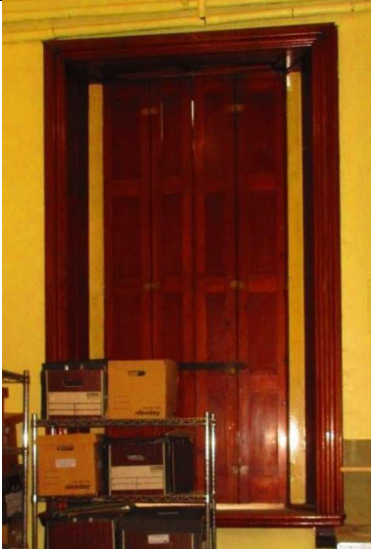
| | <b>Description</b> | Timber window shutter with brass hinges and cast-iron lock bar. |
| | <b>Condition</b> | Very good condition. |

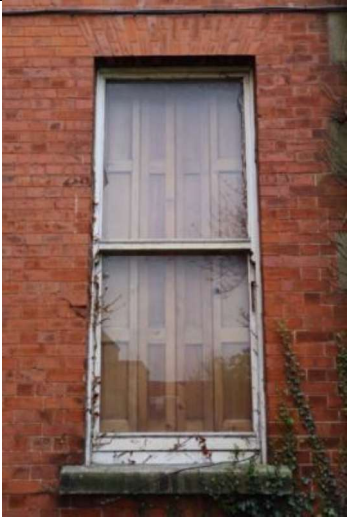
| | <b>Description</b> | Single-pane timber sash window. |
| | <b>Condition</b> | Reasonable condition. |

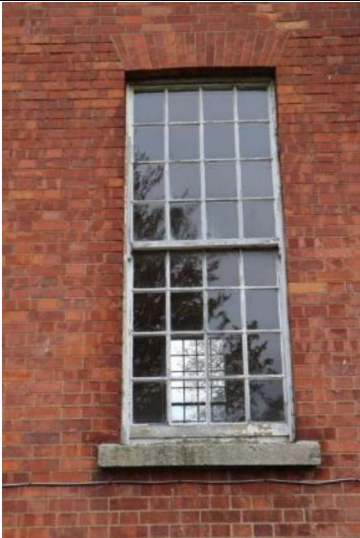
| | <b>Description</b> | 16-over-16 pane timber sash window. |
| | <b>Condition</b> | Reasonable condition. |

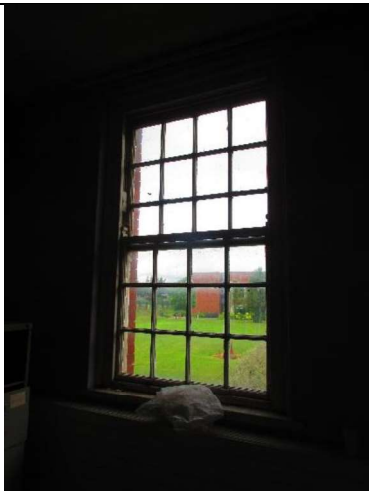
| | <b>Description</b> | 12-over-12 pane timber sash window. |
| | <b>Condition</b> | Reasonable condition. |

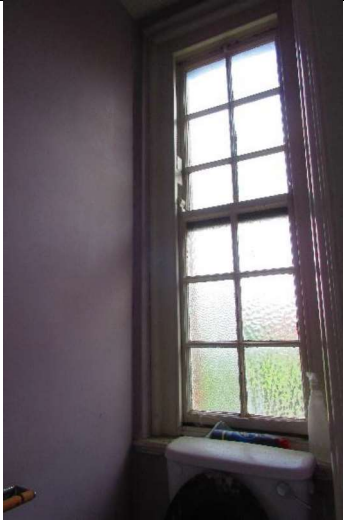
| | <b>Description</b> | 6-over-6 pane timber sash window. |
| | <b>Condition</b> | Reasonable condition. |

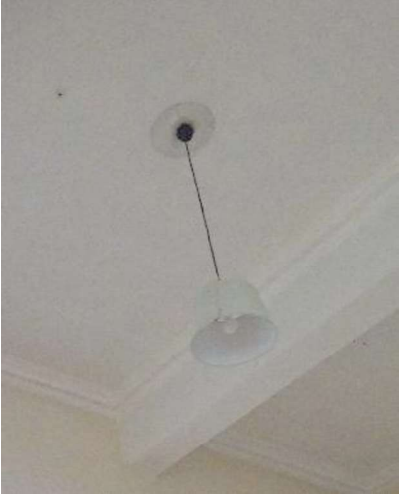
#### 6.8.4 PENDANT LAMP

| | <b>Description</b> | 6no pendant lamp of the Concert Hall. |
| | <b>Condition</b> | Reasonable condition. |
