Environmental Impact Assessment Report

St. Vincent's Hospital Fairview

Volume 2 – EIA Report Appendices

Prepared by: AWN Consulting, March 2023

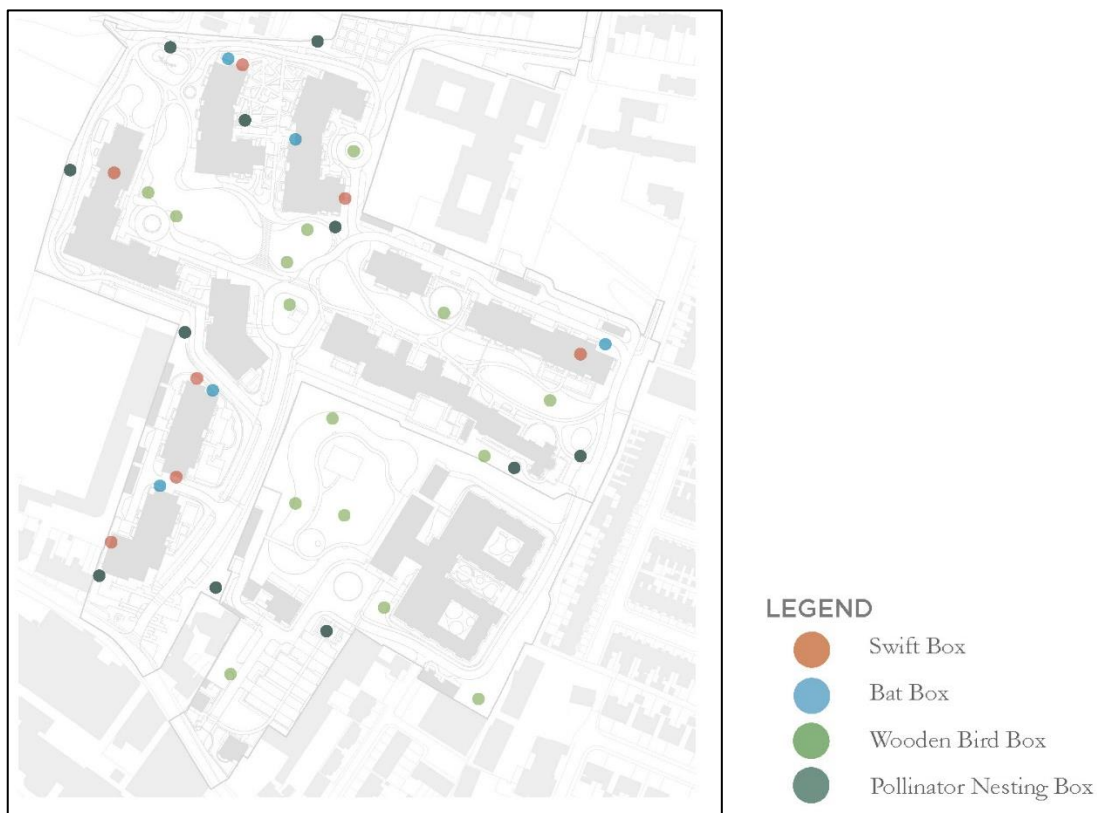
The proposed landscape general arrangement plan is demonstrated in Figure 4 and the proposed location of a selection of the bat boxes (blue) on the new buildings is seen below:

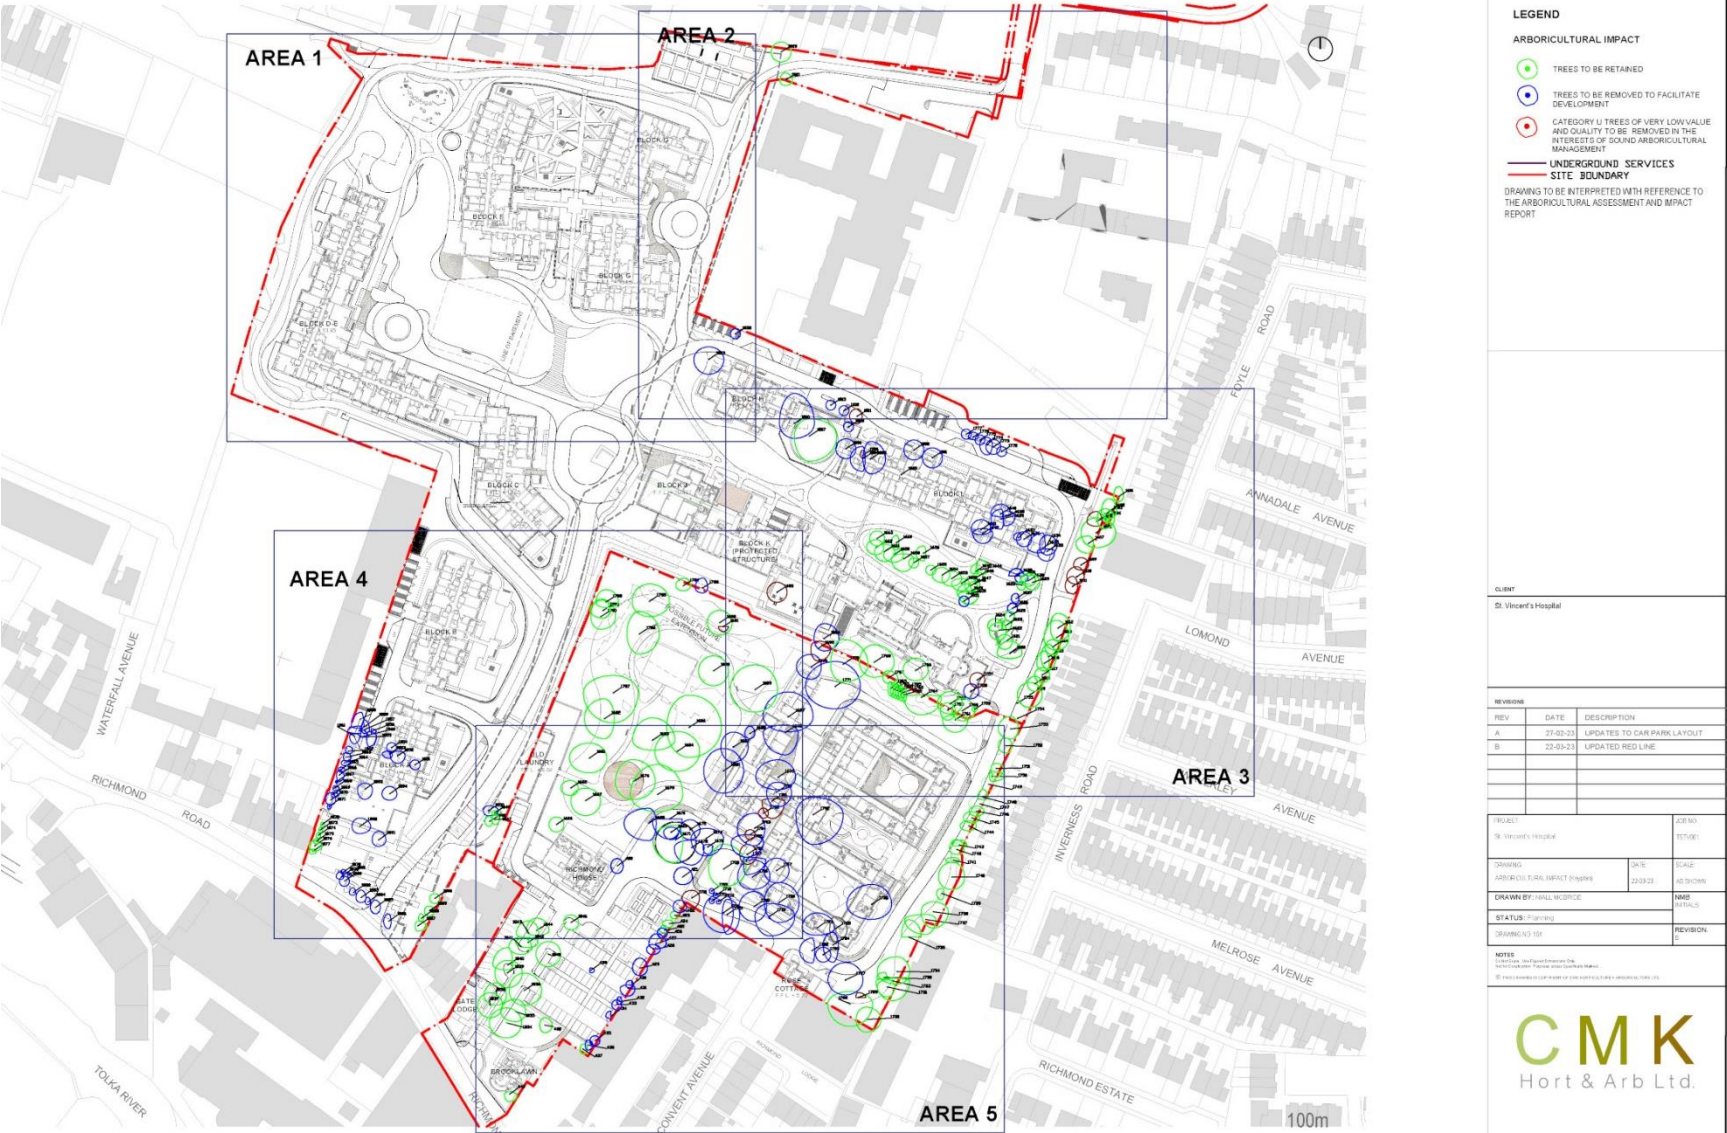
Figure 6. Tree impact drawing (Trees to be retained (green). Trees to be removed (blue)

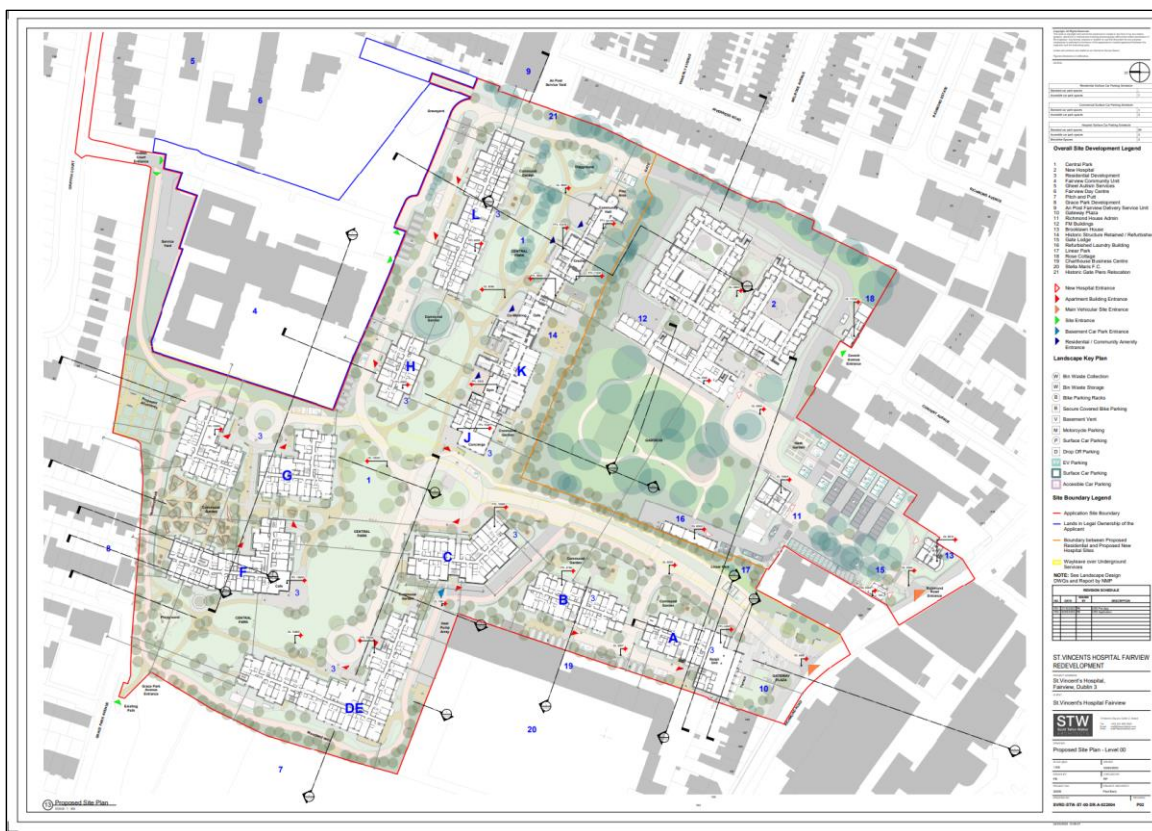
Figure 4.2 Proposed Site Layout (Source STW)

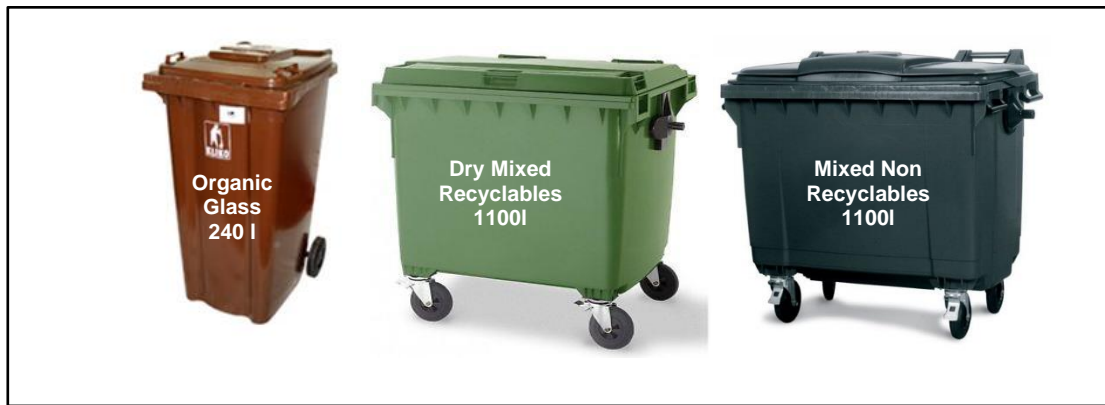
Figure 5.1 Typical waste receptacles of varying size (240L and 1100L)

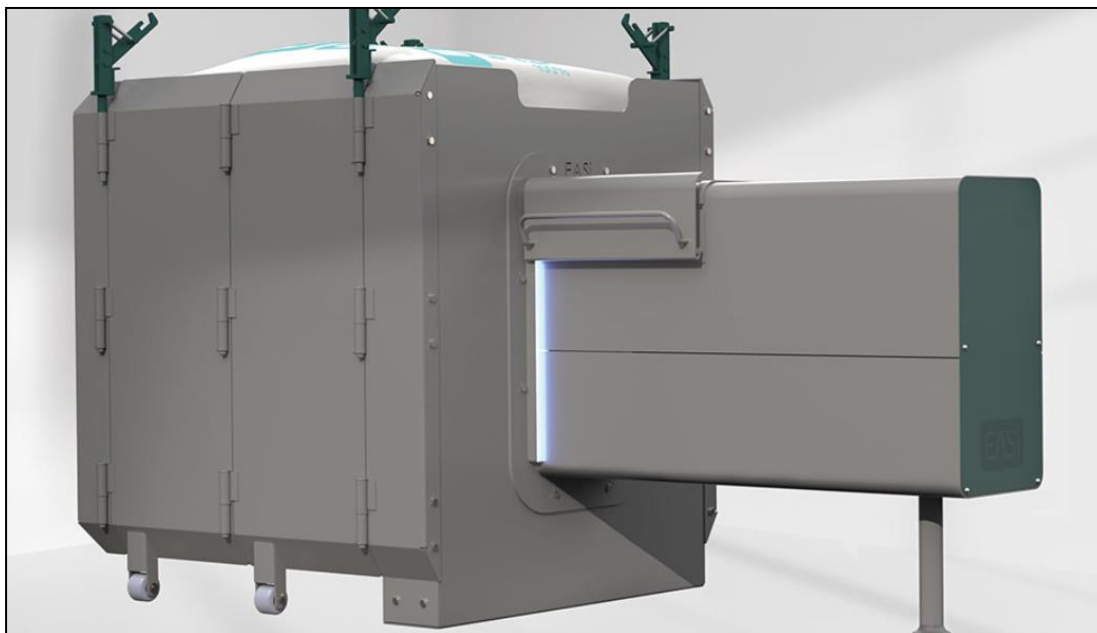
Figure 5.2 Photo of an Epac Mini Compactor (Source: bnmrecycling Website)

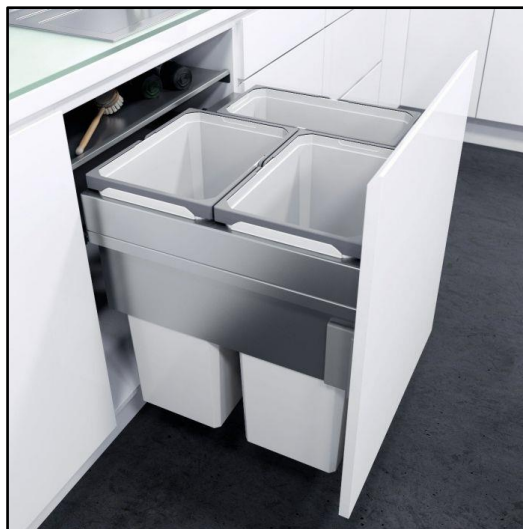
Figure 5.3 Example three bin storage system to be provided within the unit design
