# **Arboricultural Assessment, Arboricultural Impact and Tree Protection Report**

## **St. Vincent's Hospital, Fairview, Dublin 3**

<b>Project No.</b>	TSTV001	<b>Date</b>	22/03/23
<b>Project Name</b>	St. Vincent's Hospital Redevelopment	<b>Revision</b>	F

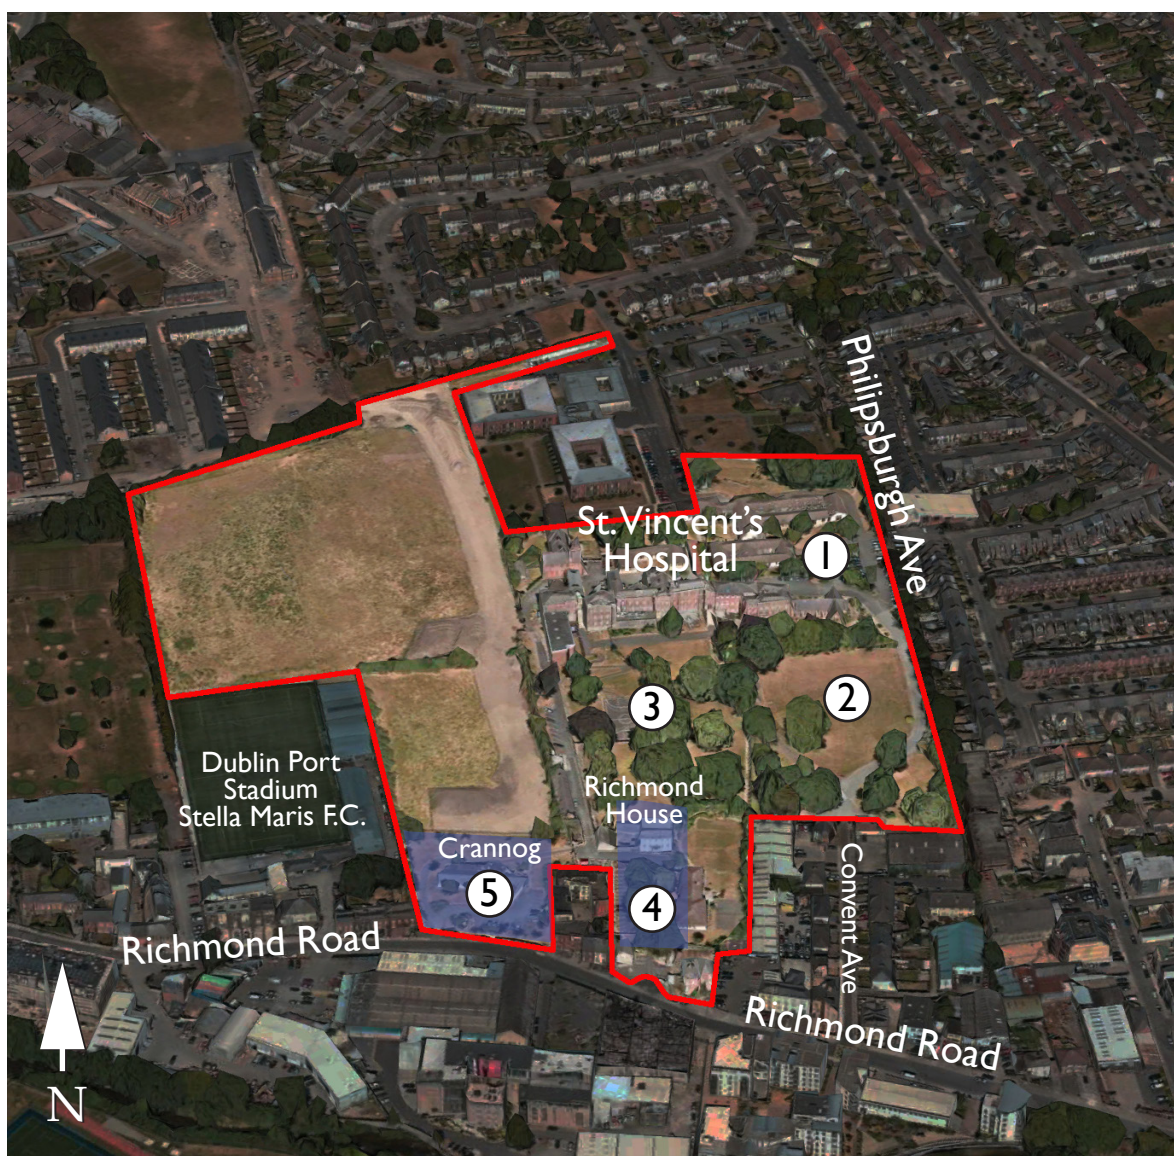
Image 1. Site overview with red line outline of survey boundary located at St. Vincent's Hospital, Richmond Road, Fairview Dublin 3. Numbered elements (areas 1-5) are referenced within the general description of trees (Pg. 2-8).

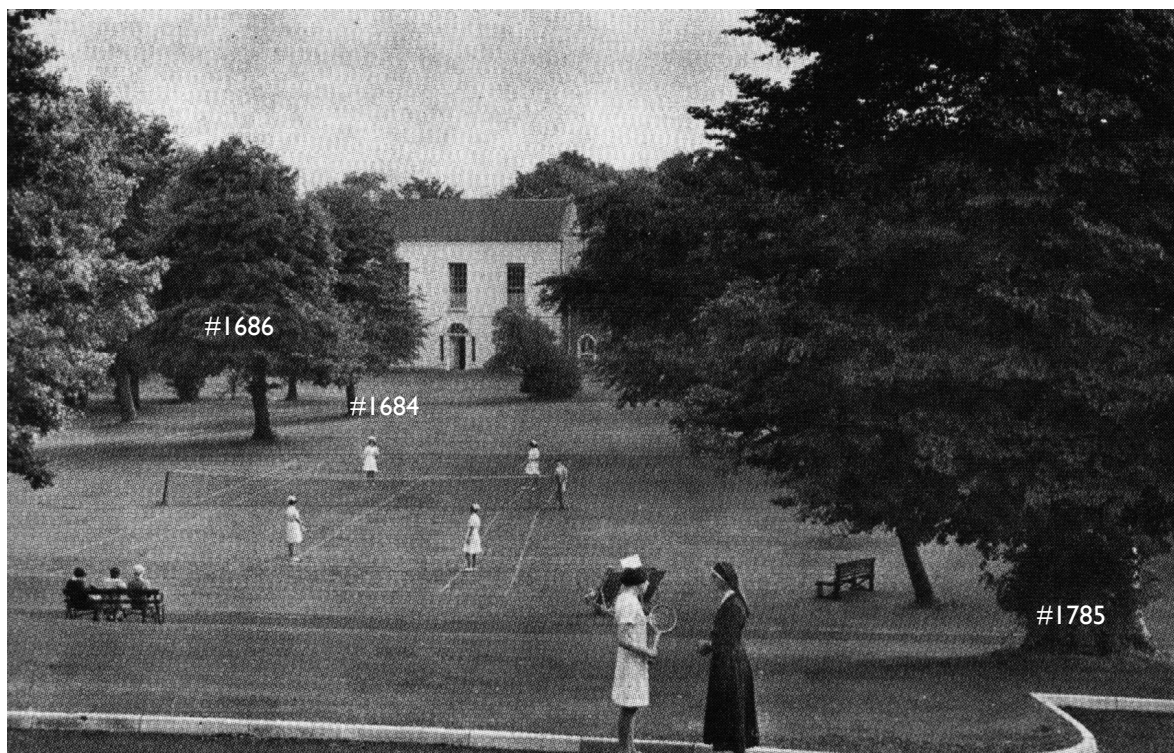
Image 18. View from St.Vincent's Hospital toward Richmond House in 1965 showing London plane (#1686), Drummond's maple (#1684) and Sycamore (#1785).

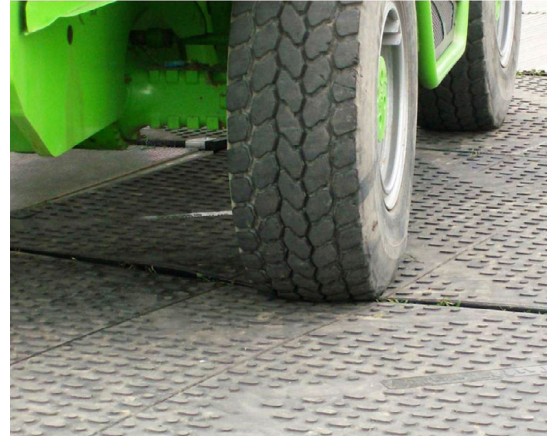
Image 19 Rola-Trac™ protective matting.

Protective matting (AKA ground mats or bog mats) such as Rola-Trac™ (image 19) should be placed over the initial work zone areas near tree root systems to mitigate any adverse effects from the presence of machinery and associated construction activity by works personnel. These also have the benefit of protecting the soil from any potential works contaminants due to works.

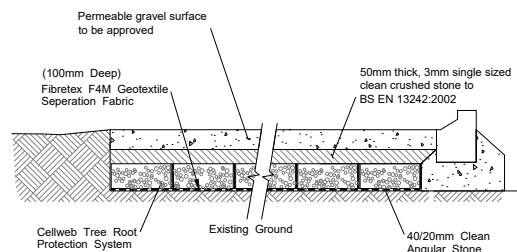
Image 20 Cellweb tree root protection system.

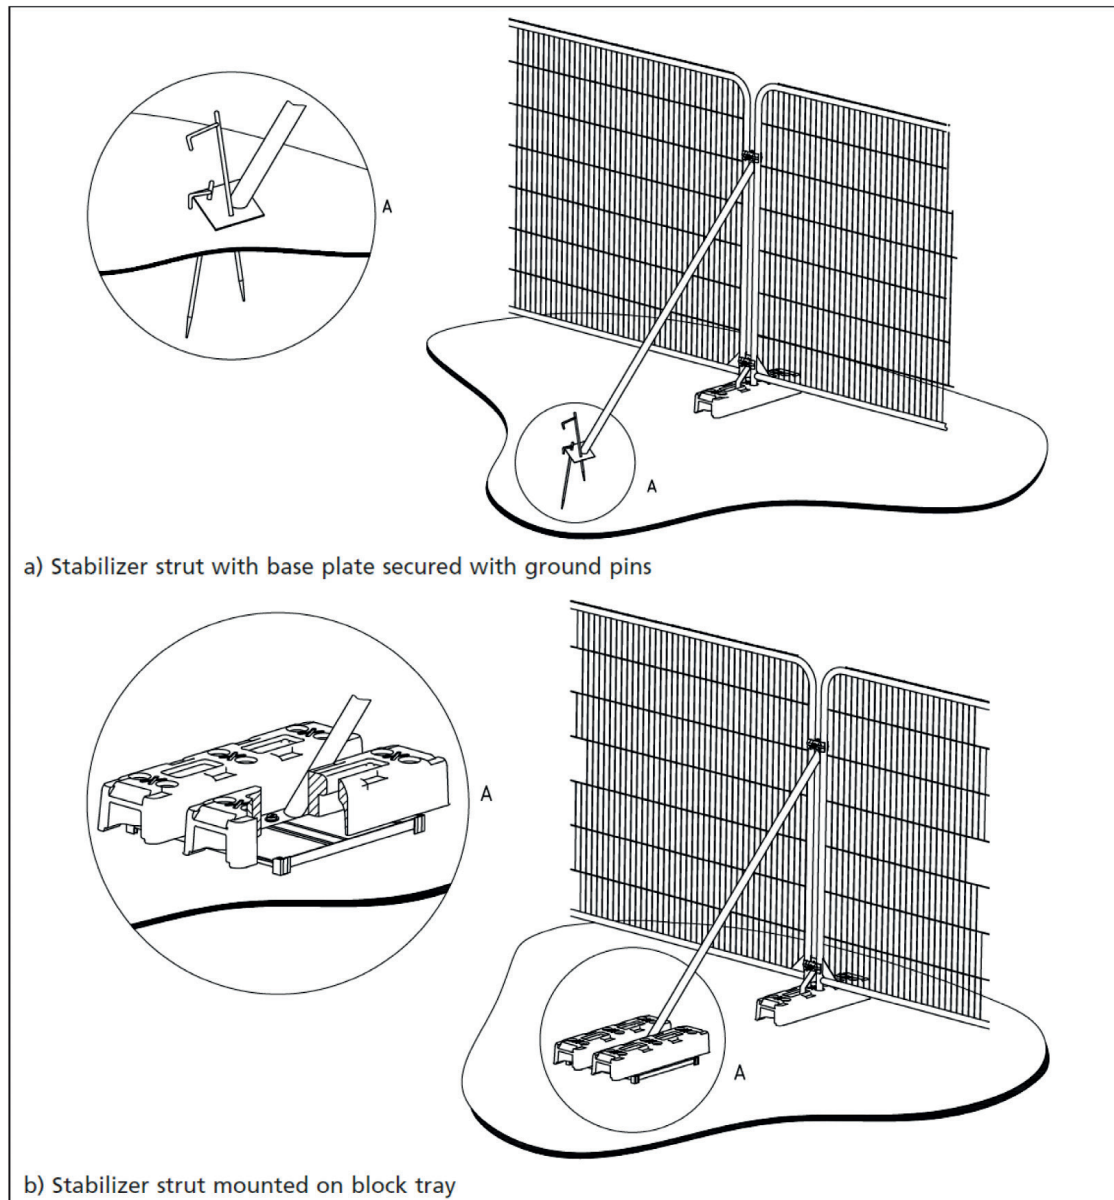
**Image 9** Tree Protection Detail (Herras type fencing or similar approved).

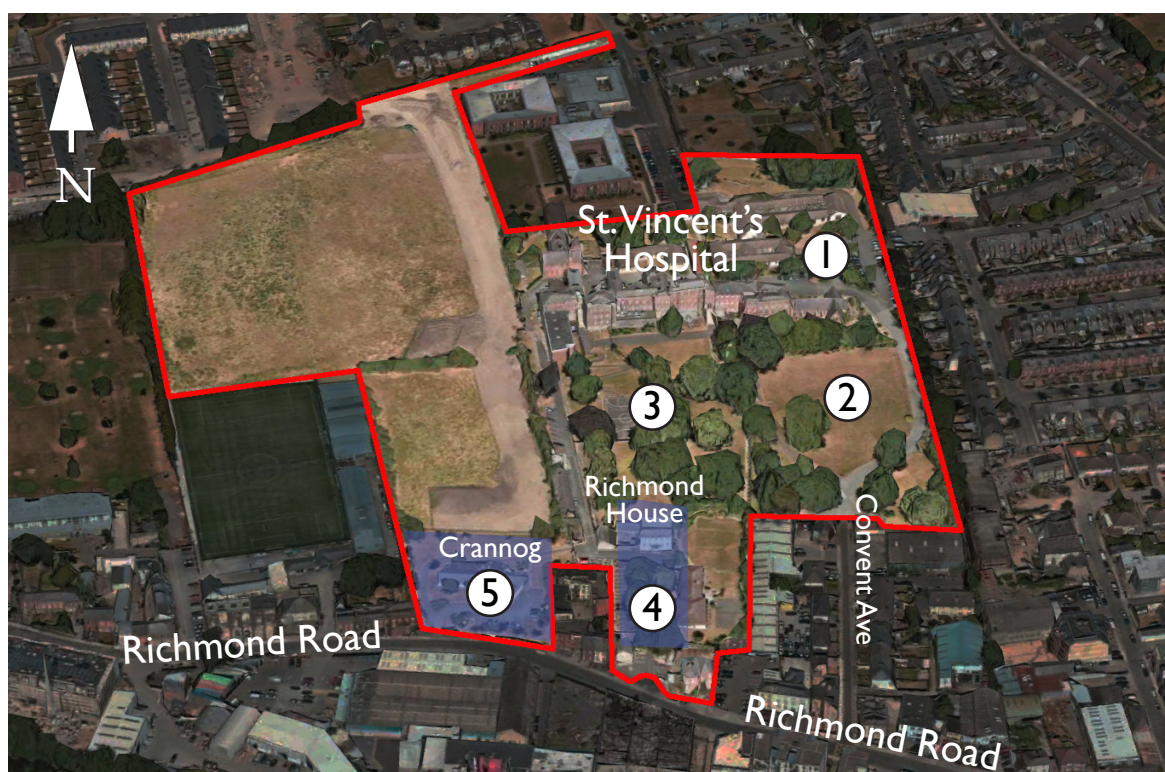
The highest concentration of historic trees is located between Richmond House and St. Vincent's Hospital (area 3; image 10). These trees have generally developed well due to adequate distances between tree within the open garden area.

East of this location (see area 2; image 10) are a number of historic trees which follow the original entrance road from Convent Avenue. This group contains a higher number of lower category tree due to issues such as cavities and denser available planting space.

Area 4 (image 10) contains a single tree identified as historic, the horse chestnut (#1834). The other trees along this entrance have been planted after the originals were removed.

Image 10. Site overview with red line outline of survey boundary located at St. Vincent's Hospital, Richmond Road, Fairview Dublin 3.
