St. Vincent's Hospital Fairview Redevelopment, Fairview Dublin 3

Daylight and Sunlight Analysis

IN2 Project No. D2116

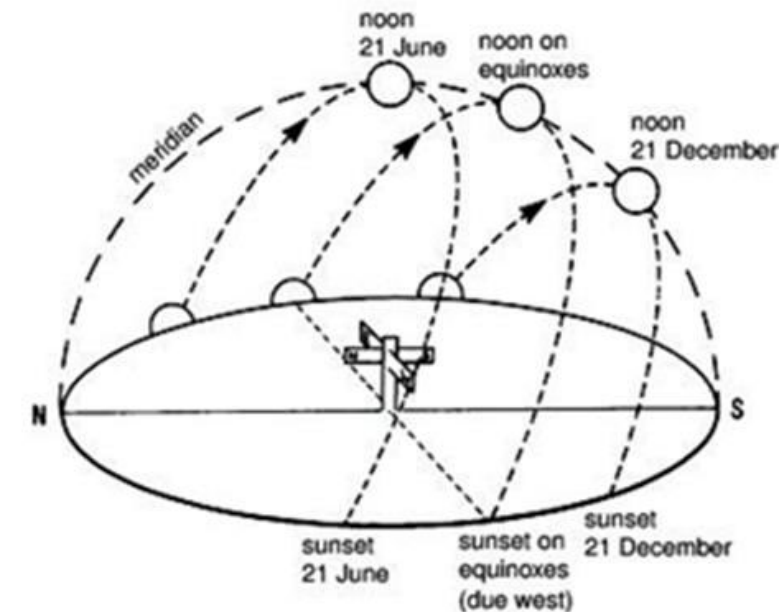
Fig 4.1.1 – Annual Solar Position

The methodology assesses sunlight performance at the Equinox, as this is the mid solar position throughout the year (as illustrated in Fig.4.1.1), with compliance indicative of spaces that will receive adequate sunlight and appealing useful spaces, including that the following attributes will be achieved as identified in BRE.209:

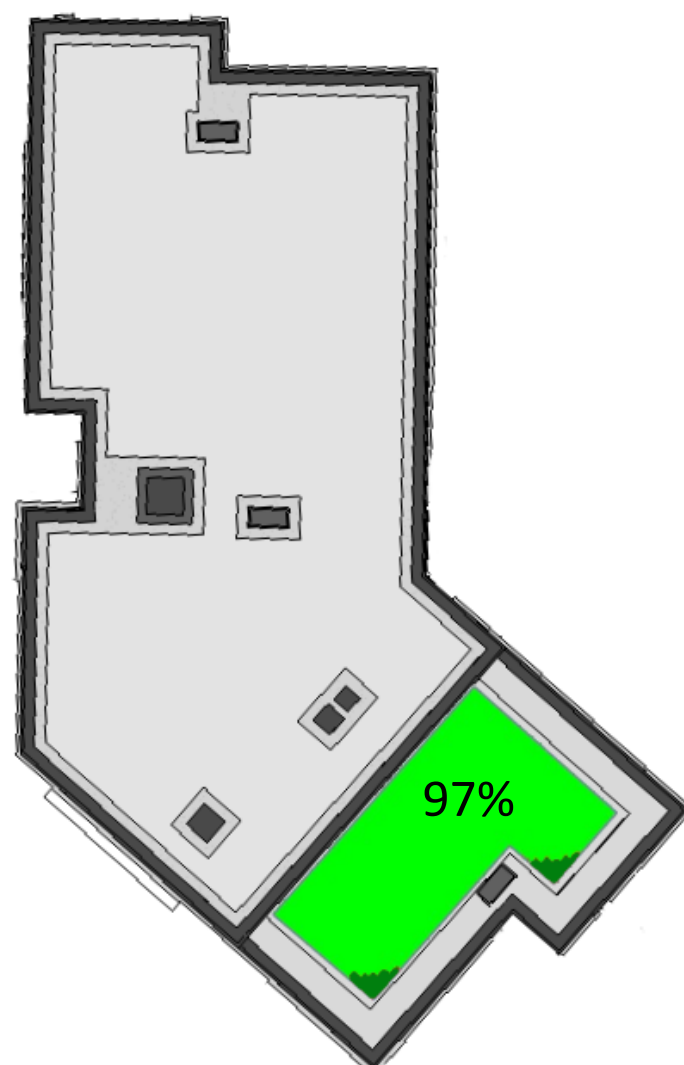
Fig 4.3.1 – Amenity Area Sunlight Availability – Block C Roof Level

Figure 4.3.1-4.3.2 illustrates the results determined for each roof level amenity space, indicating the predicted percentage area that could achieve at least 2 hours sunlight in accordance with the methodology.

Overall, these amenity spaces were found to be compliant with the guidelines. **97%** of Block C and **85%** Blocks D & E roof level amenity space as assessed is determined to be compliant, receiving at least 2 hours of direct sunlight on 21st March as defined within the guidance.

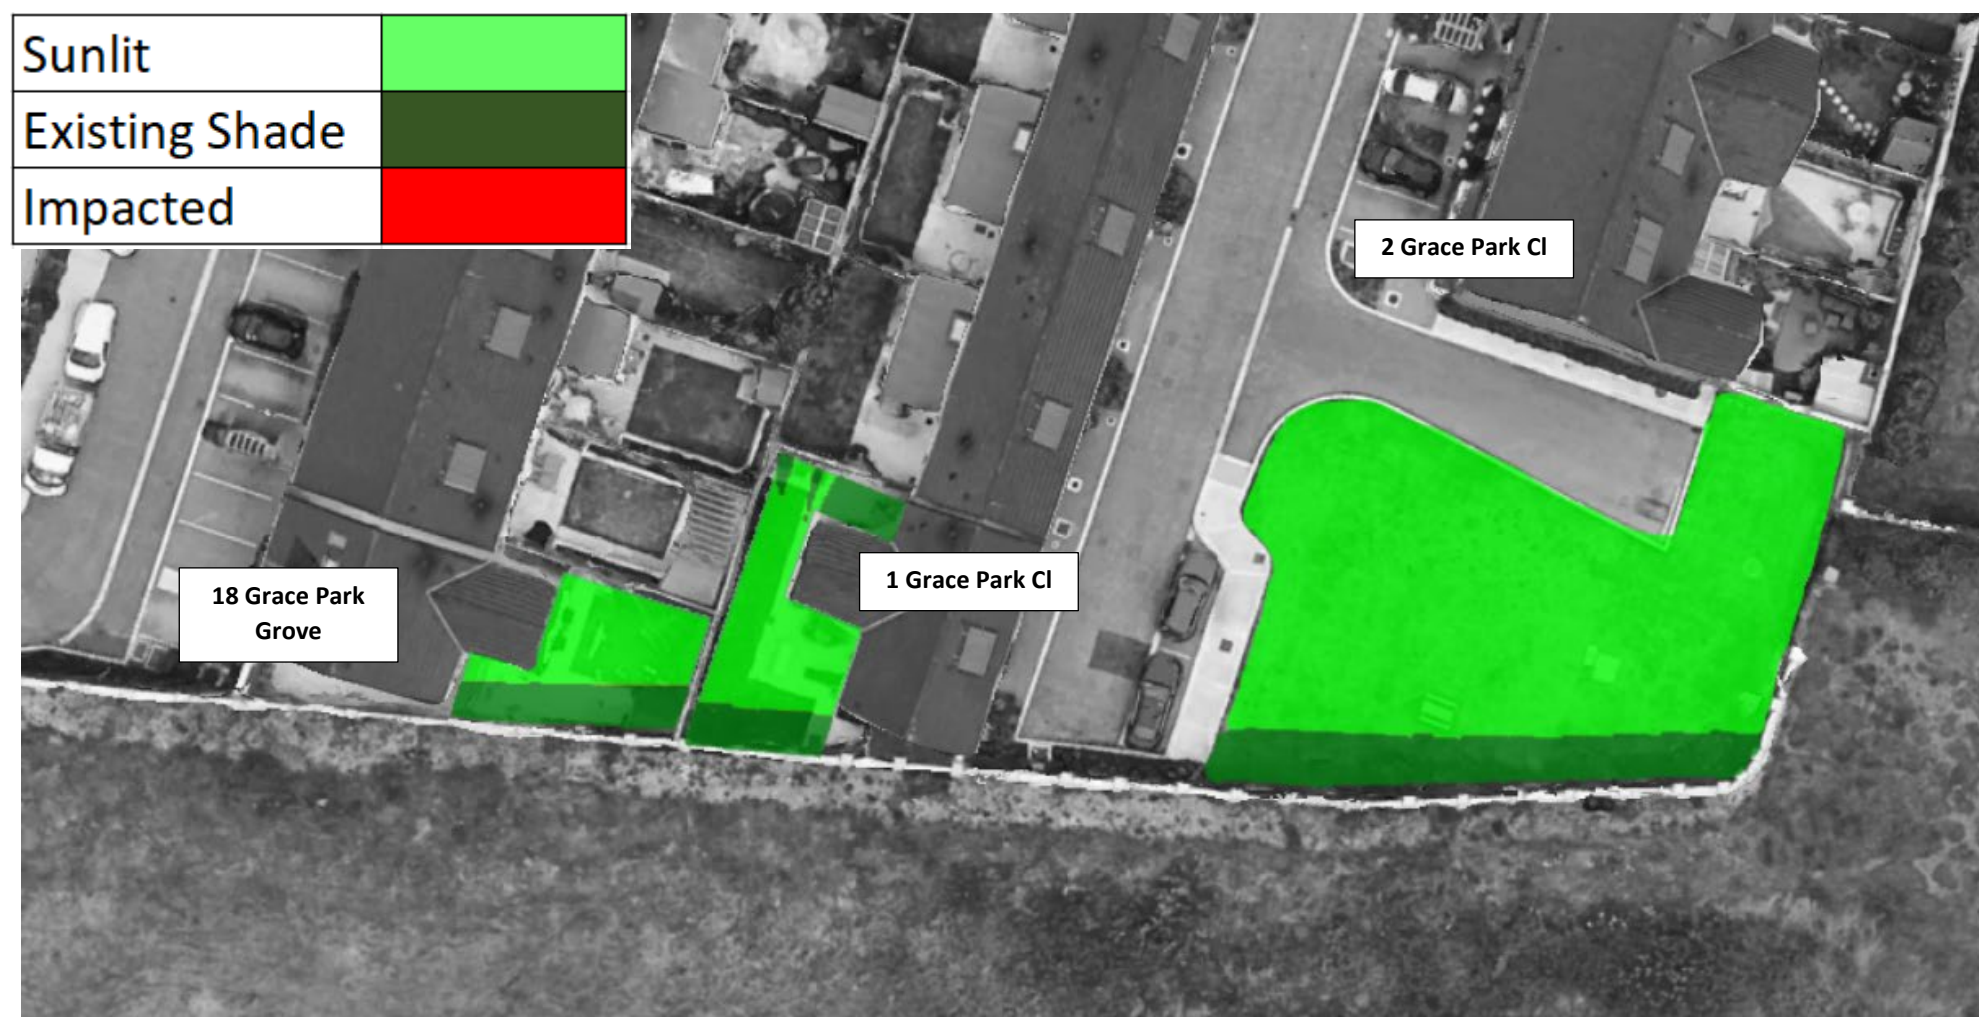
Figure 5.6 – Impact on Neighbouring Results

Neighbouring gardens are not negatively impacted by the proposed development. In the case of these nearest amenity spaces, there is no reduction in sunlight to existing gardens as a result of the proposed development.

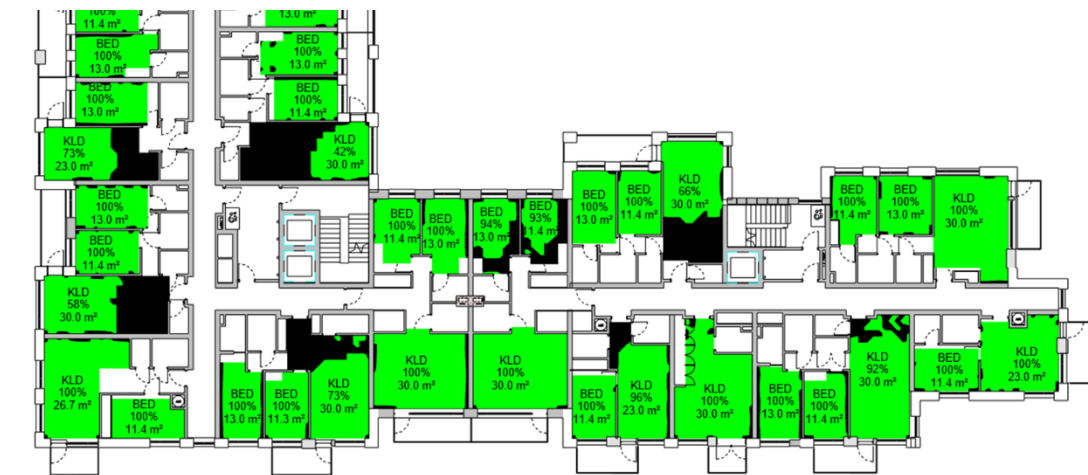
Fig 6.1.1 –Daylight Analysis Results

Fig 6.1.1 indicates overall compliance comparison, with green contours illustrating where daylight was predicted to achieve 100 Lux for bedroom 150 Lux for Livingroom and 200 Lux for KLD and Kitchen. These are the illuminance recommendations for dwellings included in Section C16 of the BR.209 2022 edition, based on BS.EN.17037:2018. Compliance for a room is then defined in the BRE Guide if at least 50% of the room achieves this target.

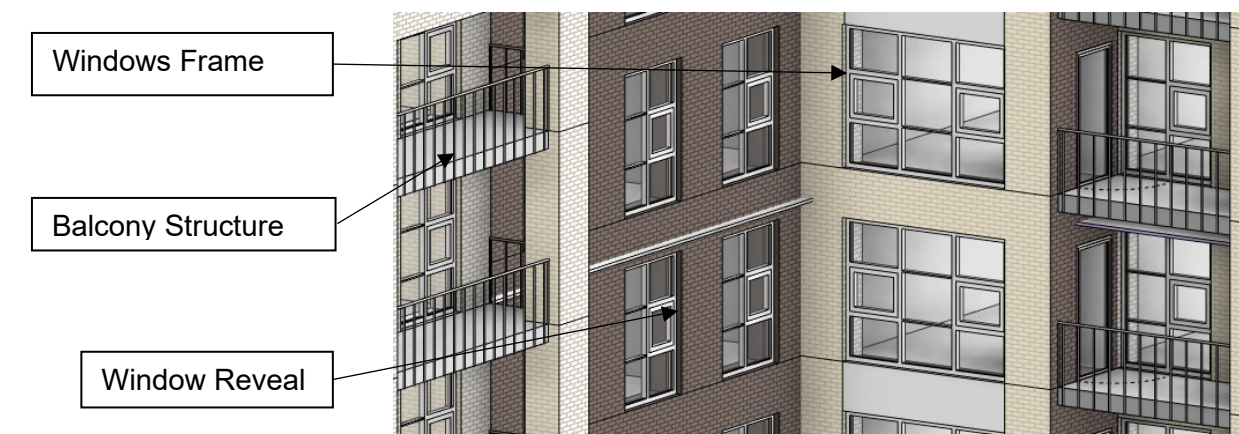
Fig 6.1.2 – Building Details included within Daylight Analysis (Sample)

The daylight analysis accounted for all aspects that can potentially restrict natural light availability including any adjacent / opposing buildings, along with explicitly modelling typical Building Details as exemplified in Figure 6.1.2 such as balcony structures, window frames, reveal and cill depth etc. in accordance with the architectural design. As the window frames have been explicitly modelled there is no requirement to include framing factors as prescribed in the BRE Guide.

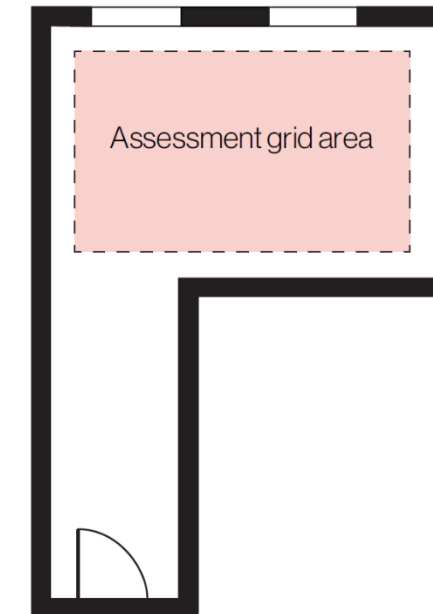
Fig 6.1.4 – BR 209 Figure C3 – Assessment Area excluding Corridor

BR.209 2022 provides additional guidance on room definitions, identifying that corridors/annexed entrances can be excluded from the assessment area as illustrated in Fig. 6.1.4.

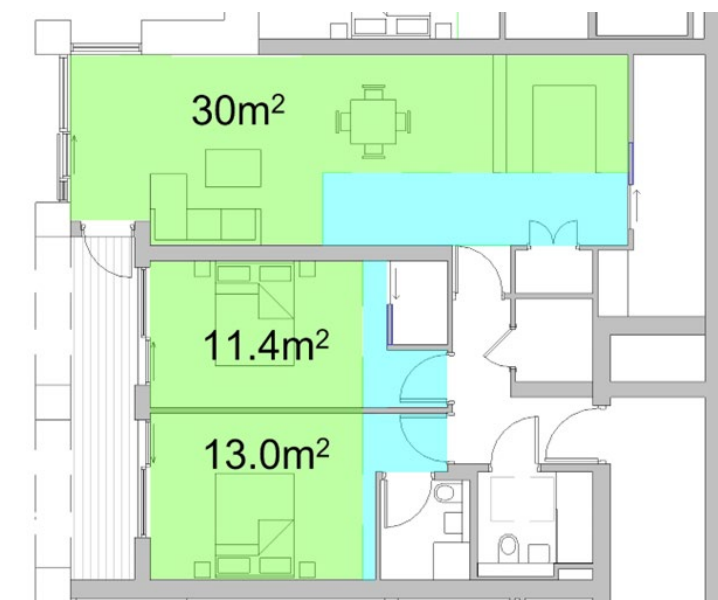
Fig 6.1.5 – Assessment Space Delineation

Fig 6.1.5 illustrates an example of how the above has been interpreted to define areas of assessment (highlighted green) ensuring:

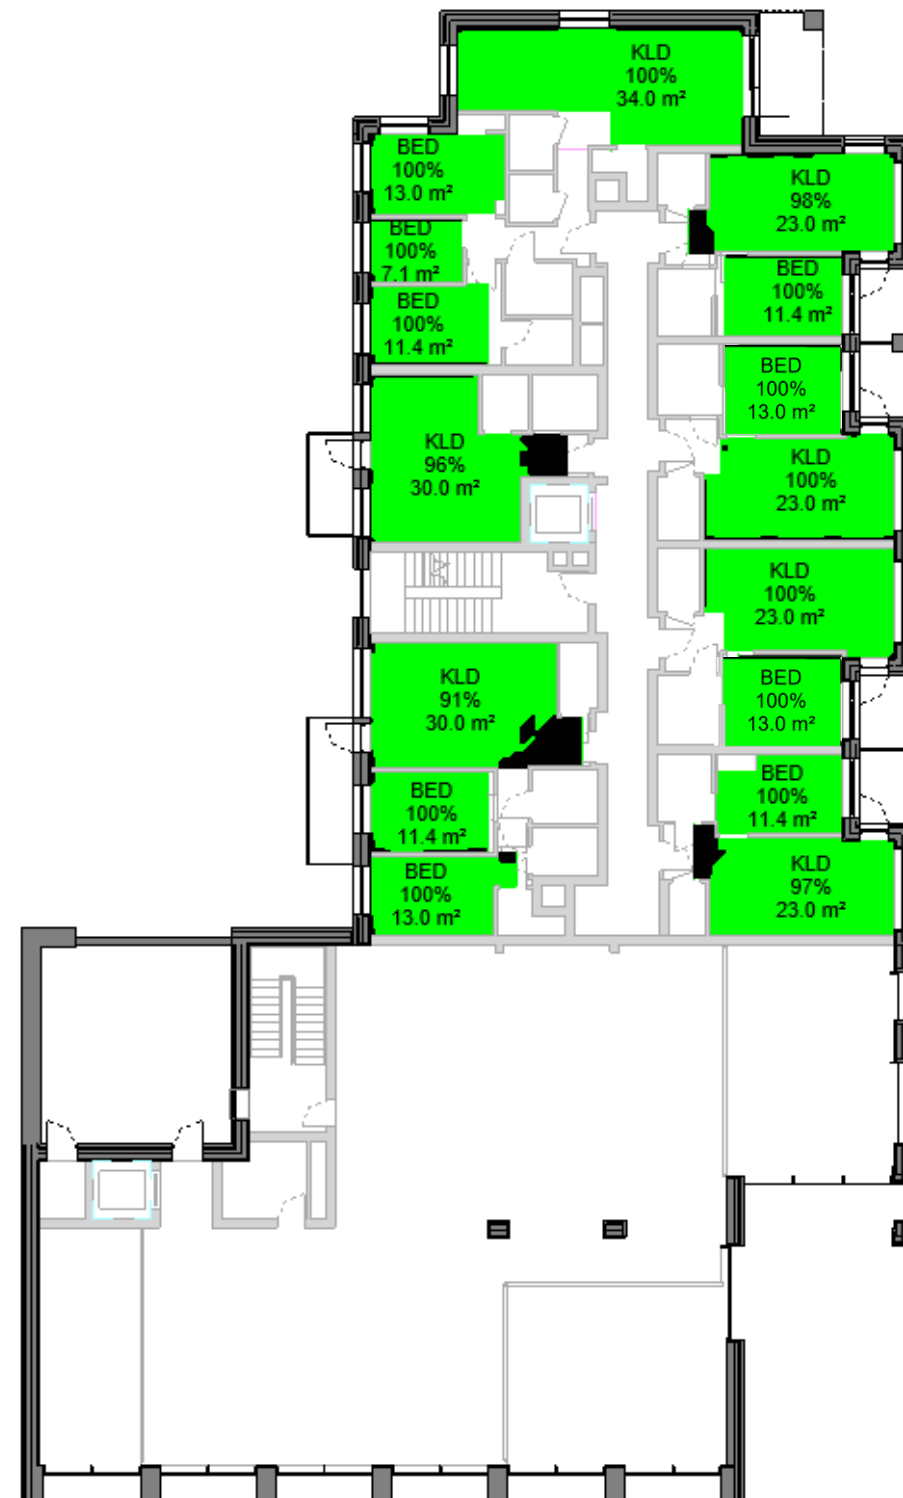
Daylight analysis results are illustrated below with green shaded area receiving targeted illuminance, 200Lux for KLDs and 100Lux for Bedrooms. Black shade is showing area where it’s receiving less than targeted illuminance. A space is deemed compliant where >50% of areas achieve target illuminance.

Every room was determined to be compliant for SDA in this area.

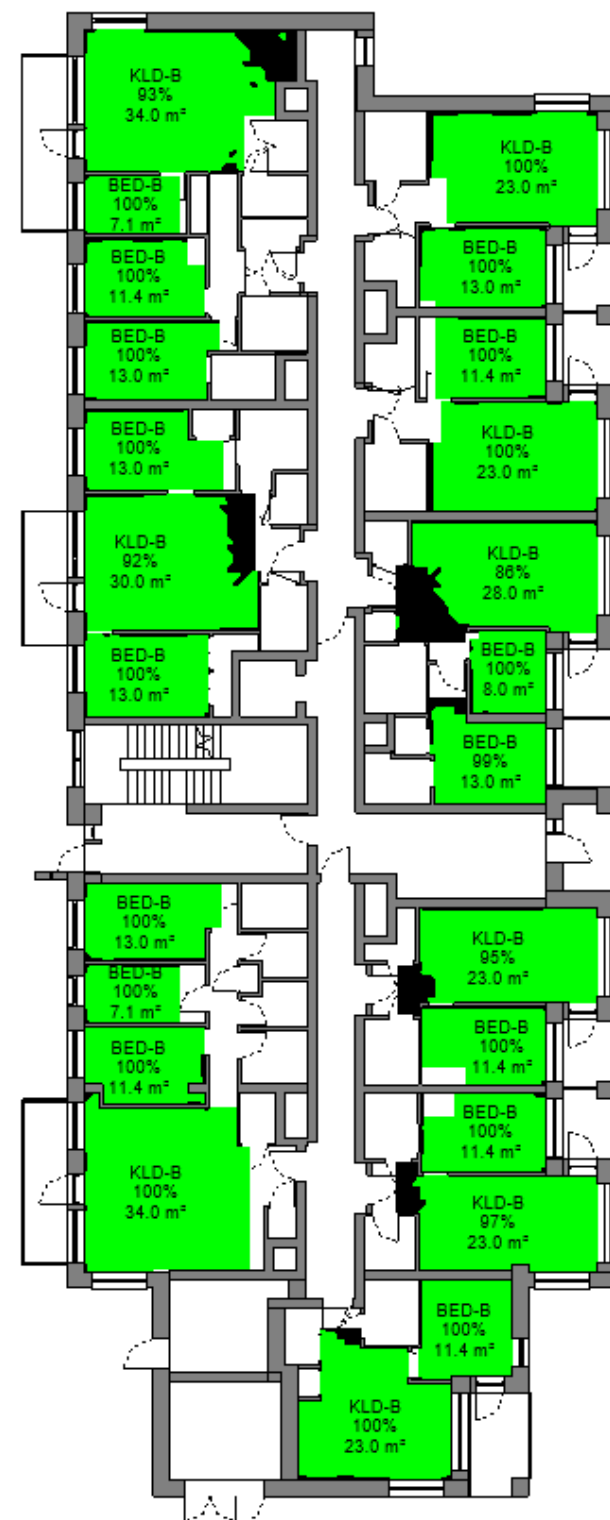
Every room was determined to be compliant for SDA in this area.

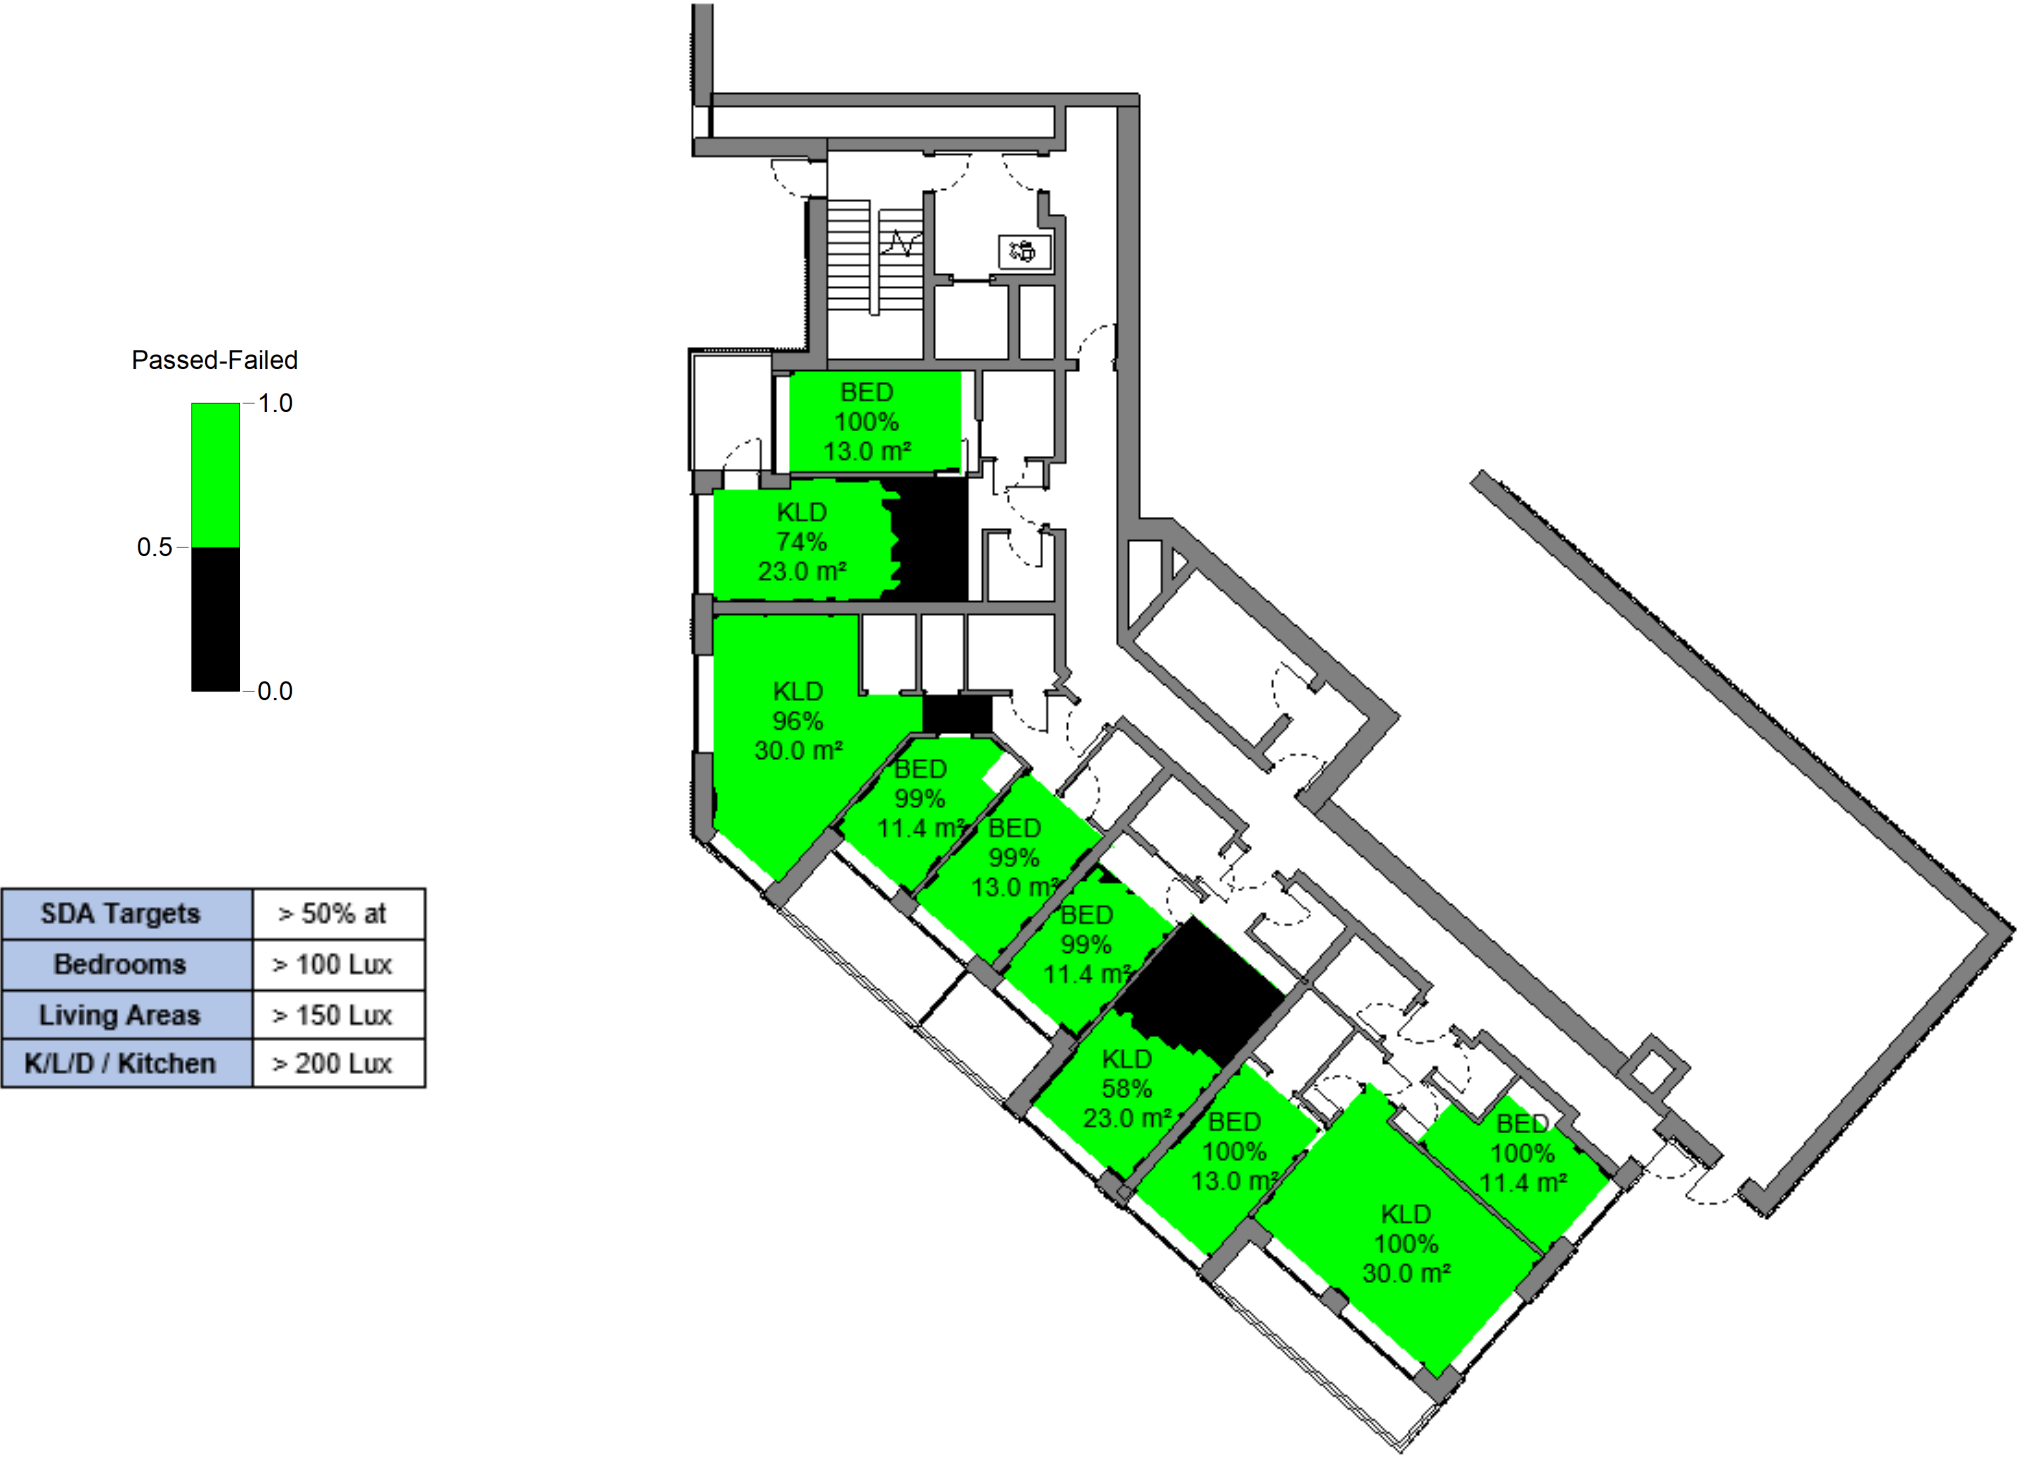
Daylight analysis results are illustrated below with green shaded area receiving targeted illuminance, 200Lux for KLDs and 100Lux for Bedrooms. Black shade is showing area where it’s receiving less than targeted illuminance. A space is deemed compliant where >50% of areas achieve target illuminance.

Every room was determined to be compliant for SDA in this area.

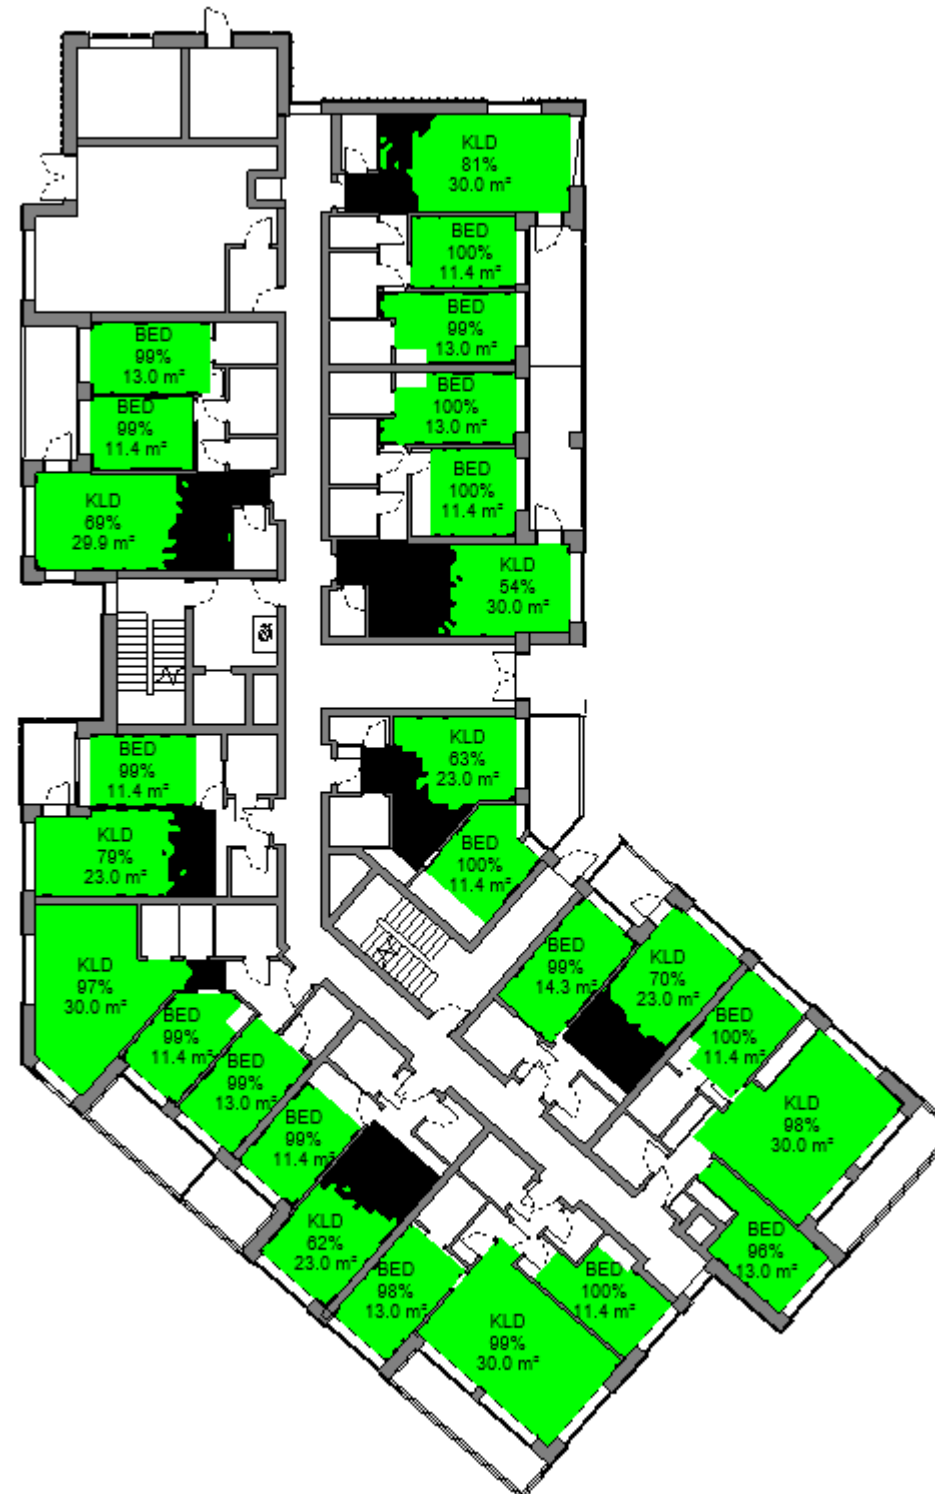
Daylight analysis results are illustrated below with green shaded area receiving targeted illuminance, 200Lux for KLDs and 100Lux for Bedrooms. Black shade is showing area where it's receiving less than targeted illuminance. A space is deemed compliant where >50% of areas achieve target illuminance.

Every room was determined to be compliant for SDA in this area.

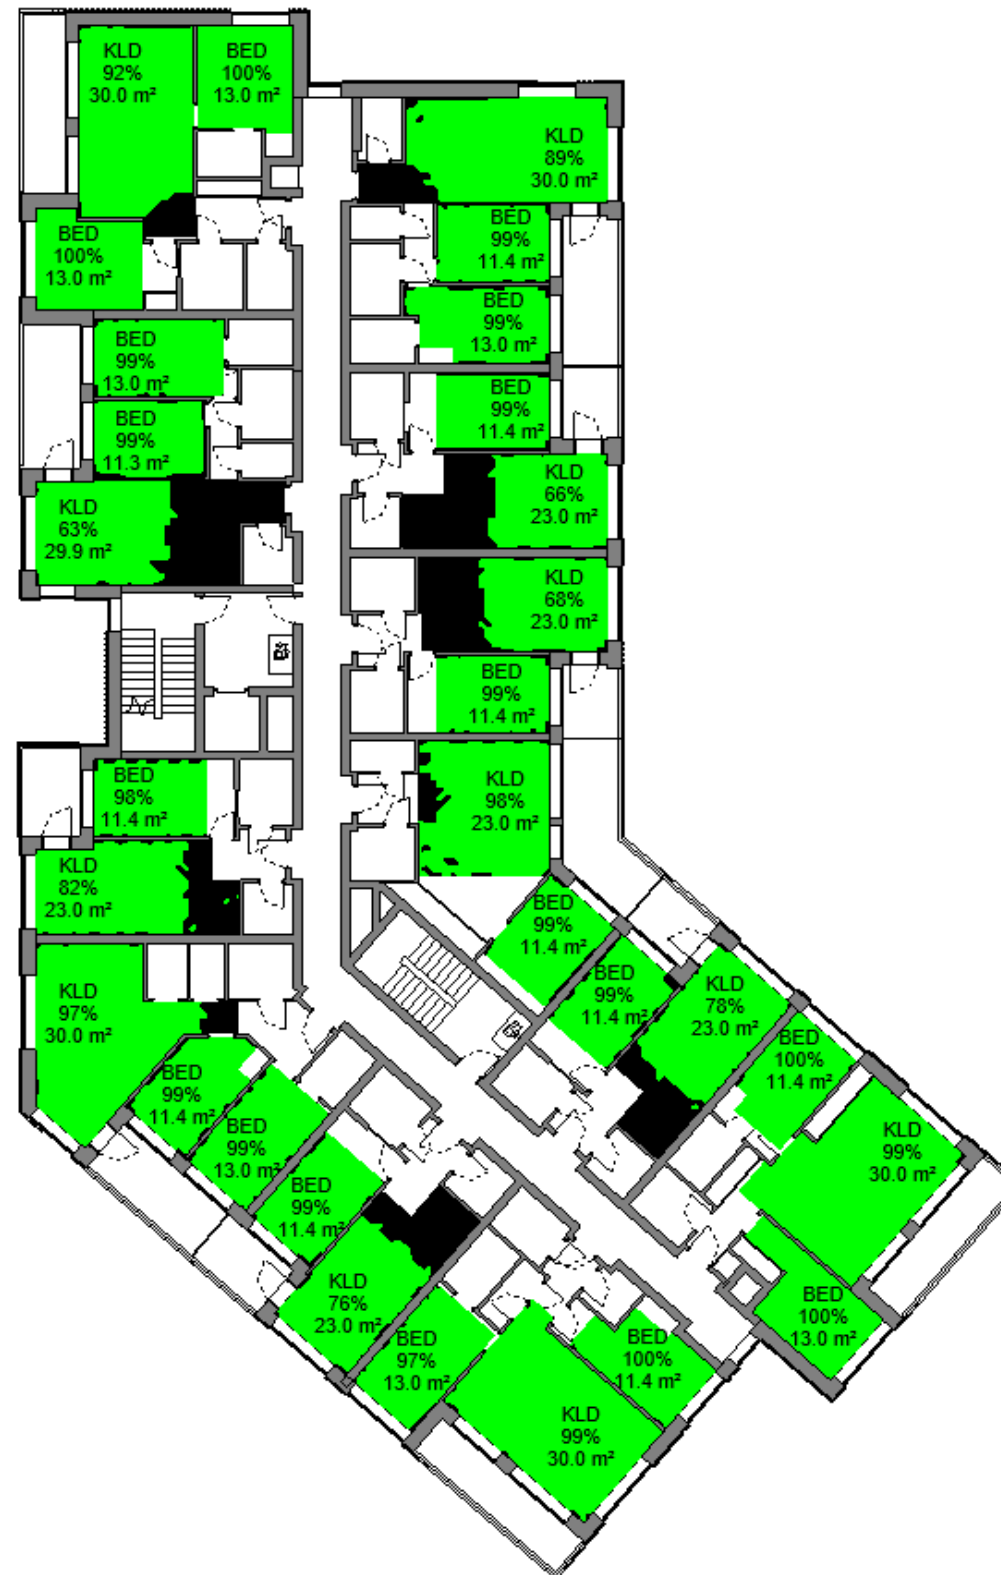
Daylight analysis results are illustrated below with green shaded area receiving targeted illuminance, 200Lux for KLDs and 100Lux for Bedrooms. Black shade is showing area where it's receiving less than targeted illuminance. A space is deemed compliant where >50% of areas achieve target illuminance.

Every room was determined to be compliant for SDA in this area.

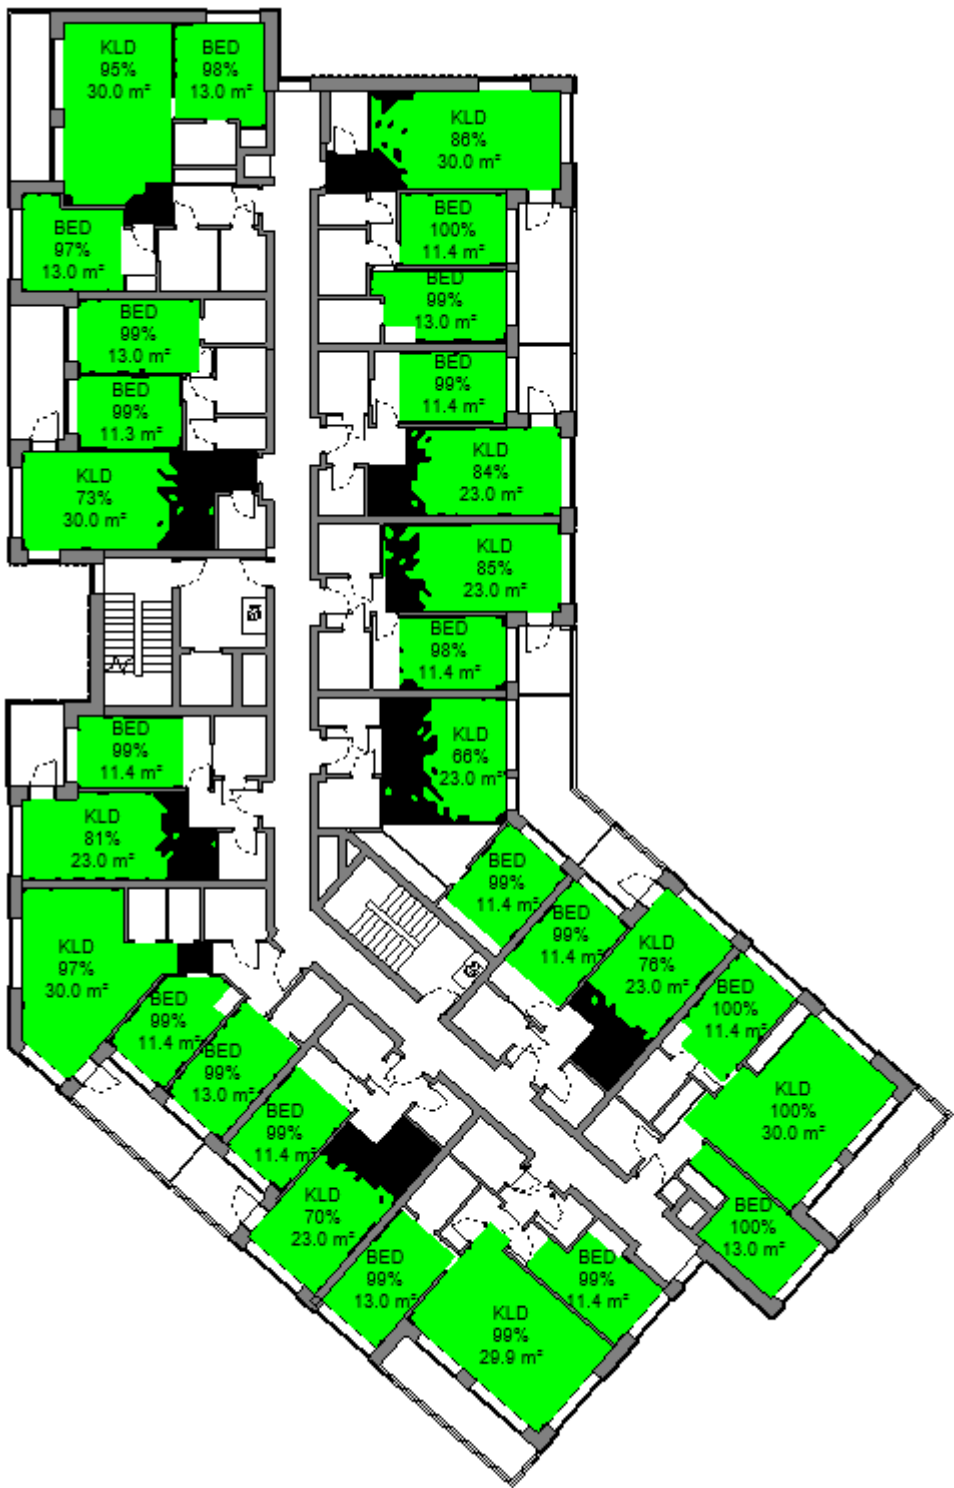
Block C – Second Floor

Daylight analysis results are illustrated below with green shaded area receiving targeted illuminance, 200Lux for KLDs and 100Lux for Bedrooms. Black shade is showing area where it’s receiving less than targeted illuminance. A space is deemed compliant where >50% of areas achieve target illuminance.
Every room was determined to be compliant for SDA in this area.

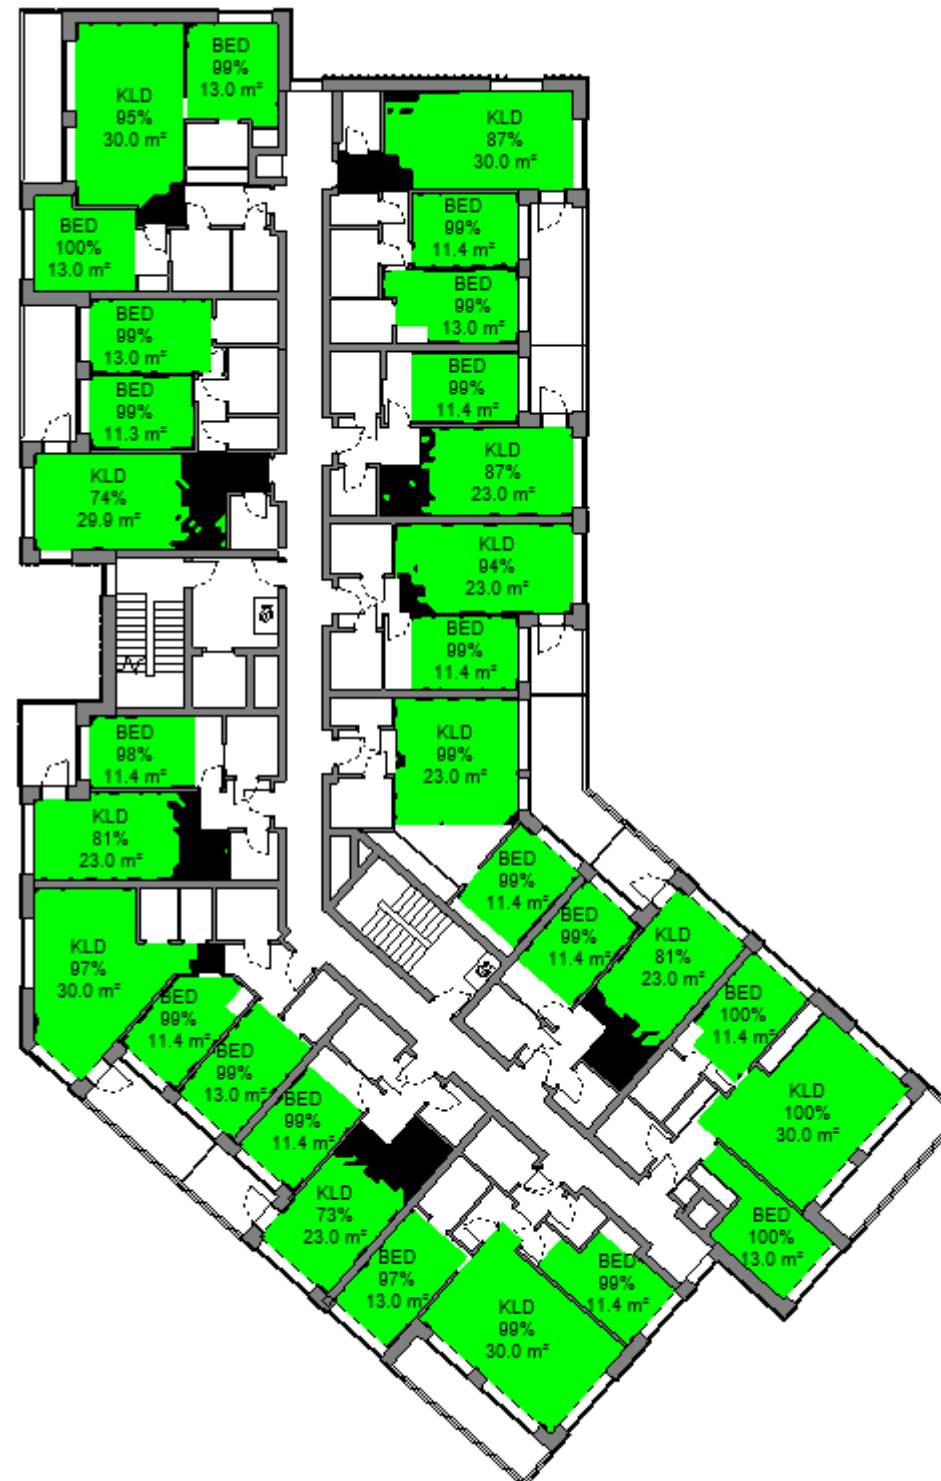
Daylight analysis results are illustrated below with green shaded area receiving targeted illuminance, 200Lux for KLDs and 100Lux for Bedrooms. Black shade is showing area where it's receiving less than targeted illuminance. A space is deemed compliant where >50% of areas achieve target illuminance.

Every room was determined to be compliant for SDA in this area.

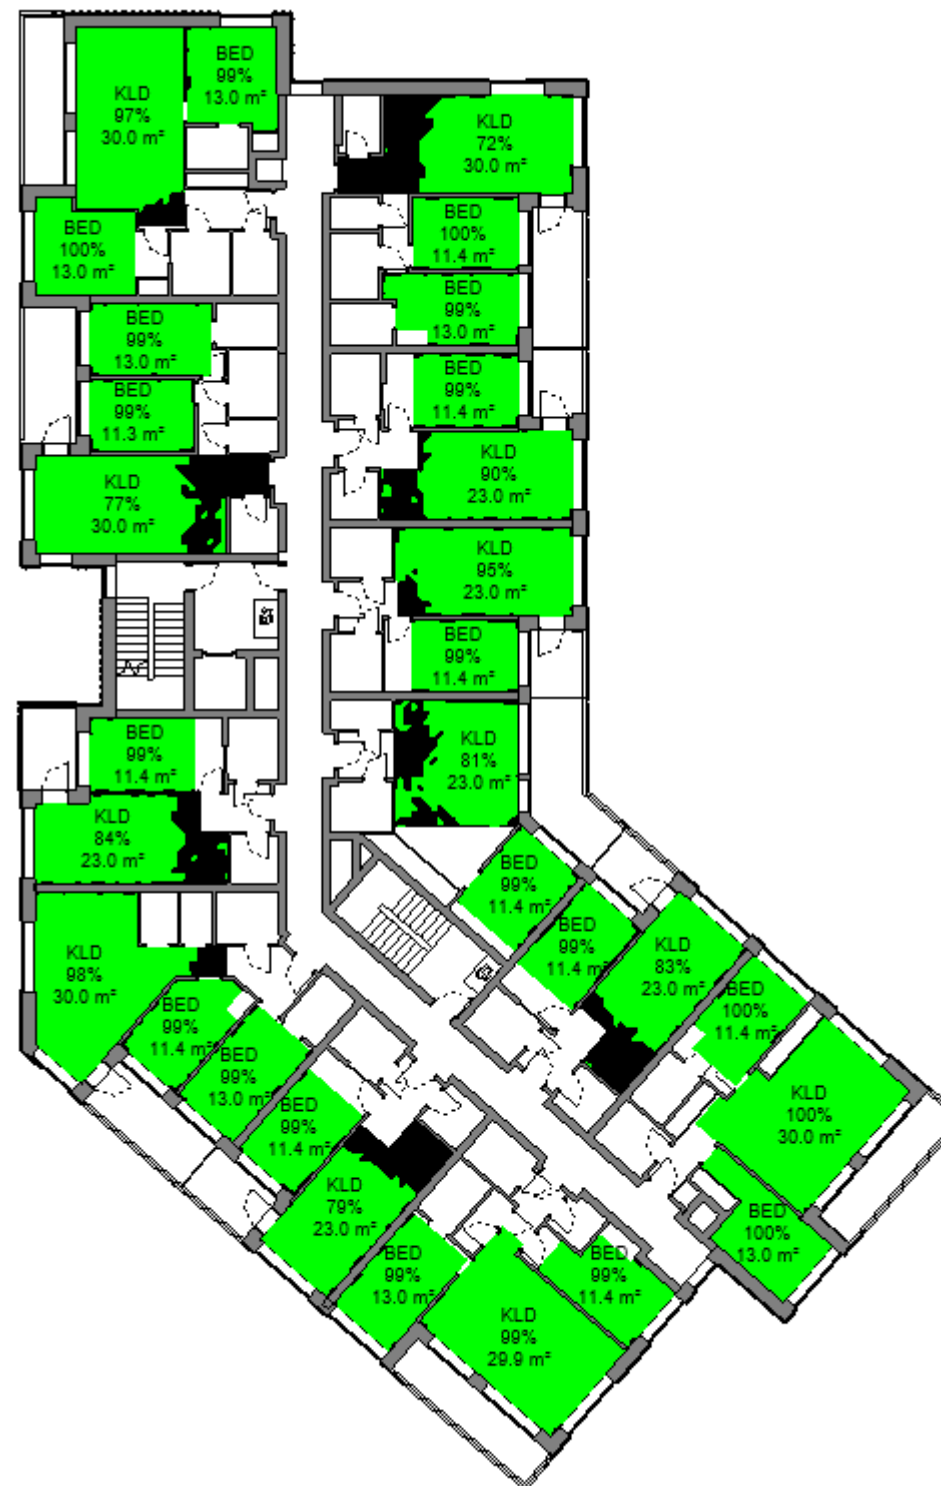
Daylight analysis results are illustrated below with green shaded area receiving targeted illuminance, 200Lux for KLDs and 100Lux for Bedrooms. Black shade is showing area where it's receiving less than targeted illuminance. A space is deemed compliant where >50% of areas achieve target illuminance.

Every room was determined to be compliant for SDA in this area.

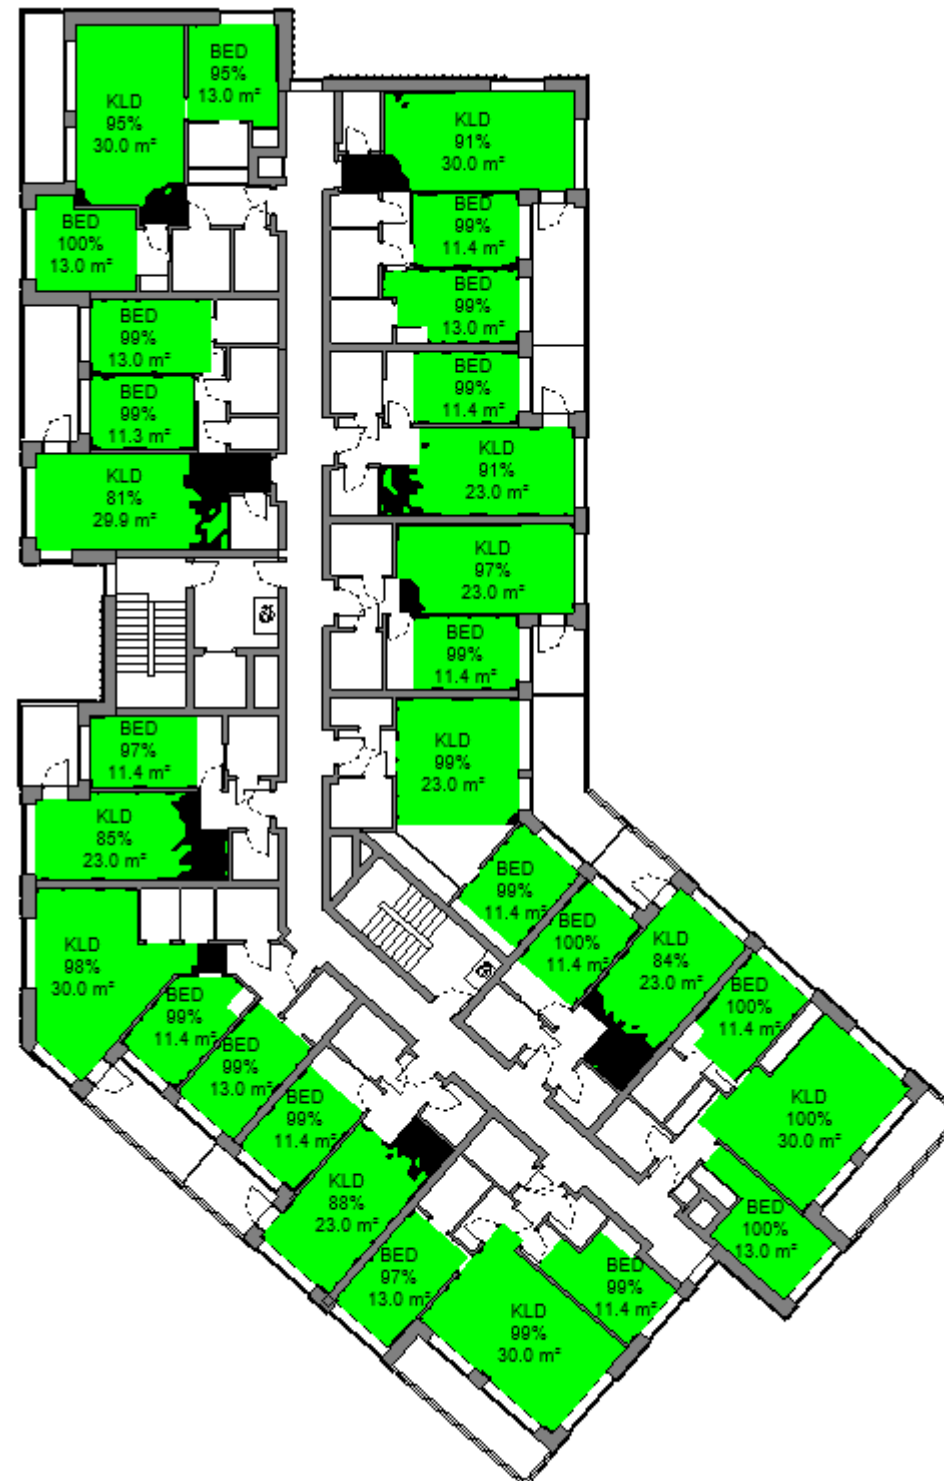
Daylight analysis results are illustrated below with green shaded area receiving targeted illuminance, 200Lux for KLDs and 100Lux for Bedrooms. Black shade is showing area where it's receiving less than targeted illuminance. A space is deemed compliant where >50% of areas achieve target illuminance.

Every room was determined to be compliant for SDA in this area.

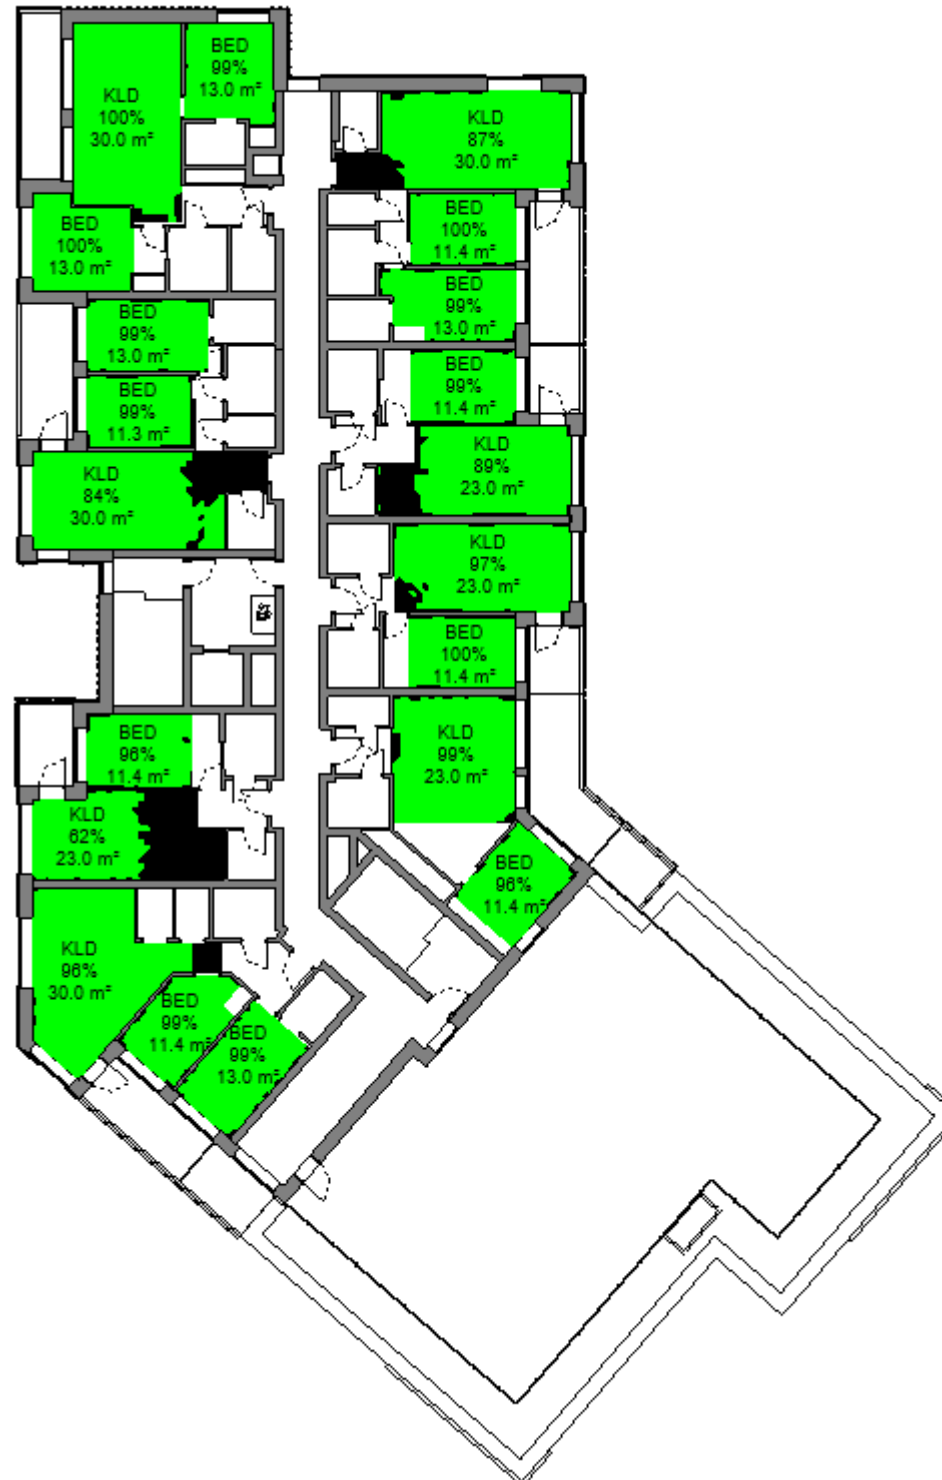
Daylight analysis results are illustrated below with green shaded area receiving targeted illuminance, 200Lux for KLDs and 100Lux for Bedrooms. Black shade is showing area where it's receiving less than targeted illuminance. A space is deemed compliant where >50% of areas achieve target illuminance.

Every room was determined to be compliant for SDA in this area.
