St. Vincent's Hospital Fairview Redevelopment, Fairview Dublin 3

Daylight and Sunlight Analysis

IN2 Project No. D2116

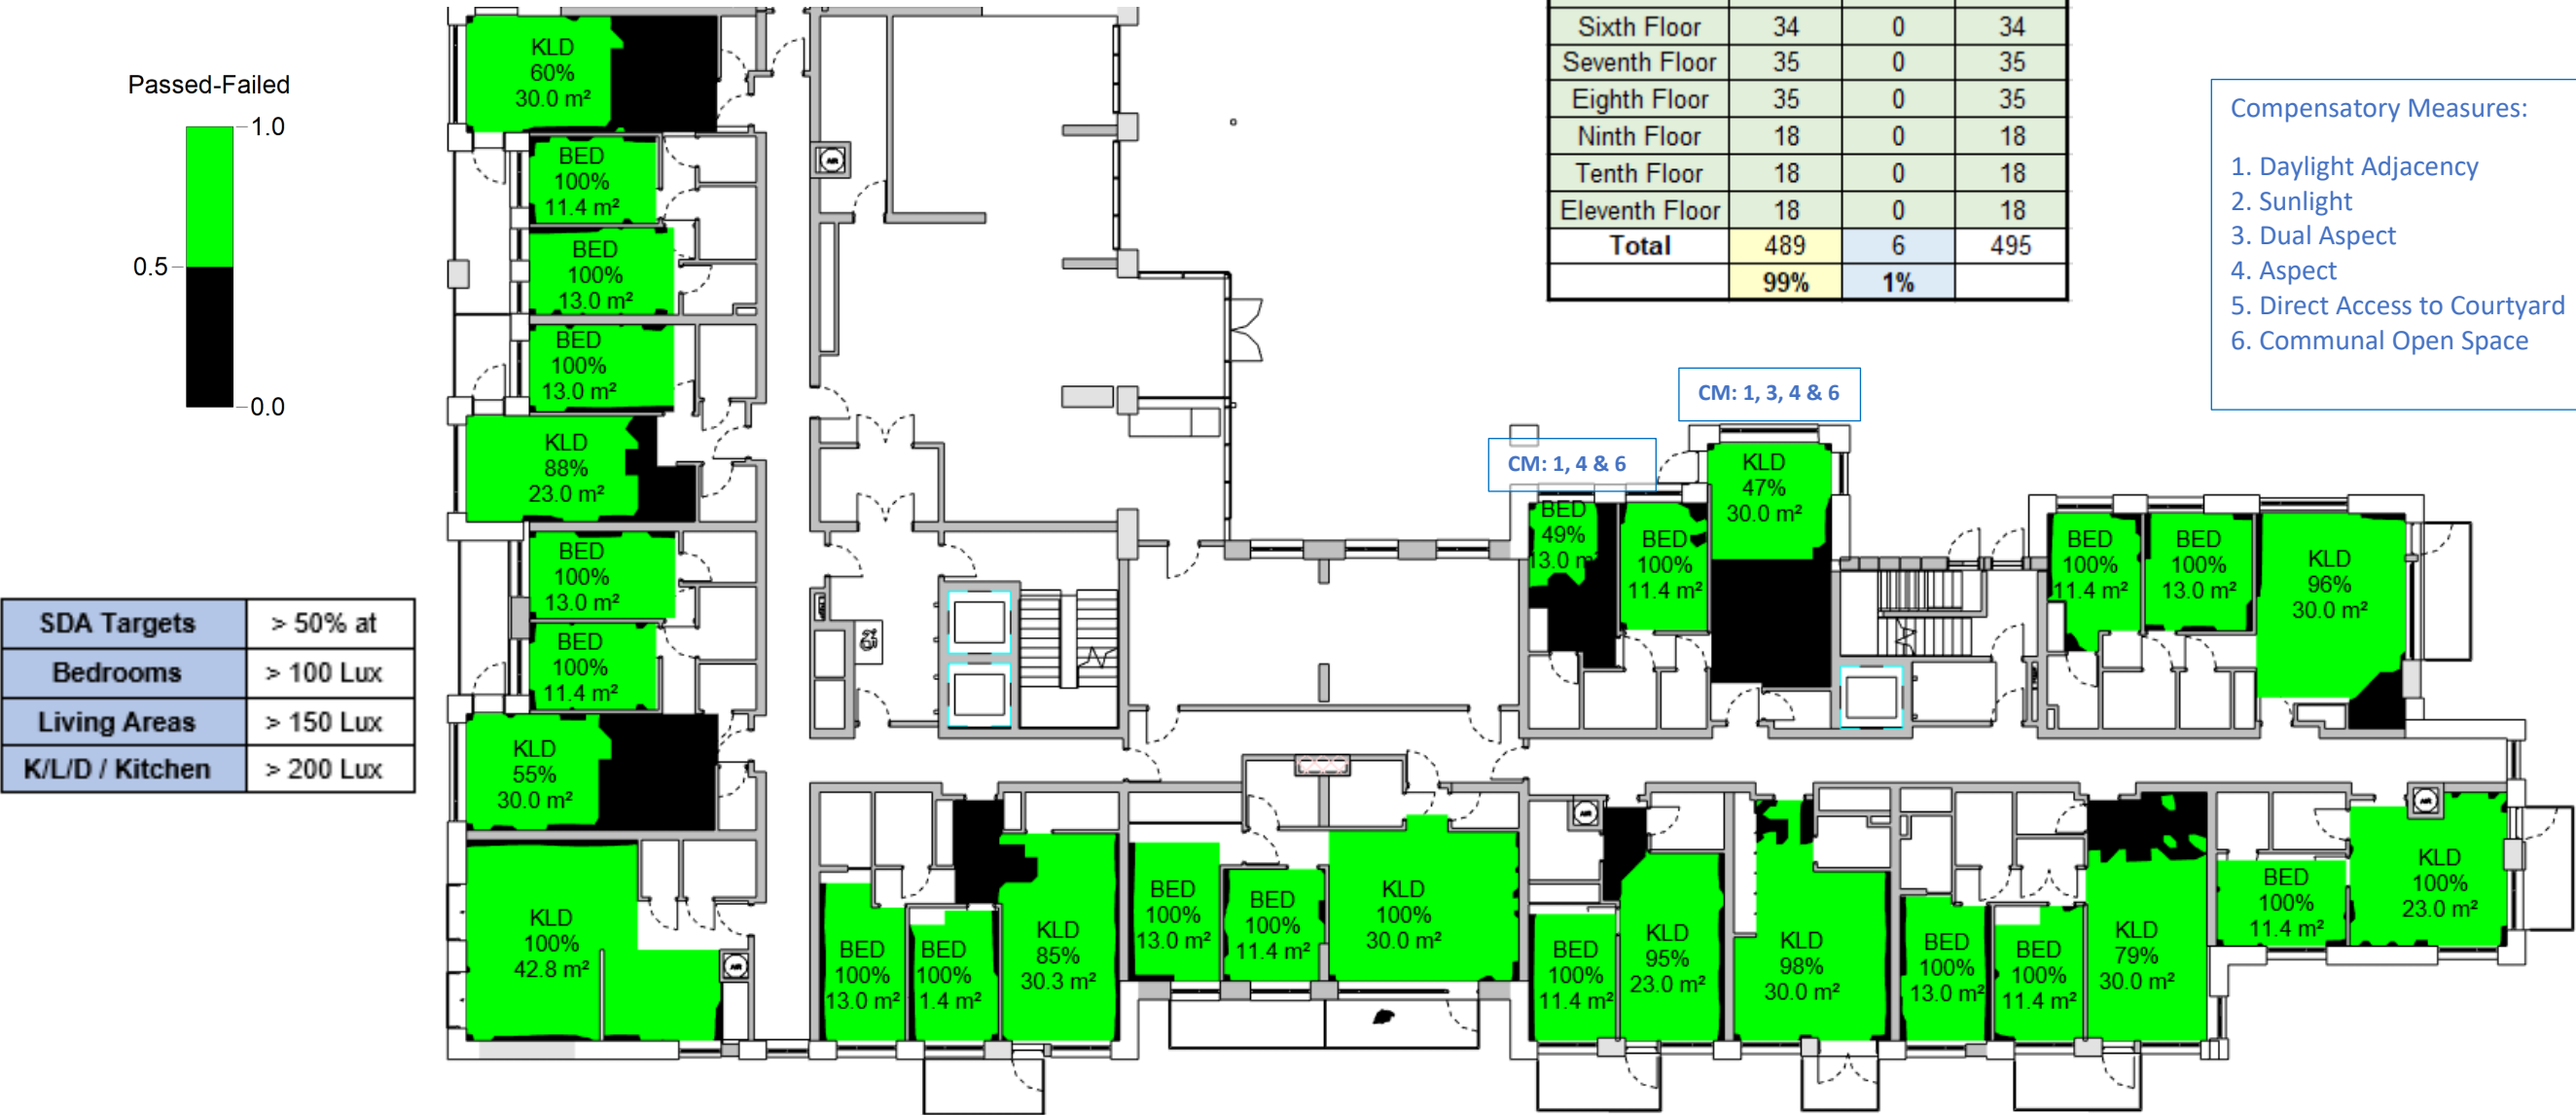
Daylight analysis results are illustrated below with green shaded area receiving targeted illuminance, 200Lux for KLDs and 100Lux for Bedrooms. Black shade is showing area where it’s receiving less than targeted illuminance. A space is deemed compliant where >50% of areas achieve target illuminance.

1 KLD and 1 bedroom were determined to be non-compliant.
The rest of the rooms were determined to be compliant for SDA in this area.

- Compensatory Measures:
- 1. Daylight Adjacency
 - 2. Sunlight
 - 3. Dual Aspect
 - 4. Aspect
 - 5. Direct Access to Courtyard
 - 6. Communal Open Space

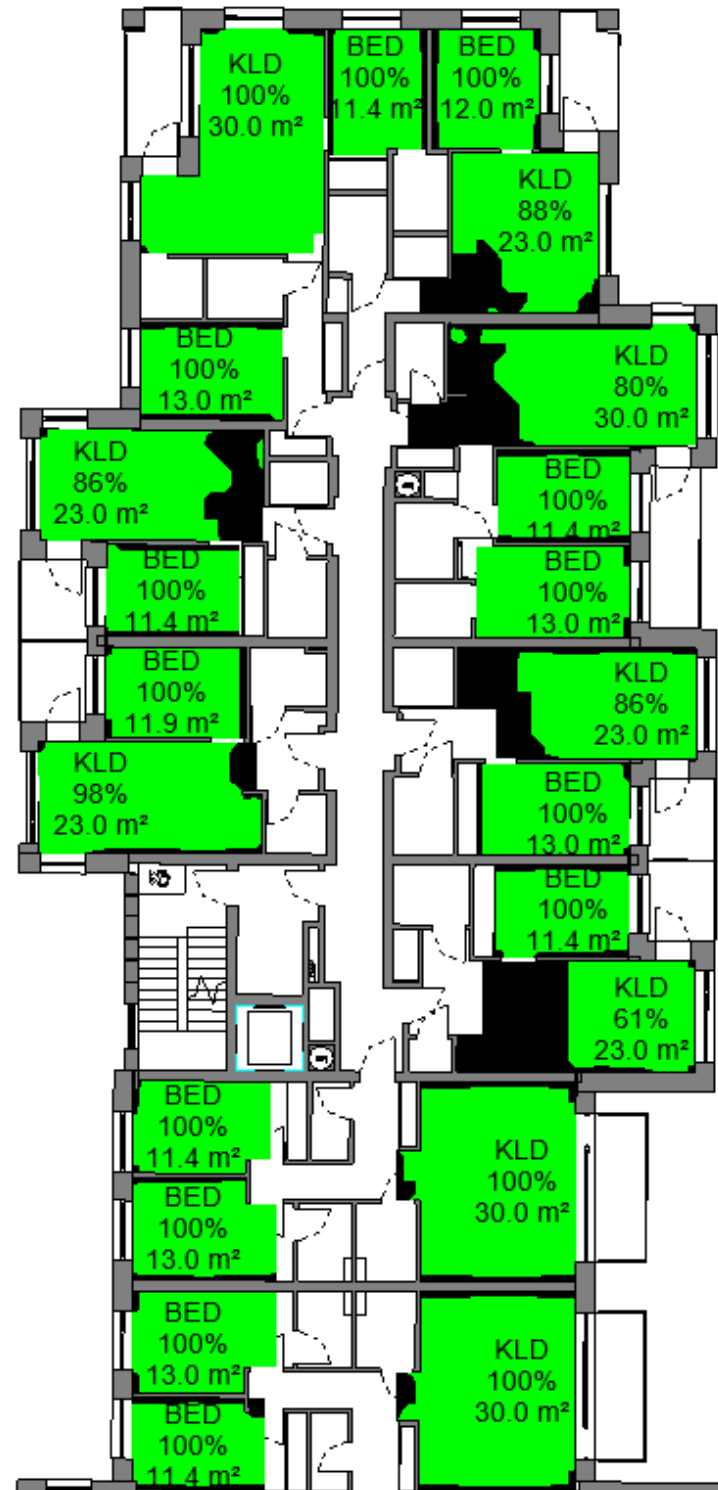
Daylight analysis results are illustrated below with green shaded area receiving targeted illuminance, 200Lux for KLDs and 100Lux for Bedrooms. Black shade is showing area where it's receiving less than targeted illuminance. A space is deemed compliant where >50% of areas achieve target illuminance.

Every room was determined to be compliant for SDA in this area.

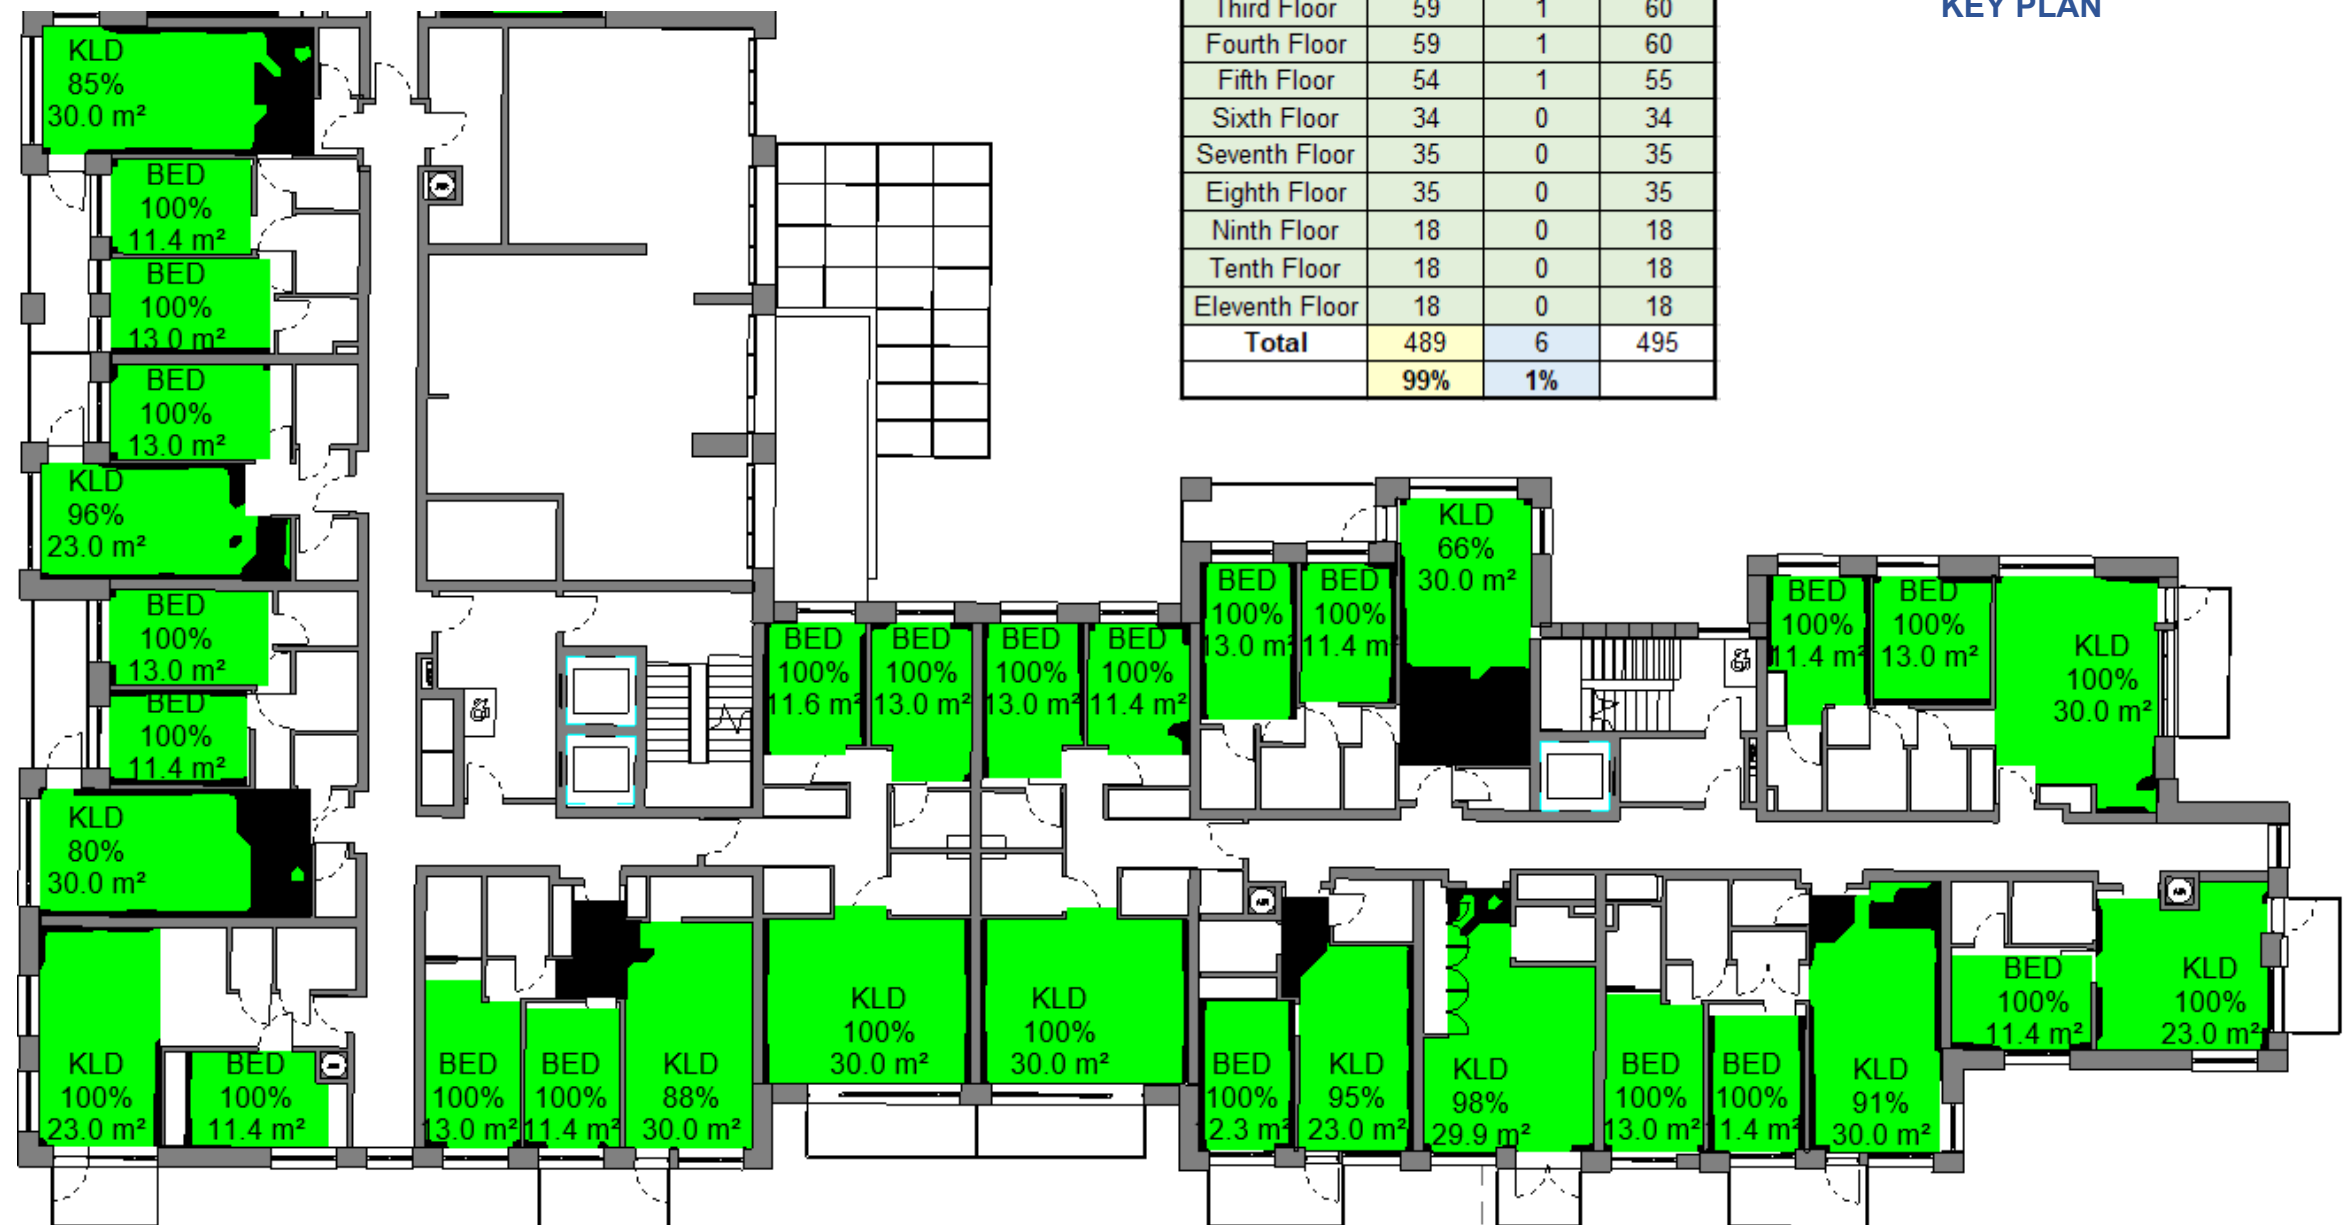
Daylight analysis results are illustrated below with green shaded area receiving targeted illuminance, 200Lux for KLDs and 100Lux for Bedrooms. Black shade is showing area where it's receiving less than targeted illuminance. A space is deemed compliant where >50% of areas achieve target illuminance.

Every room was determined to be compliant for SDA in this area.

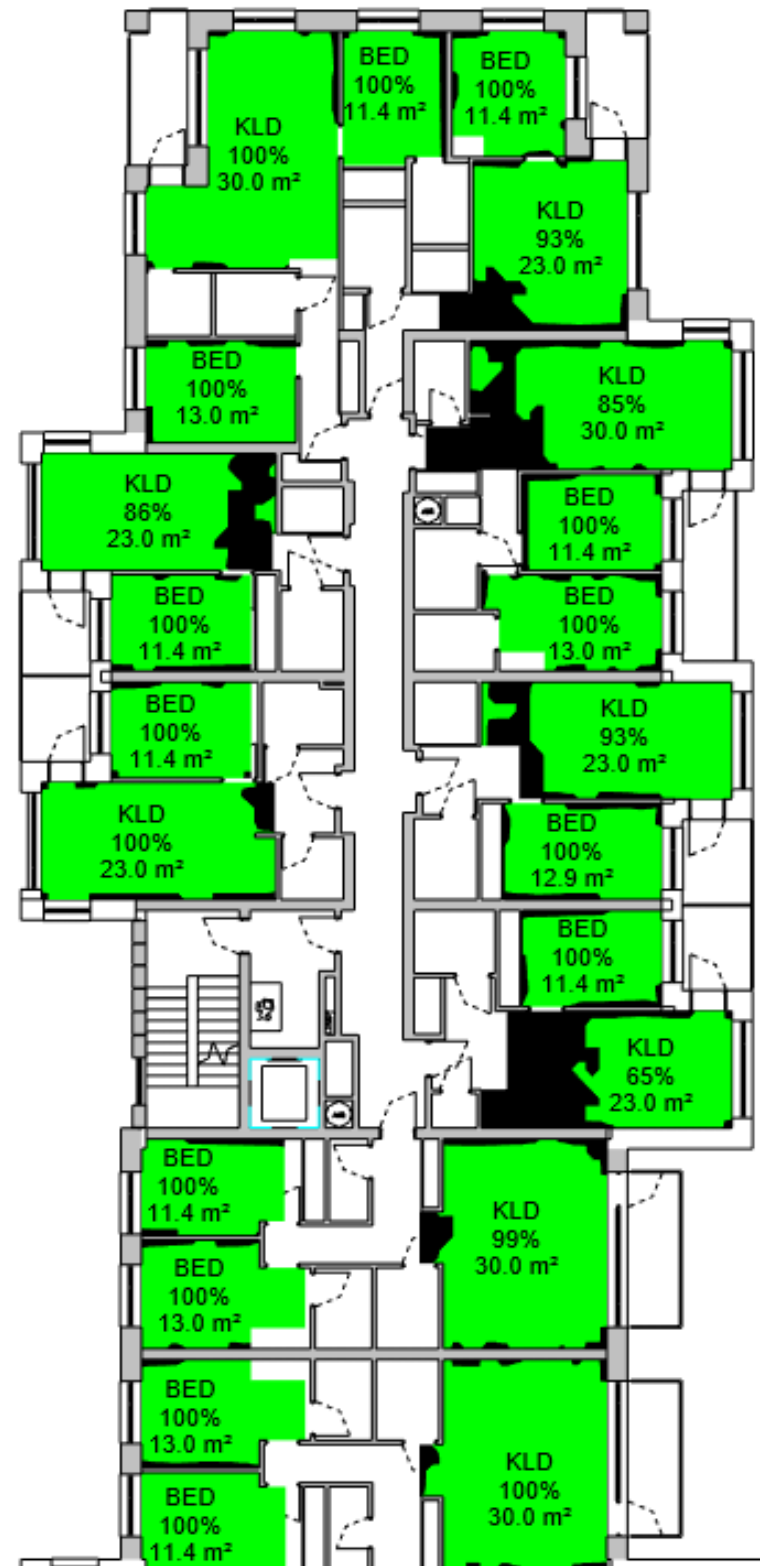
Daylight analysis results are illustrated below with green shaded area receiving targeted illuminance, 200Lux for KLDs and 100Lux for Bedrooms. Black shade is showing area where it's receiving less than targeted illuminance. A space is deemed compliant where >50% of areas achieve target illuminance.

Every room was determined to be compliant for SDA in this area.

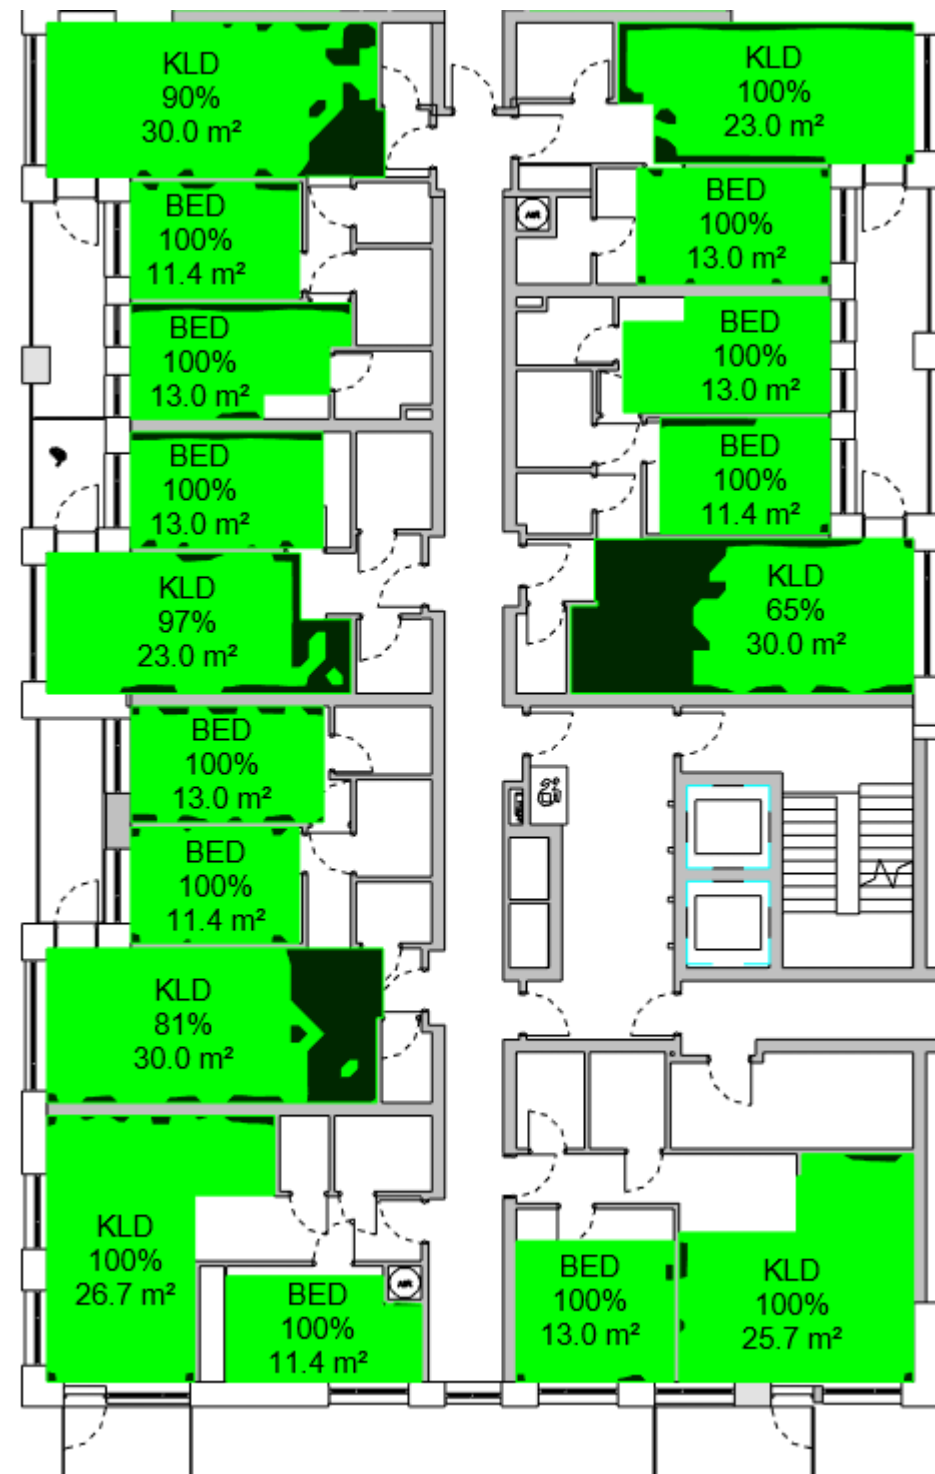
Daylight analysis results are illustrated below with green shaded area receiving targeted illuminance, 200Lux for KLDs and 100Lux for Bedrooms. Black shade is showing area where it's receiving less than targeted illuminance. A space is deemed compliant where >50% of areas achieve target illuminance.

Every room was determined to be compliant for SDA in this area.

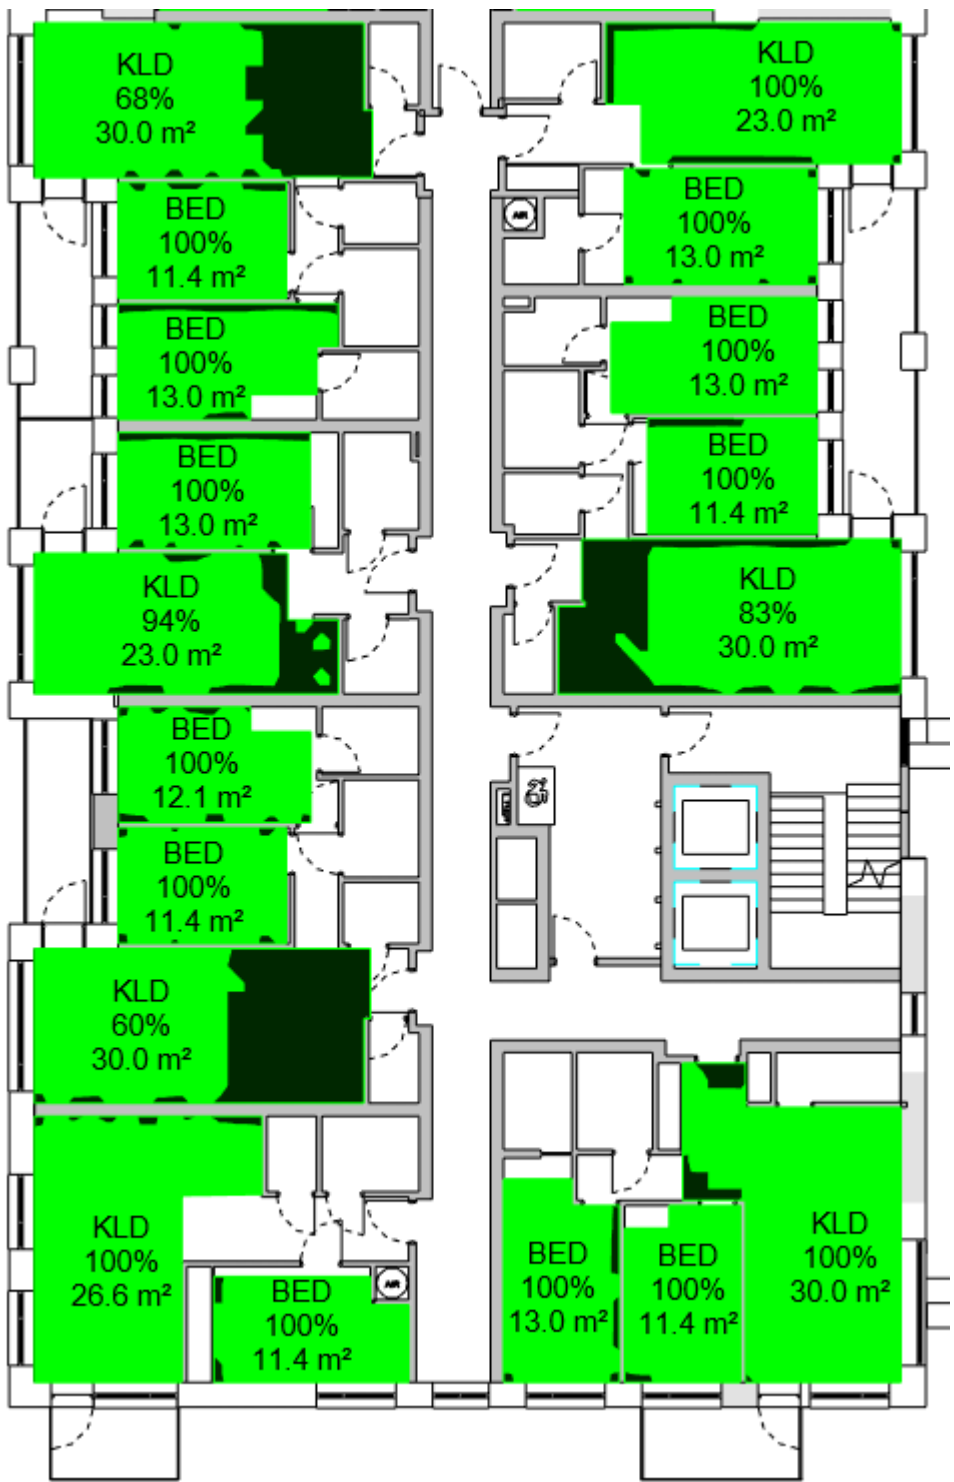
Daylight analysis results are illustrated below with green shaded area receiving targeted illuminance, 200Lux for KLDs and 100Lux for Bedrooms. Black shade is showing area where it’s receiving less than targeted illuminance. A space is deemed compliant where >50% of areas achieve target illuminance.

Every room was determined to be compliant for SDA in this area.

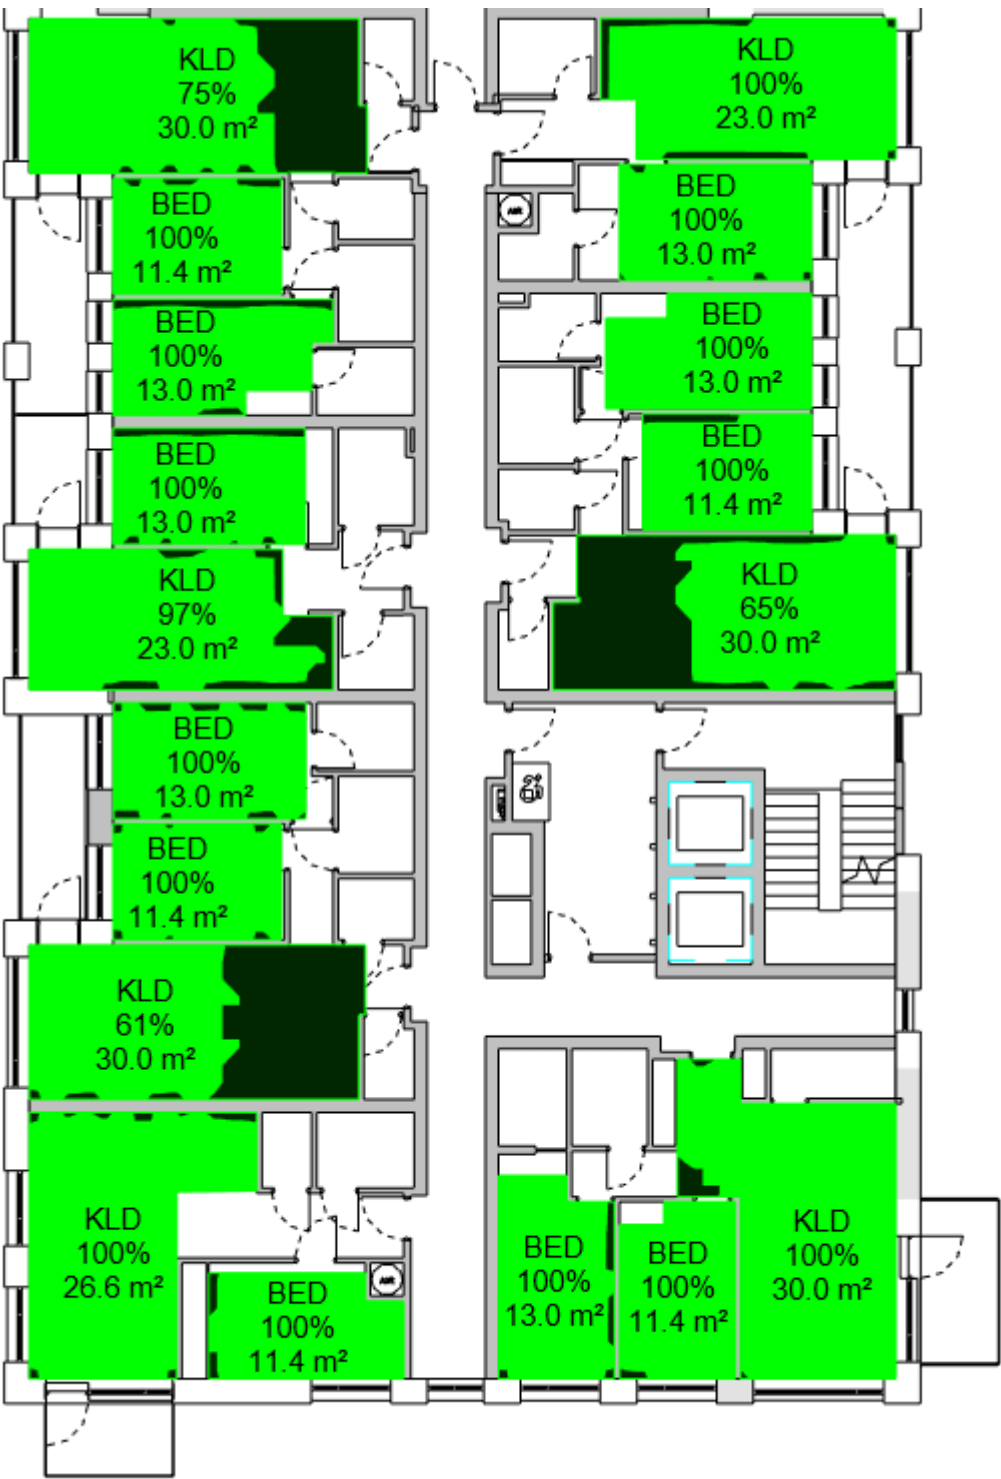
Daylight analysis results are illustrated below with green shaded area receiving targeted illuminance, 200Lux for KLDs and 100Lux for Bedrooms. Black shade is showing area where it's receiving less than targeted illuminance. A space is deemed compliant where >50% of areas achieve target illuminance.

Every room was determined to be compliant for SDA in this area.

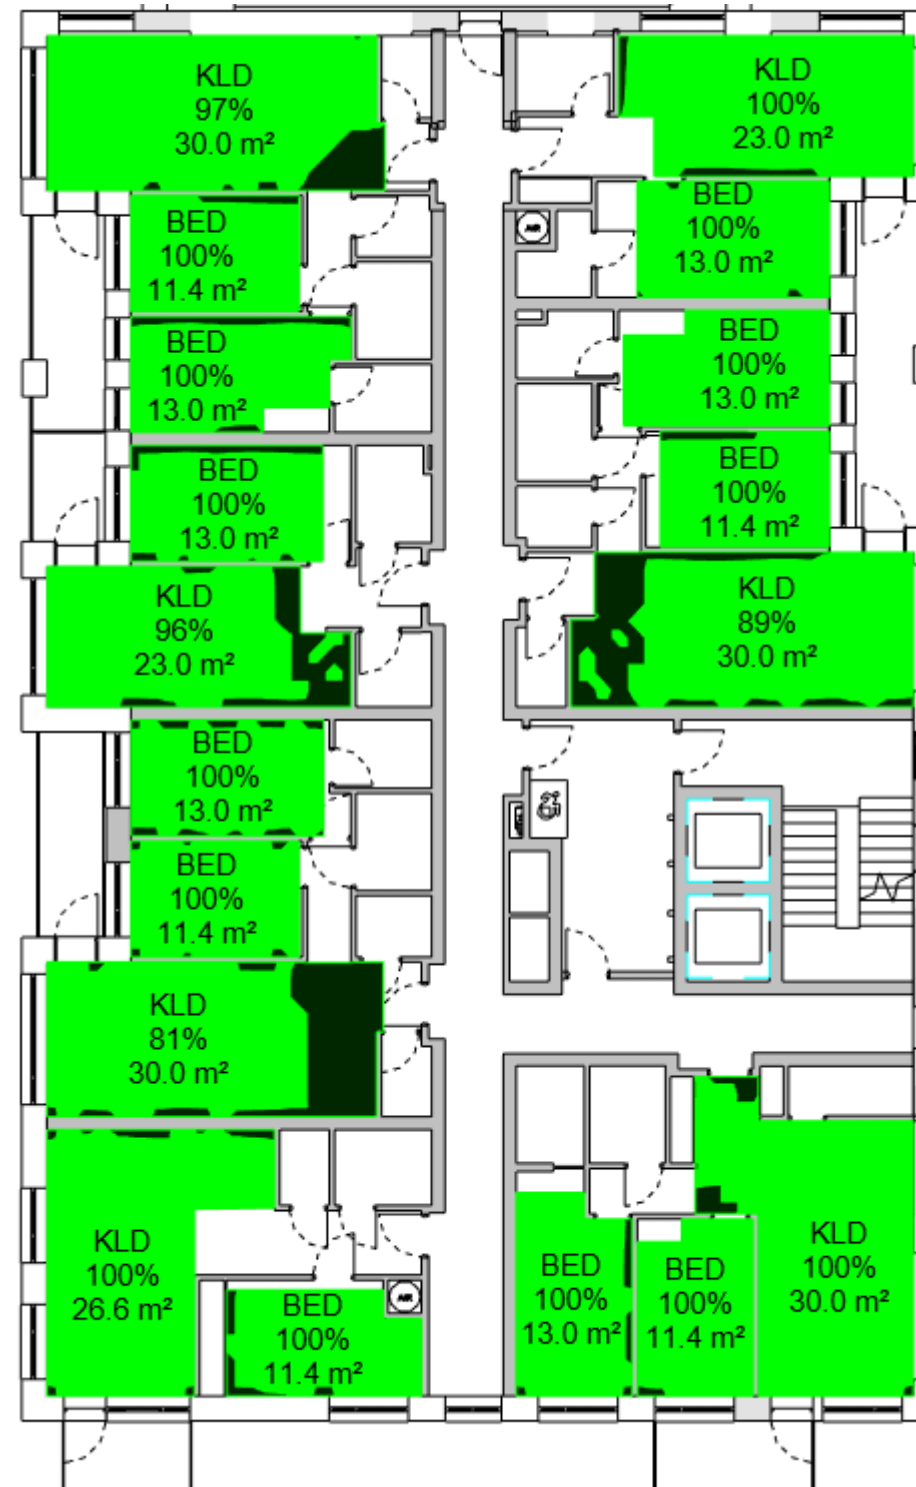
Daylight analysis results are illustrated below with green shaded area receiving targeted illuminance, 200Lux for KLDs and 100Lux for Bedrooms. Black shade is showing area where it's receiving less than targeted illuminance. A space is deemed compliant where >50% of areas achieve target illuminance.

Every room was determined to be compliant for SDA in this area.

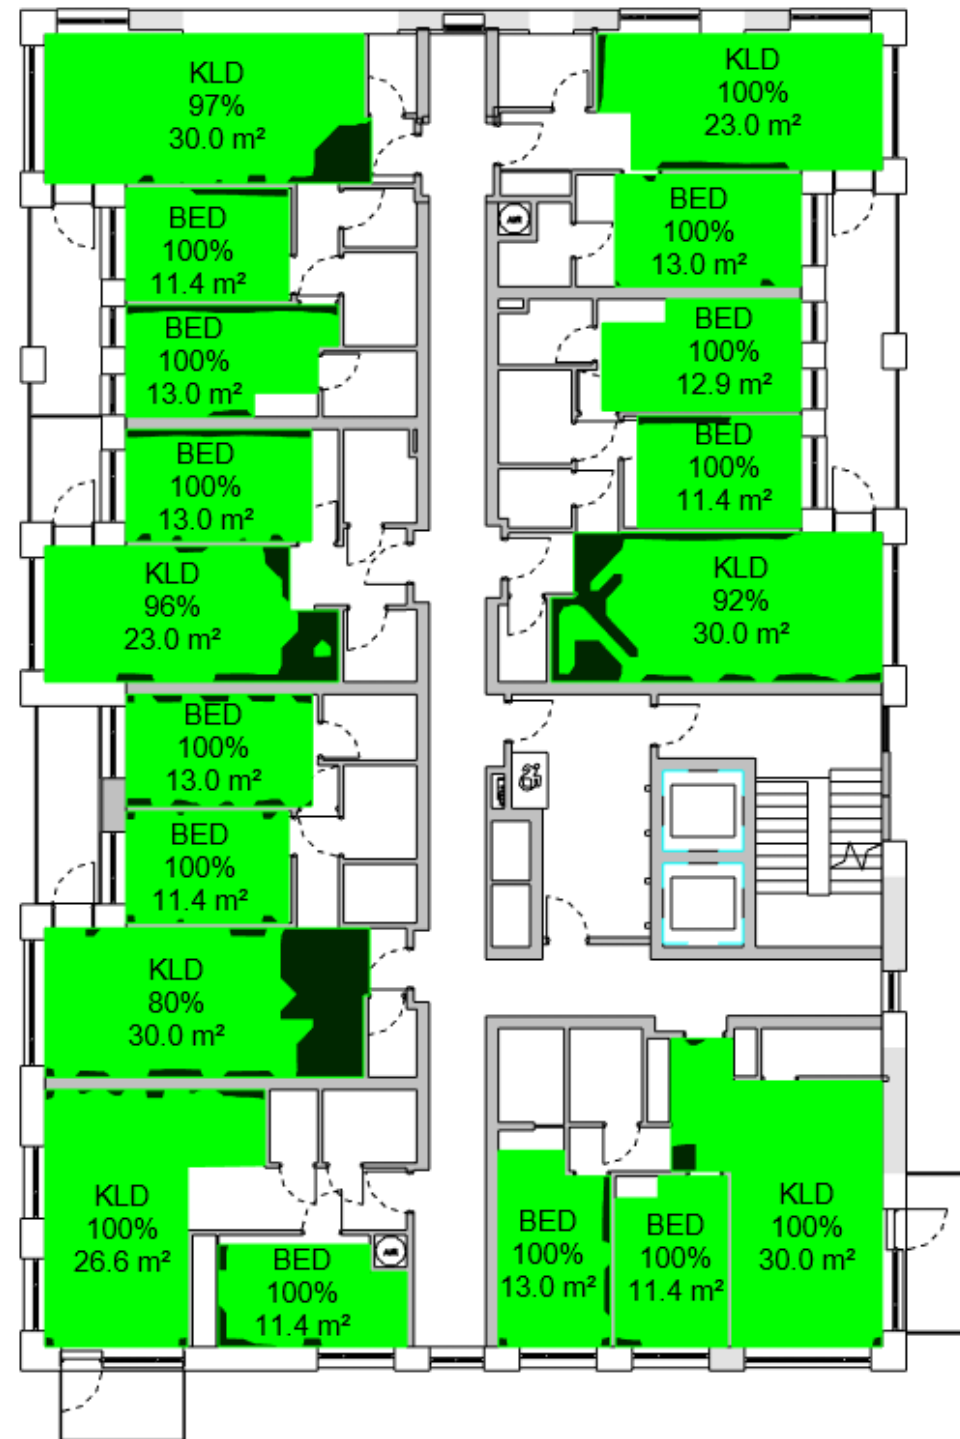
Daylight analysis results are illustrated below with green shaded area receiving targeted illuminance, 200Lux for KLDs and 100Lux for Bedrooms. Black shade is showing area where it’s receiving less than targeted illuminance. A space is deemed compliant where >50% of areas achieve target illuminance.

Every room was determined to be compliant for SDA in this area.

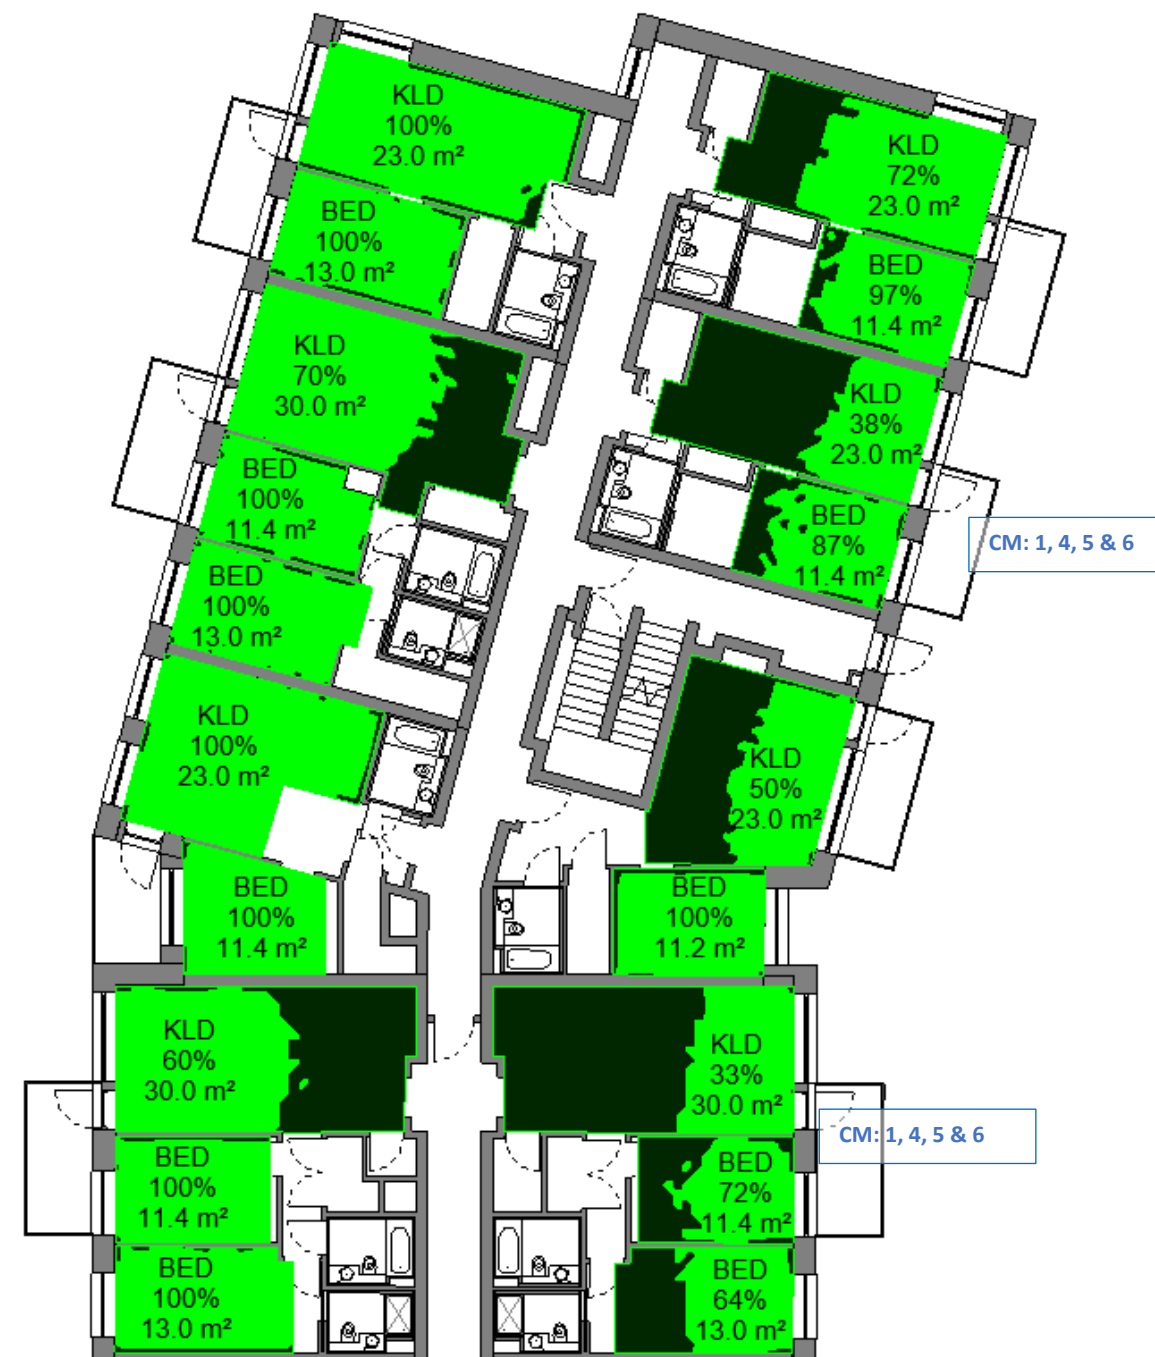
Daylight analysis results are illustrated below with green shaded area receiving targeted illuminance, 200Lux for KLDs and 100Lux for Bedrooms. Black shade is showing area where it’s receiving less than targeted illuminance. A space is deemed compliant where >50% of areas achieve target illuminance.

Every room was determined to be compliant for SDA in this area.

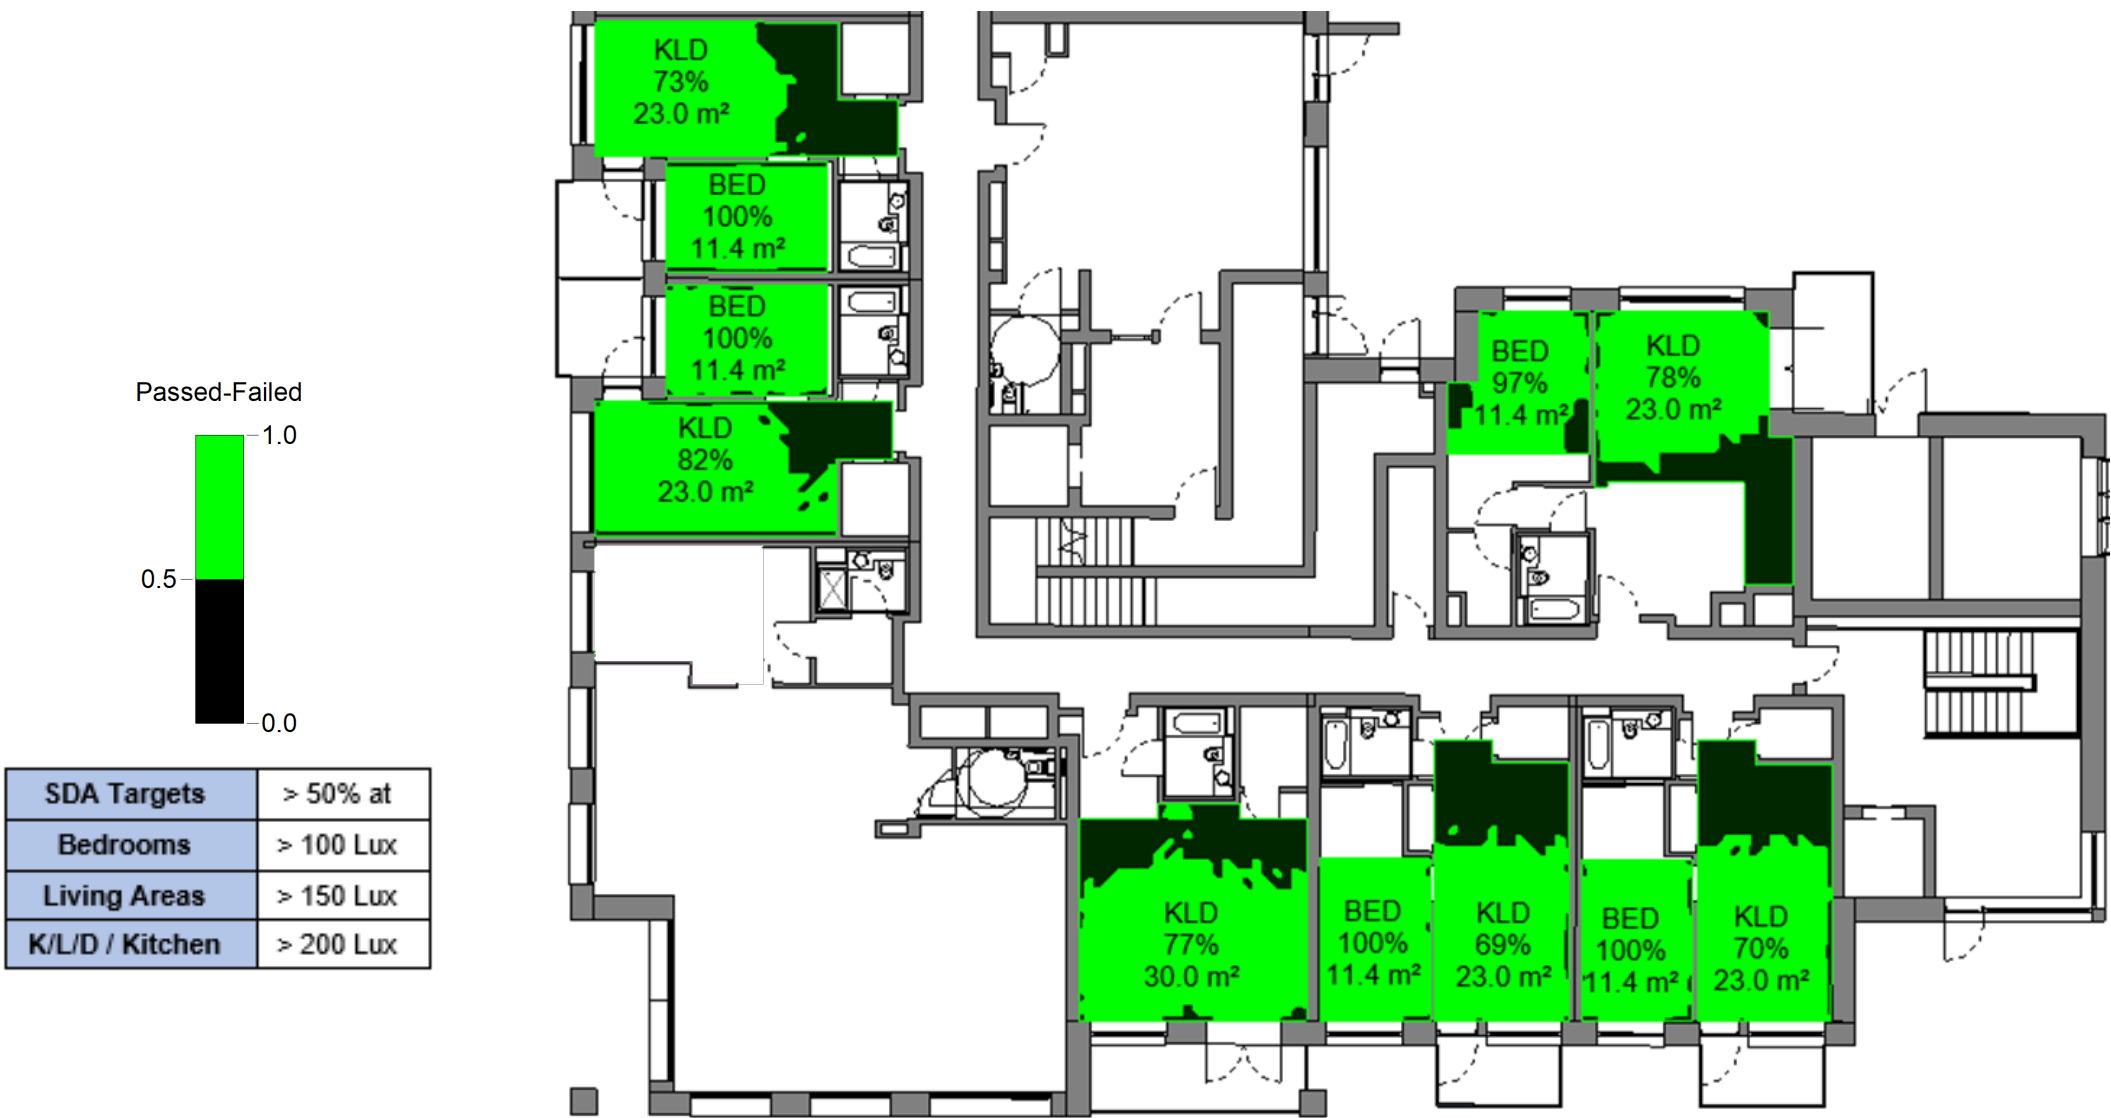
2no. KLDs were found to be non-compliant in this area.

The rest of the rooms were determined to be compliant for SDA.

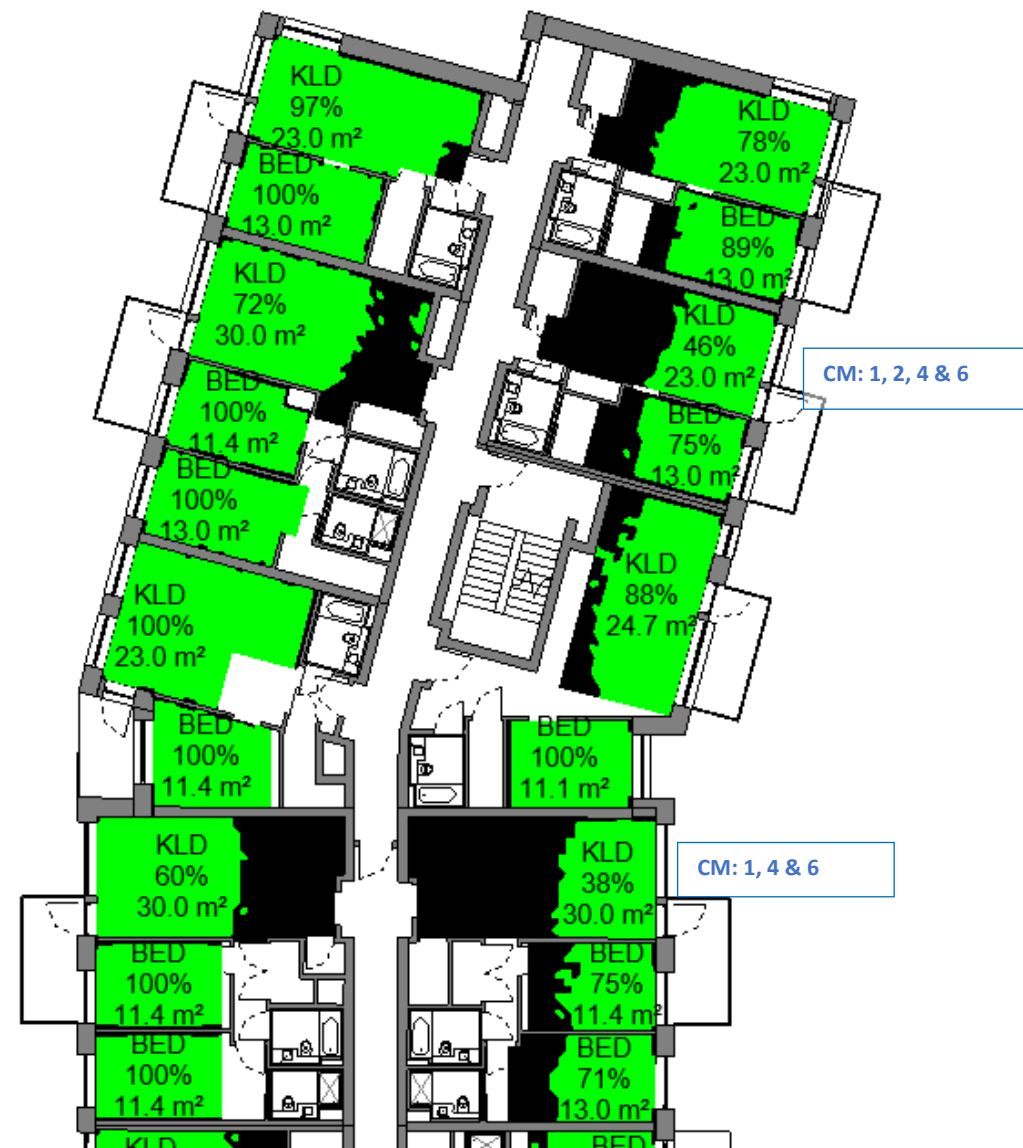
1 KLD was found to be non-compliant in this area.

The rest of the rooms were determined to be compliant for SDA.

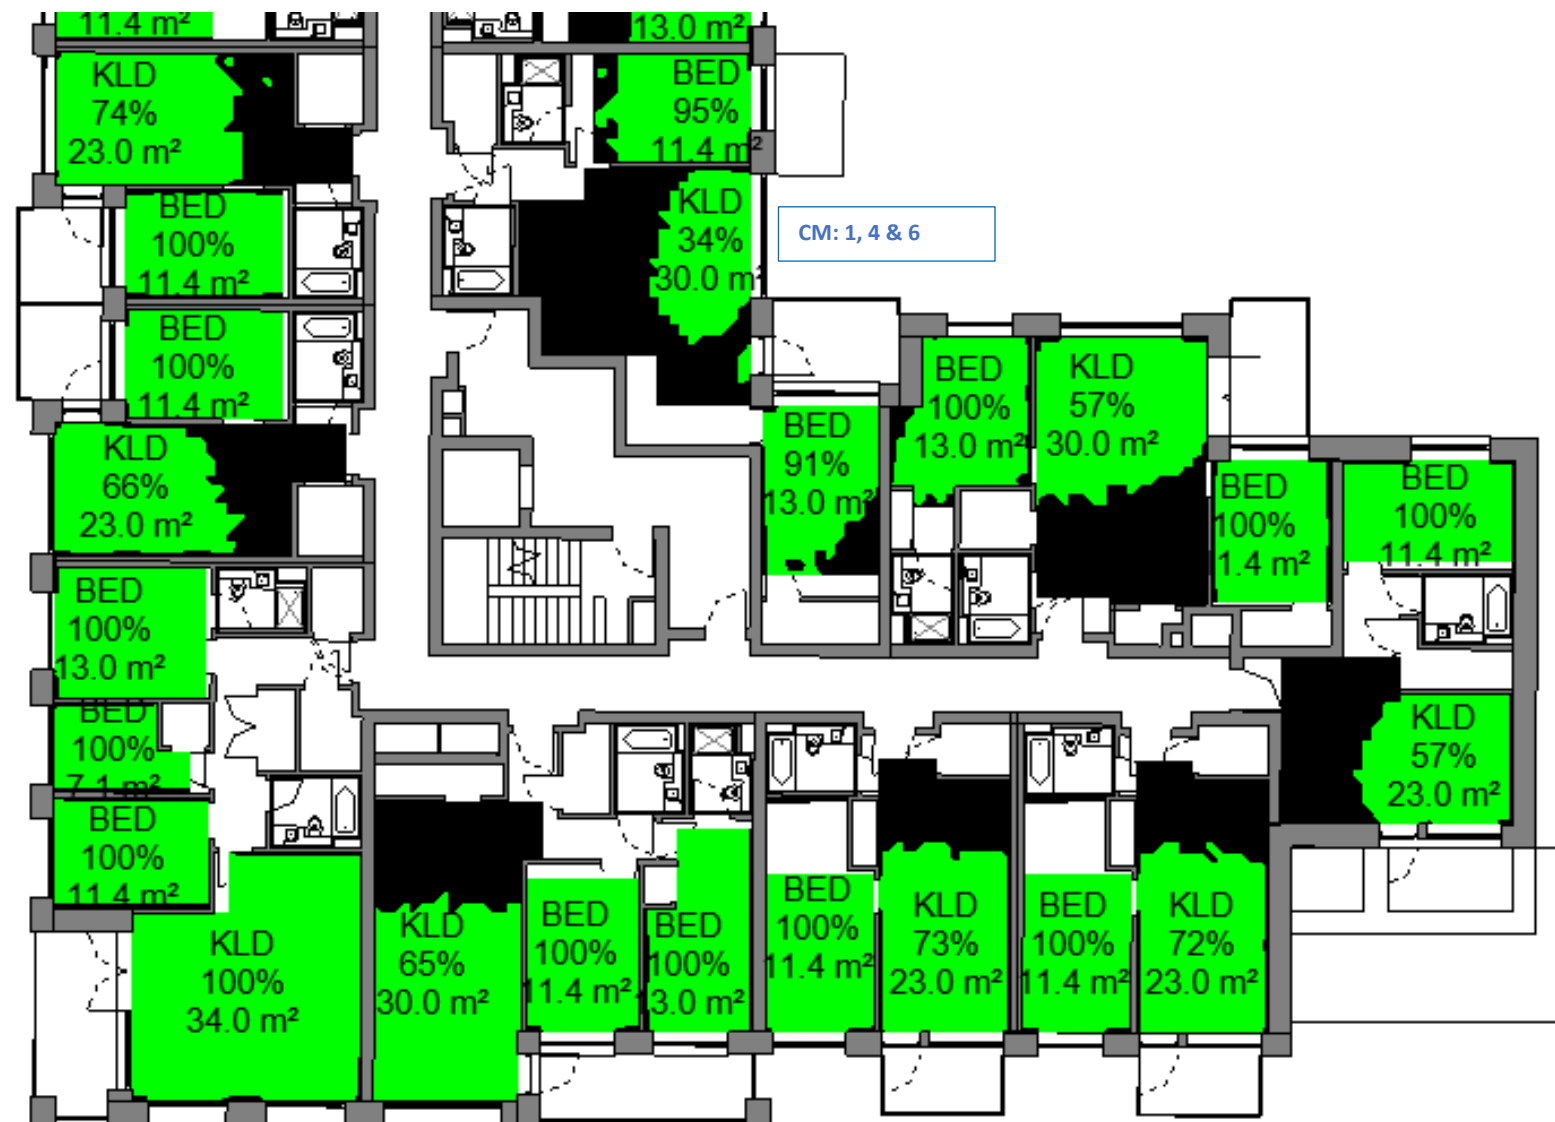
1 KLD was found to be non-compliant in this area.
