St. Vincent's Hospital Fairview Redevelopment, Fairview Dublin 3

Daylight and Sunlight Analysis

IN2 Project No. D2116

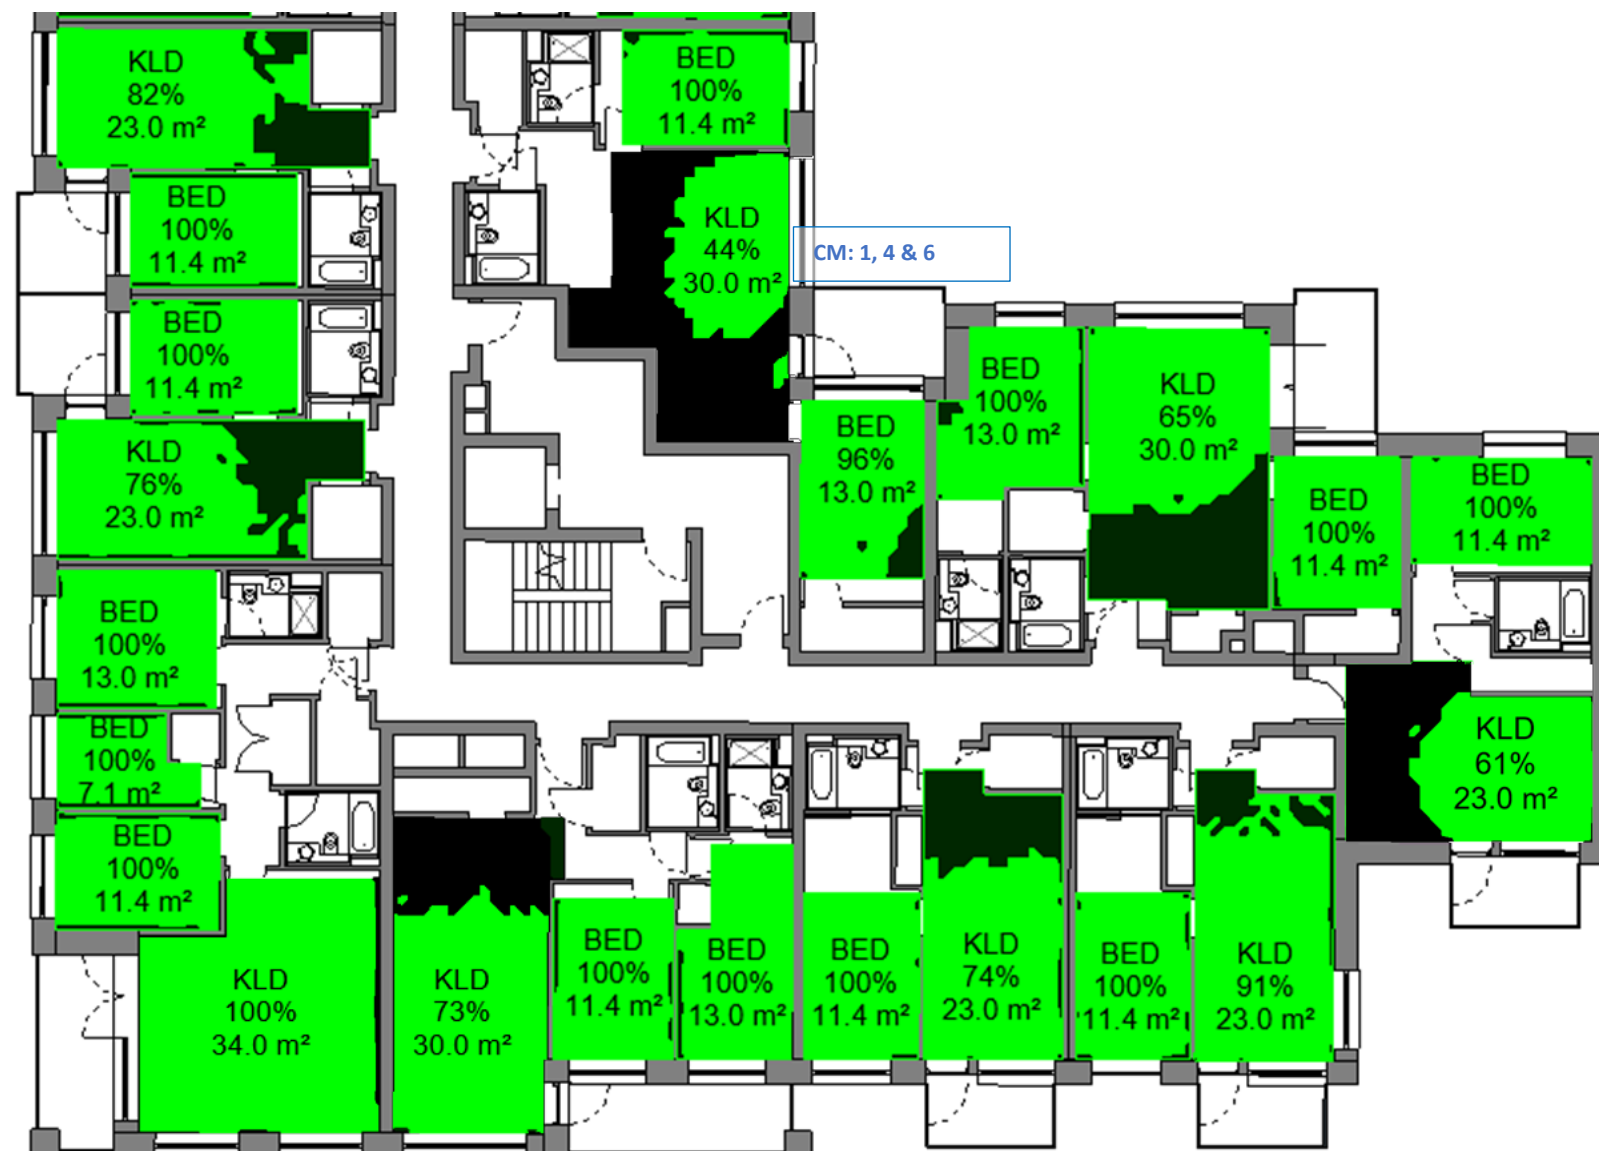
1 KLD was found to be non-compliant in this area.

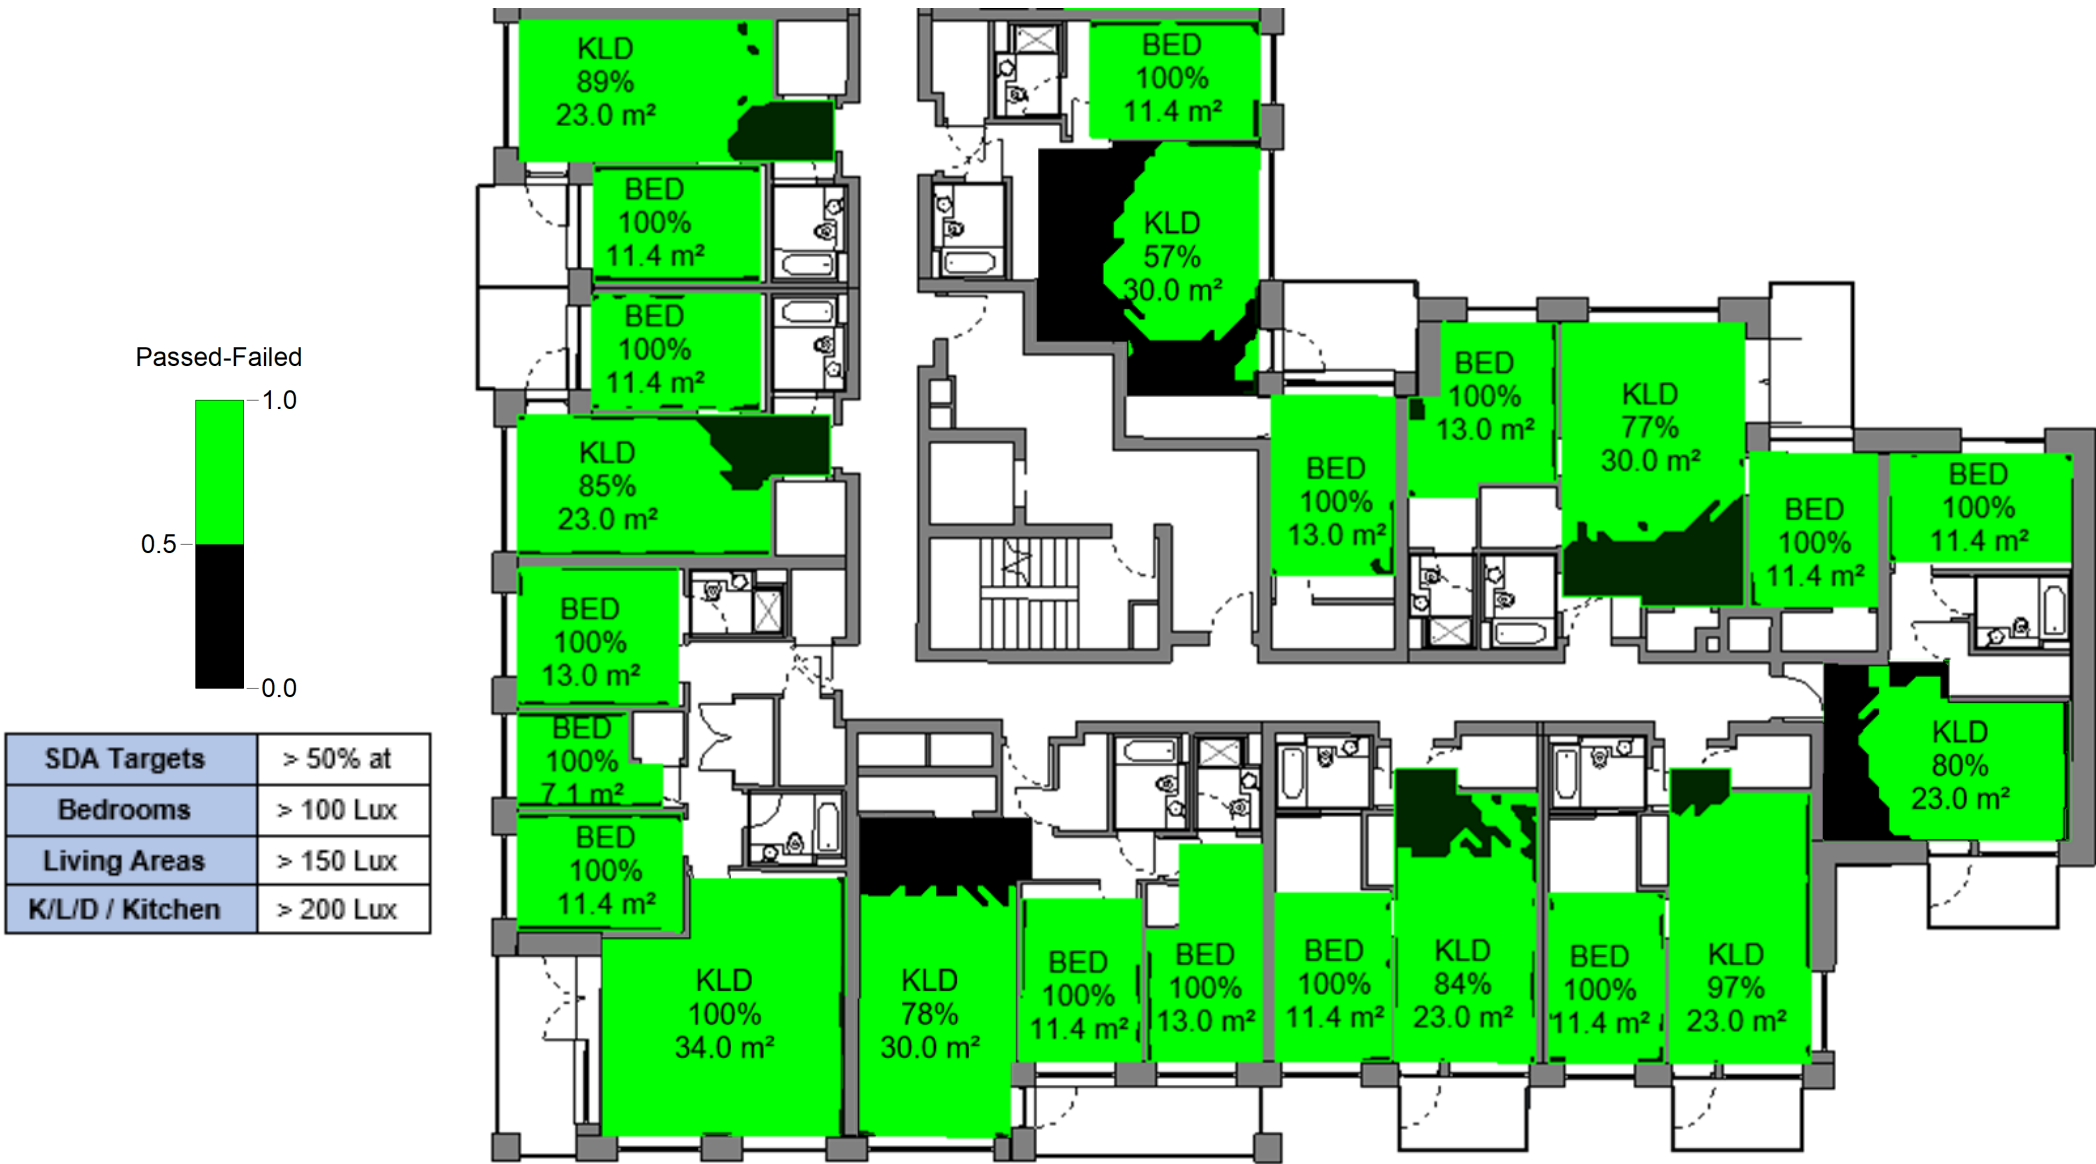
Daylight analysis results are illustrated below with green shaded area receiving targeted illuminance, 200Lux for KLDs and 100Lux for Bedrooms. Black shade is showing area where it's receiving less than targeted illuminance. A space is deemed compliant where >50% of areas achieve target illuminance.

Every room was determined to be compliant for SDA in this area.

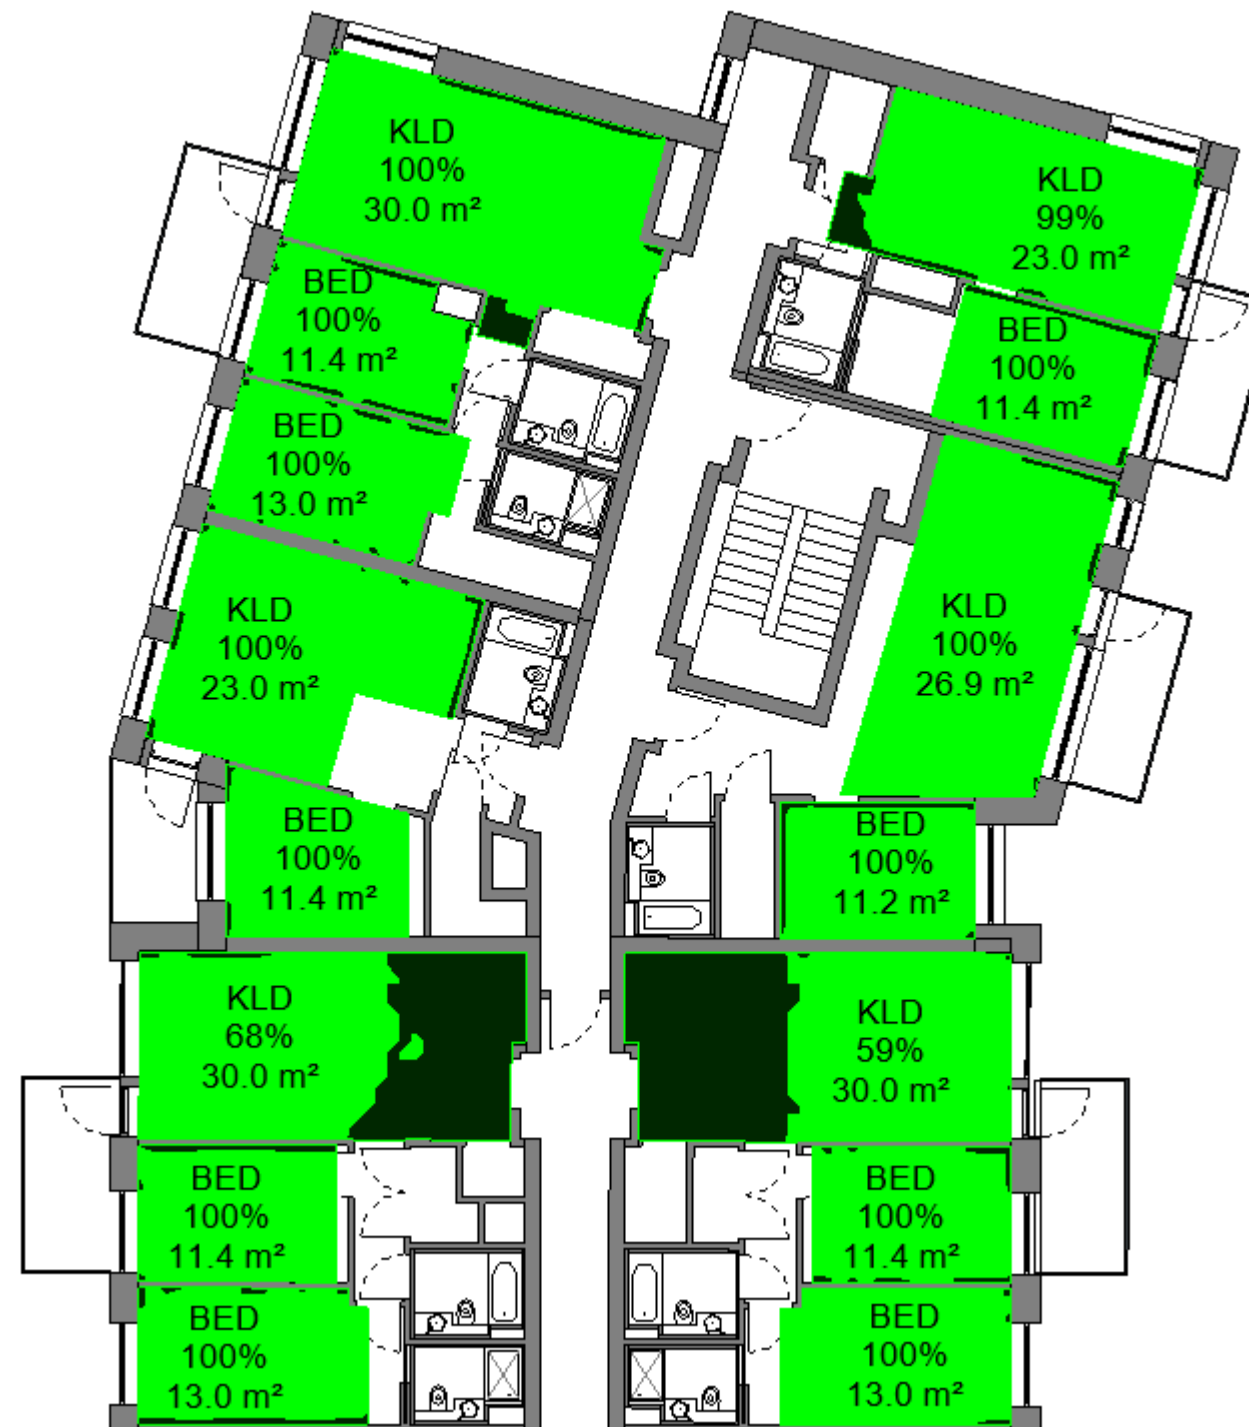
Daylight analysis results are illustrated below with green shaded area receiving targeted illuminance, 200Lux for KLDs and 100Lux for Bedrooms. Black shade is showing area where it’s receiving less than targeted illuminance. A space is deemed compliant where >50% of areas achieve target illuminance.

Every room was determined to be compliant for SDA in this area.

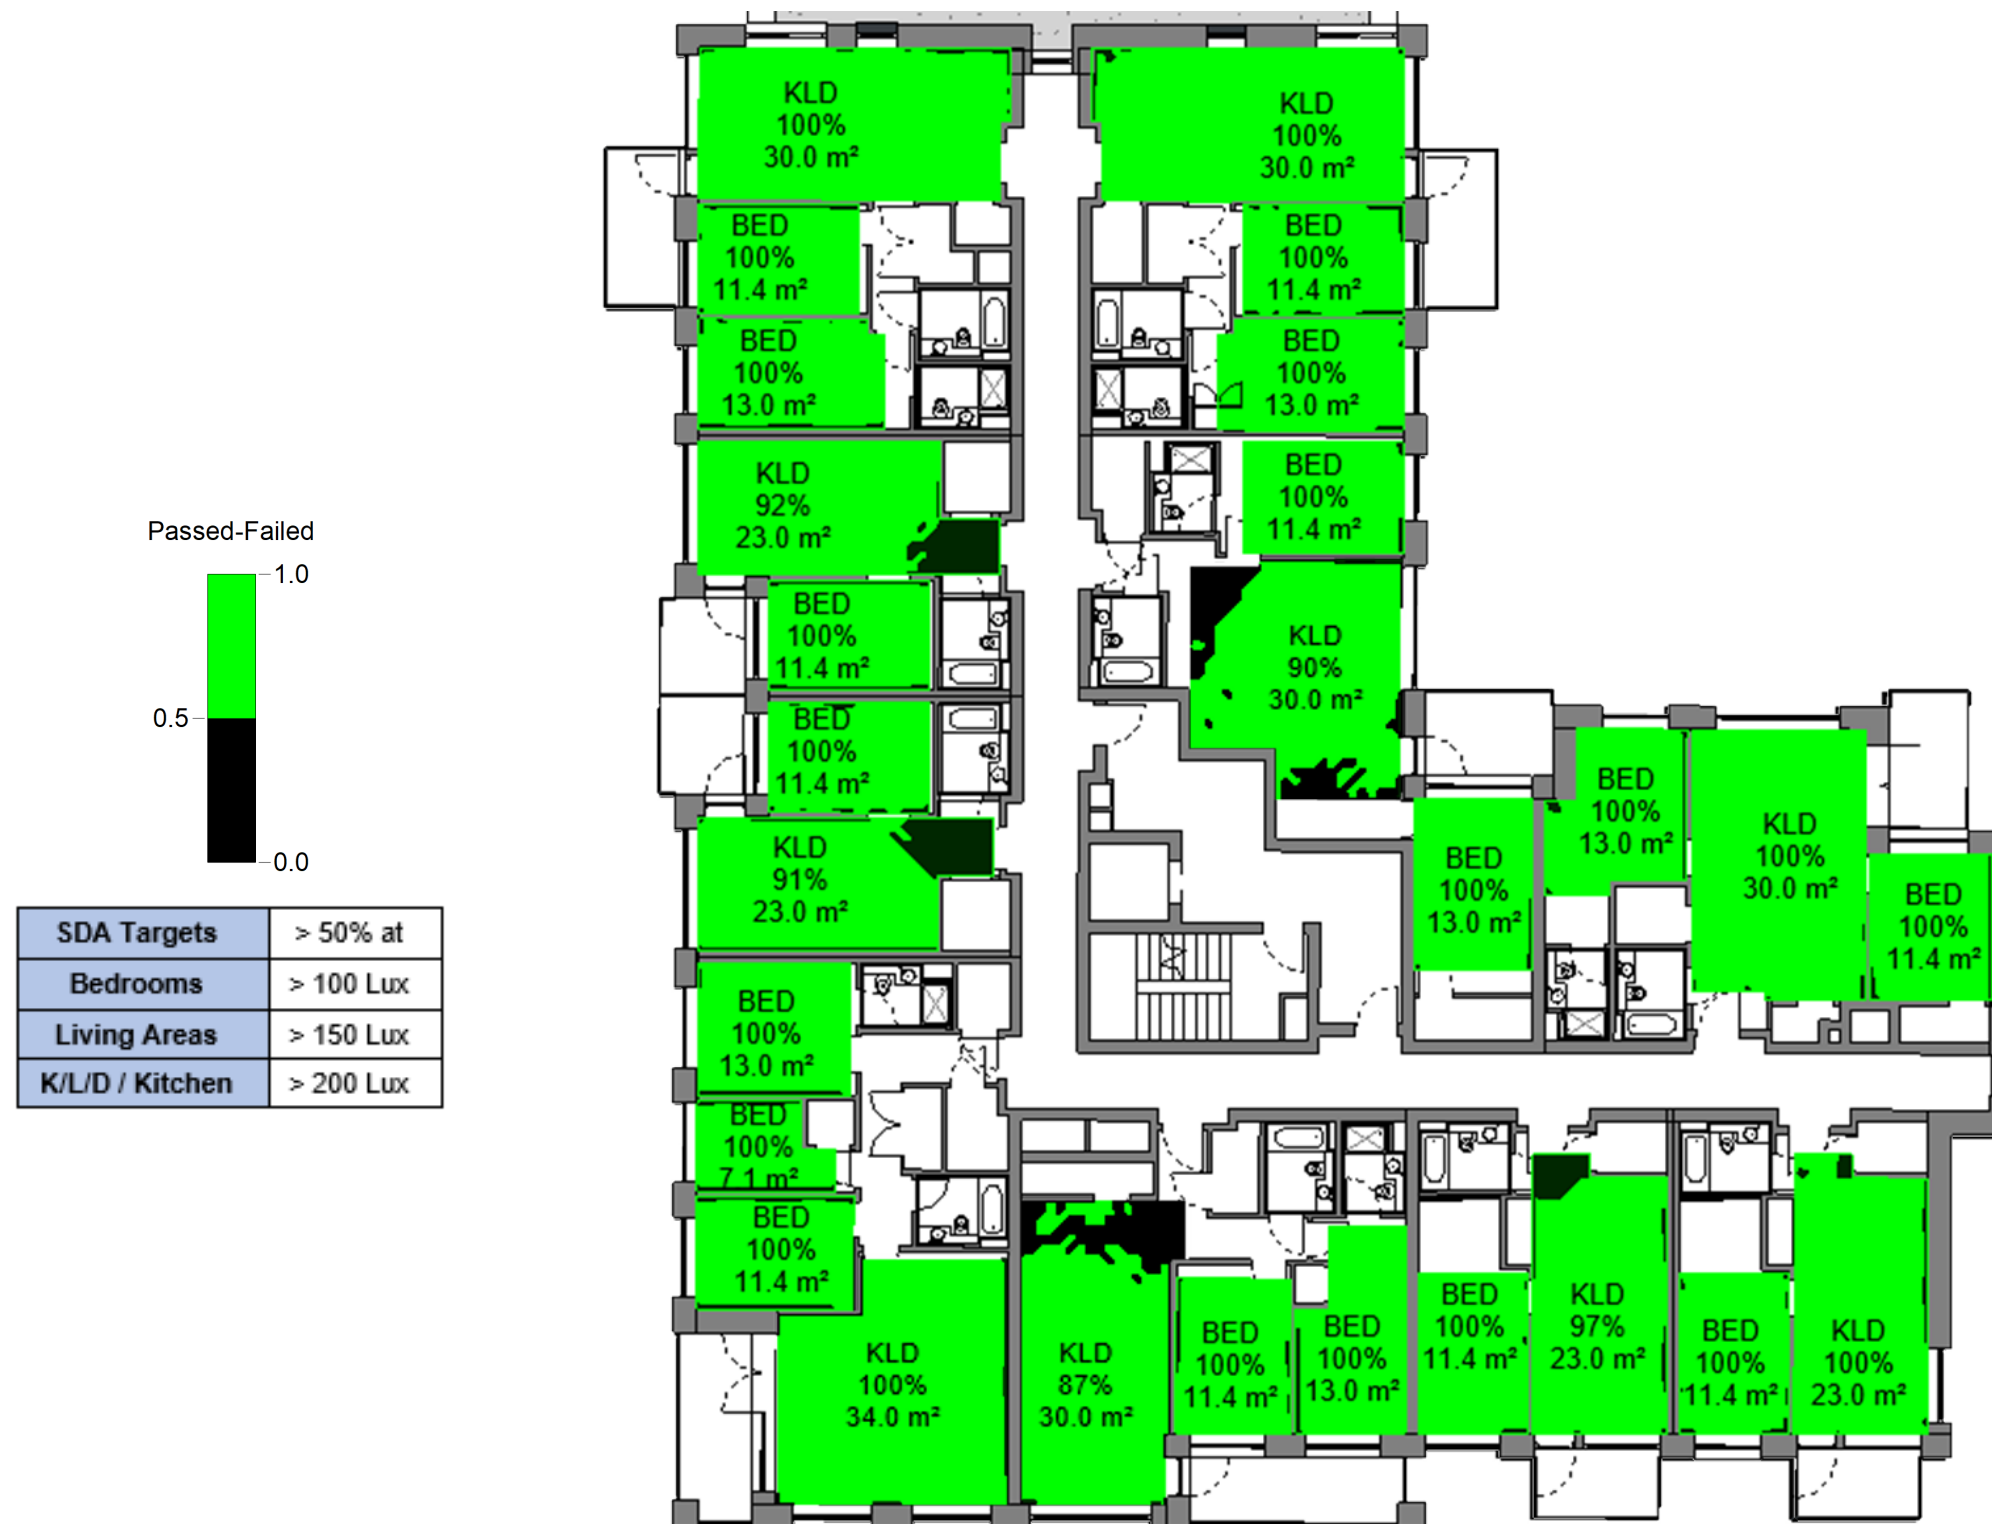
Daylight analysis results are illustrated below with green shaded area receiving targeted illuminance, 200Lux for KLDs and 100Lux for Bedrooms. Black shade is showing area where it's receiving less than targeted illuminance. A space is deemed compliant where >50% of areas achieve target illuminance.

Every room was determined to be compliant for SDA in this area.

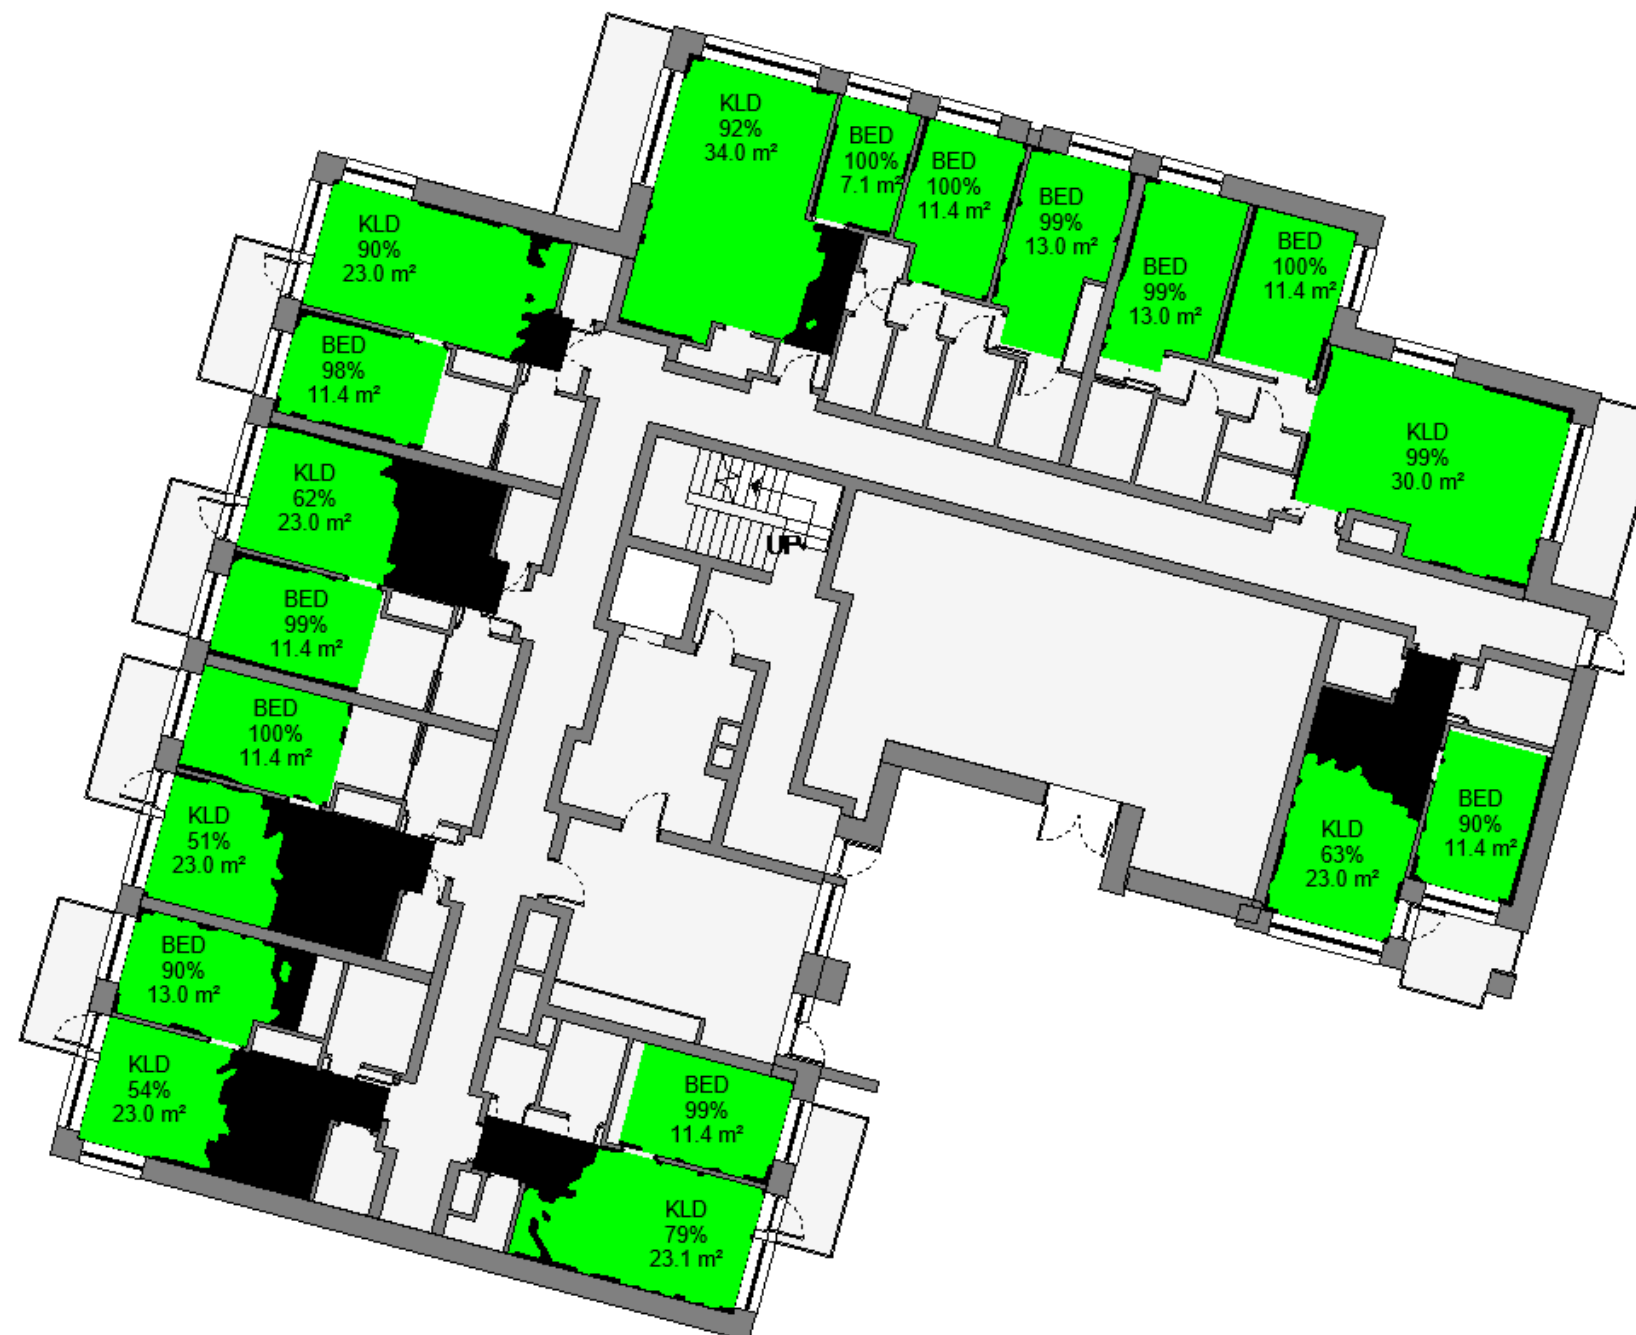
Daylight analysis results are illustrated below with green shaded area receiving targeted illuminance, 200Lux for KLDs and 100Lux for Bedrooms. Black shade is showing area where it’s receiving less than targeted illuminance. A space is deemed compliant where >50% of areas achieve target illuminance.

2no. KLDs were found to be non-compliant in this area.
The rest of the rooms were determined to be compliant for SDA.

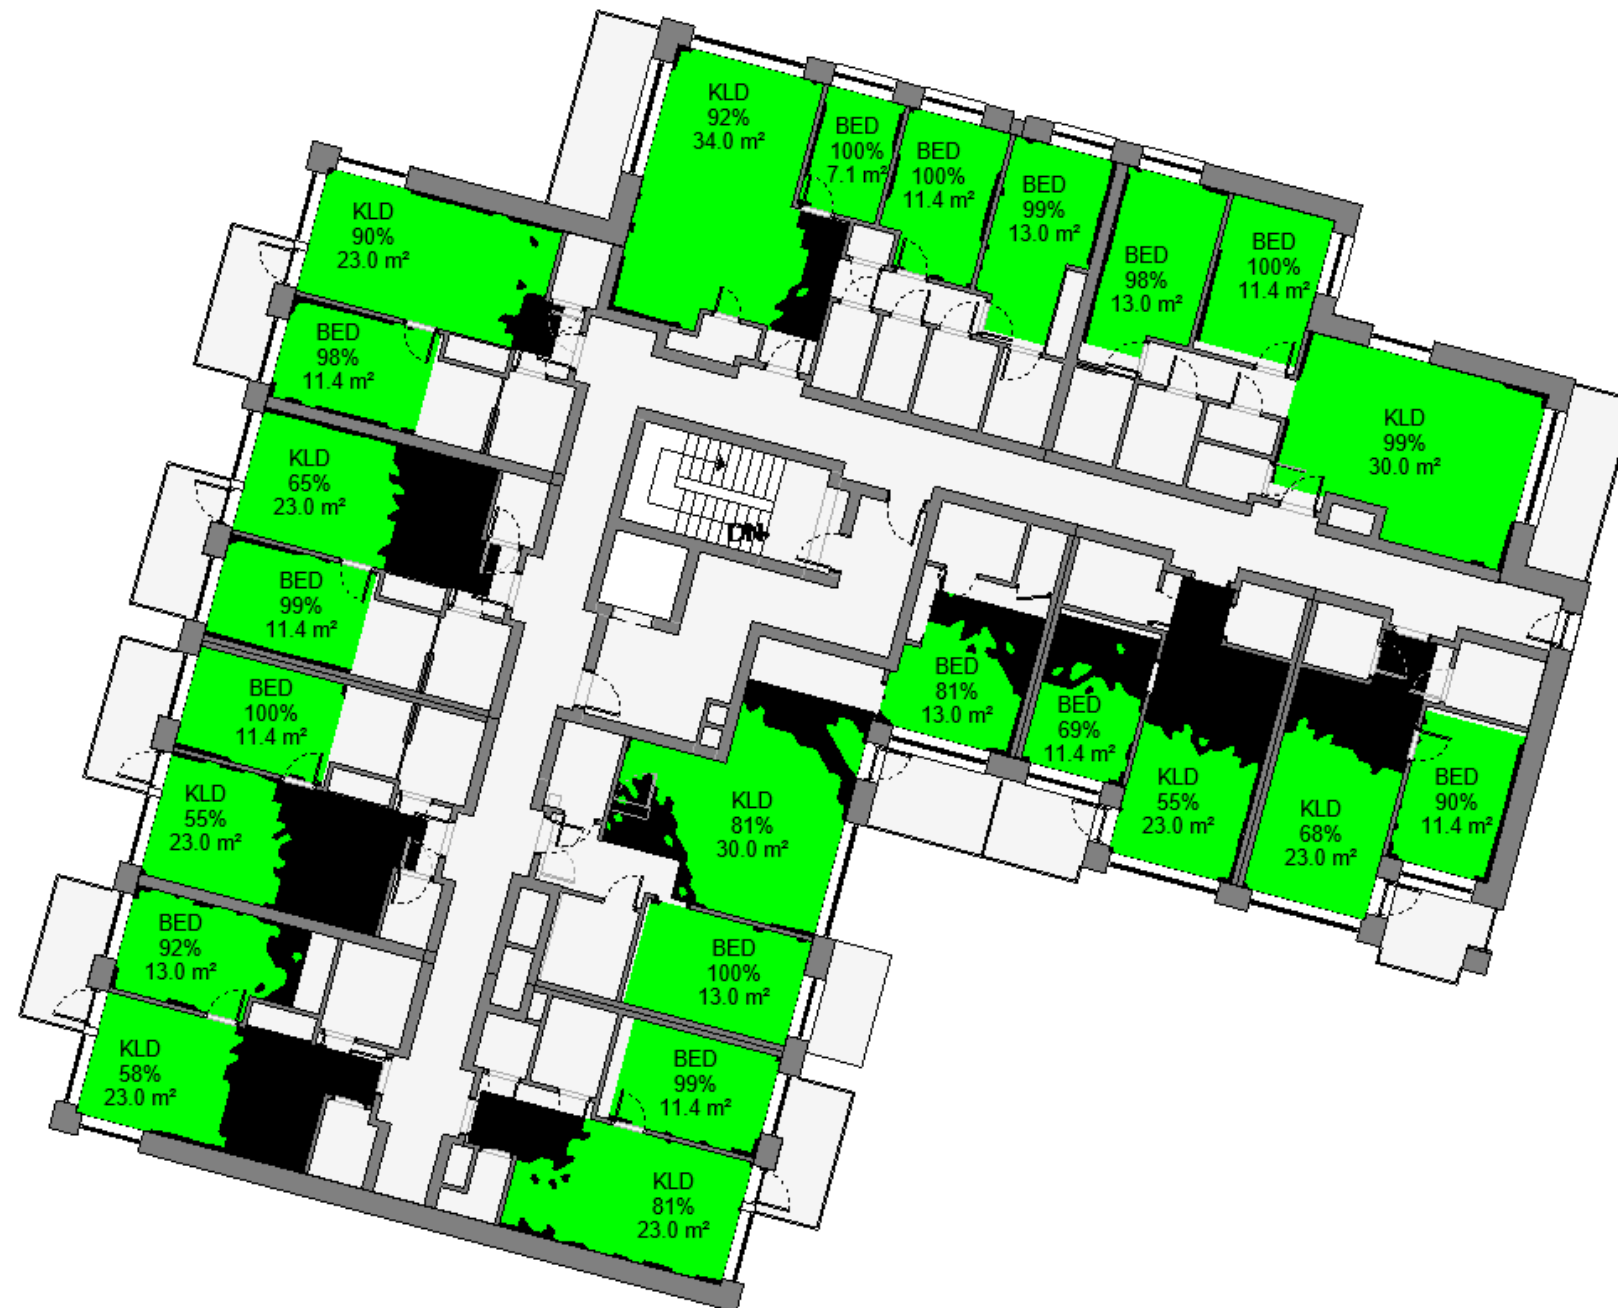
2no. KLDs were found to be non-compliant in this area.

The rest of the rooms were determined to be compliant for SDA.

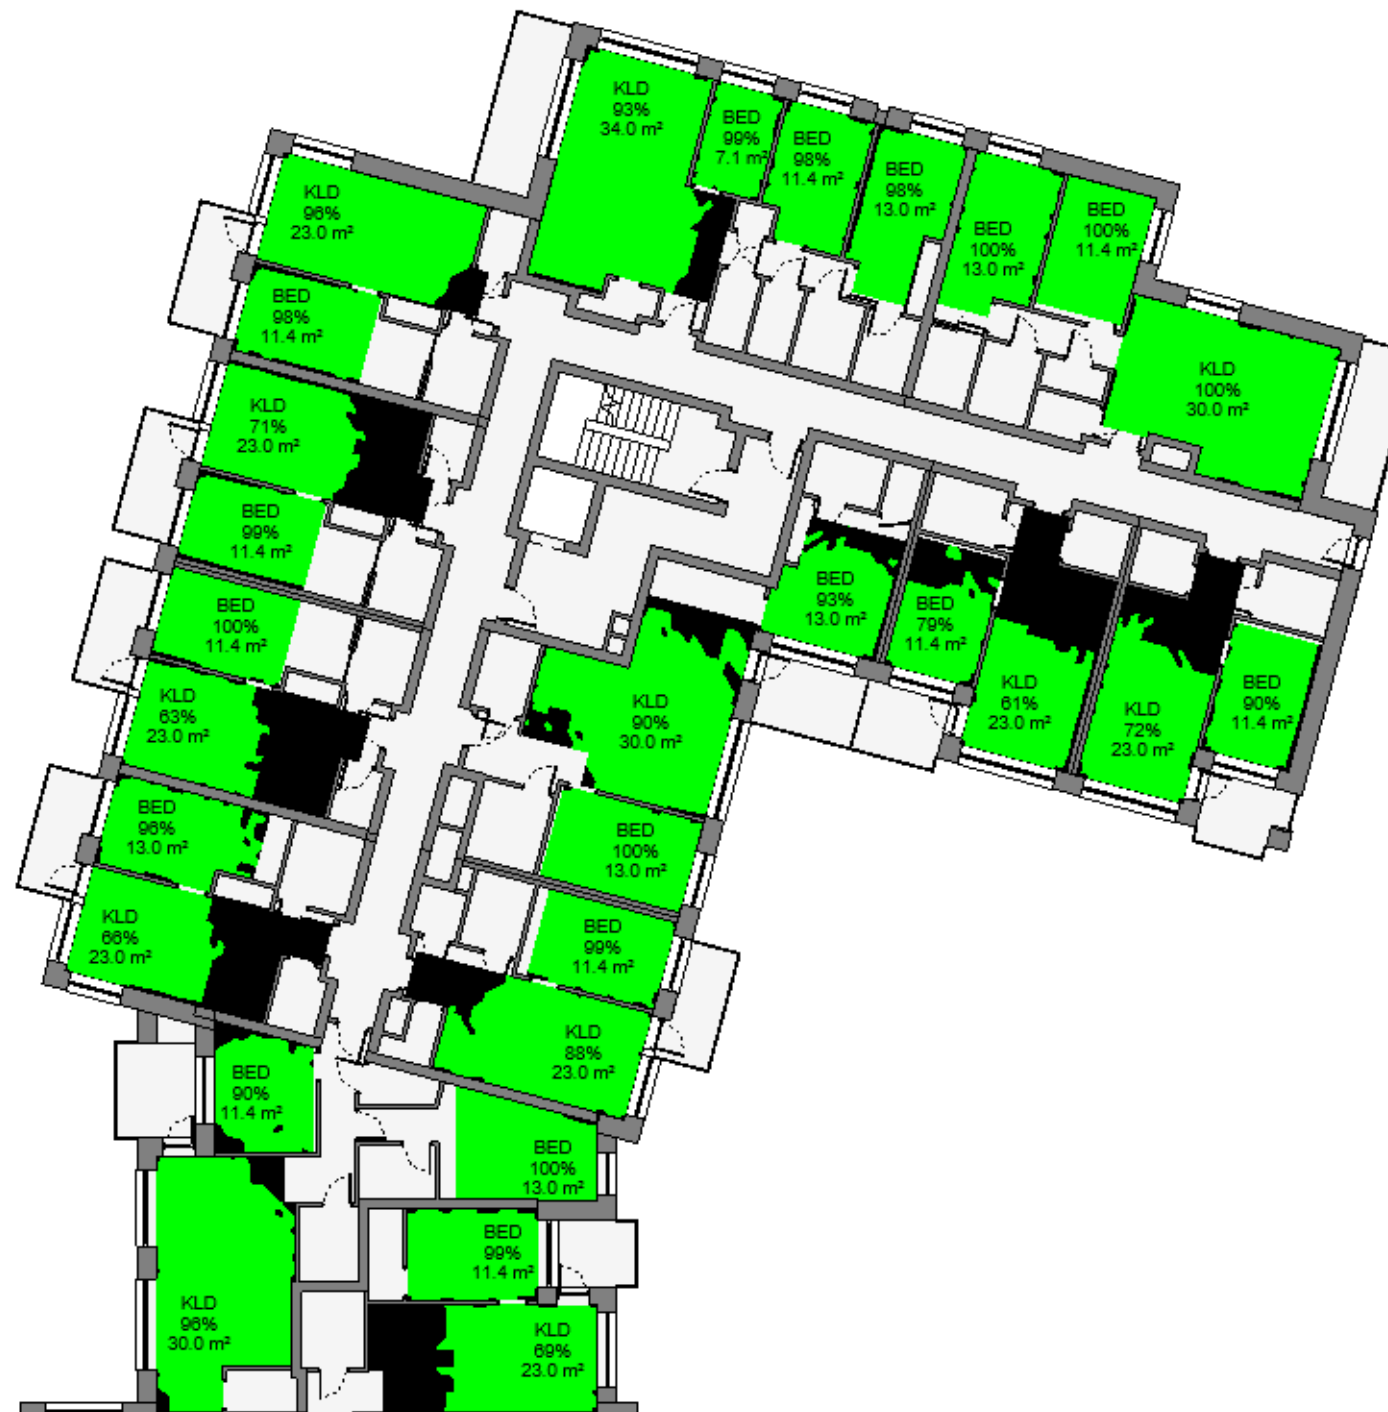
Daylight analysis results are illustrated below with green shaded area receiving targeted illuminance, 200Lux for KLDs and 100Lux for Bedrooms. Black shade is showing area where it's receiving less than targeted illuminance. A space is deemed compliant where >50% of areas achieve target illuminance.

Every room was determined to be compliant for SDA in this area.

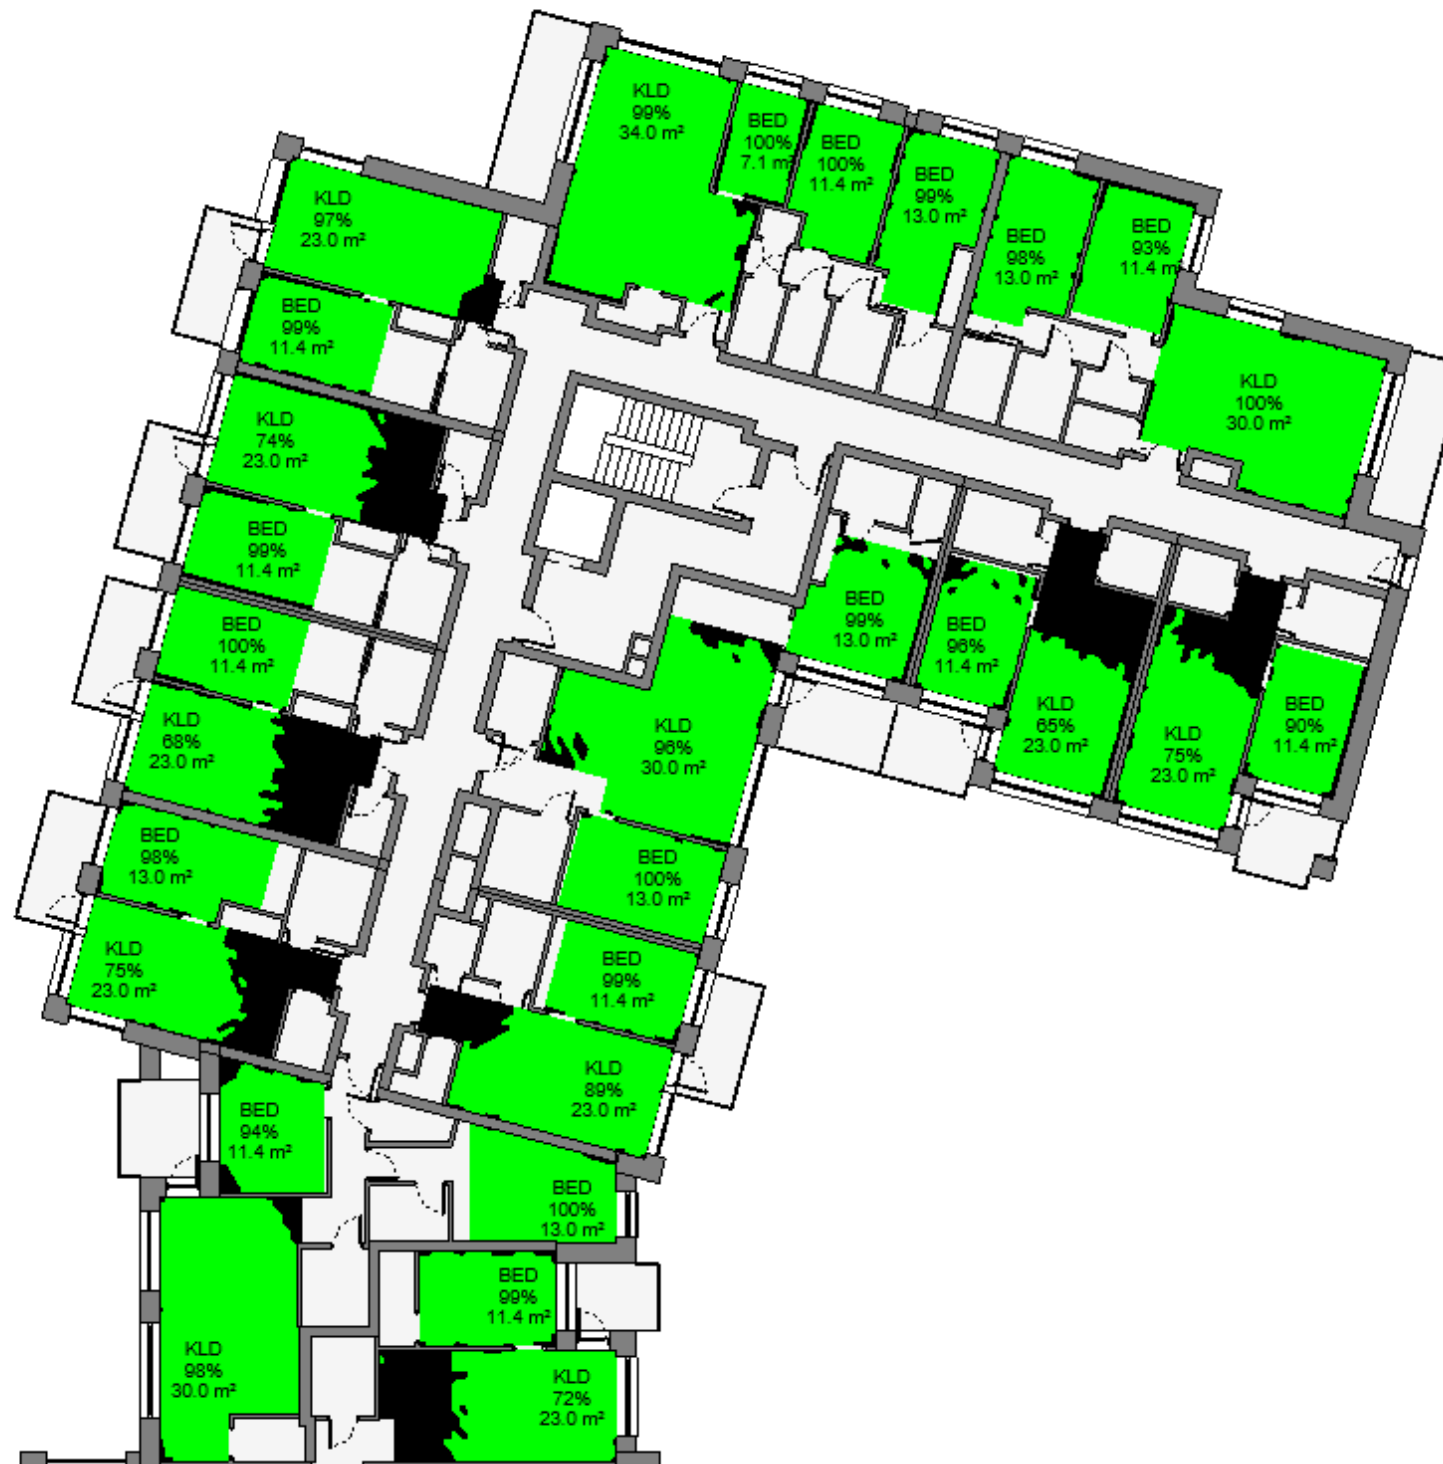
Daylight analysis results are illustrated below with green shaded area receiving targeted illuminance, 200Lux for KLDs and 100Lux for Bedrooms. Black shade is showing area where it’s receiving less than targeted illuminance. A space is deemed compliant where >50% of areas achieve target illuminance.

Every room was determined to be compliant for SDA in this area.

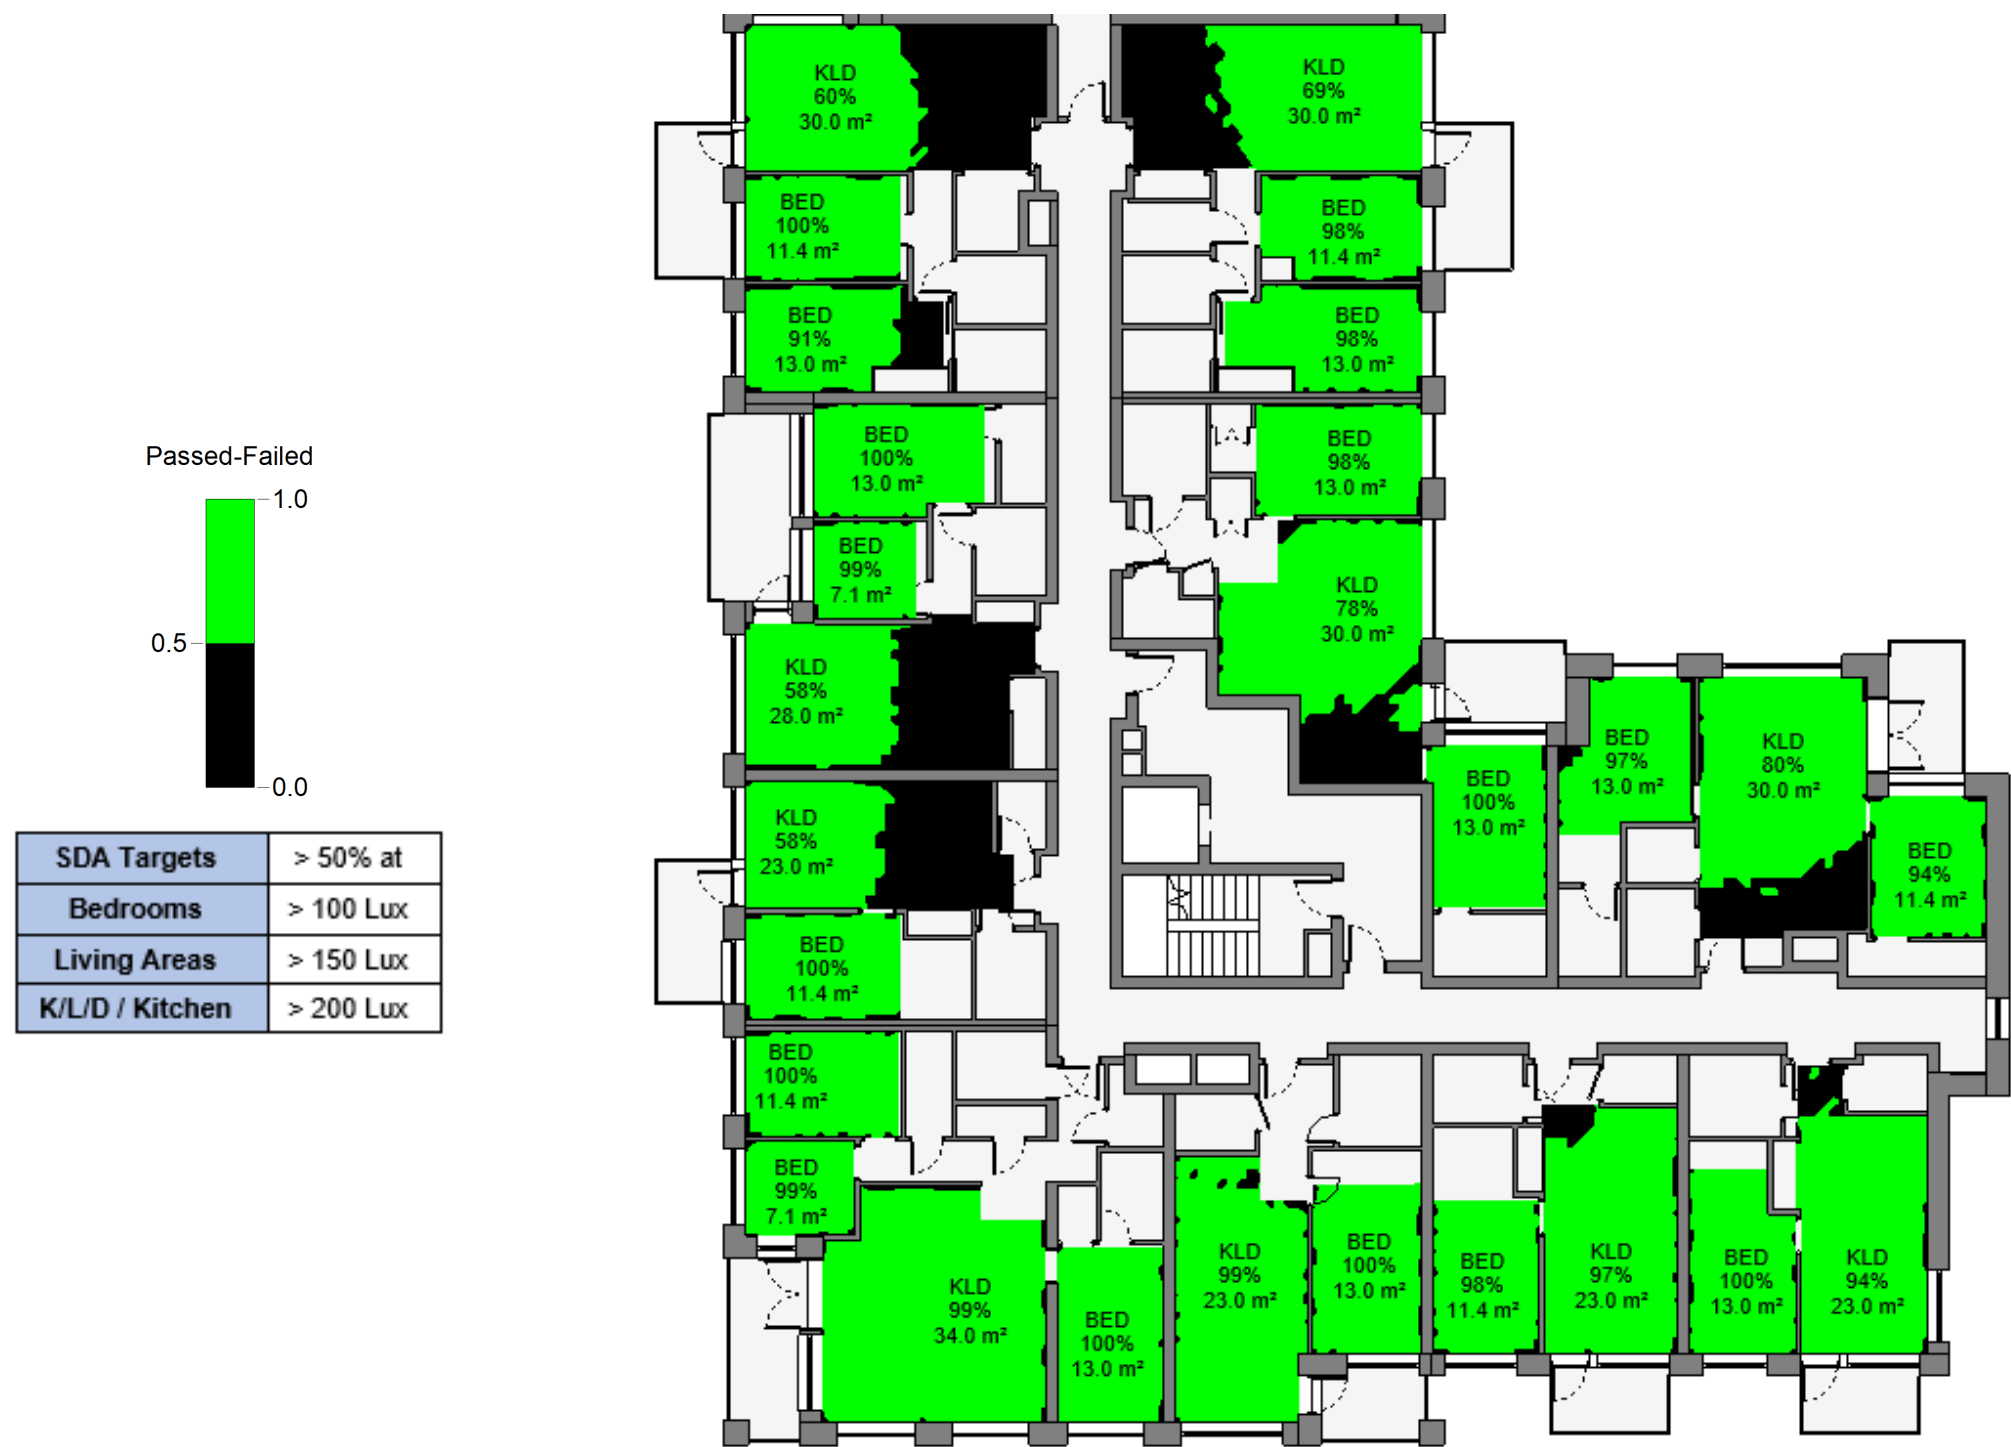
Daylight analysis results are illustrated below with green shaded area receiving targeted illuminance, 200Lux for KLDs and 100Lux for Bedrooms. Black shade is showing area where it's receiving less than targeted illuminance. A space is deemed compliant where >50% of areas achieve target illuminance.

Every room was determined to be compliant for SDA in this area.
