St. Vincent's Hospital Fairview Redevelopment, Fairview Dublin 3

Daylight and Sunlight Analysis

IN2 Project No. D2116

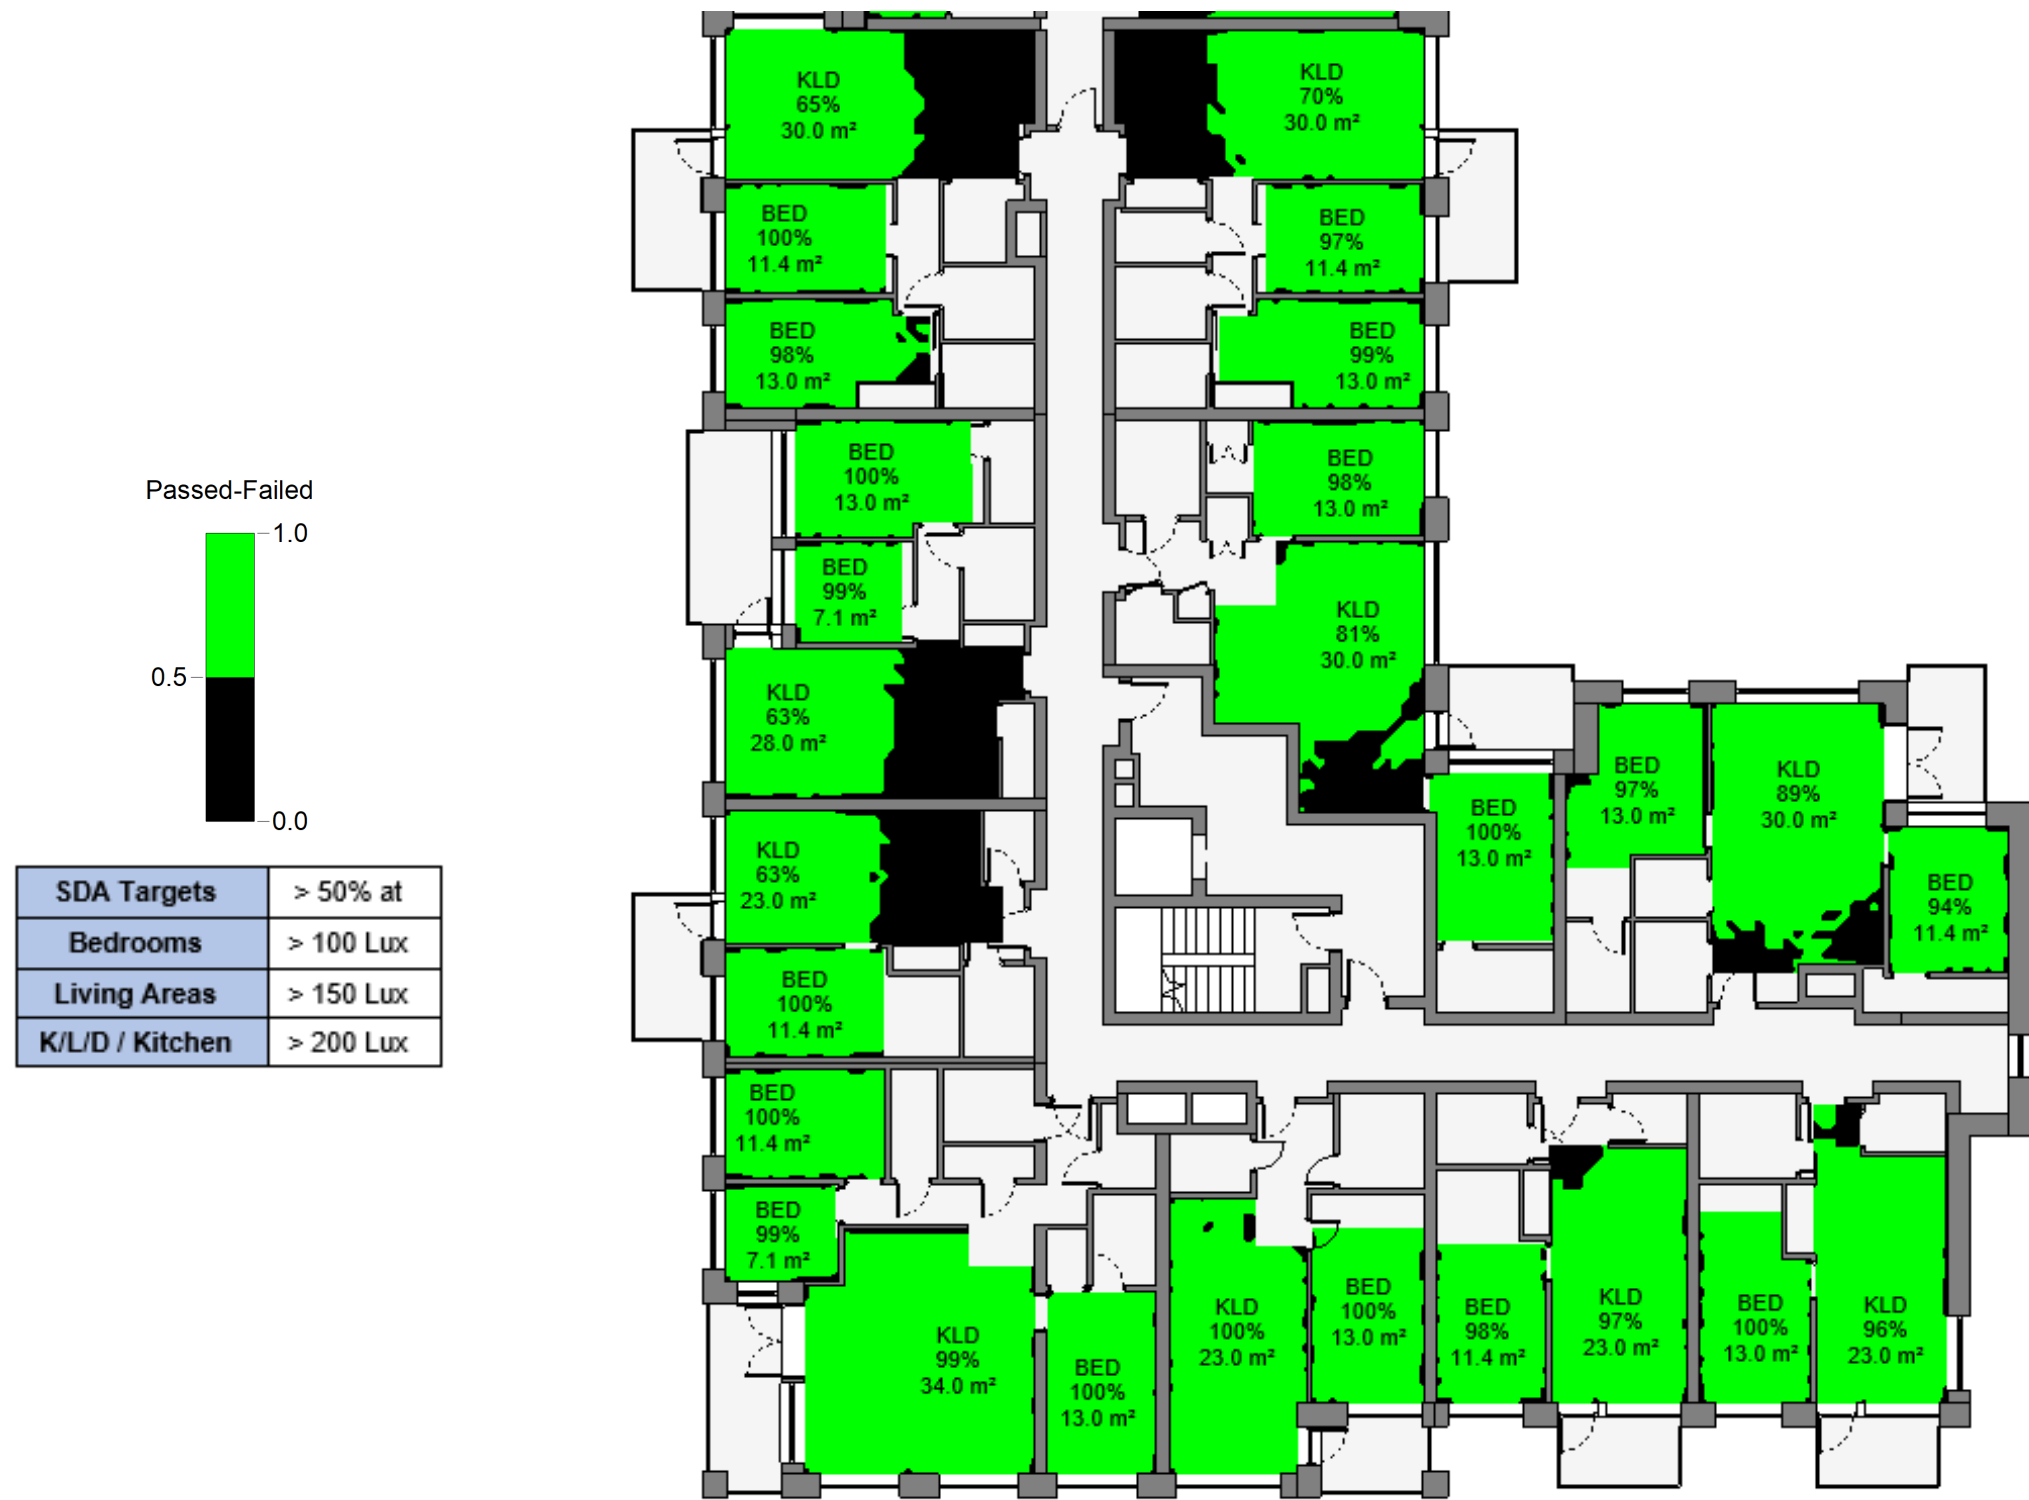
Daylight analysis results are illustrated below with green shaded area receiving targeted illuminance, 200Lux for KLDs and 100Lux for Bedrooms. Black shade is showing area where it's receiving less than targeted illuminance. A space is deemed compliant where >50% of areas achieve target illuminance.

Every room was determined to be compliant for SDA in this area.

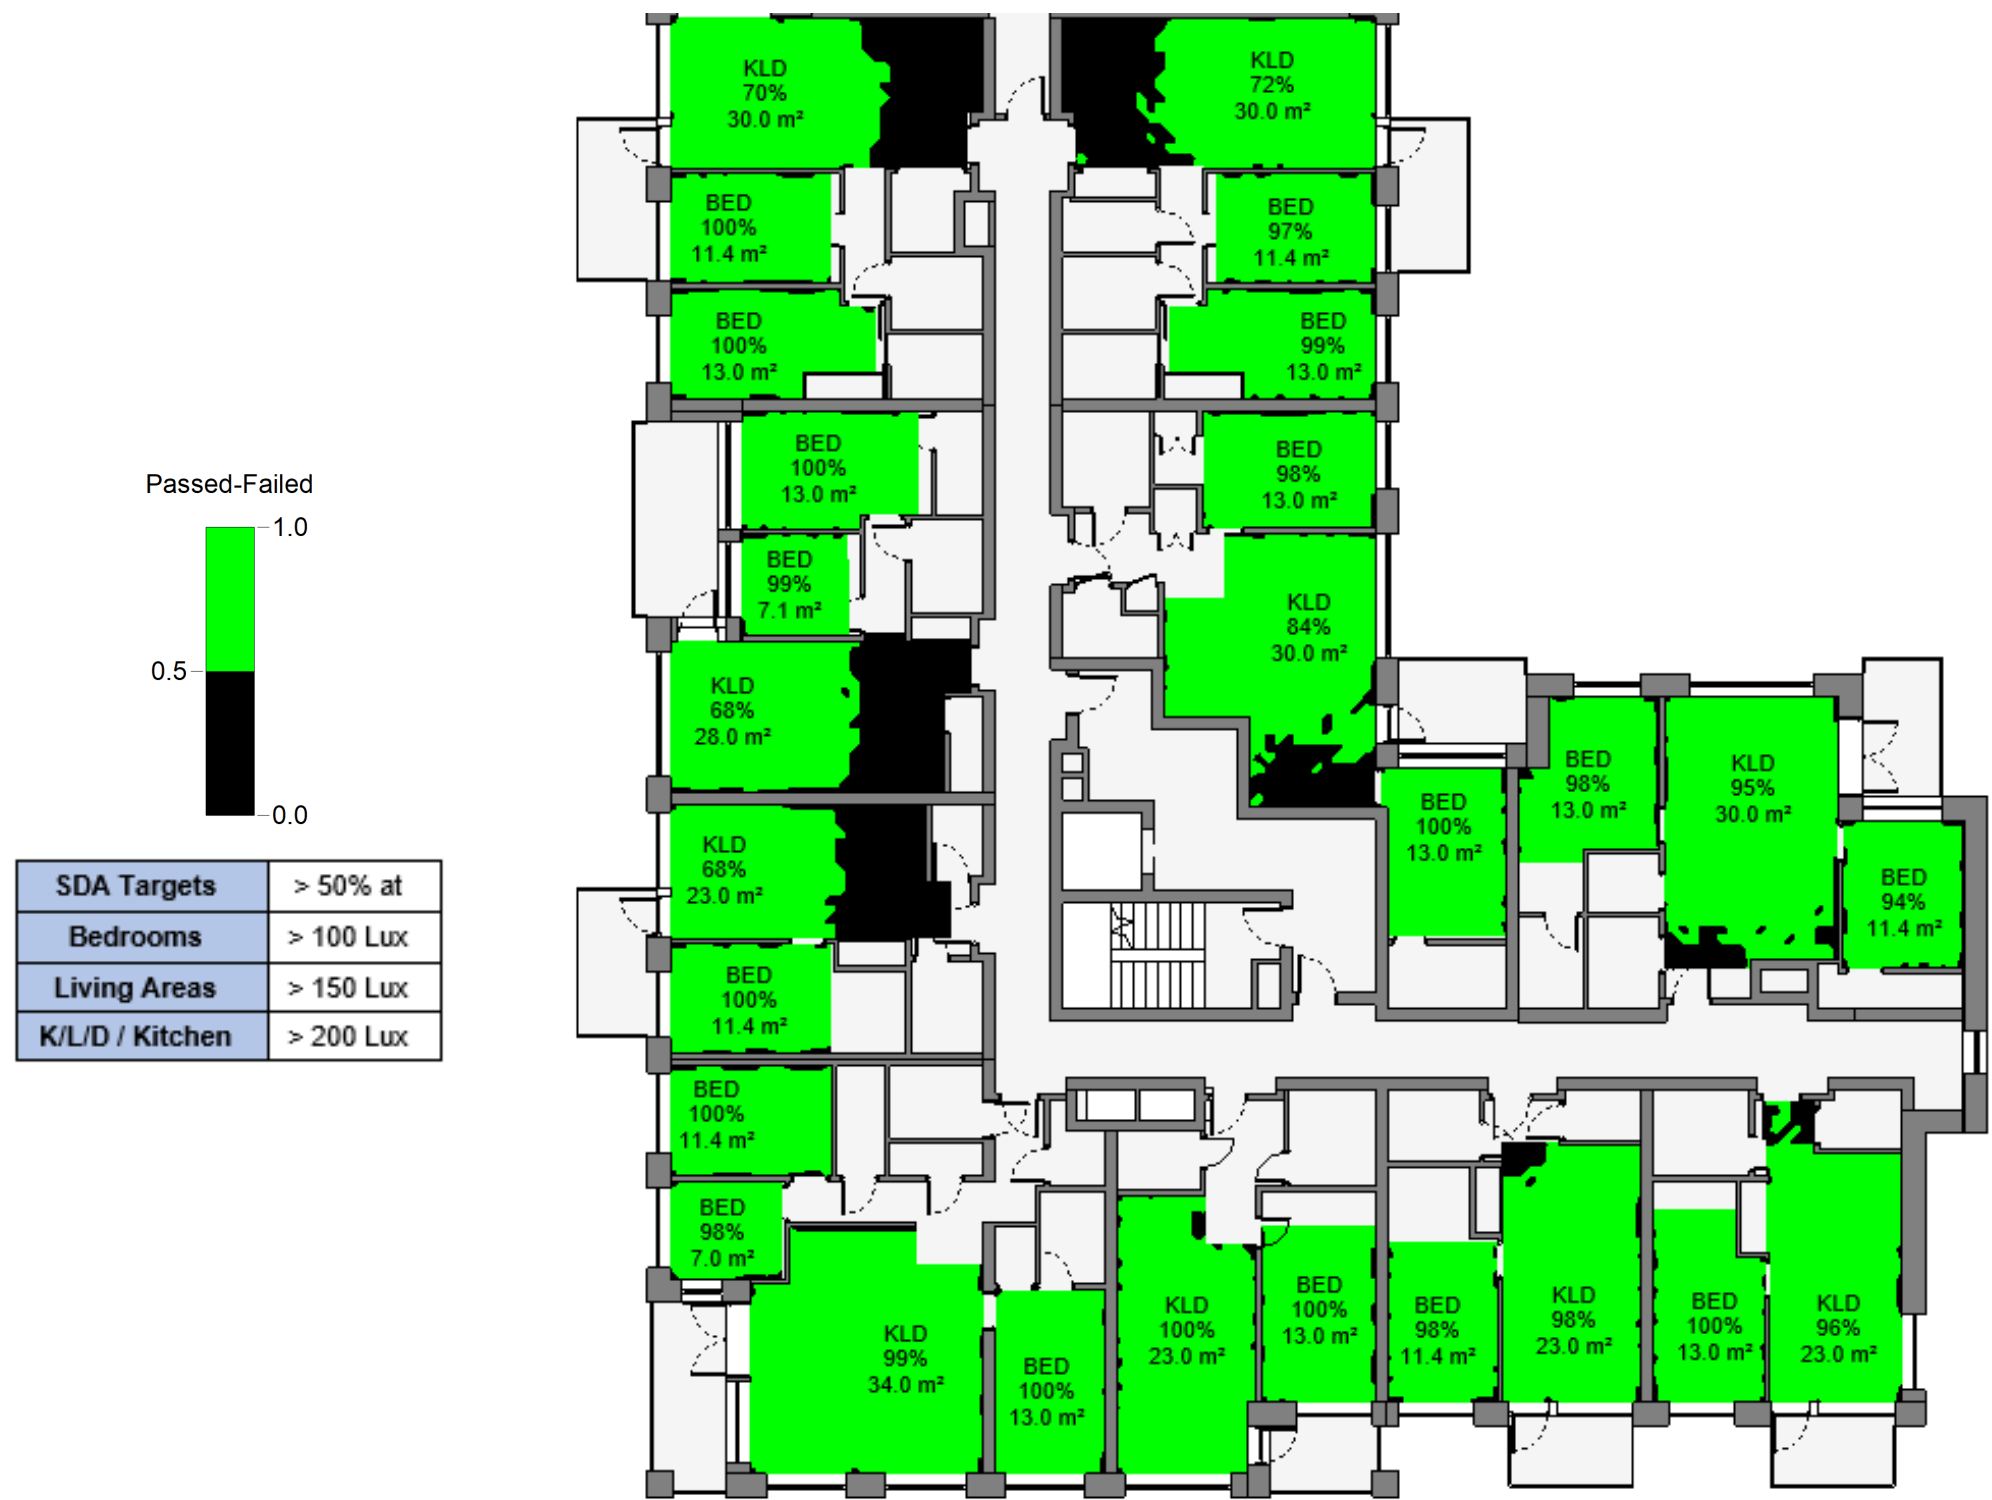
Daylight analysis results are illustrated below with green shaded area receiving targeted illuminance, 200Lux for KLDs and 100Lux for Bedrooms. Black shade is showing area where it's receiving less than targeted illuminance. A space is deemed compliant where >50% of areas achieve target illuminance.

Every room was determined to be compliant for SDA in this area.

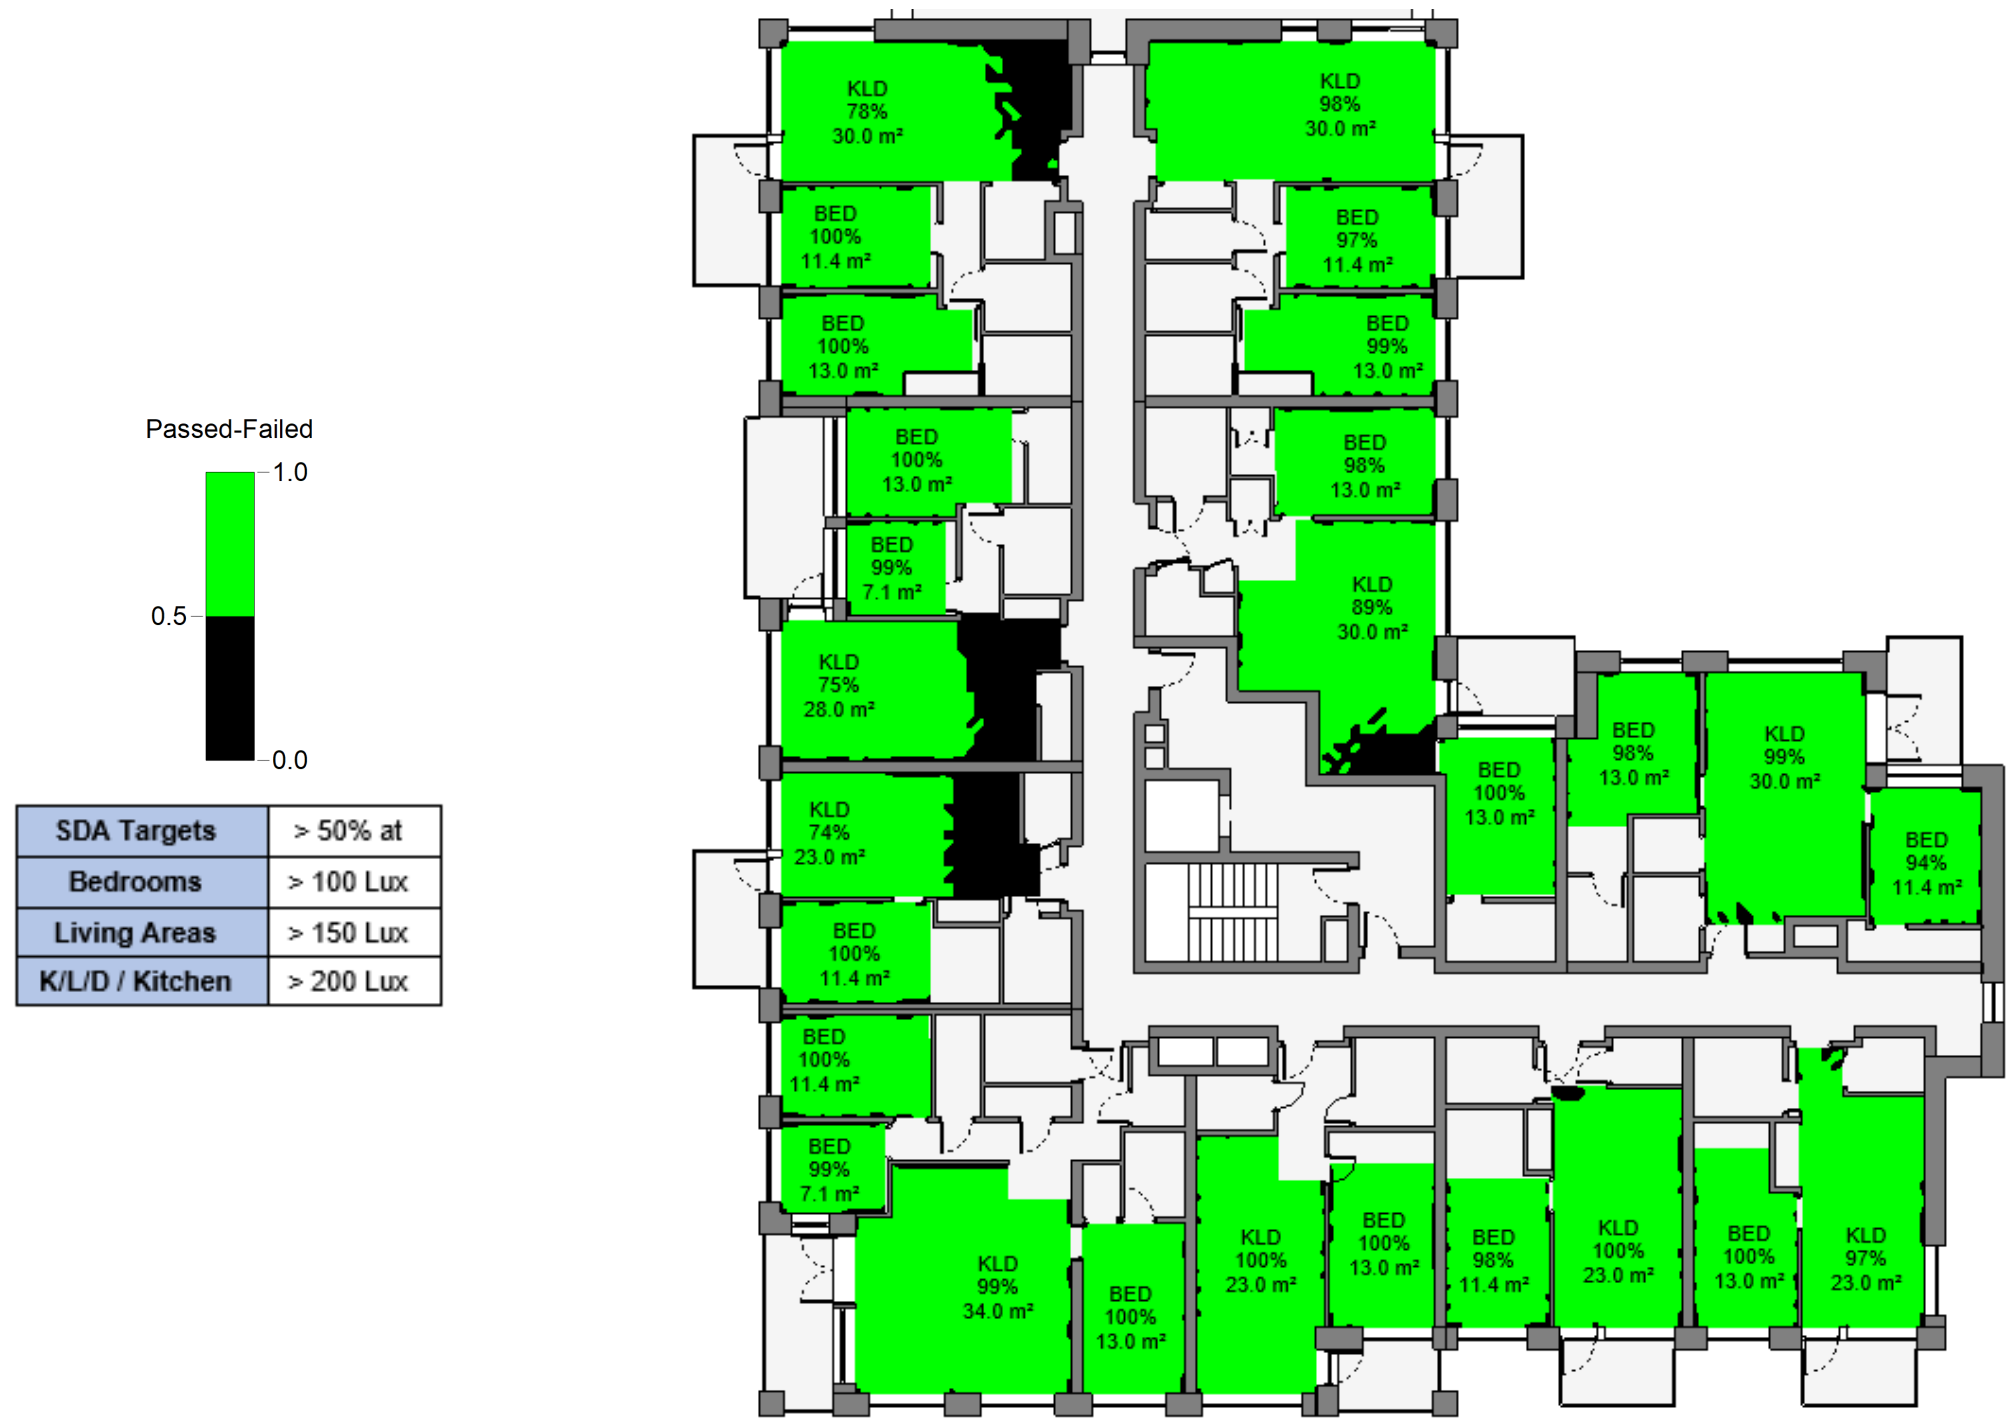
Daylight analysis results are illustrated below with green shaded area receiving targeted illuminance, 200Lux for KLDs and 100Lux for Bedrooms. Black shade is showing area where it’s receiving less than targeted illuminance. A space is deemed compliant where >50% of areas achieve target illuminance.

Every room was determined to be compliant for SDA in this area.

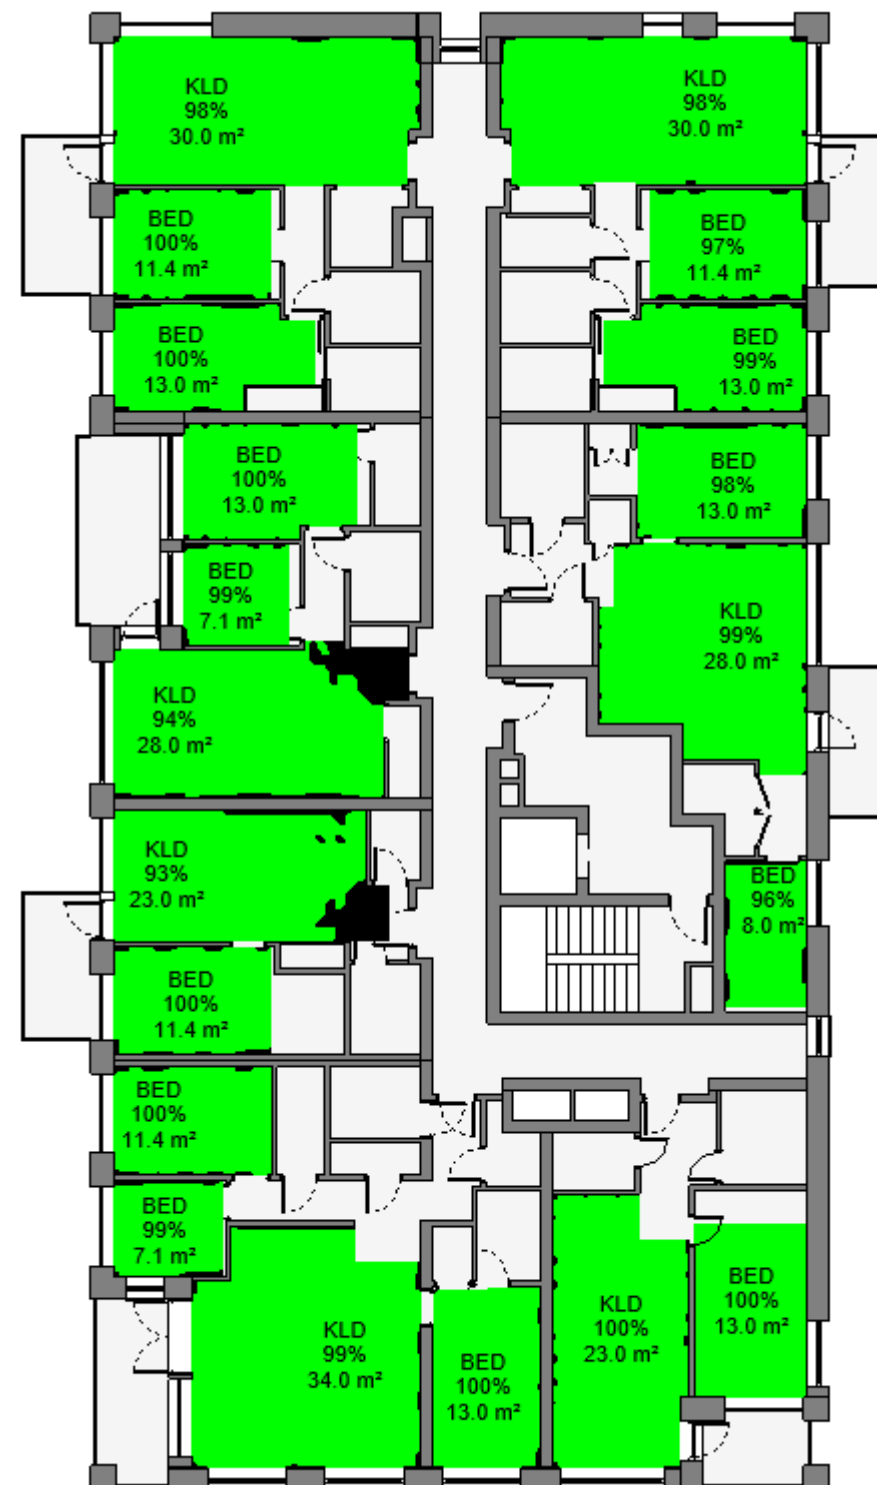
Daylight analysis results are illustrated below with green shaded area receiving targeted illuminance, 200Lux for KLDs and 100Lux for Bedrooms. Black shade is showing area where it's receiving less than targeted illuminance. A space is deemed compliant where >50% of areas achieve target illuminance.

Every room was determined to be compliant for SDA in this area.

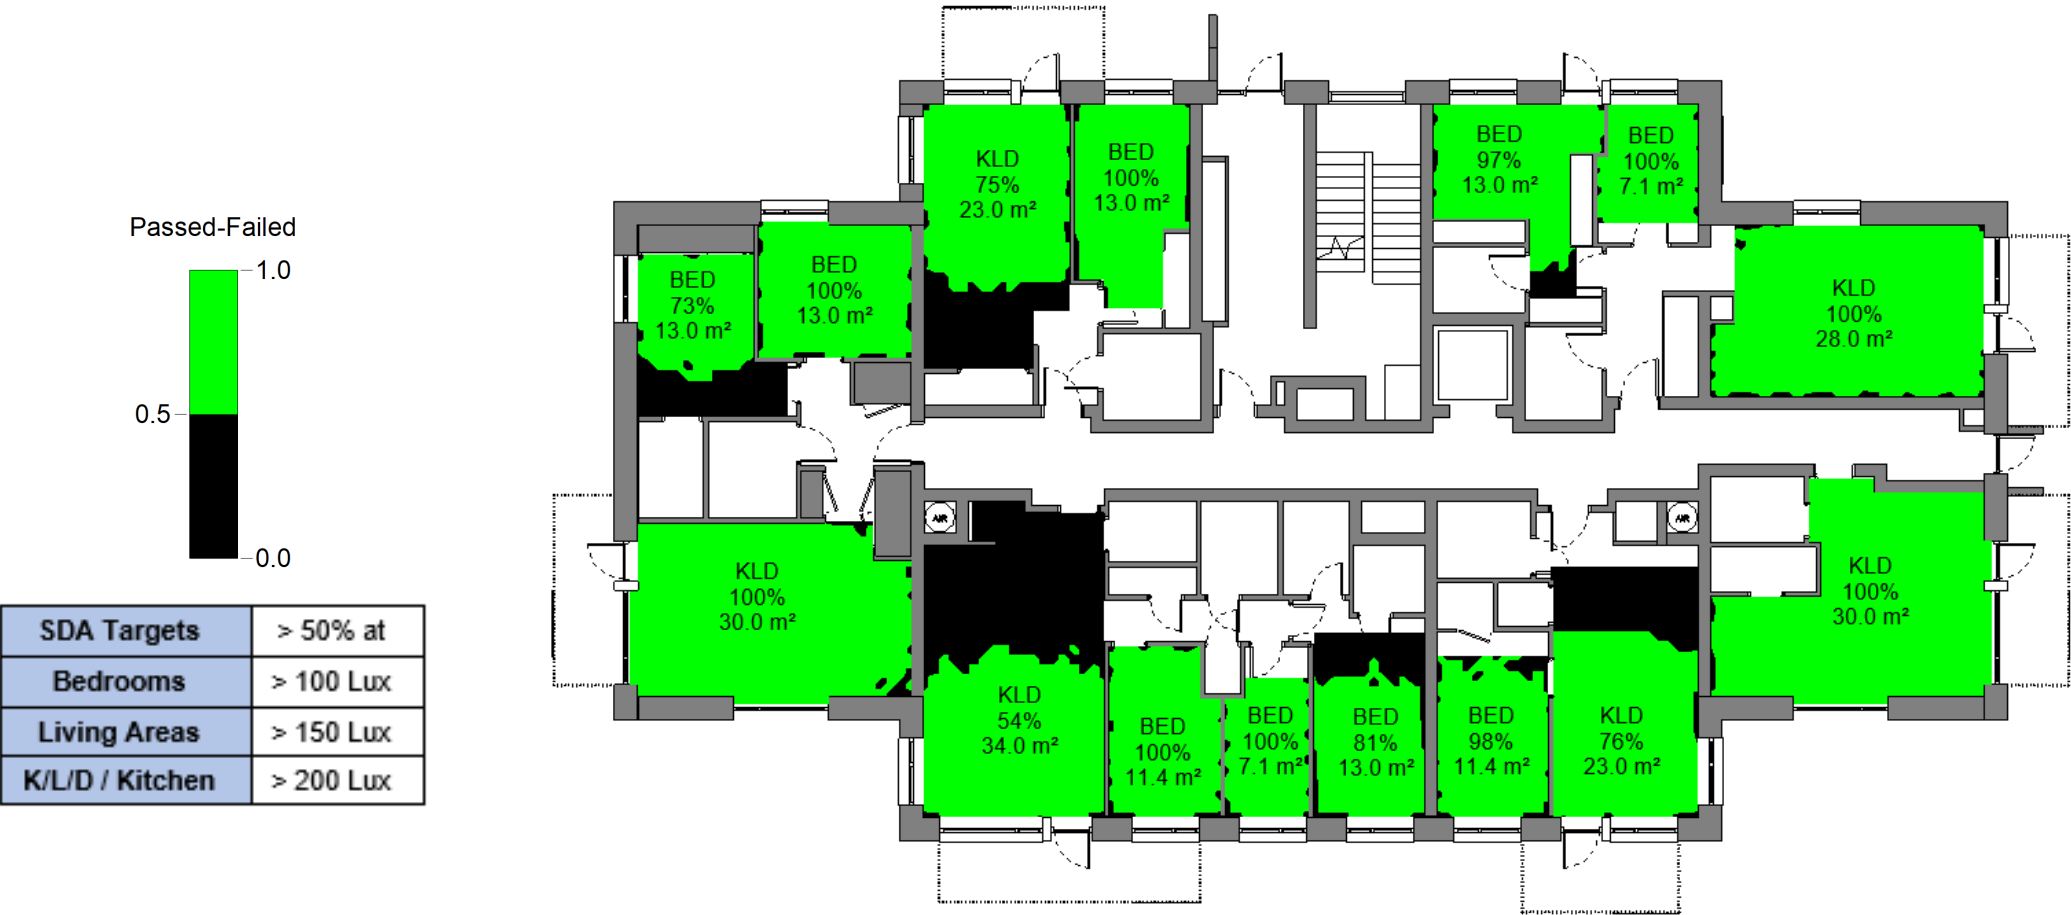
Daylight analysis results are illustrated below with green shaded area receiving targeted illuminance, 200Lux for KLDs and 100Lux for Bedrooms. Black shade is showing area where it’s receiving less than targeted illuminance. A space is deemed compliant where >50% of areas achieve target illuminance.

Every room was determined to be compliant for SDA in this area.

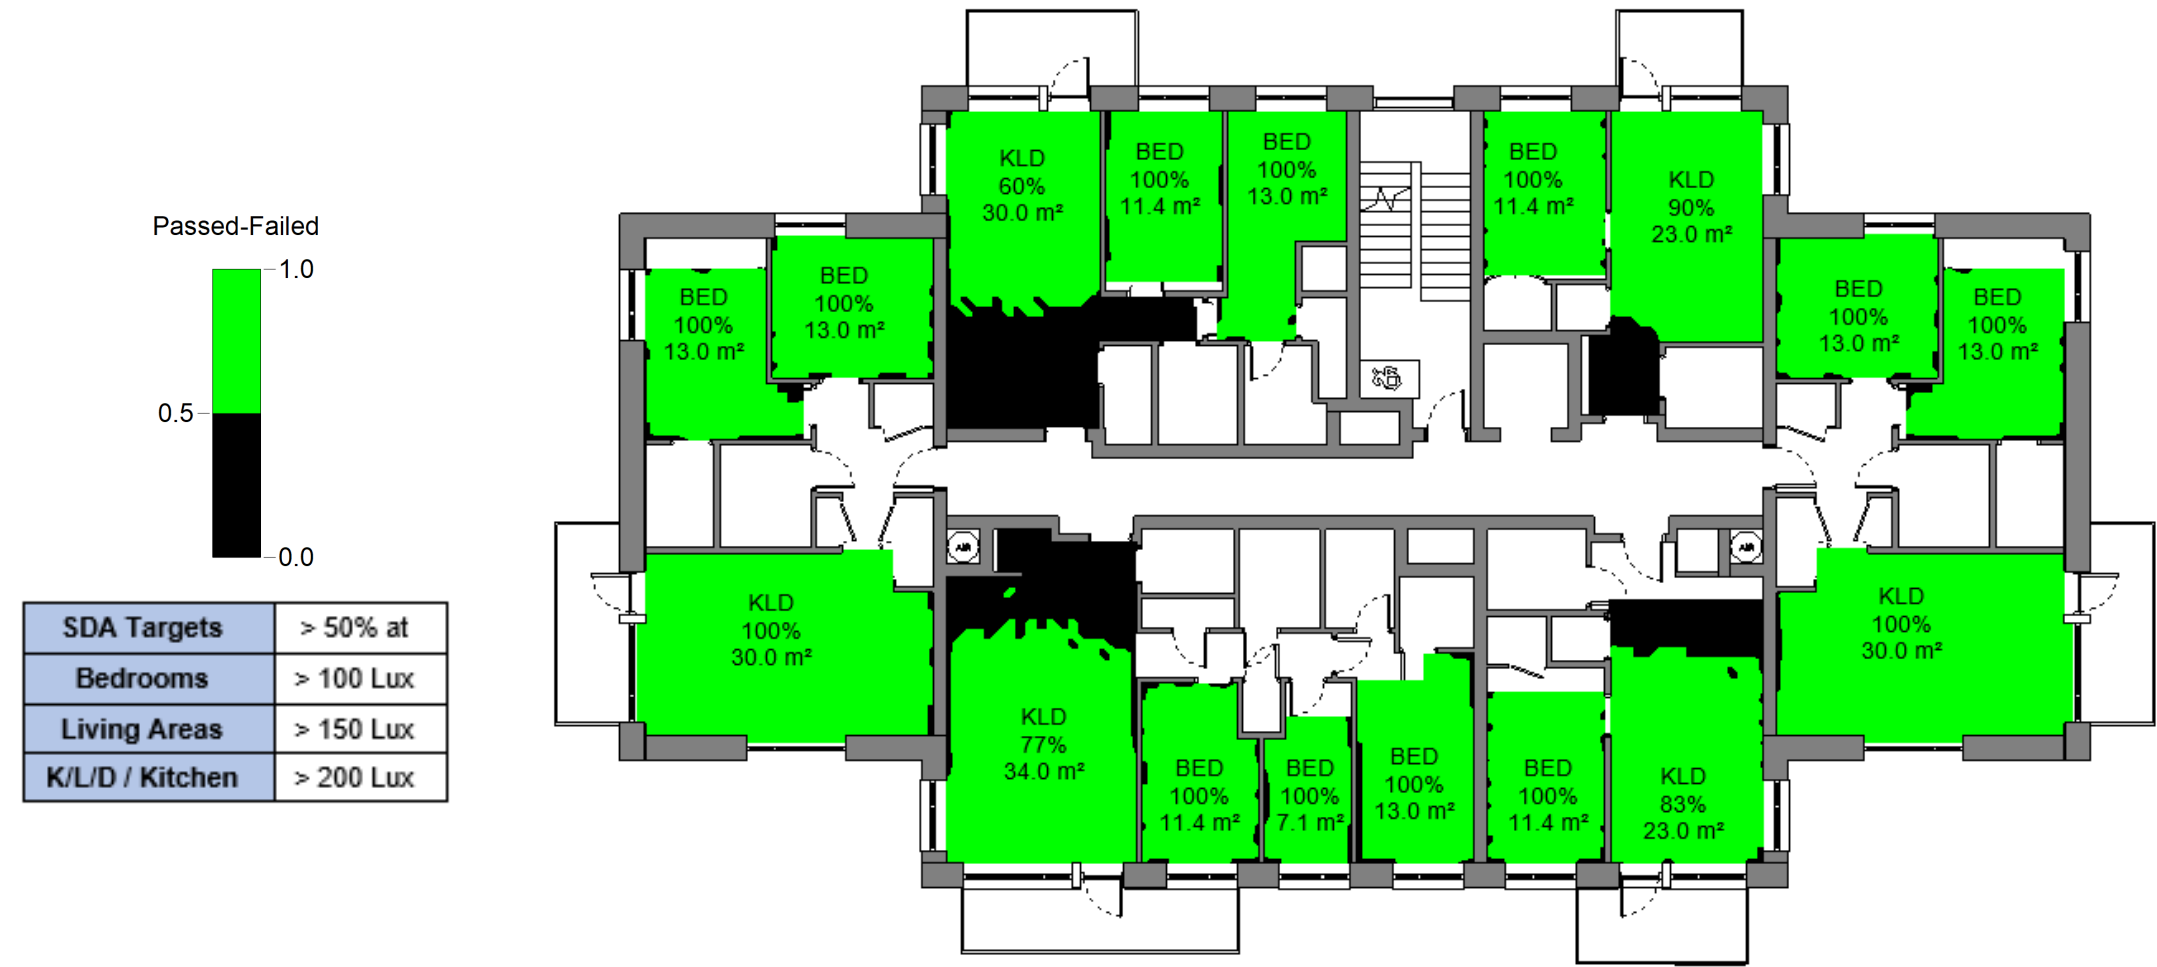
Daylight analysis results are illustrated below with green shaded area receiving targeted illuminance, 200Lux for KLDs and 100Lux for Bedrooms. Black shade is showing area where it’s receiving less than targeted illuminance. A space is deemed compliant where >50% of areas achieve target illuminance.

All rooms were determined to be compliant for SDA.

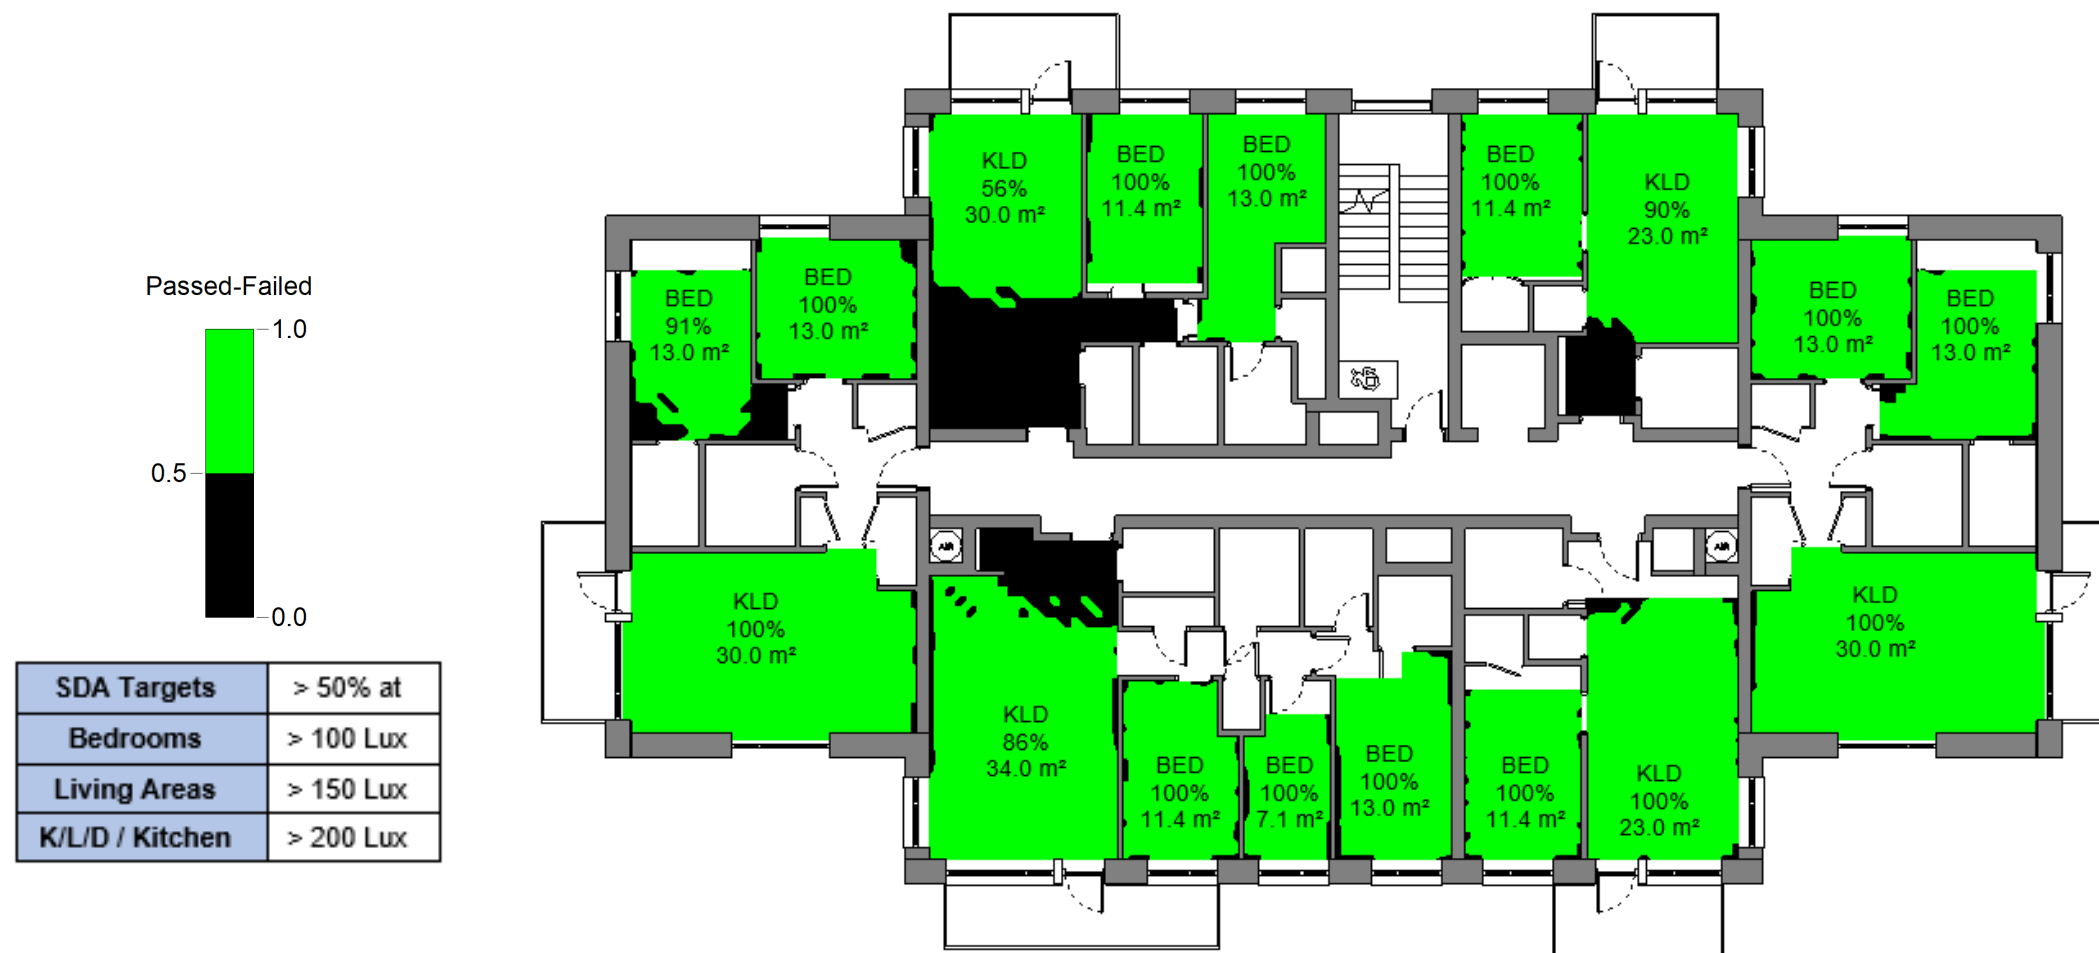
Daylight analysis results are illustrated below with green shaded area receiving targeted illuminance, 200Lux for KLDs and 100Lux for Bedrooms. Black shade is showing area where it's receiving less than targeted illuminance. A space is deemed compliant where >50% of areas achieve target illuminance.

All rooms were determined to be compliant for SDA.

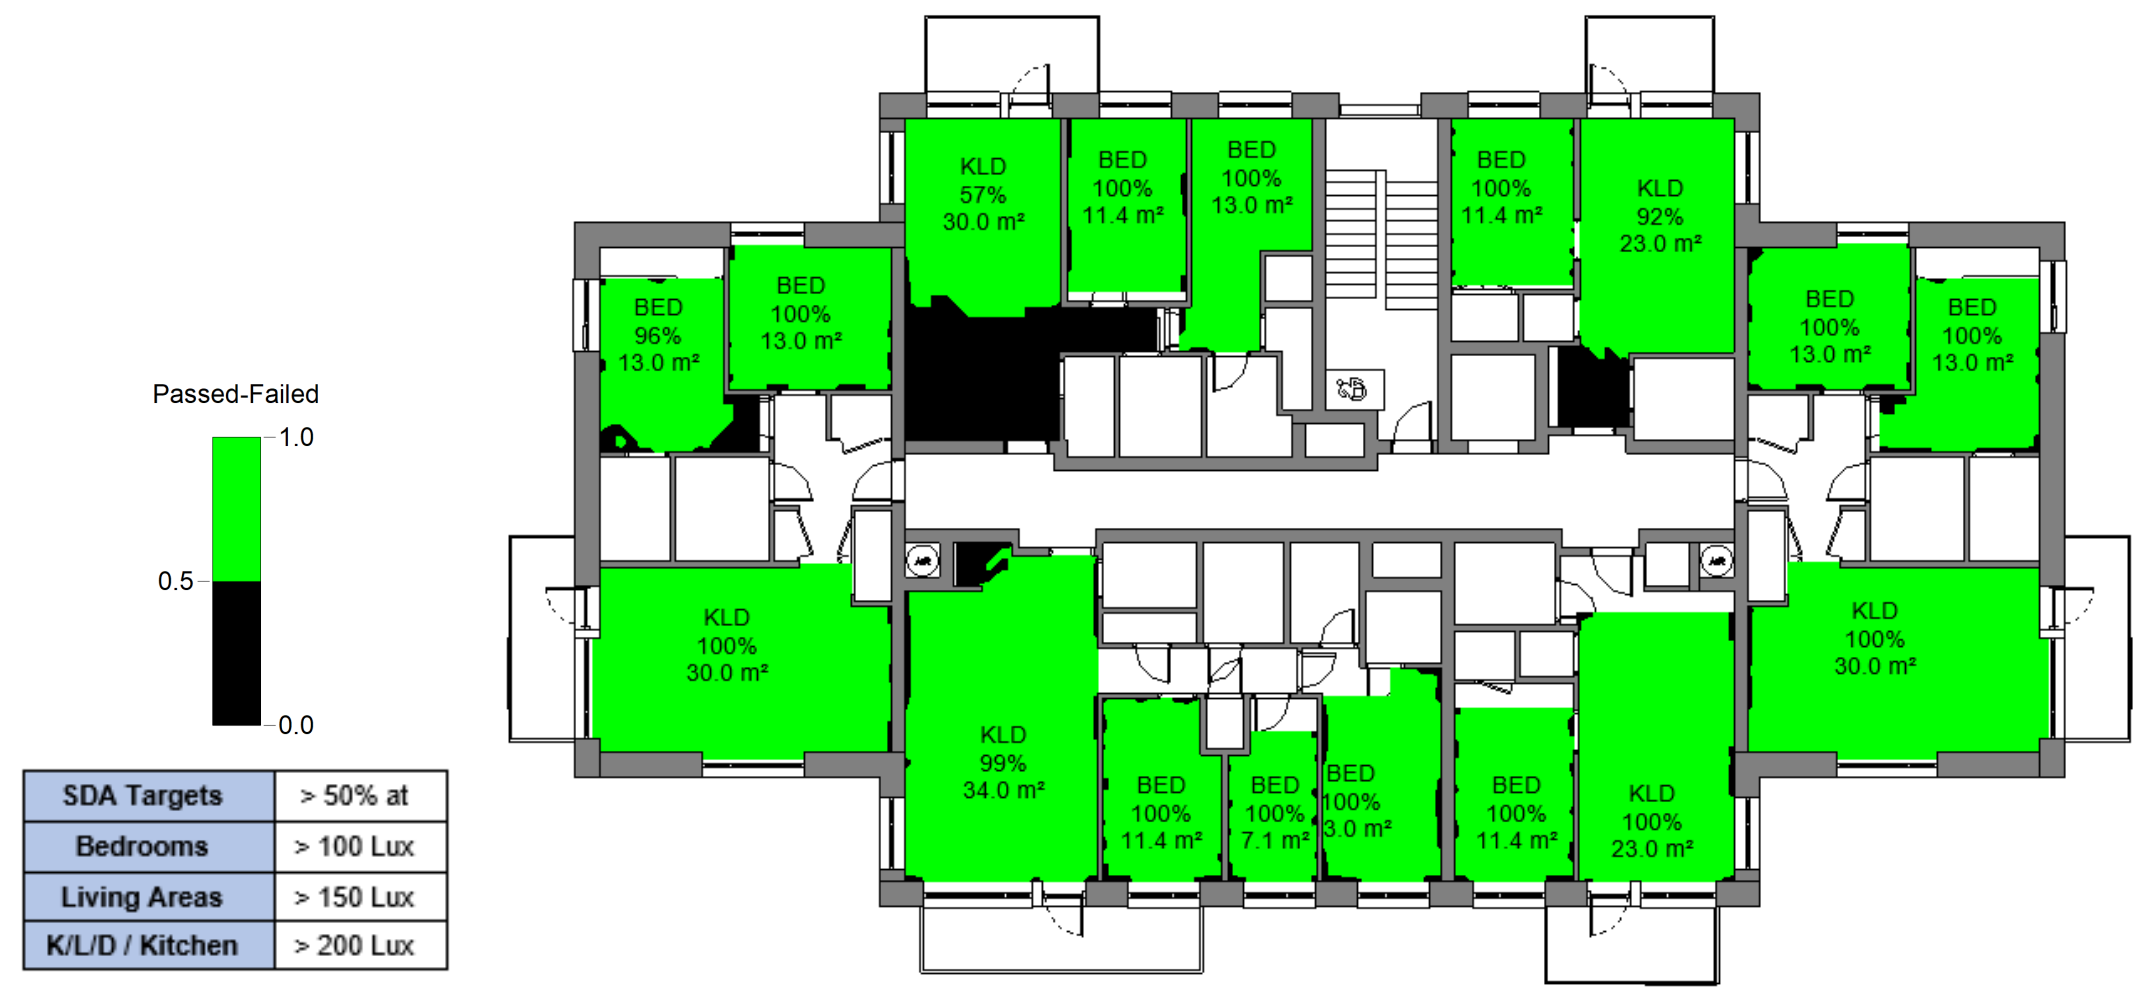
Daylight analysis results are illustrated below with green shaded area receiving targeted illuminance, 200Lux for KLDs and 100Lux for Bedrooms. Black shade is showing area where it’s receiving less than targeted illuminance. A space is deemed compliant where >50% of areas achieve target illuminance.

All were determined to be compliant for SDA.

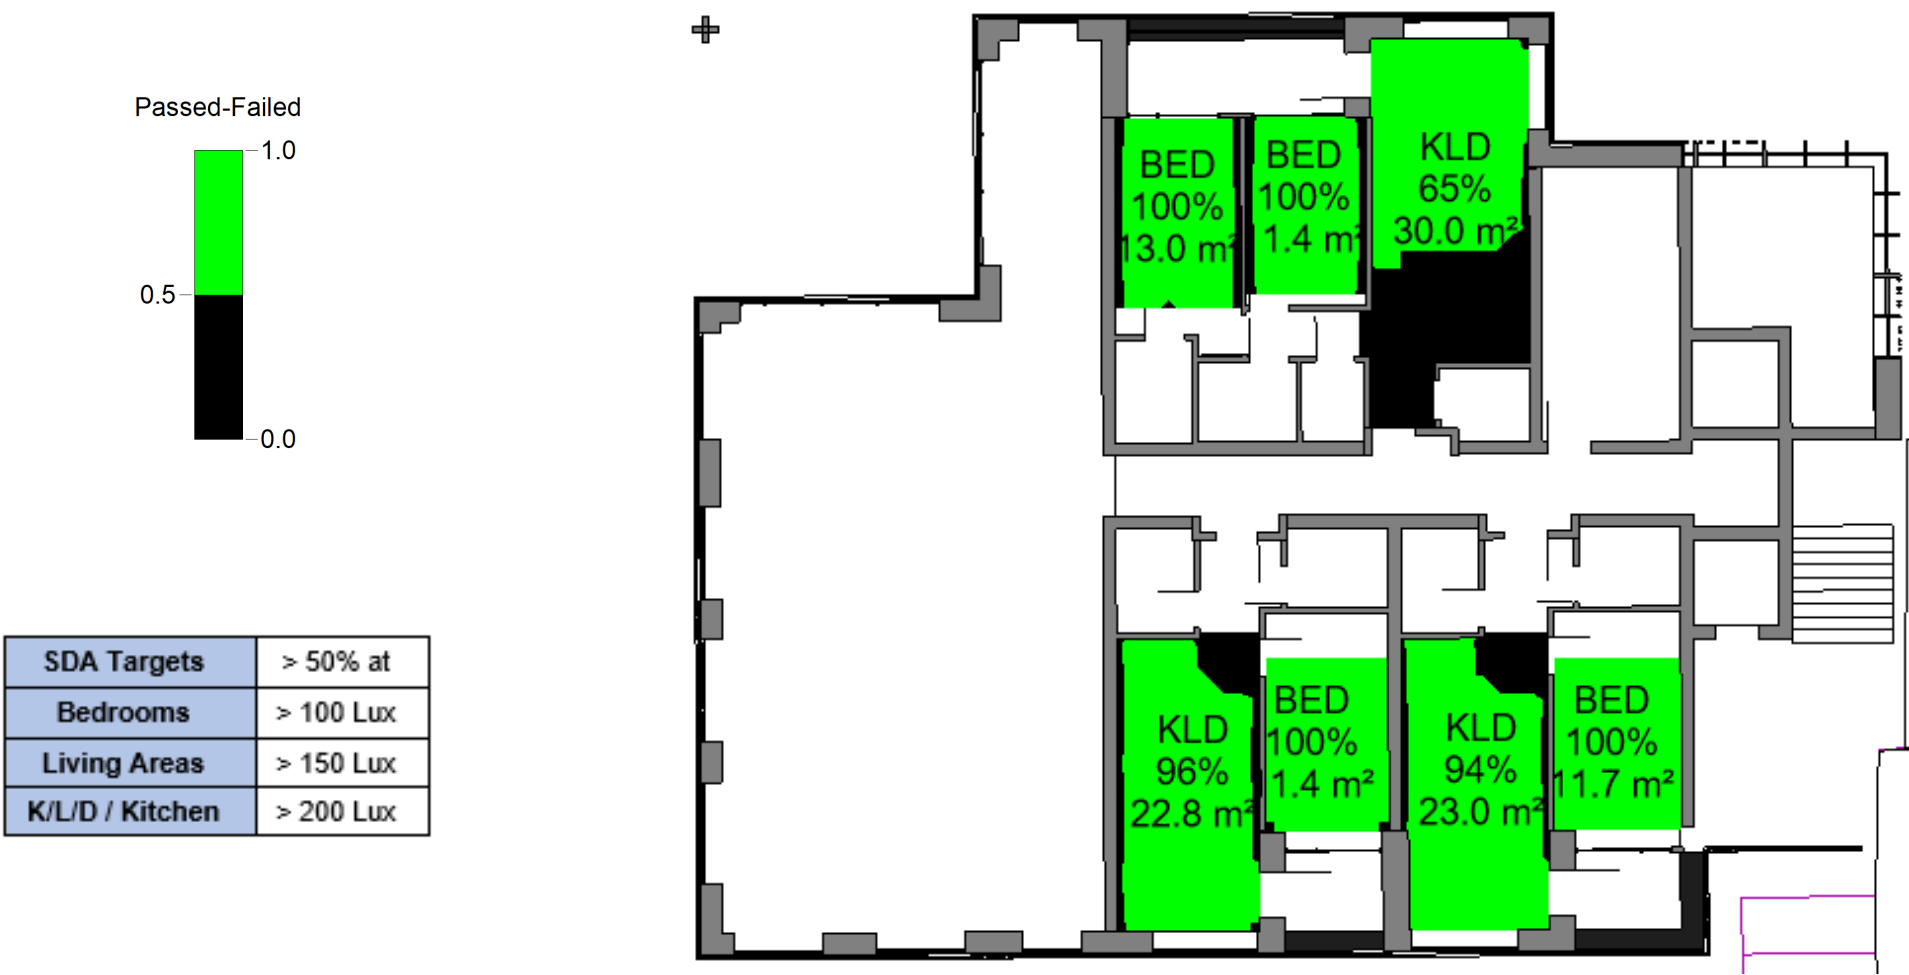
Daylight analysis results are illustrated below with green shaded area receiving targeted illuminance, 200Lux for KLDs and 100Lux for Bedrooms. Black shade is showing area where it’s receiving less than targeted illuminance. A space is deemed compliant where >50% of areas achieve target illuminance.

Every room was determined to be compliant for SDA in this area.

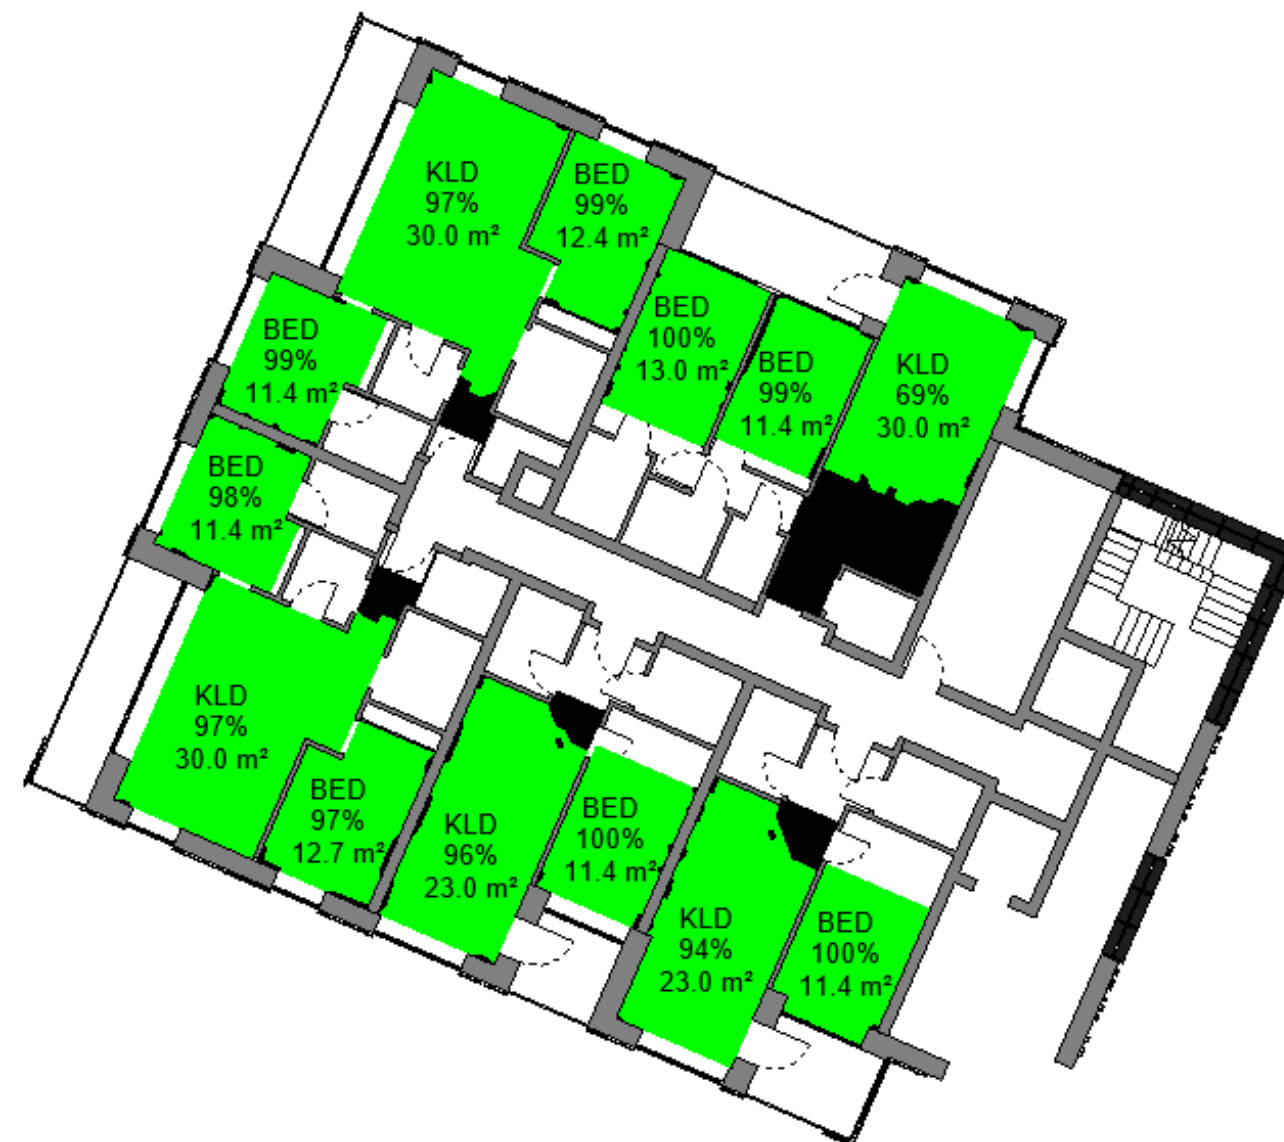
Daylight analysis results are illustrated below with green shaded area receiving targeted illuminance, 200Lux for KLDs and 100Lux for Bedrooms. Black shade is showing area where it's receiving less than targeted illuminance. A space is deemed compliant where >50% of areas achieve target illuminance.

Every room was determined to be compliant for SDA in this area.
