St. Vincent's Hospital Fairview Redevelopment, Fairview Dublin 3

Daylight and Sunlight Analysis

IN2 Project No. D2116

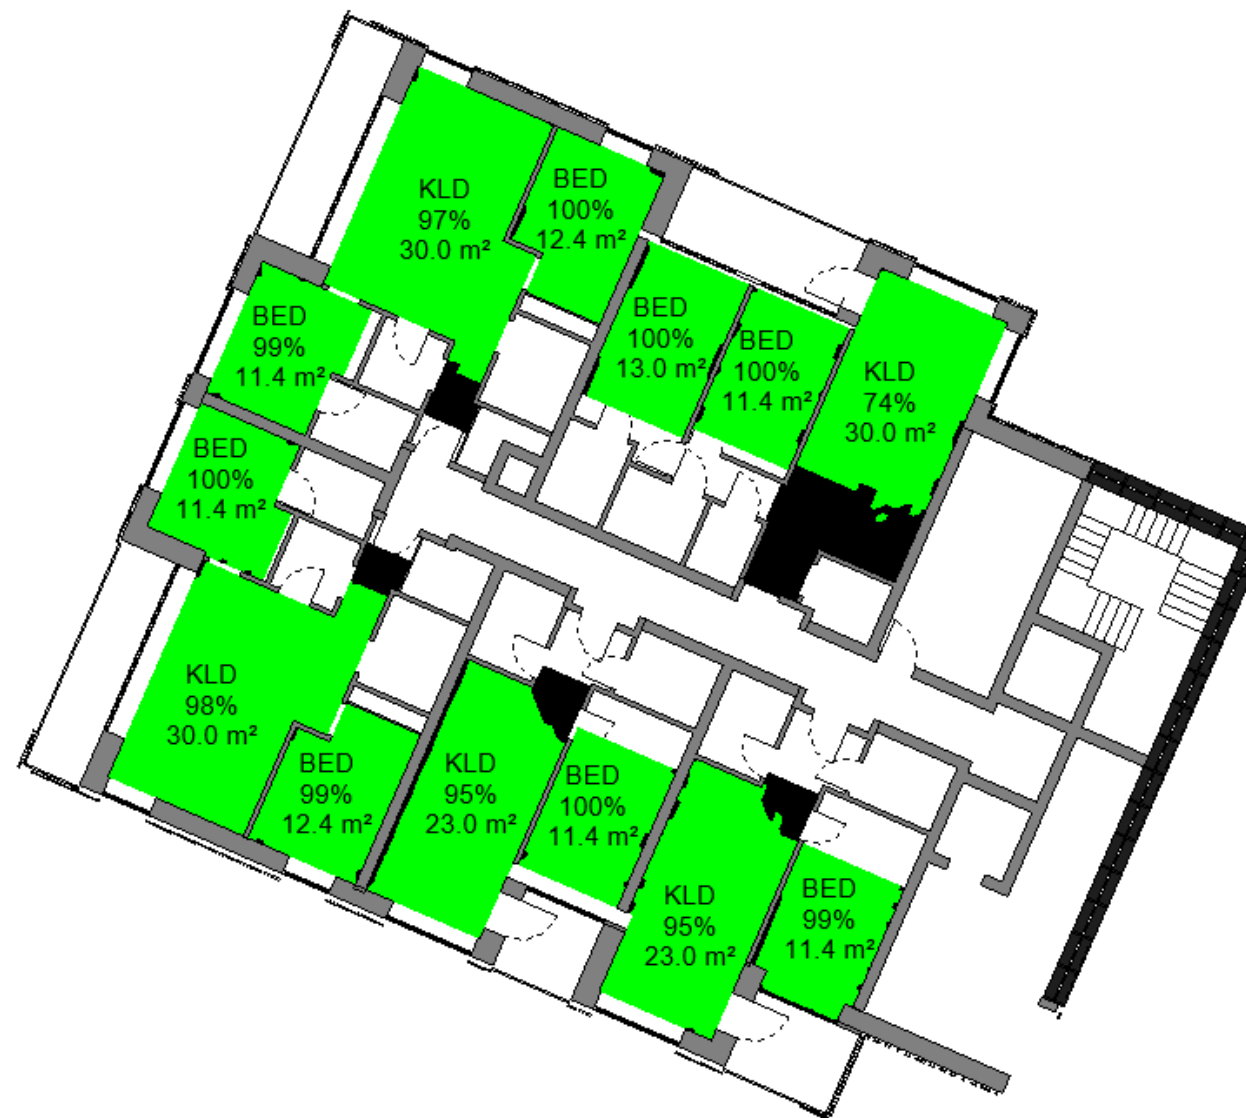
Daylight analysis results are illustrated below with green shaded area receiving targeted illuminance, 200Lux for KLDs and 100Lux for Bedrooms. Black shade is showing area where it's receiving less than targeted illuminance. A space is deemed compliant where >50% of areas achieve target illuminance.

Every room was determined to be compliant for SDA in this area.

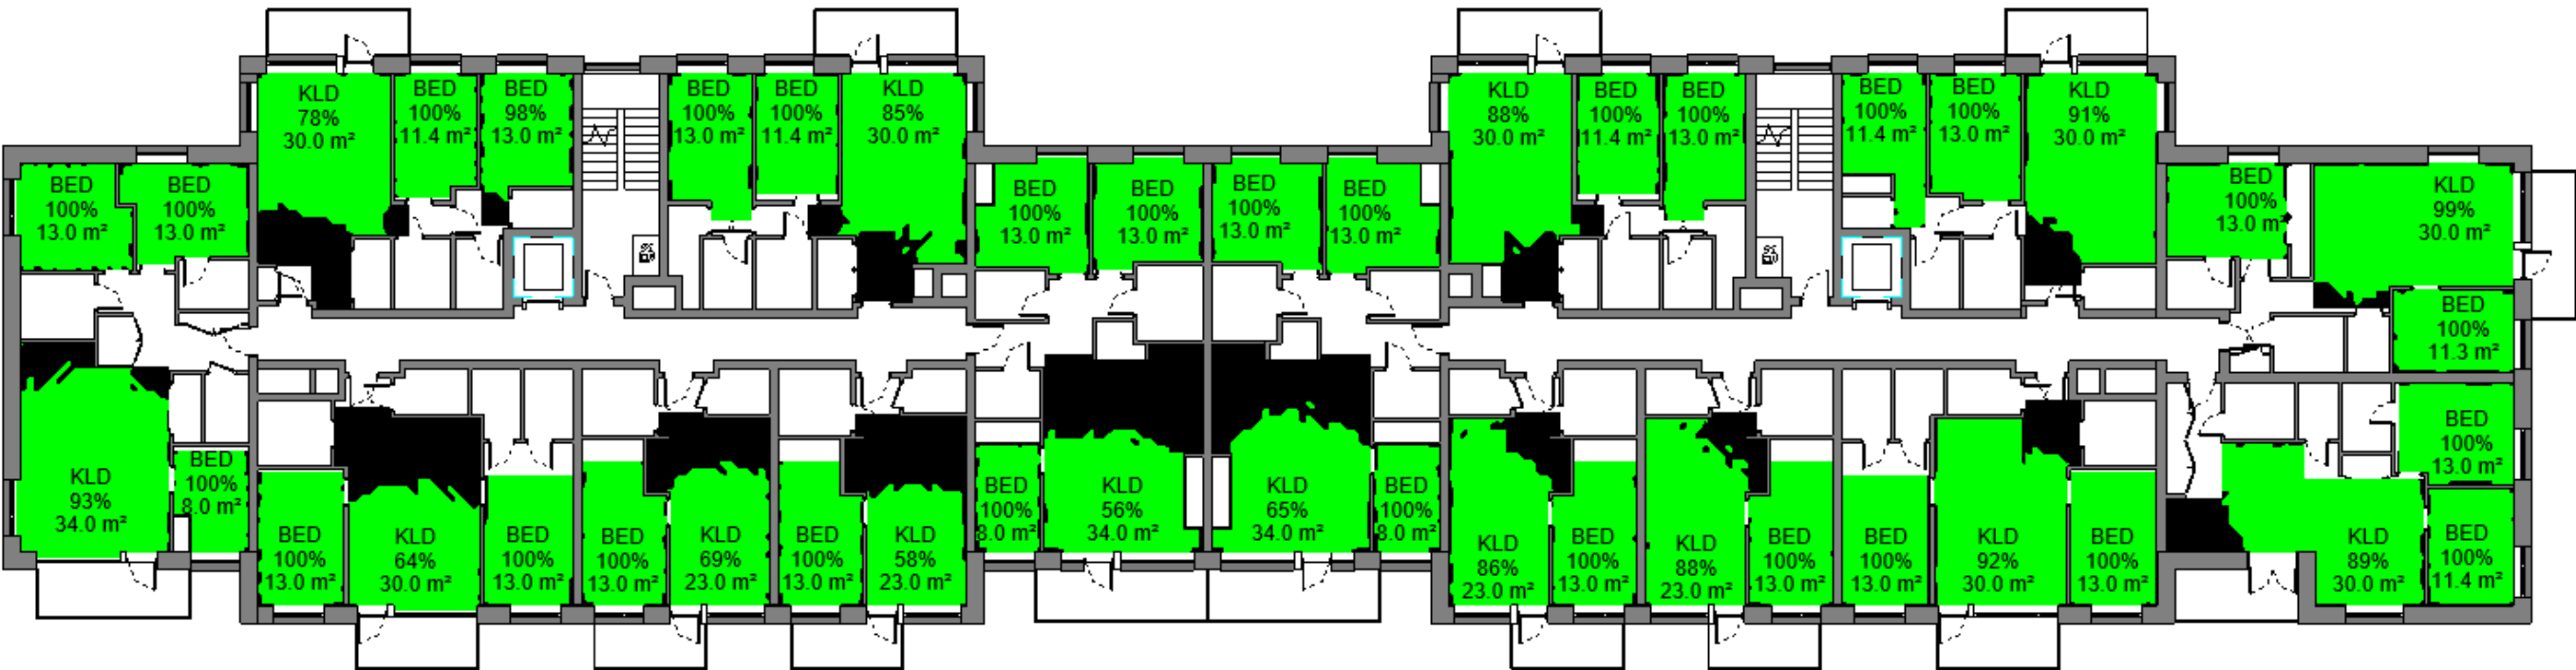
Block L – First Floor

Daylight analysis results are illustrated below with green shaded area receiving targeted illuminance, 200Lux for KLDs and 100Lux for Bedrooms. Black shade is showing area where it’s receiving less than targeted illuminance. A space is deemed compliant where >50% of areas achieve target illuminance.

Every room was determined to be compliant for SDA in this area.

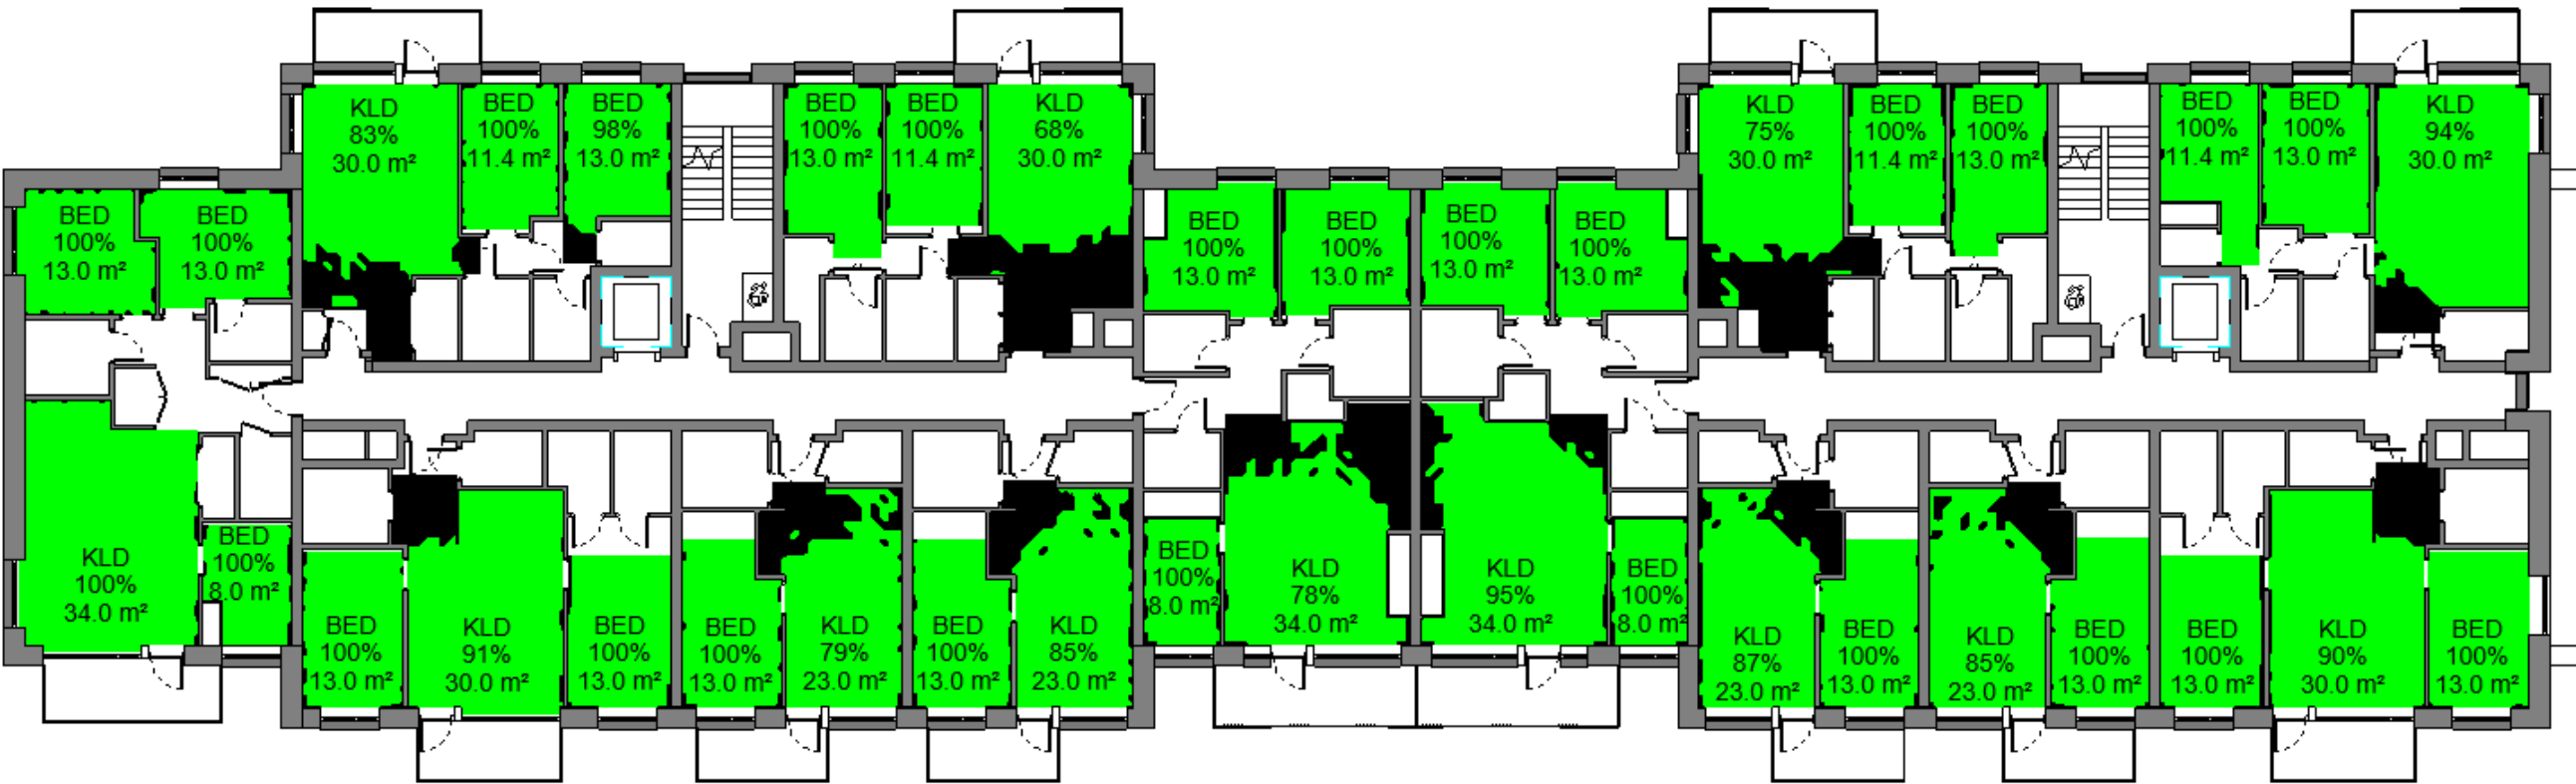
Block L – Fourth Floor

Daylight analysis results are illustrated below with green shaded area receiving targeted illuminance, 200Lux for KLDs and 100Lux for Bedrooms. Black shade is showing area where it’s receiving less than targeted illuminance. A space is deemed compliant where >50% of areas achieve target illuminance.

Every room was determined to be compliant for SDA in this area.

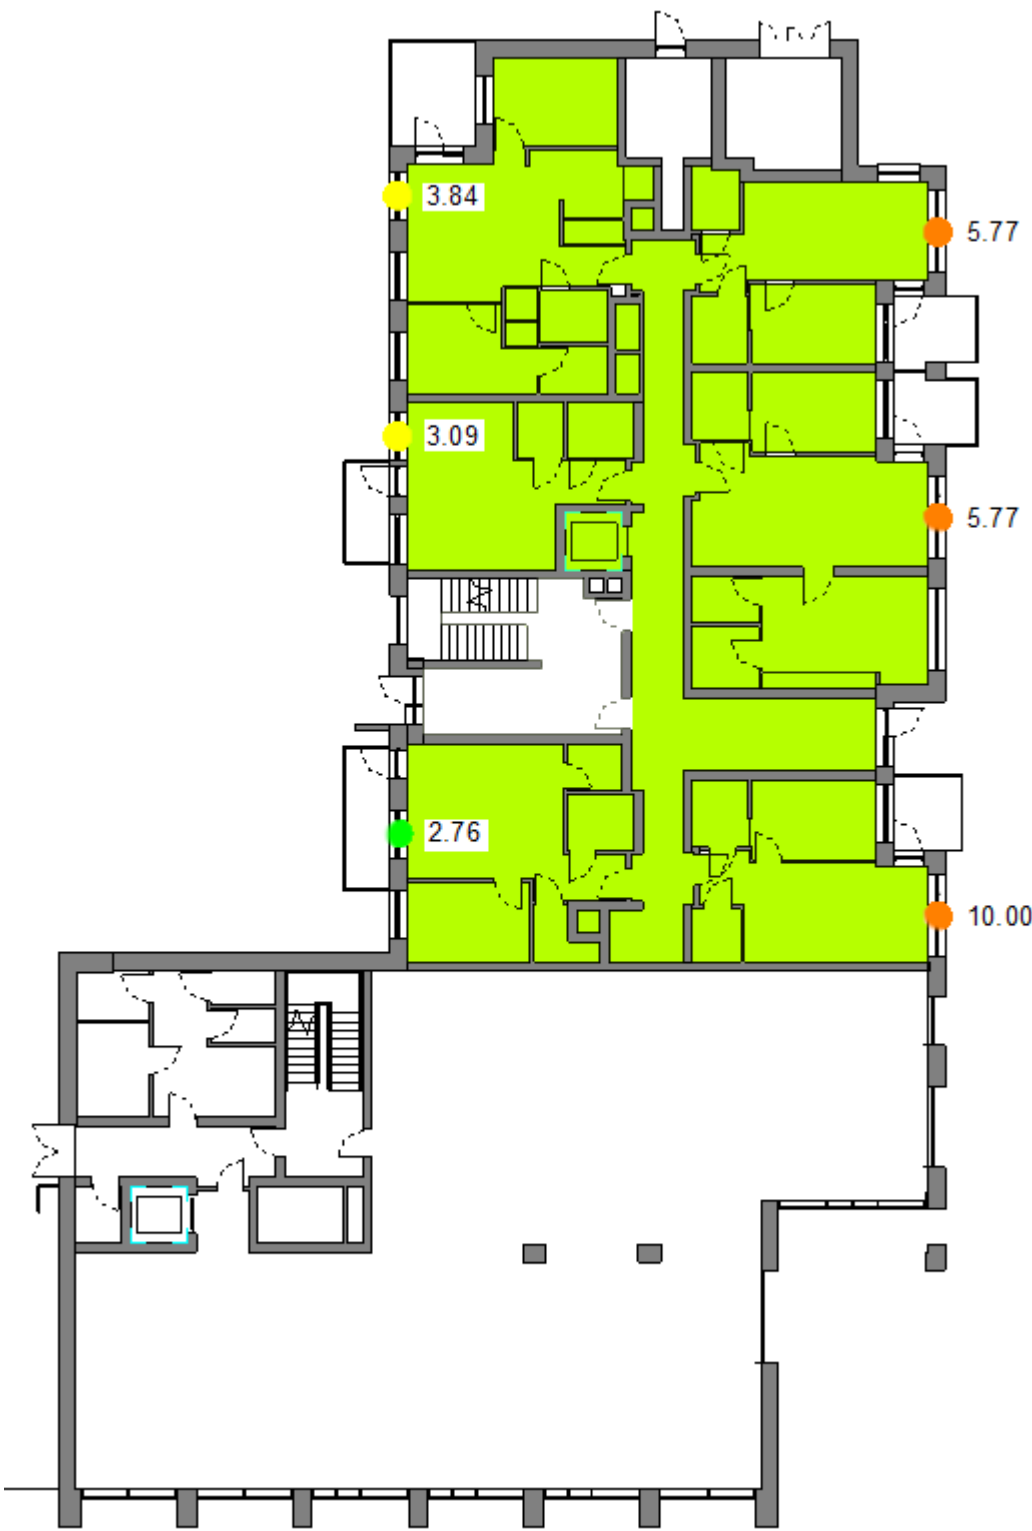
Block A – Ground Floor

Sunlight Analysis as illustrated below, determined all units on this block achieve the minimum recommendations.

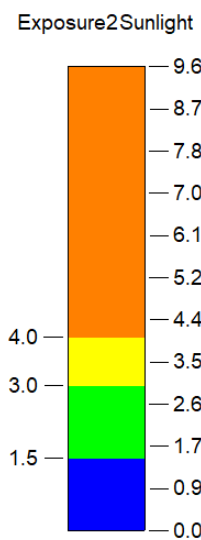
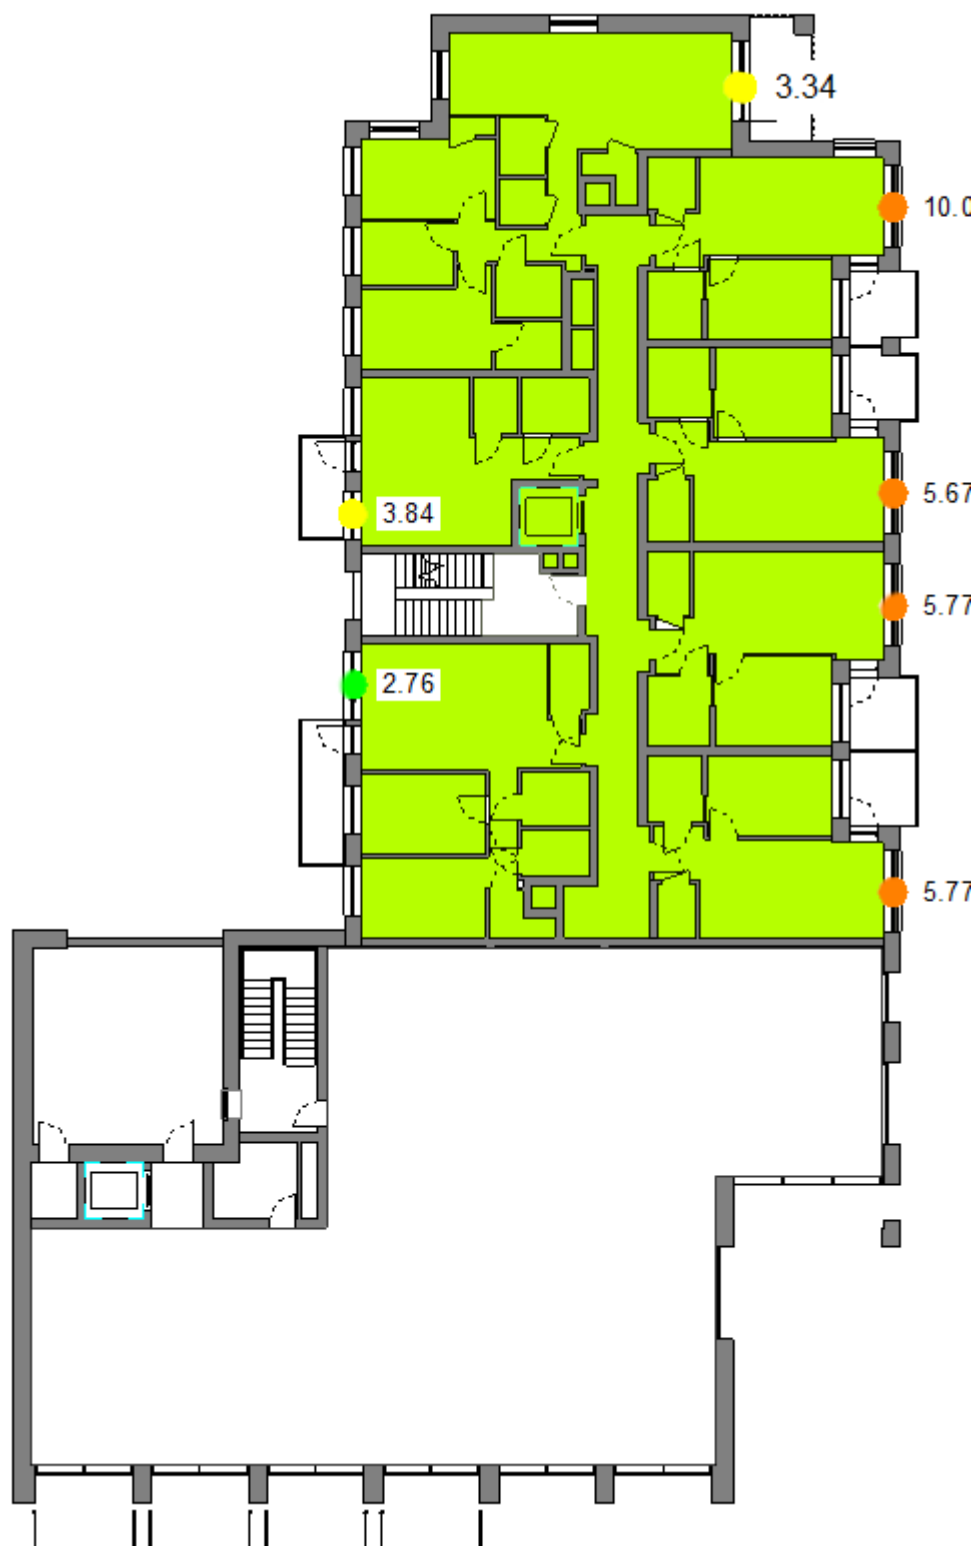
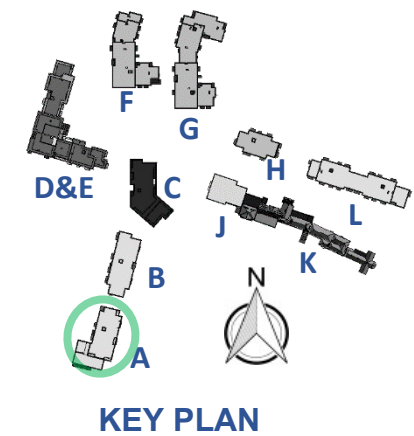
Block A – First Floor

Sunlight Analysis as illustrated below, determined all units on this block achieve the minimum recommendations.

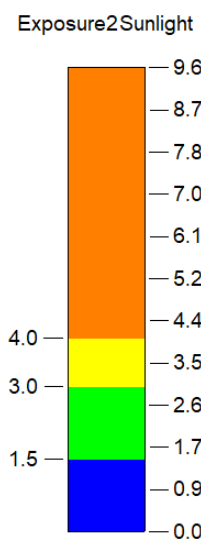
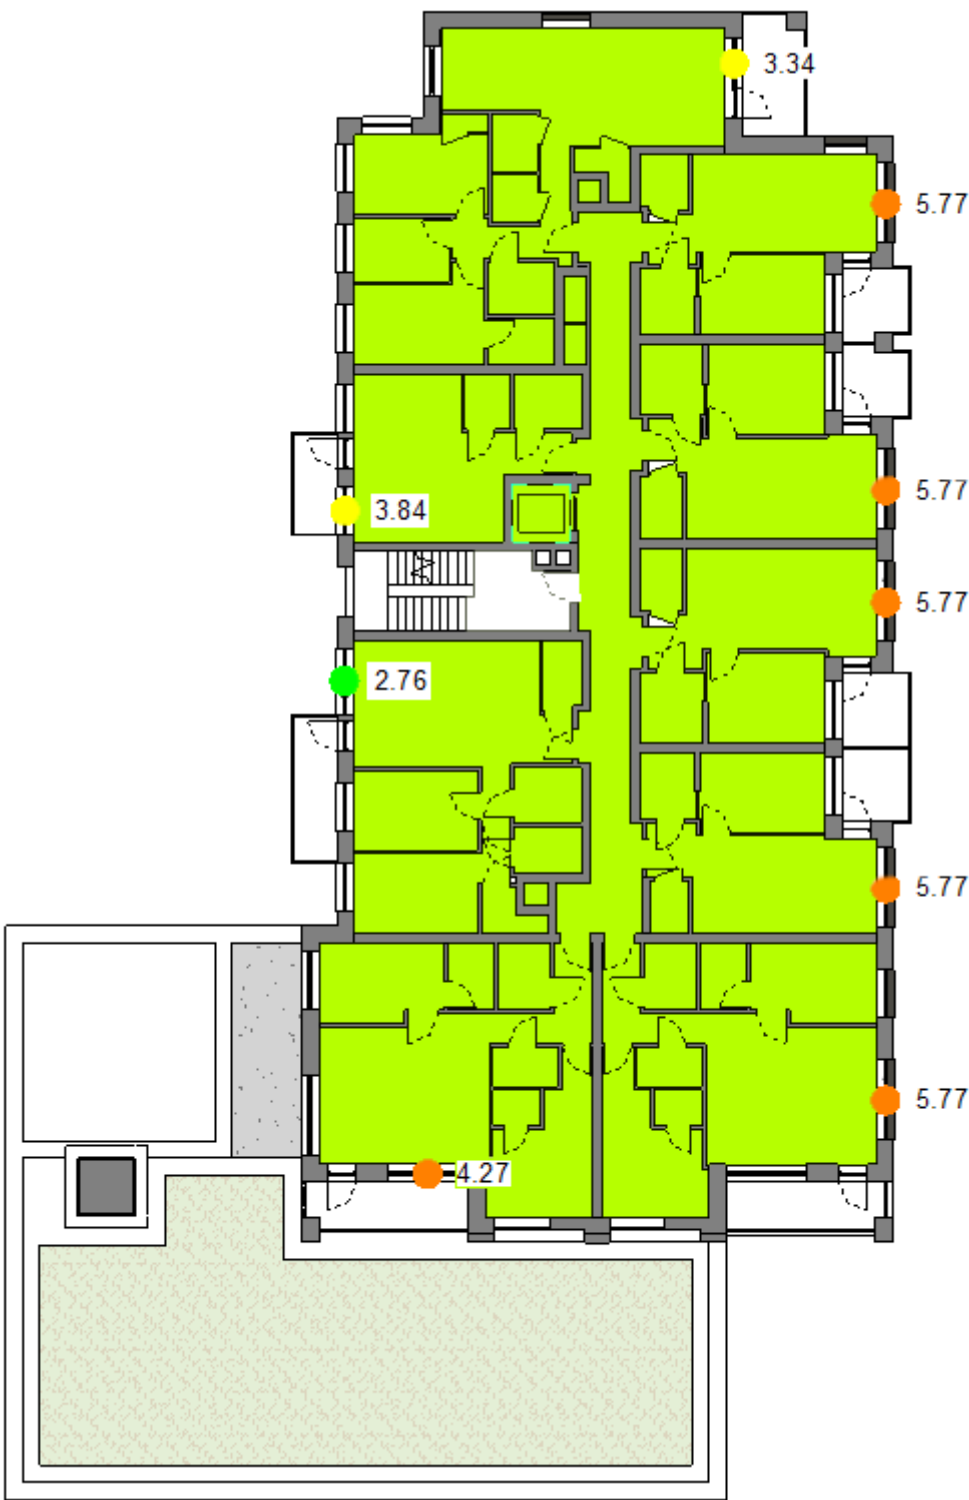
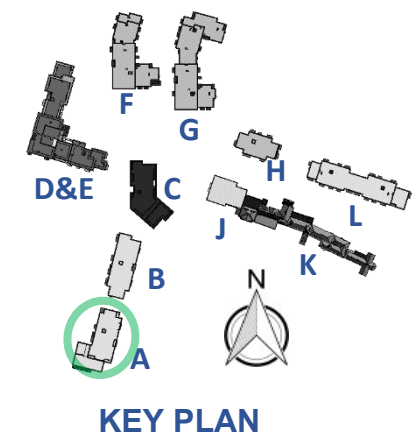
Block A – Second Floor

Sunlight Analysis as illustrated below, determined all units on this block achieve the minimum recommendations.

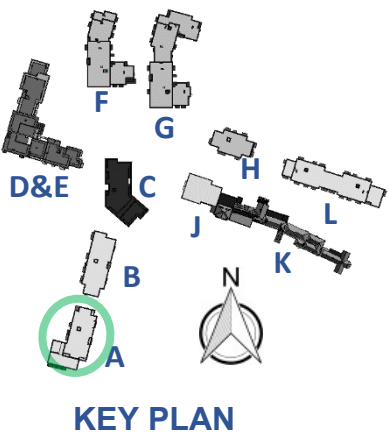
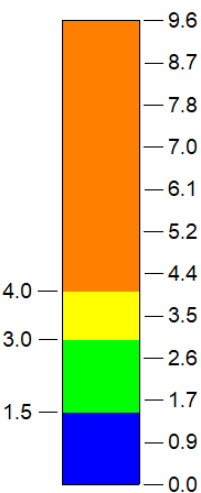
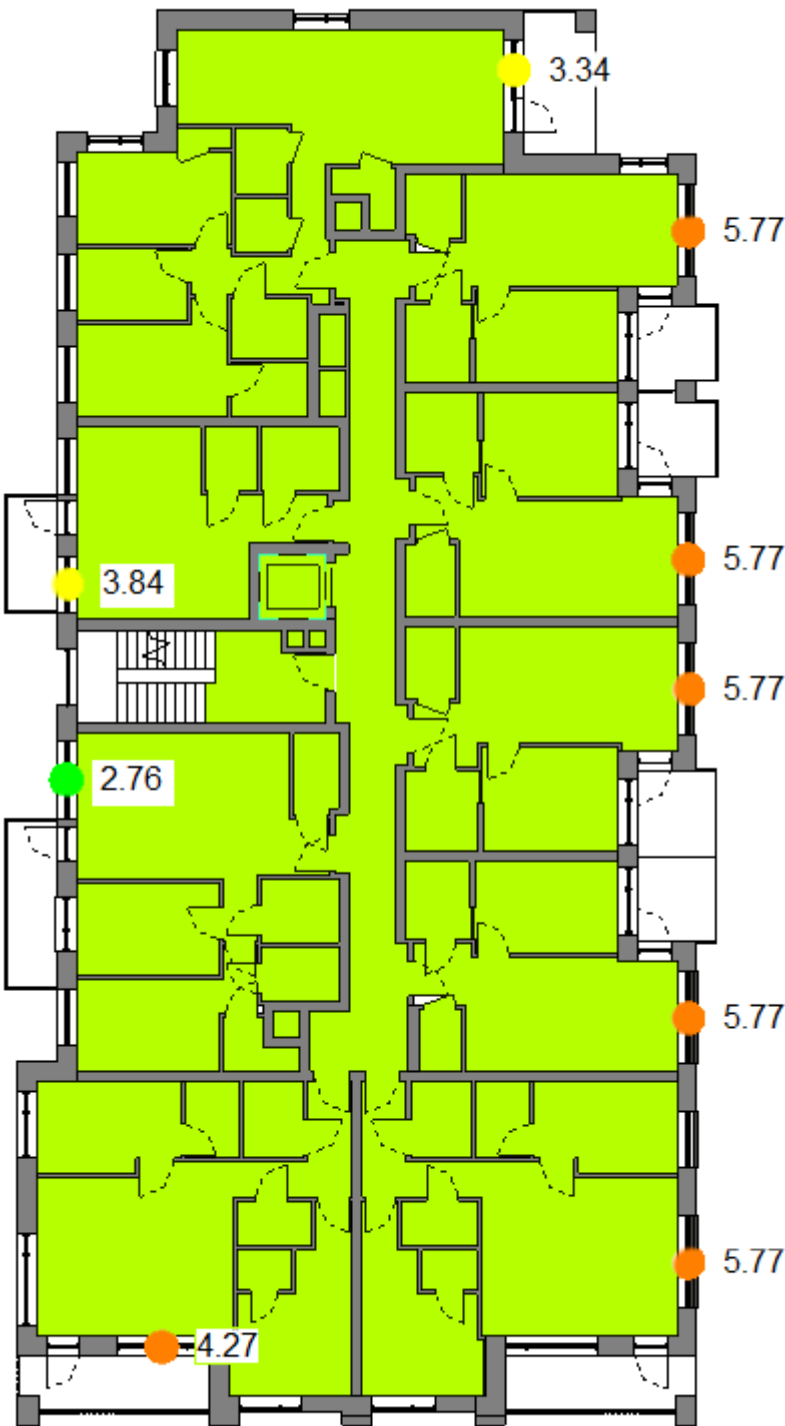
Block A – Third Floor

Sunlight Analysis as illustrated below, determined all units on this block achieve the minimum recommendations.

Exposure2Sunlight

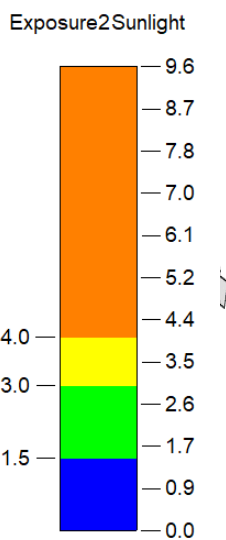
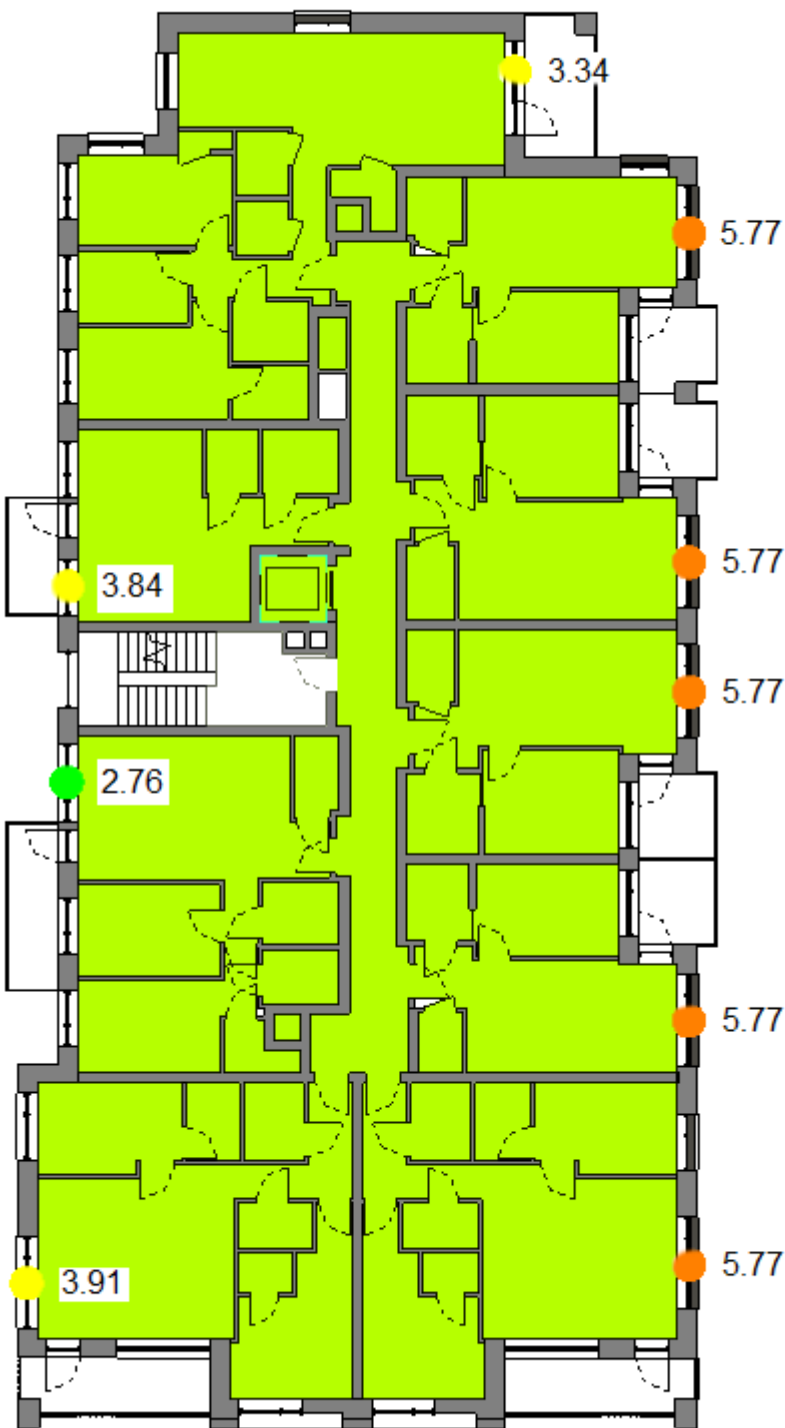
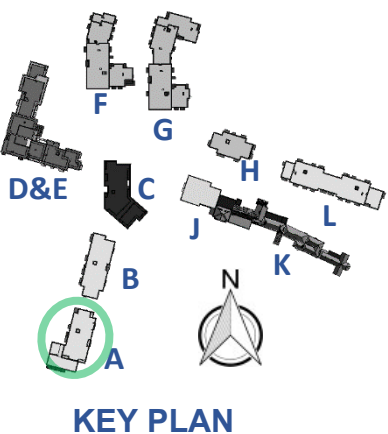
Block A – Fourth Floor

Sunlight Analysis as illustrated below, determined all units on this block achieve the minimum recommendations.

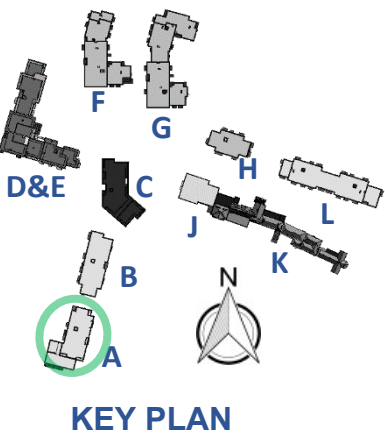
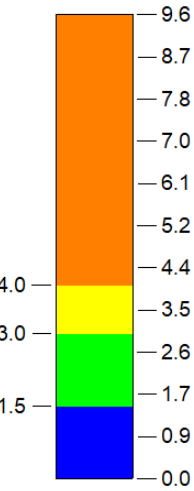
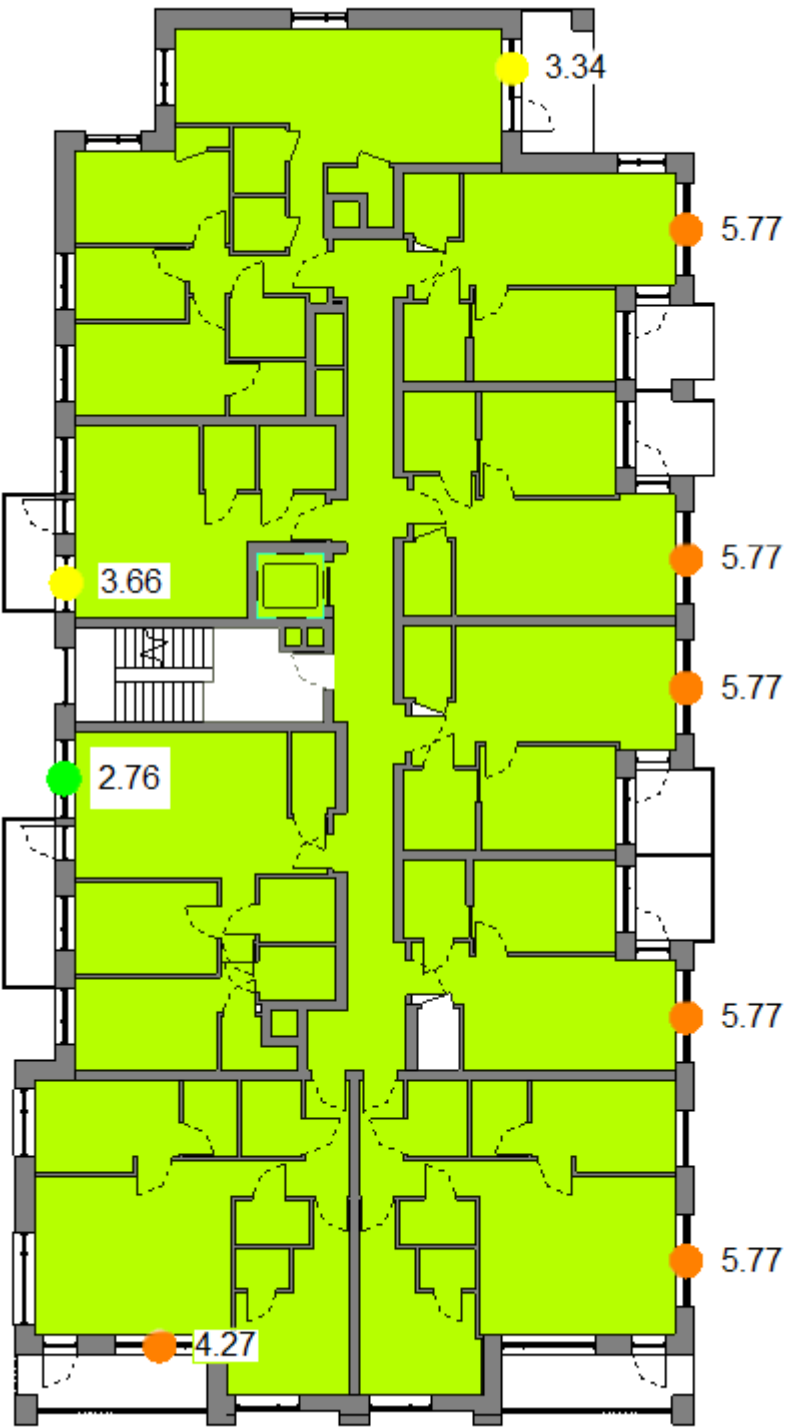
Block A – Fifth Floor

Sunlight Analysis as illustrated below, determined all units on this block achieve the minimum recommendations.

Exposure2Sunlight

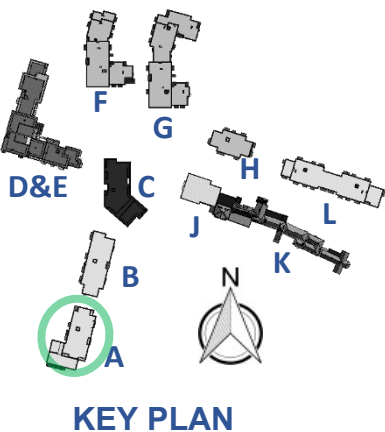
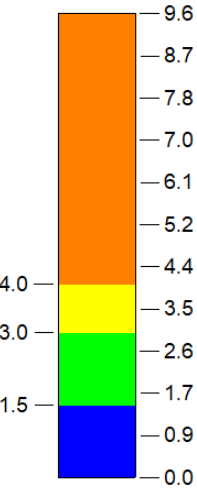
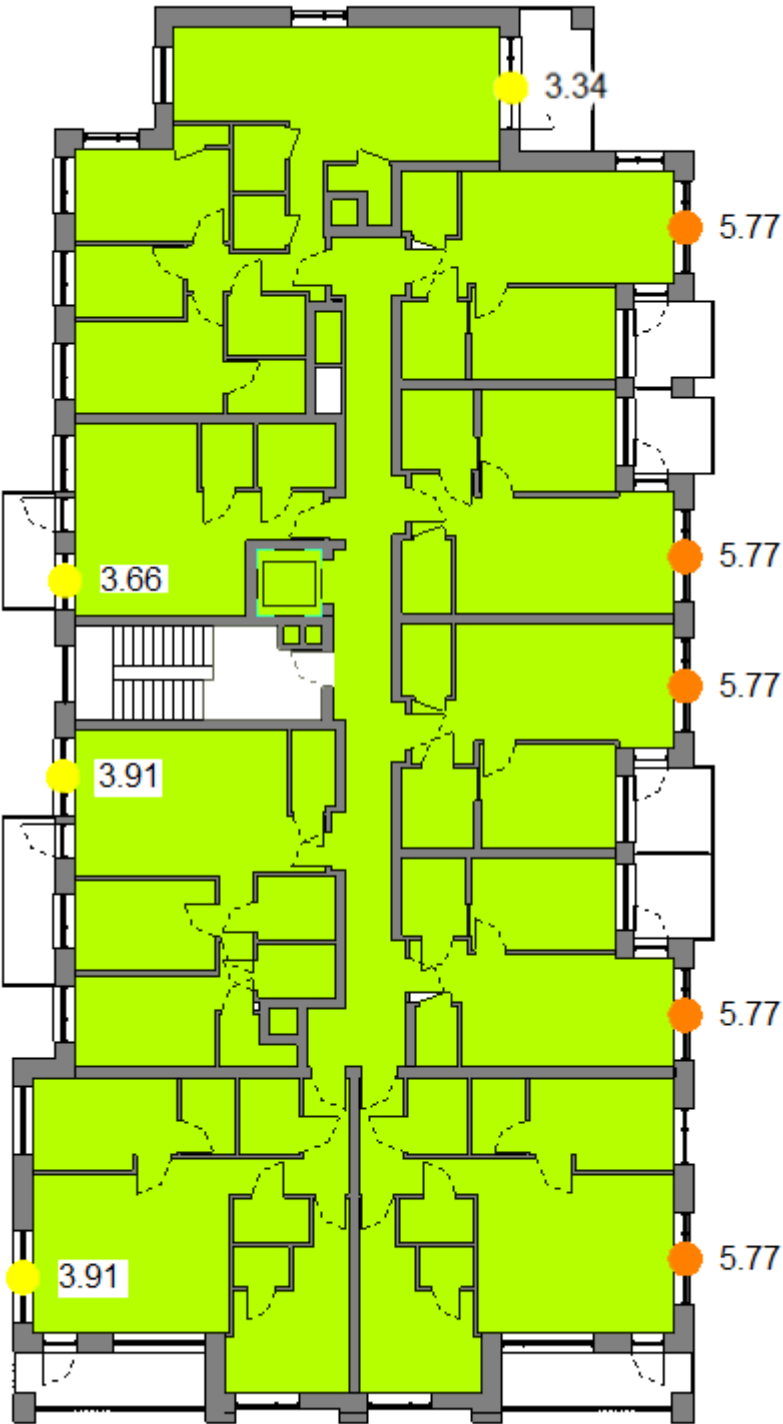
Block A – Sixth Floor

Sunlight Analysis as illustrated below, determined all units on this block achieve the minimum recommendations.

Exposure2Sunlight

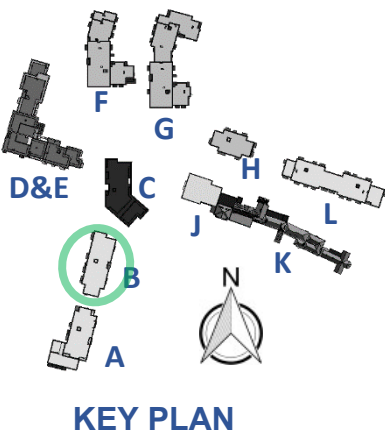
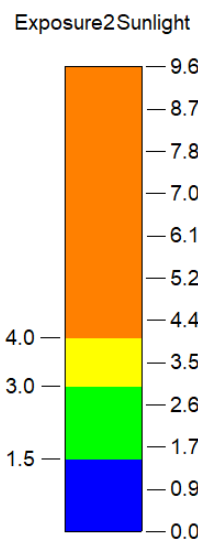
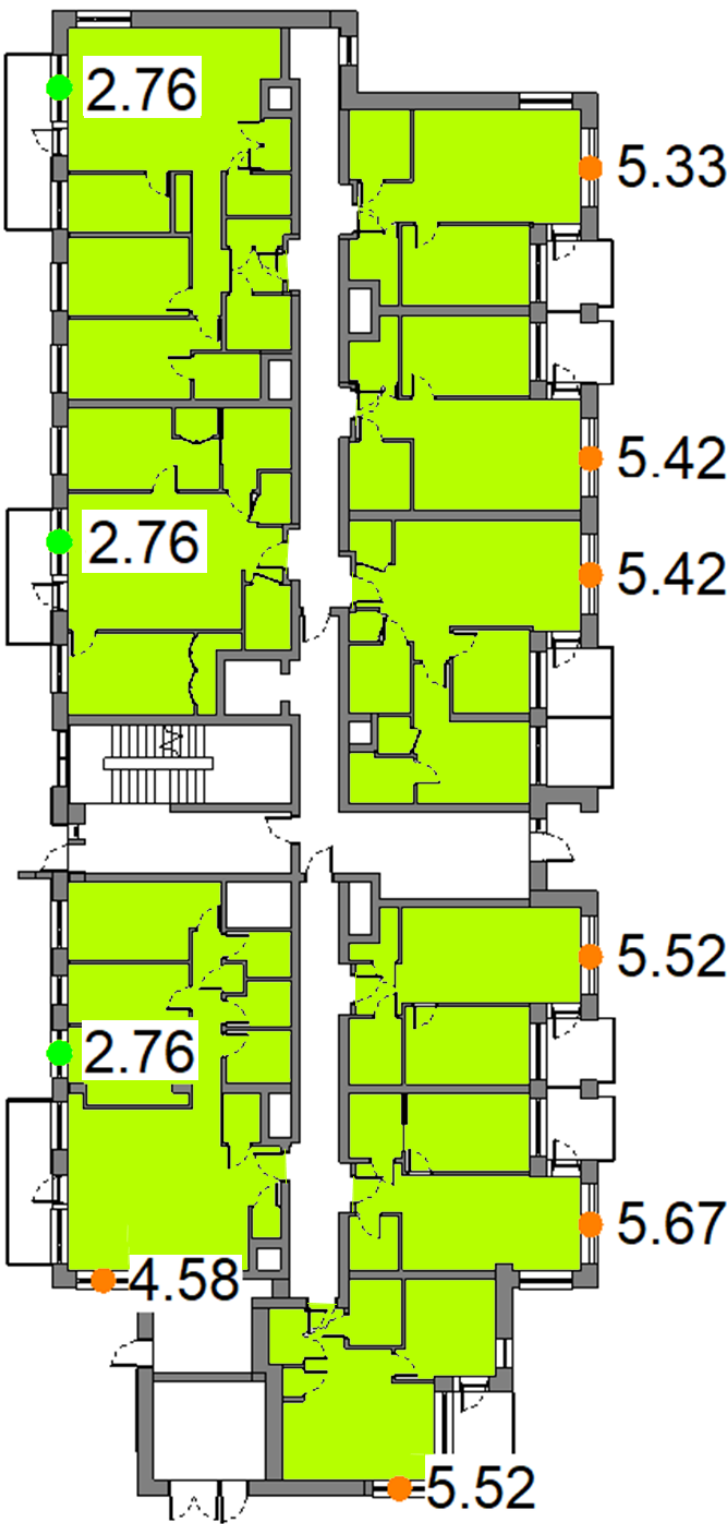
Block B – Ground Floor

Sunlight Analysis as illustrated below, determined all units on this block achieve the minimum recommendations.

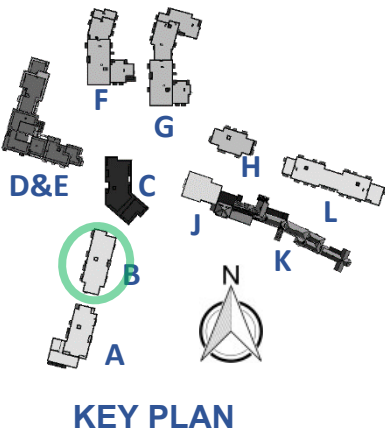
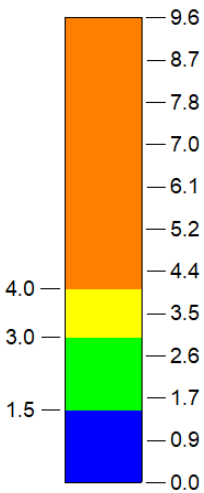
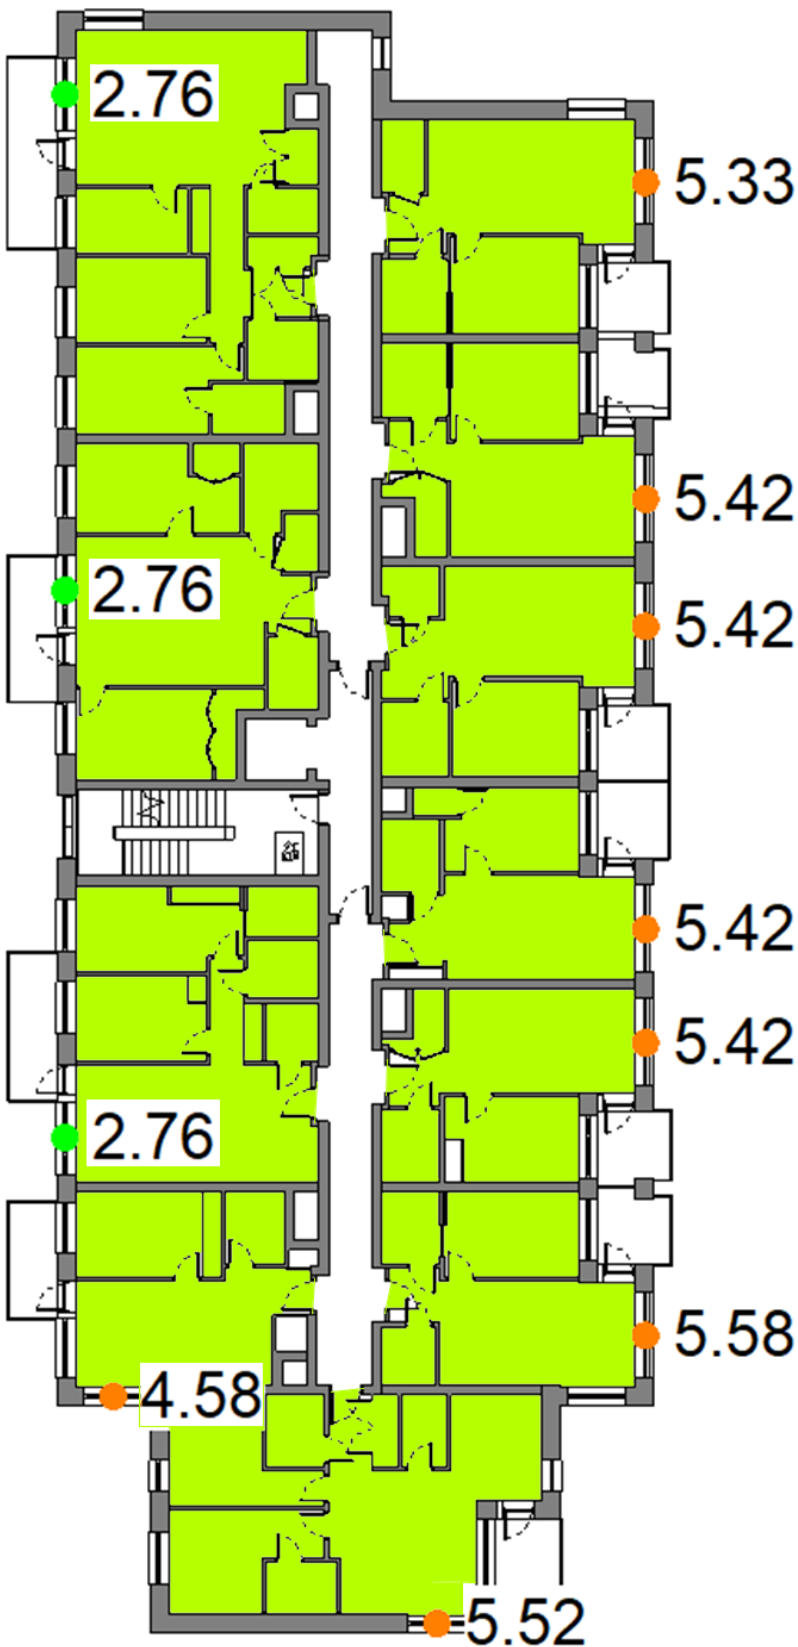
Block B – First Floor

Sunlight Analysis as illustrated below, determined all units on this block achieve the minimum recommendations.

Exposure2Sunlight

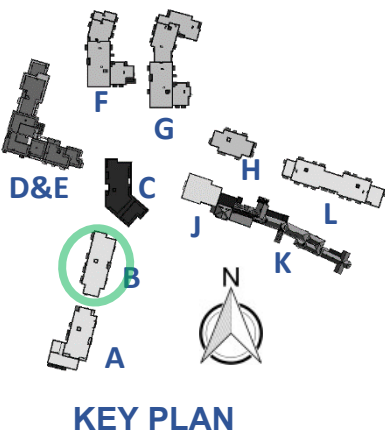
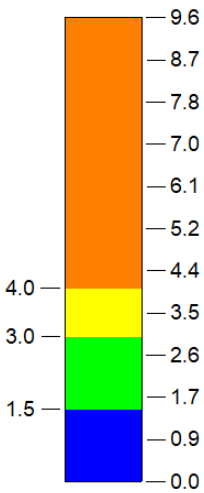
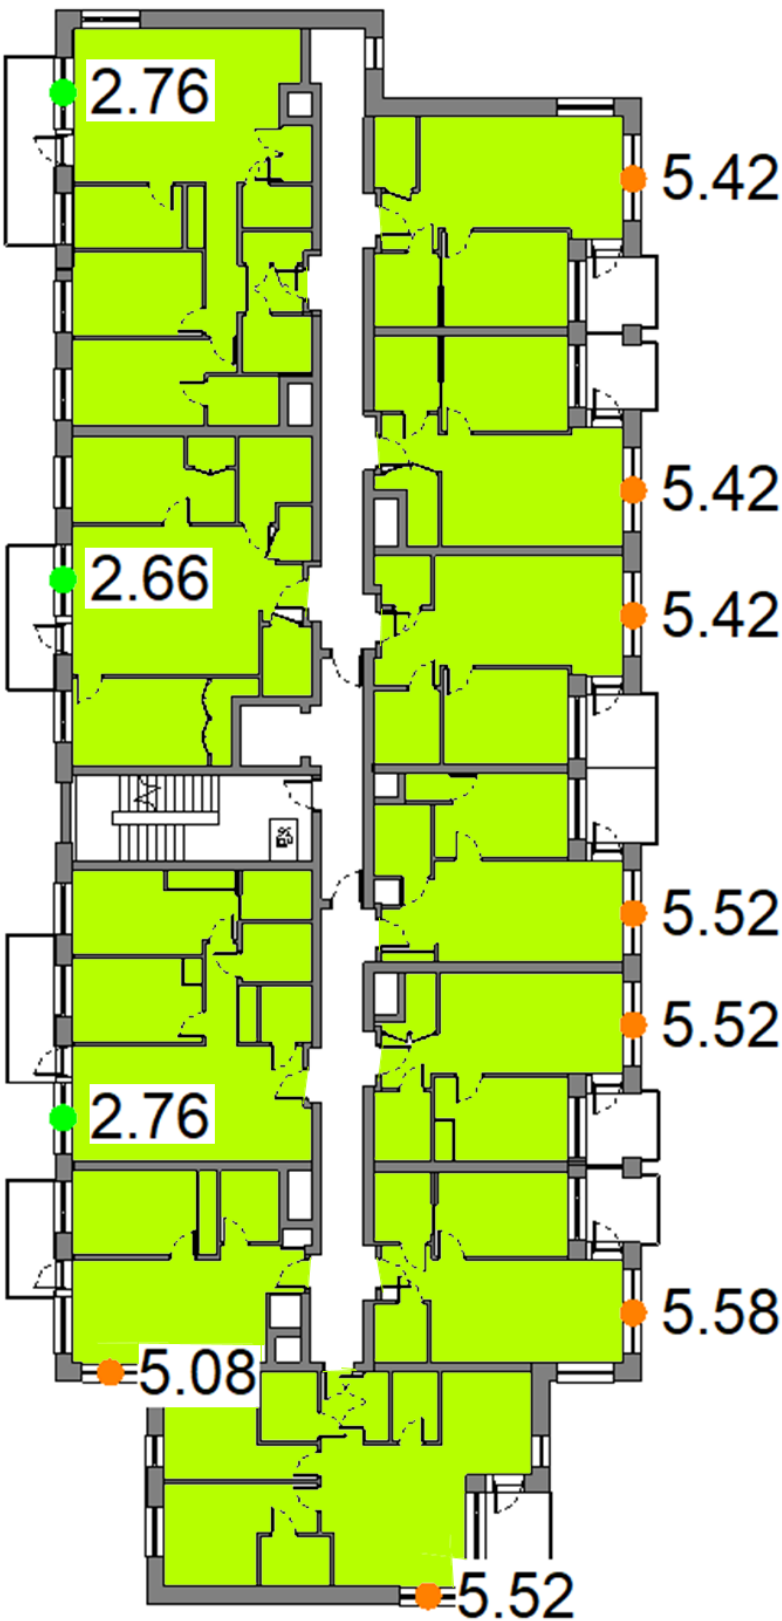
Block B – Second Floor

Sunlight Analysis as illustrated below, determined all units on this block achieve the minimum recommendations.

Exposure2Sunlight

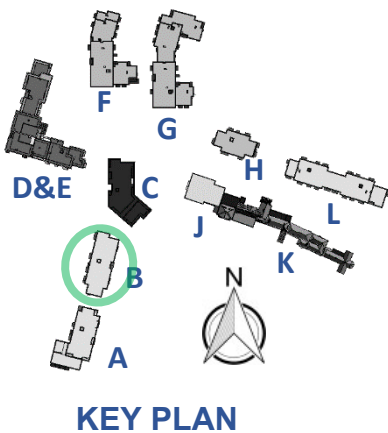
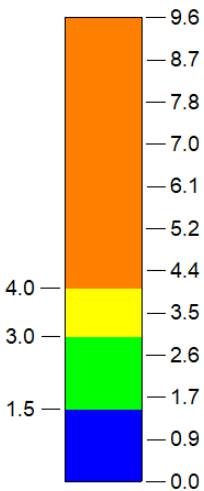
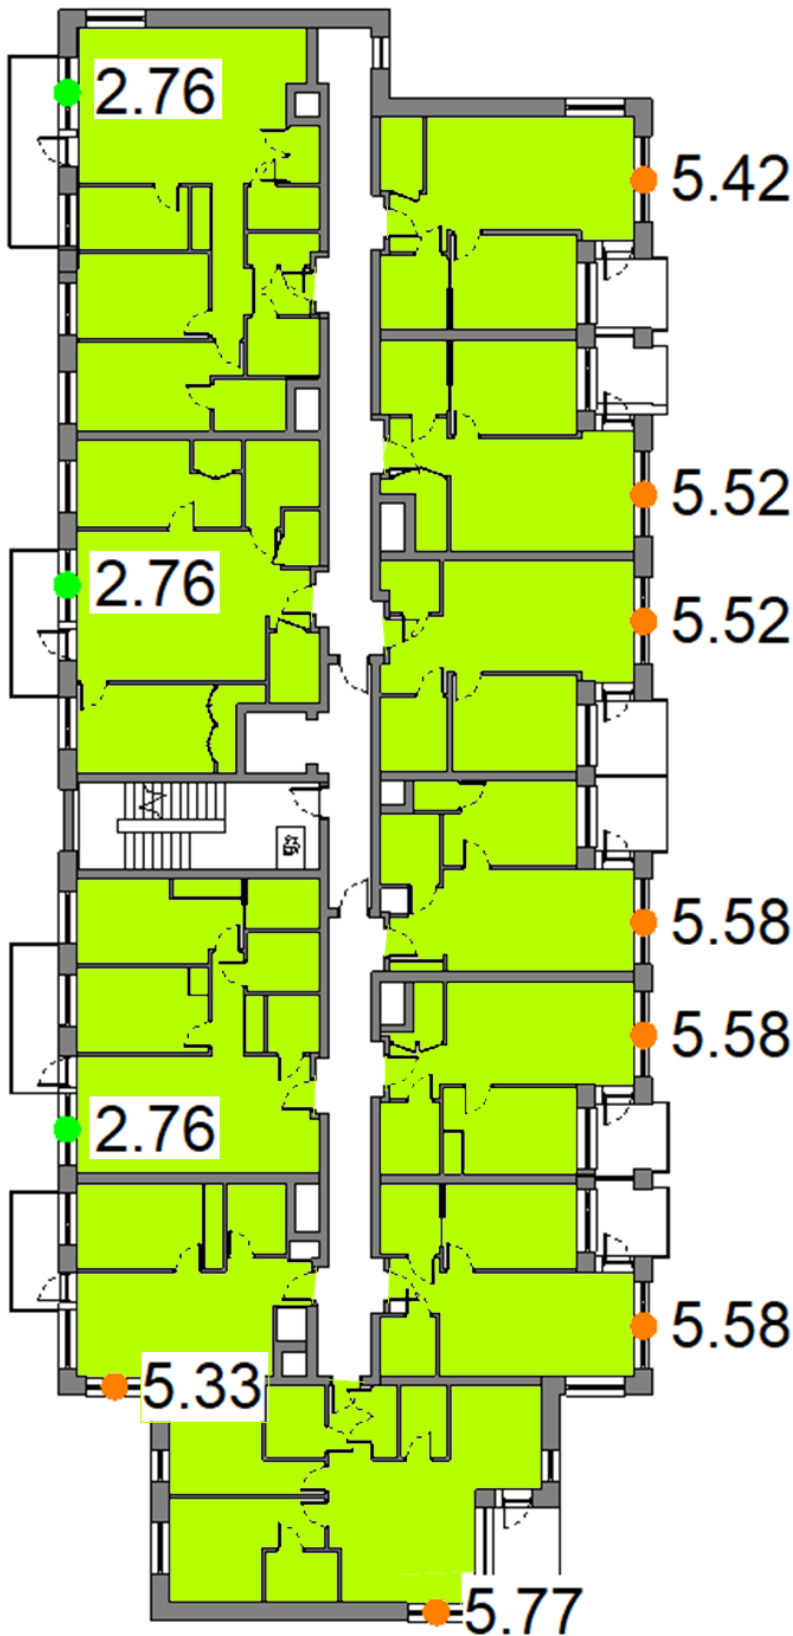
Block B – Third Floor

Sunlight Analysis as illustrated below, determined all units on this block achieve the minimum recommendations.

Exposure2Sunlight
