St. Vincent's Hospital Fairview Redevelopment, Fairview Dublin 3

Daylight and Sunlight Analysis

IN2 Project No. D2116

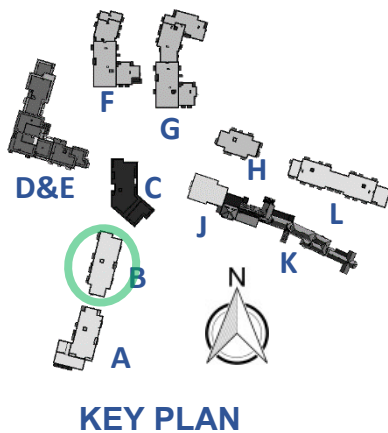
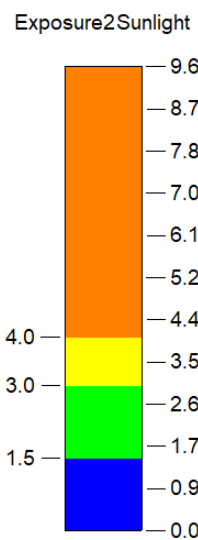
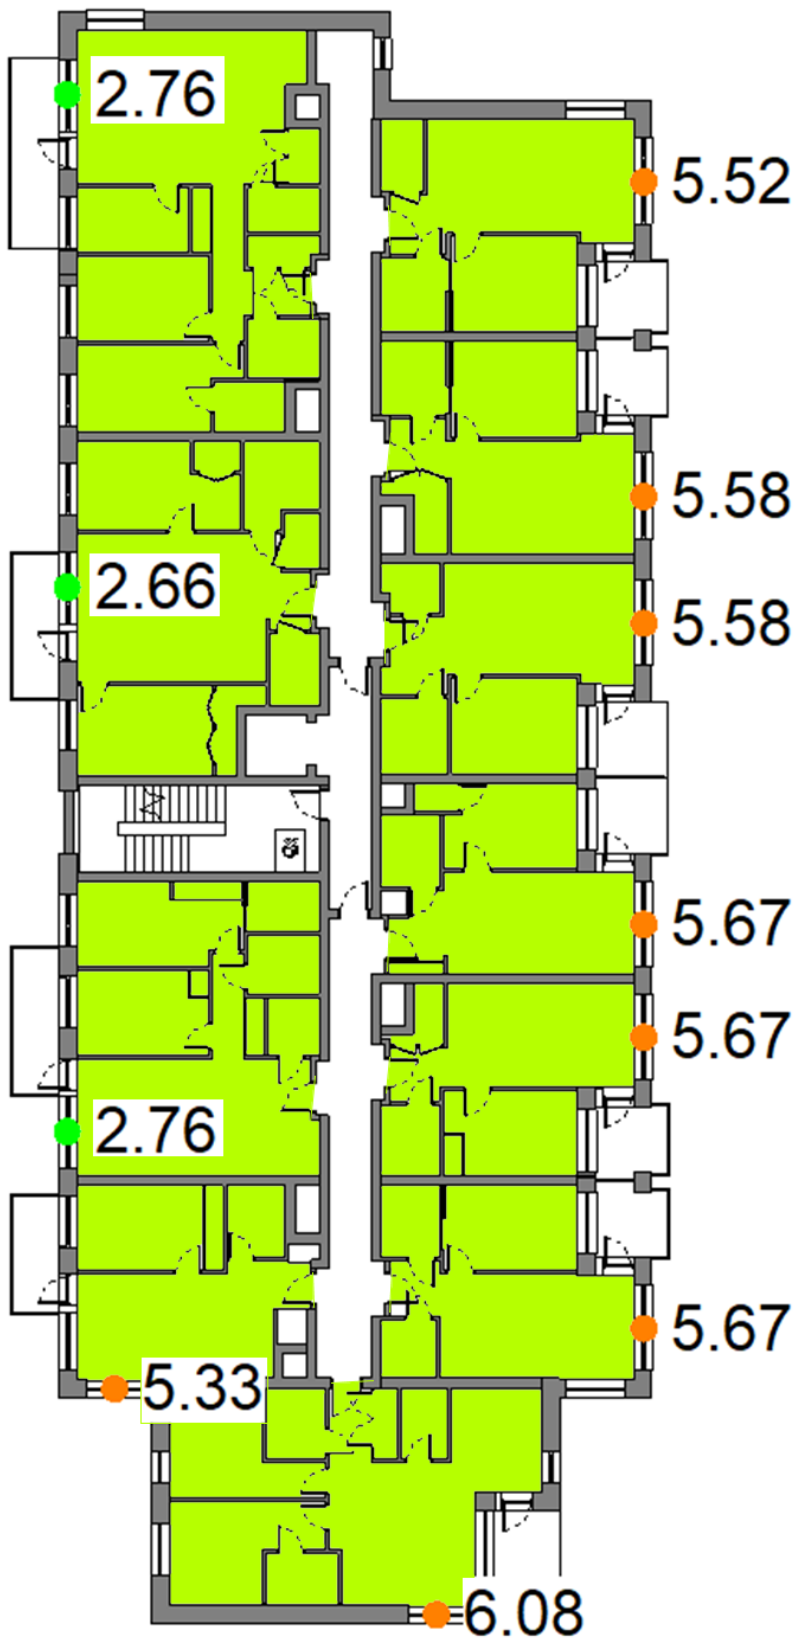
Block B – Fourth Floor

Sunlight Analysis as illustrated below, determined all units on this block achieve the minimum recommendations.

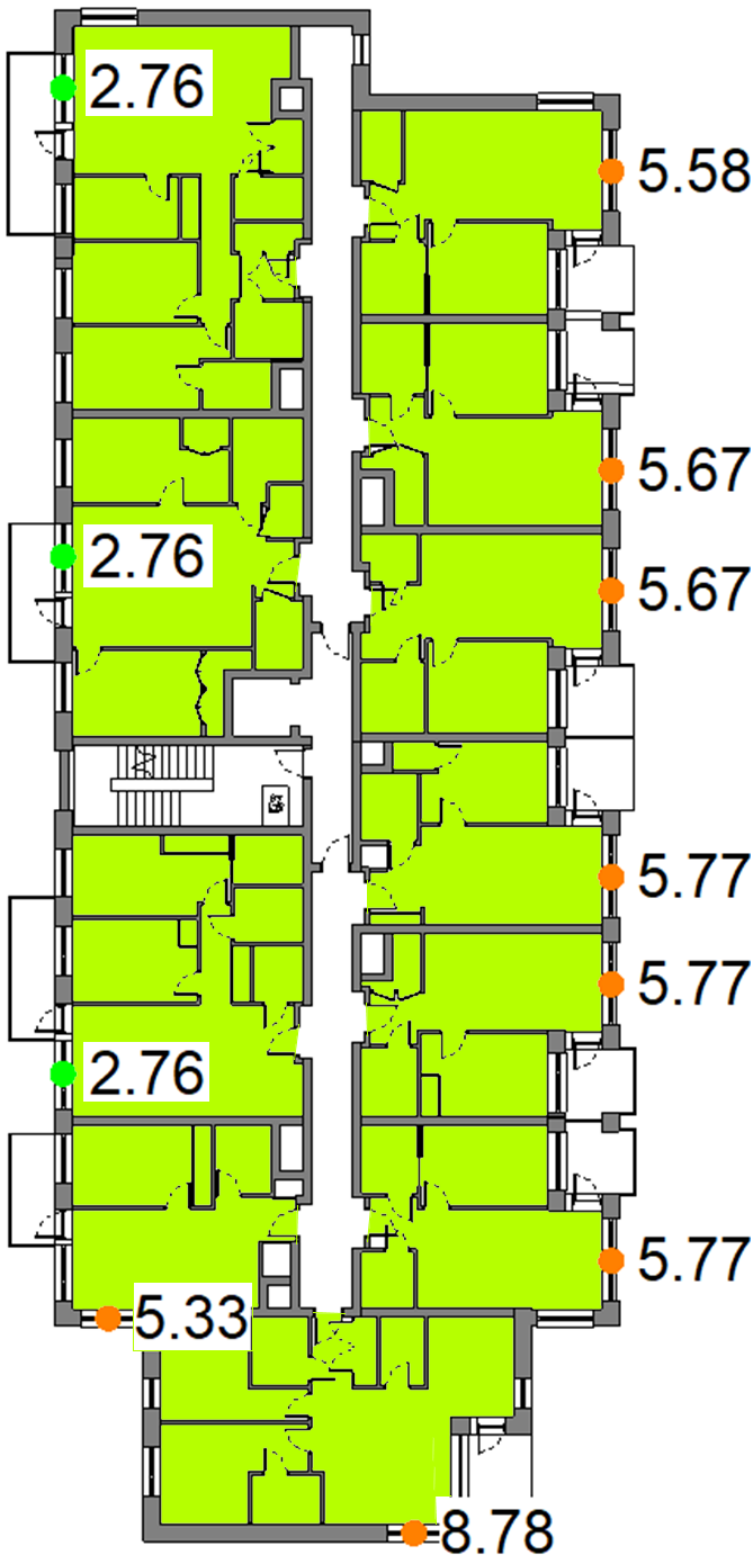
Sunlight Analysis as illustrated below, determined all units on this block achieve the minimum recommendations.

Exposure2Sunlight

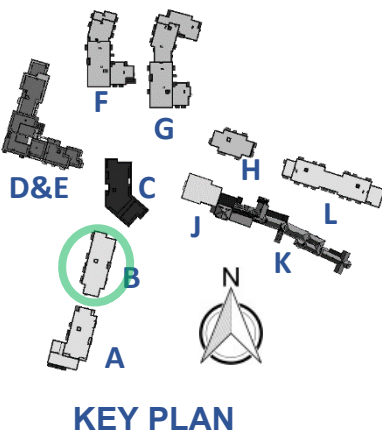
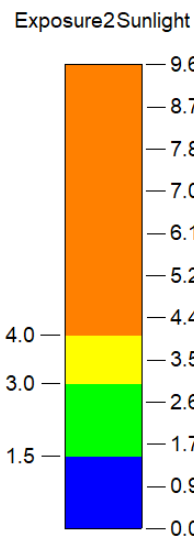
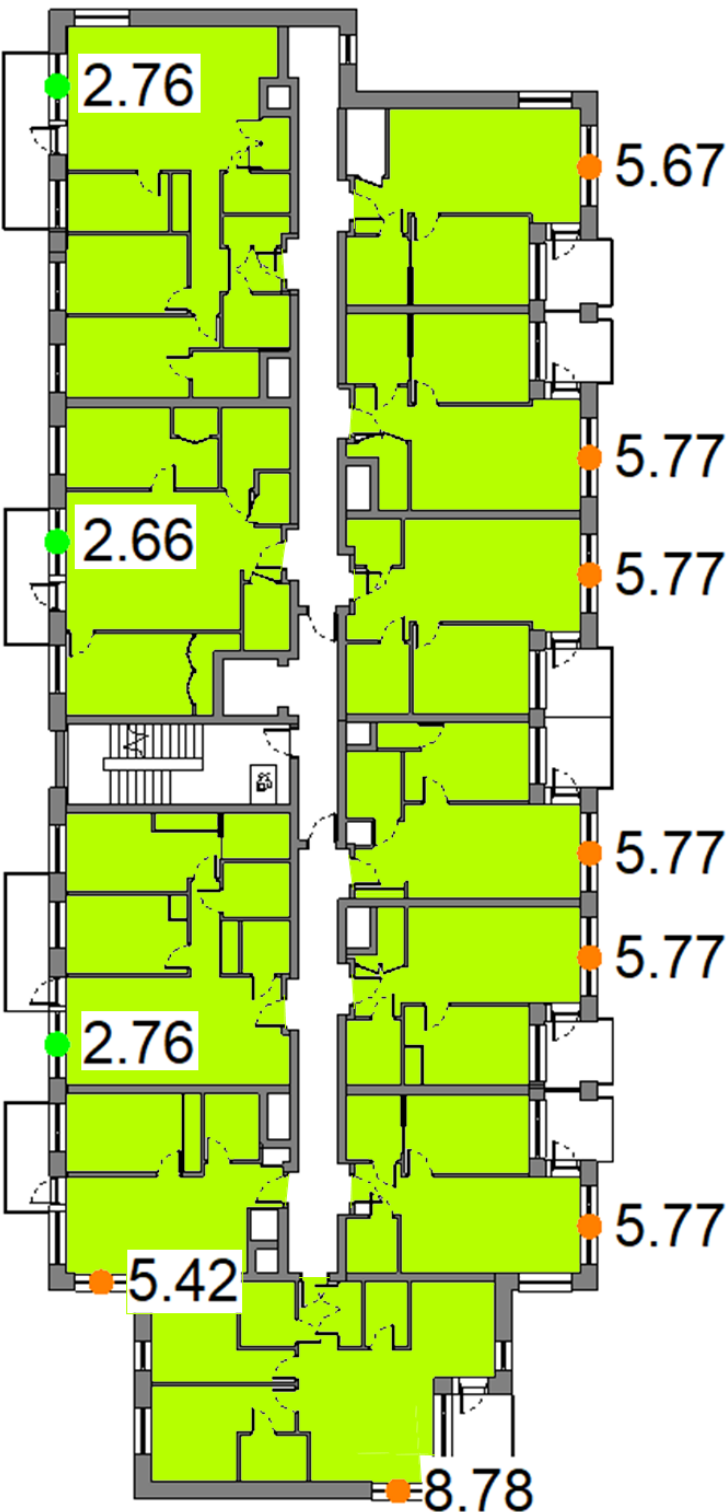
Block B – Sixth Floor

Sunlight Analysis as illustrated below, determined all units on this block achieve the minimum recommendations.

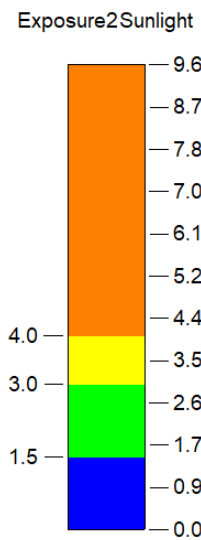
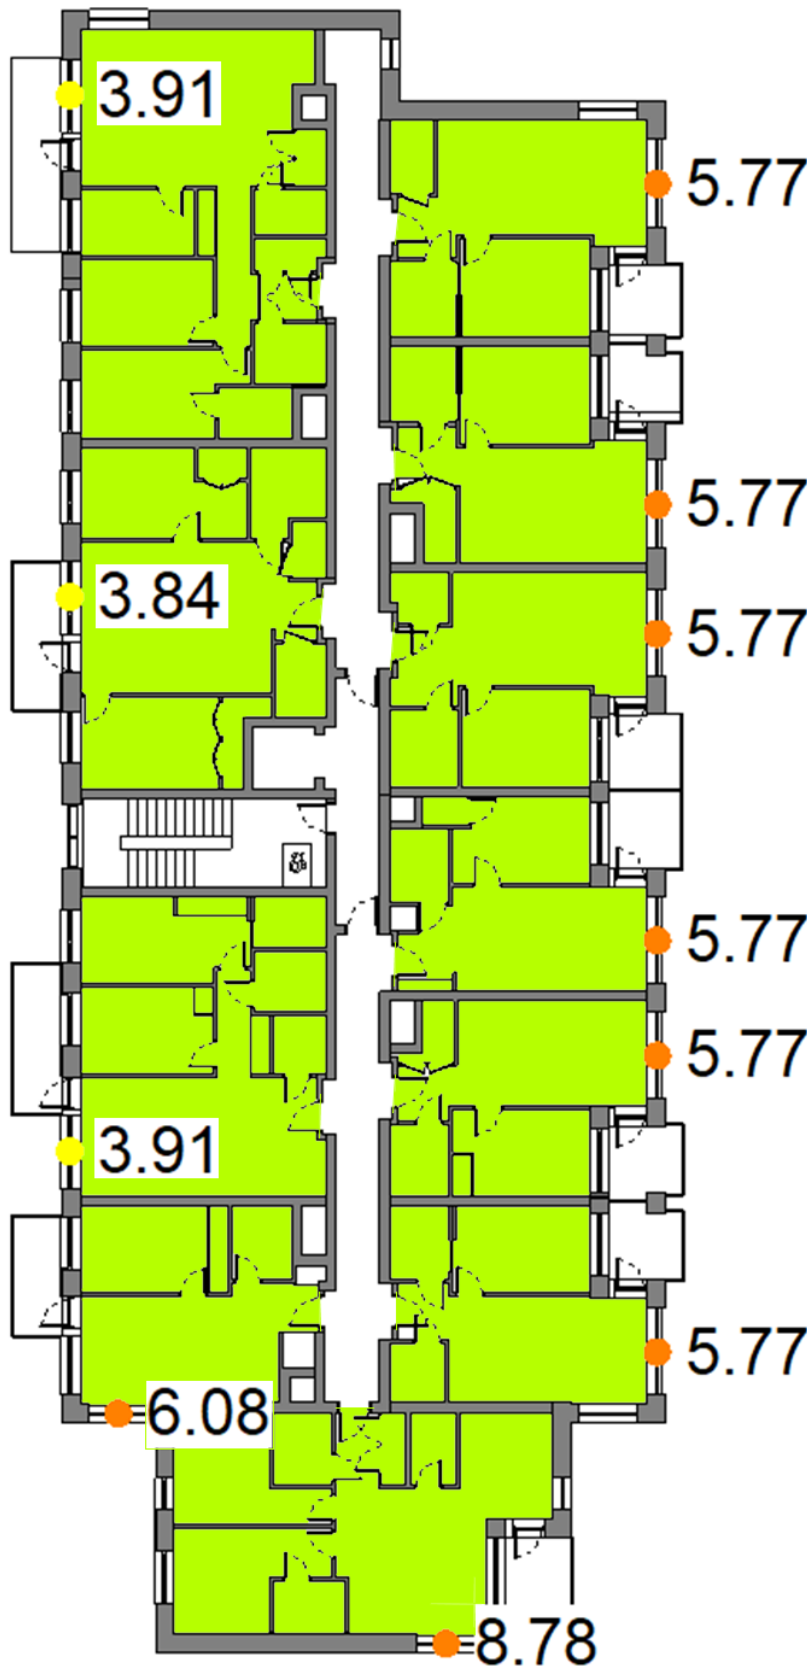
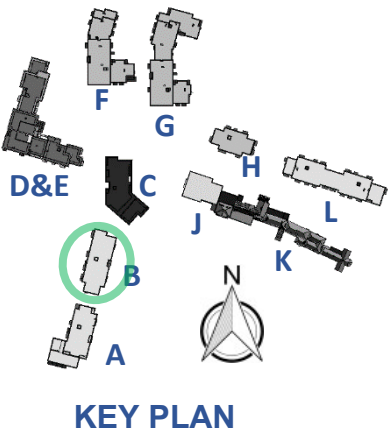
Block B – Seventh Floor

Sunlight Analysis as illustrated below, determined all units on this block achieve the minimum recommendations.

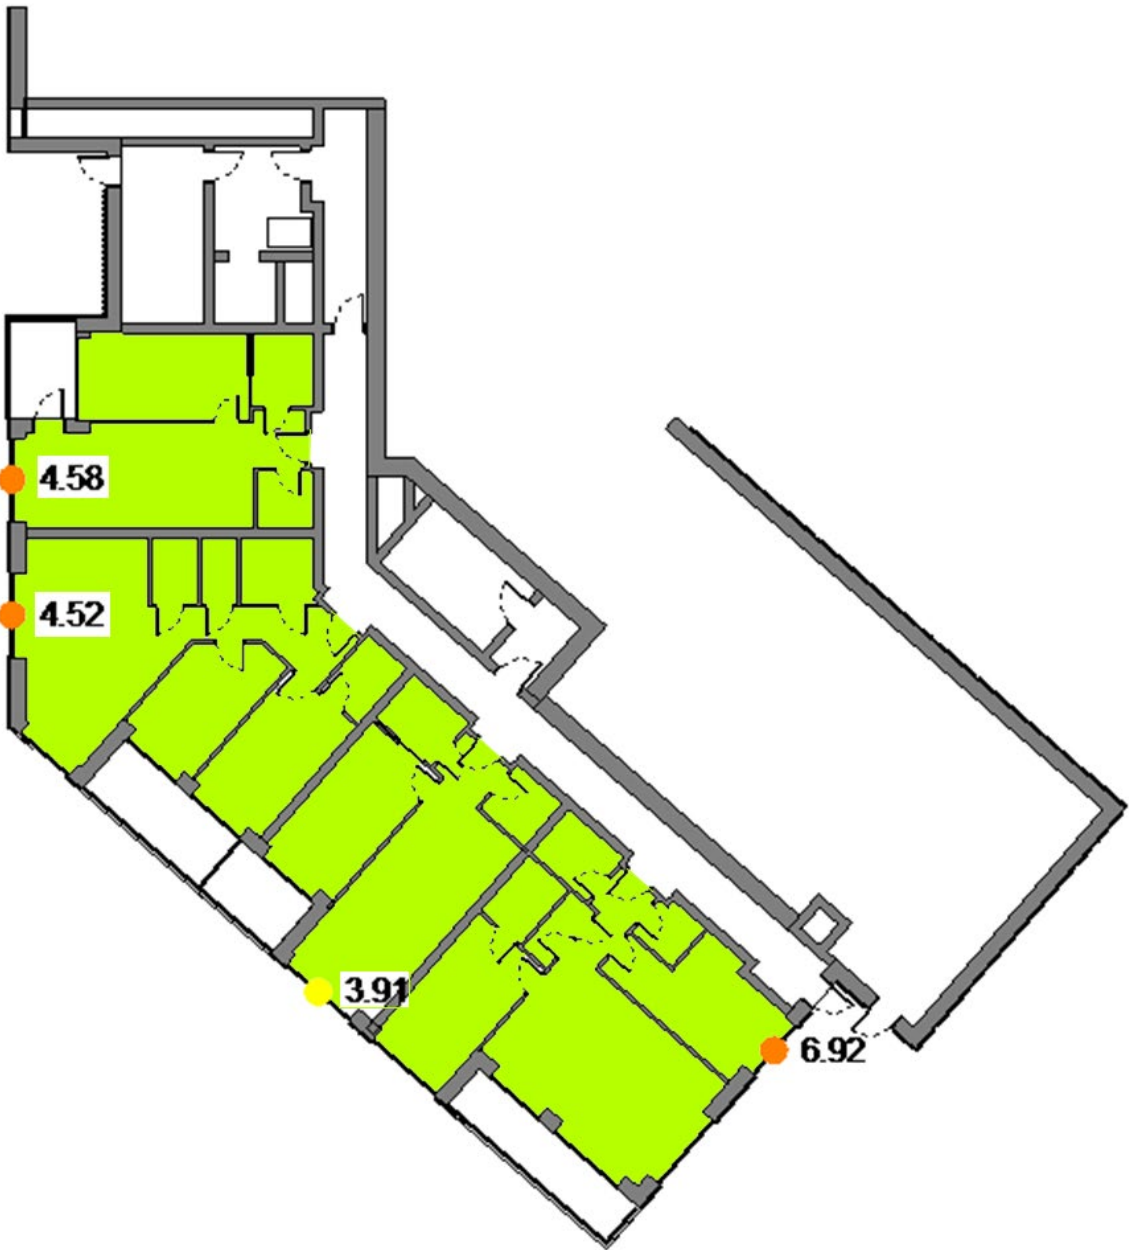
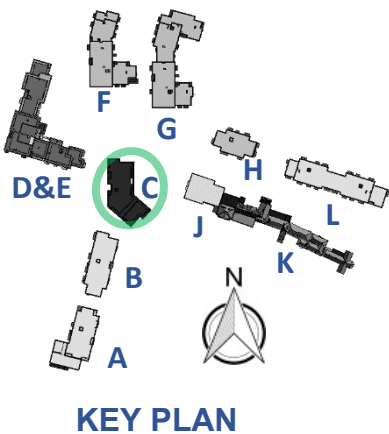
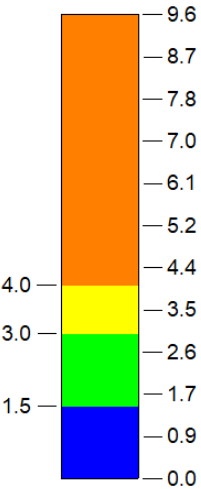
Block C – Basement

Sunlight Analysis as illustrated below, determined all units on this block achieve the minimum recommendations.

Exposure2Sunlight

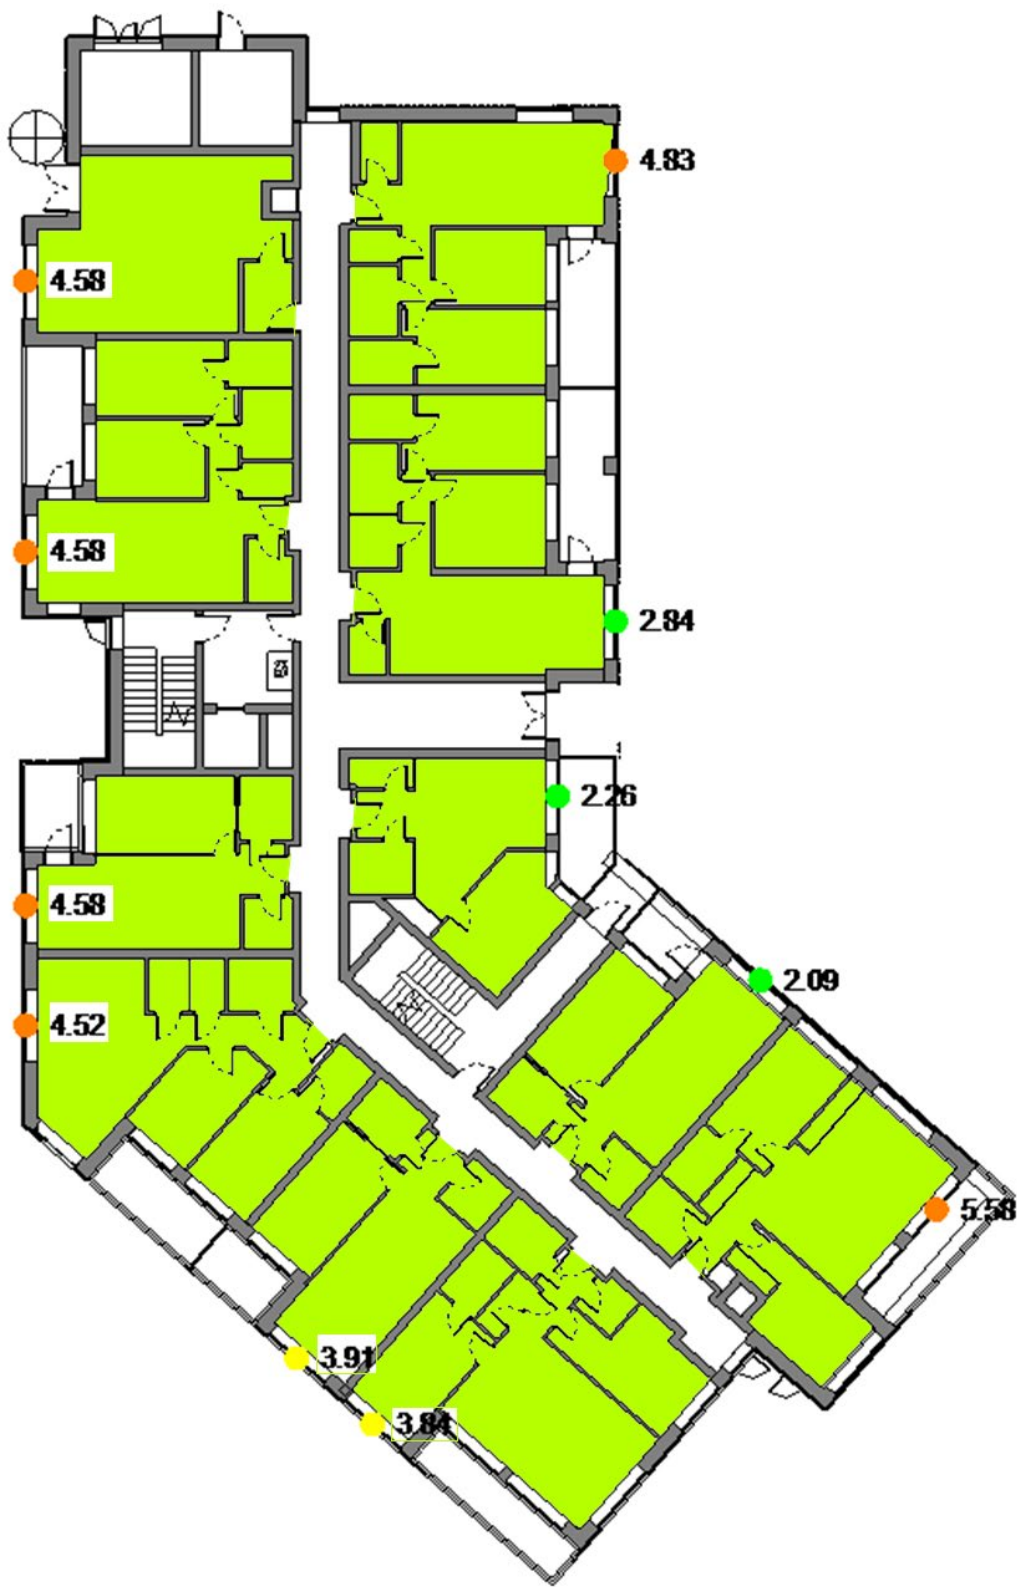
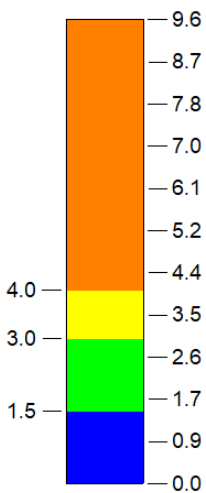
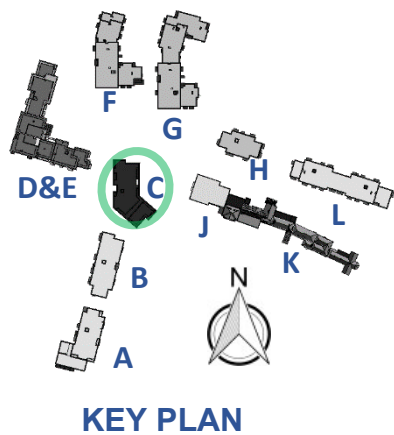
Sunlight Analysis as illustrated below, determined all units on this block achieve the minimum recommendations.

Exposure2Sunlight

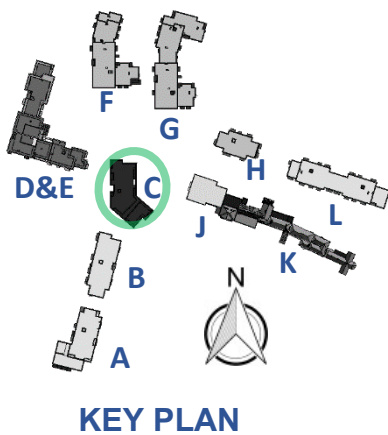
Block C – First Floor

Sunlight Analysis as illustrated below, determined all units on this block achieve the minimum recommendations.

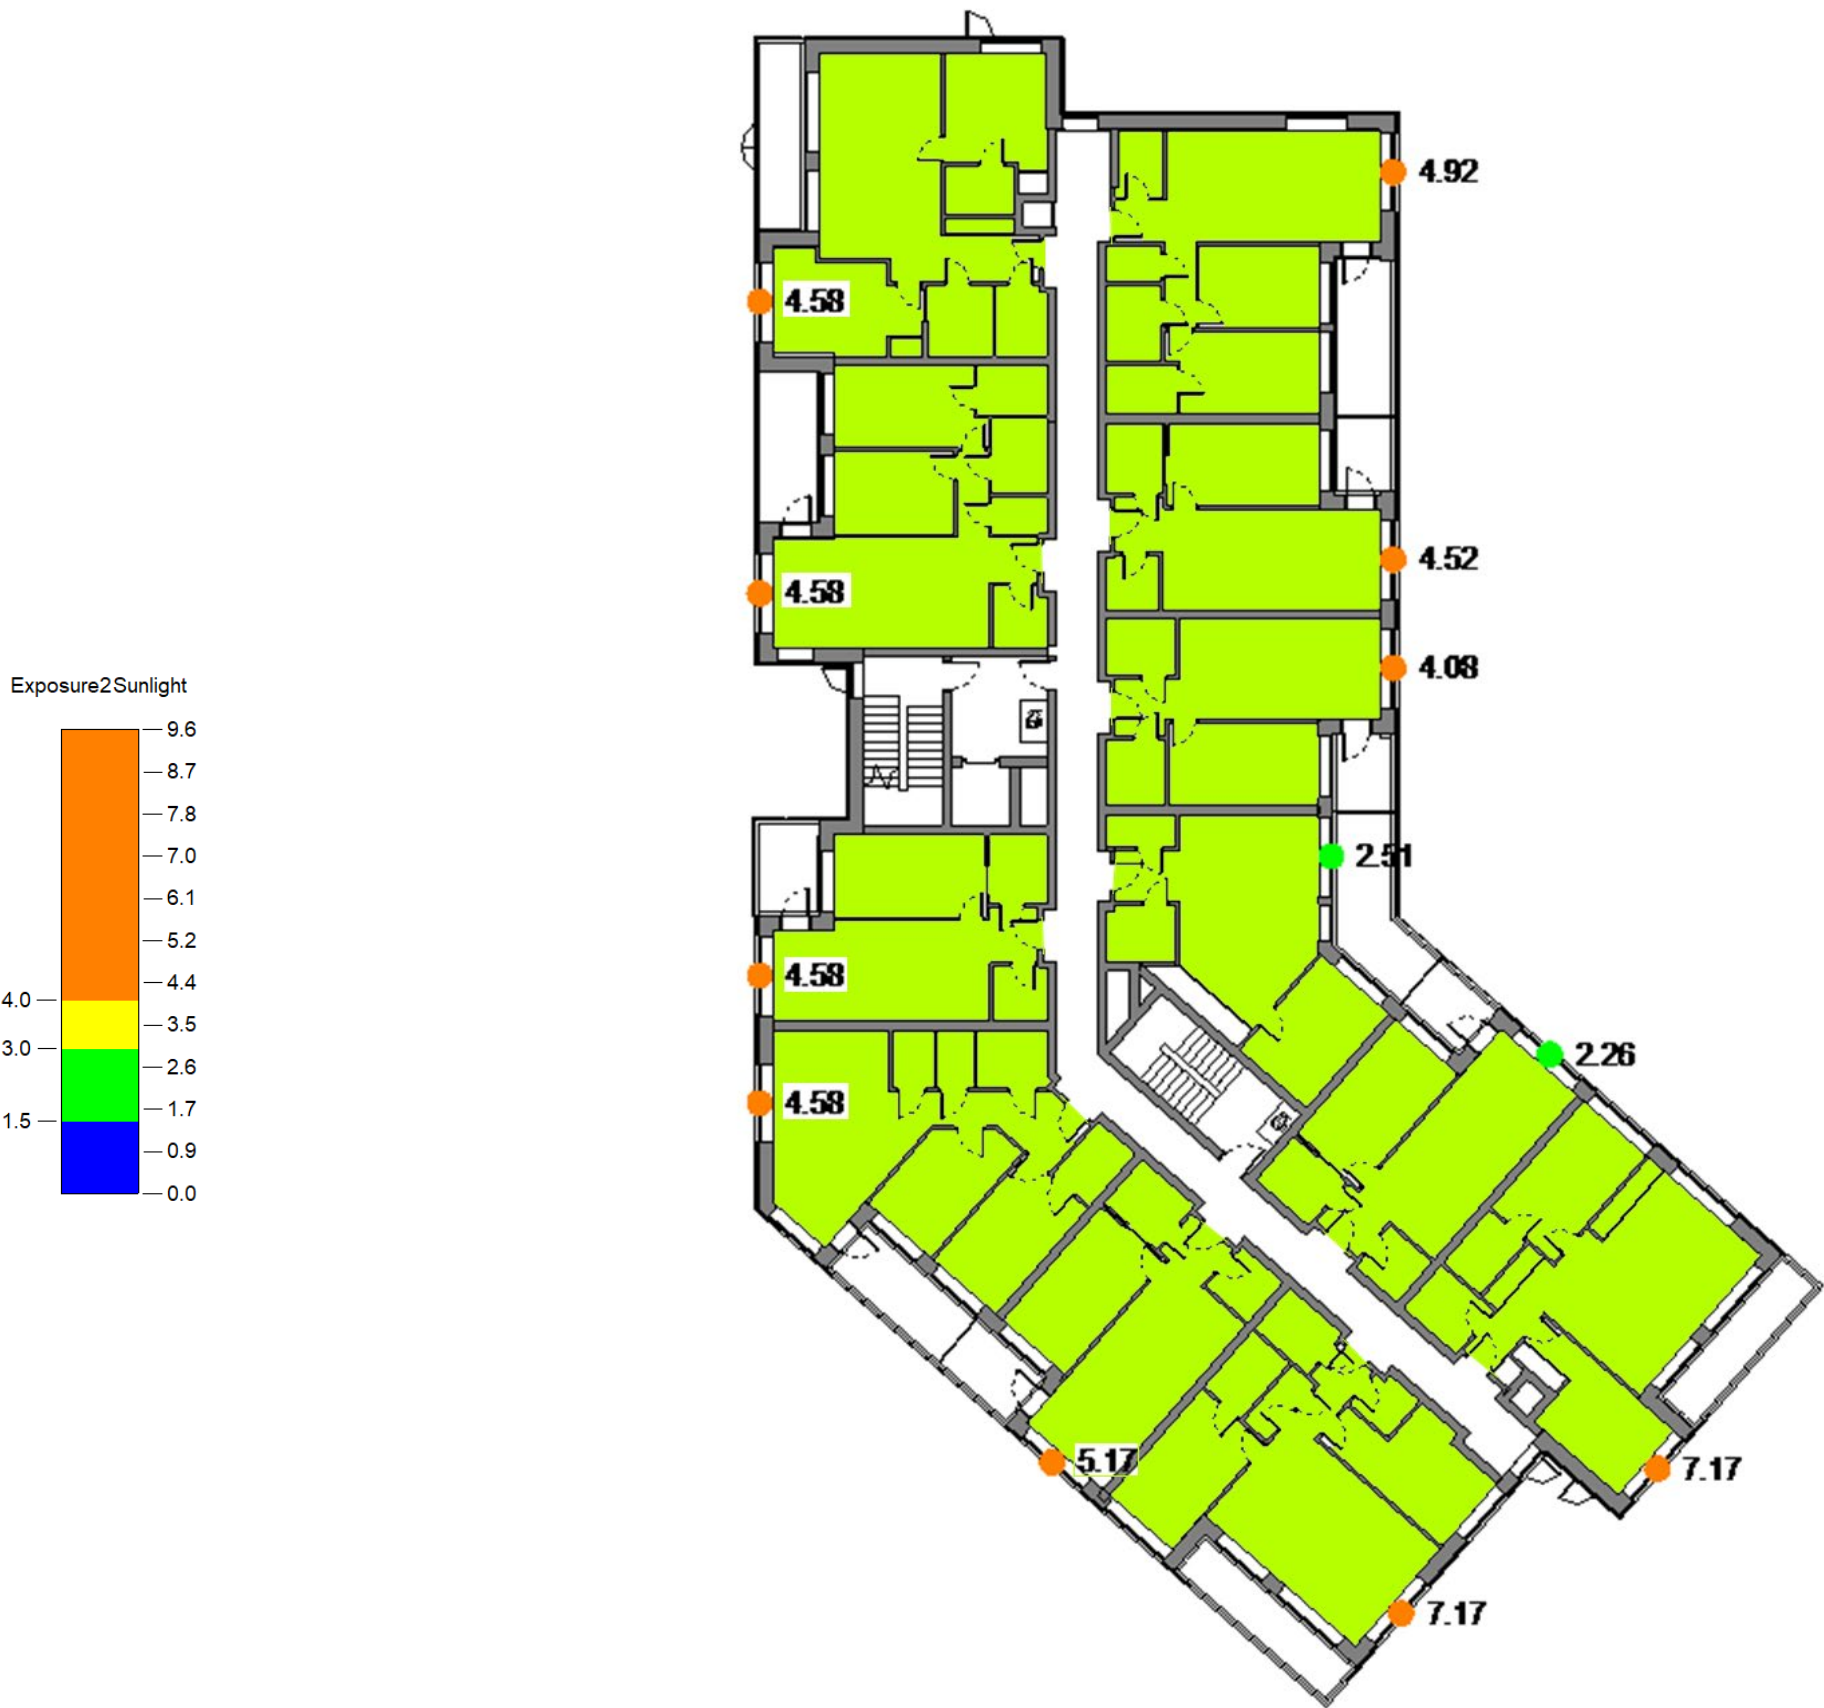
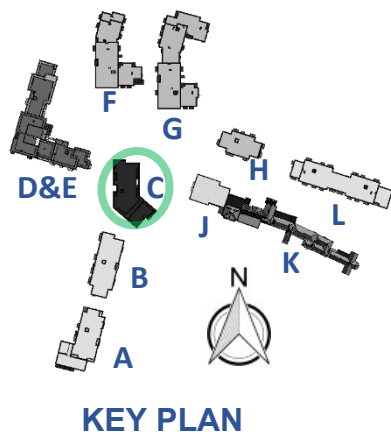
Block C – Second Floor

Sunlight Analysis as illustrated below, determined all units on this block achieve the minimum recommendations.

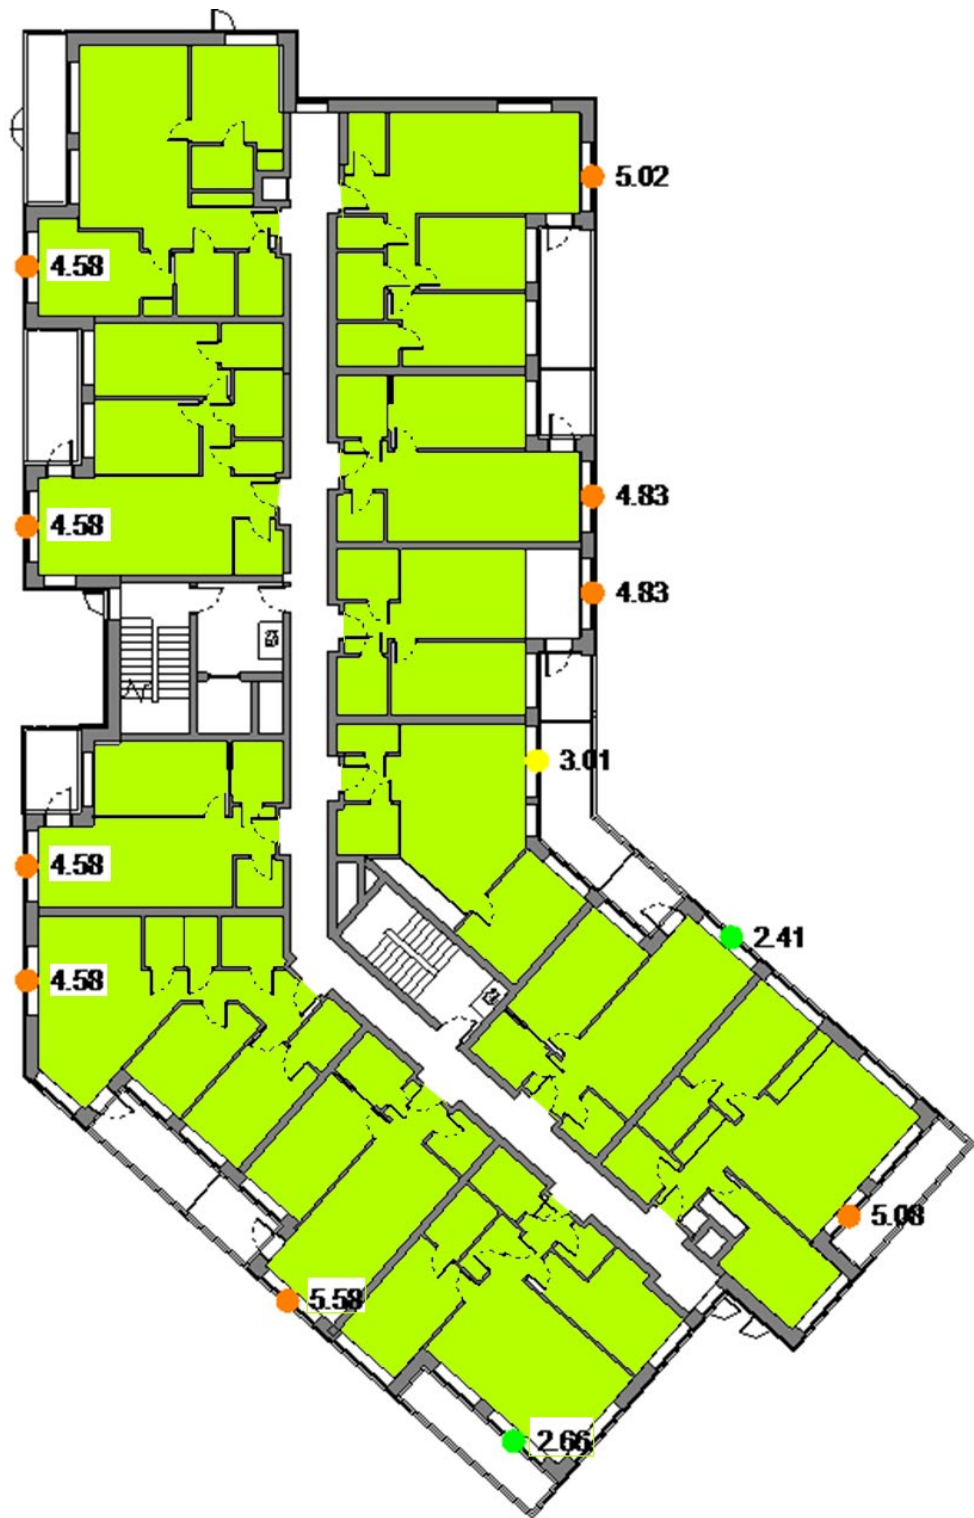
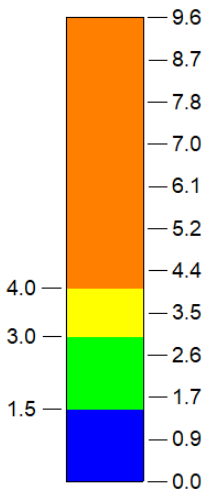
Sunlight Analysis as illustrated below, determined all units on this block achieve the minimum recommendations.

Exposure2Sunlight

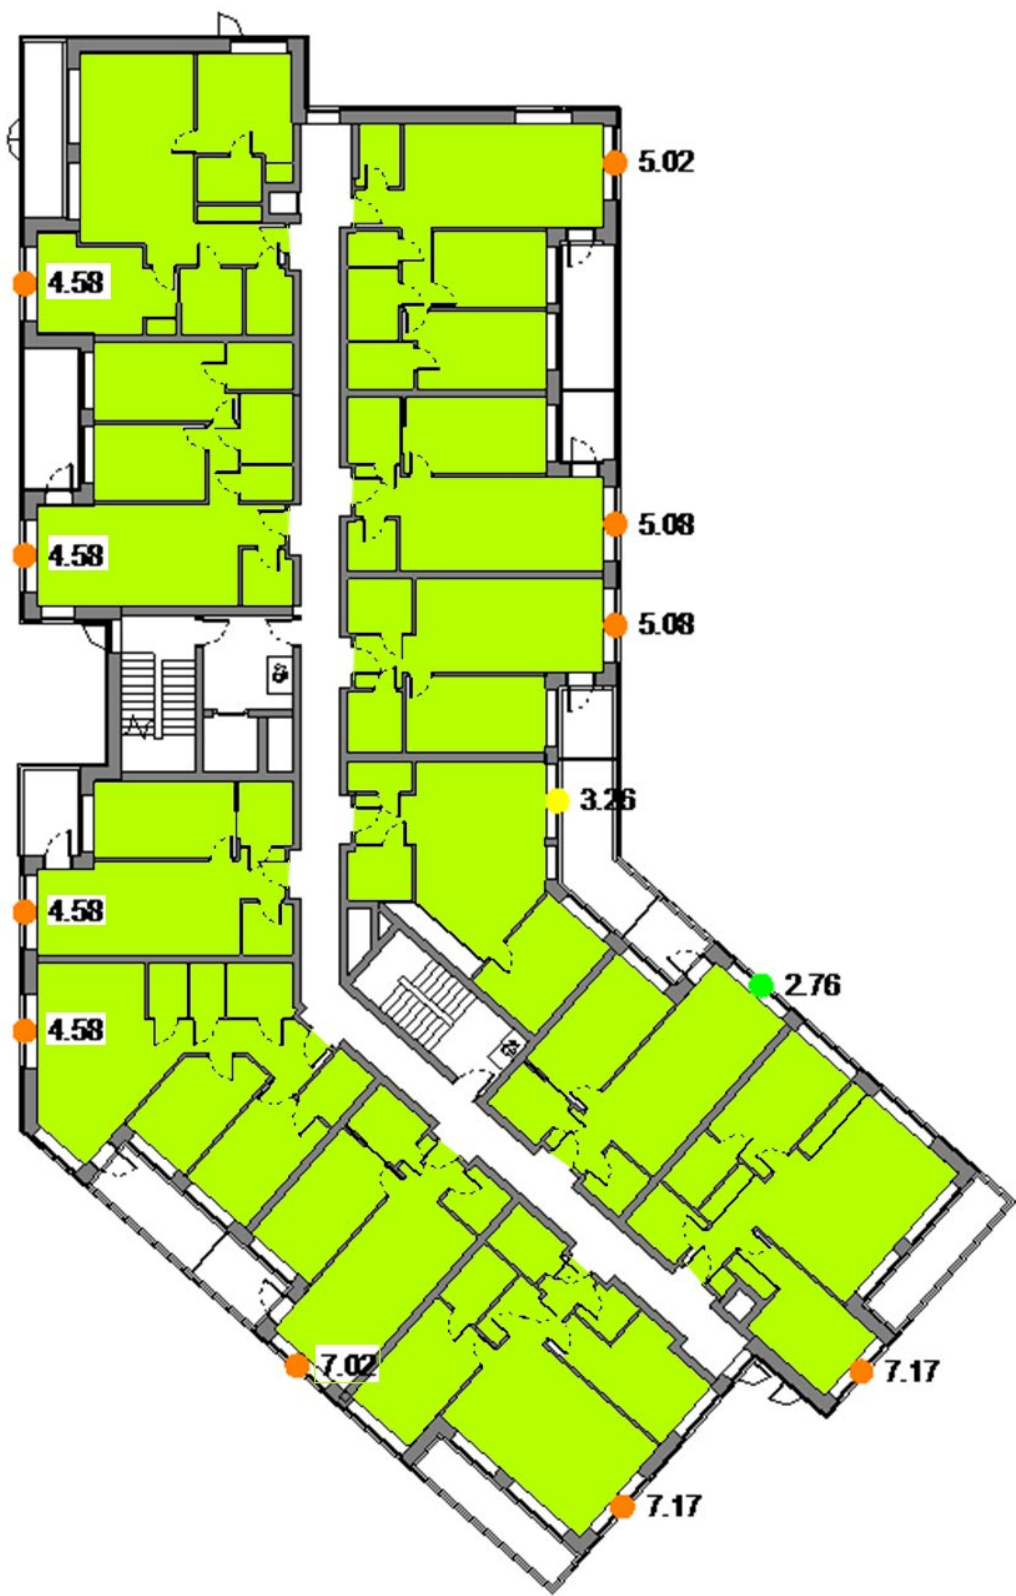
Sunlight Analysis as illustrated below, determined all units on this block achieve the minimum recommendations.

Exposure2Sunlight

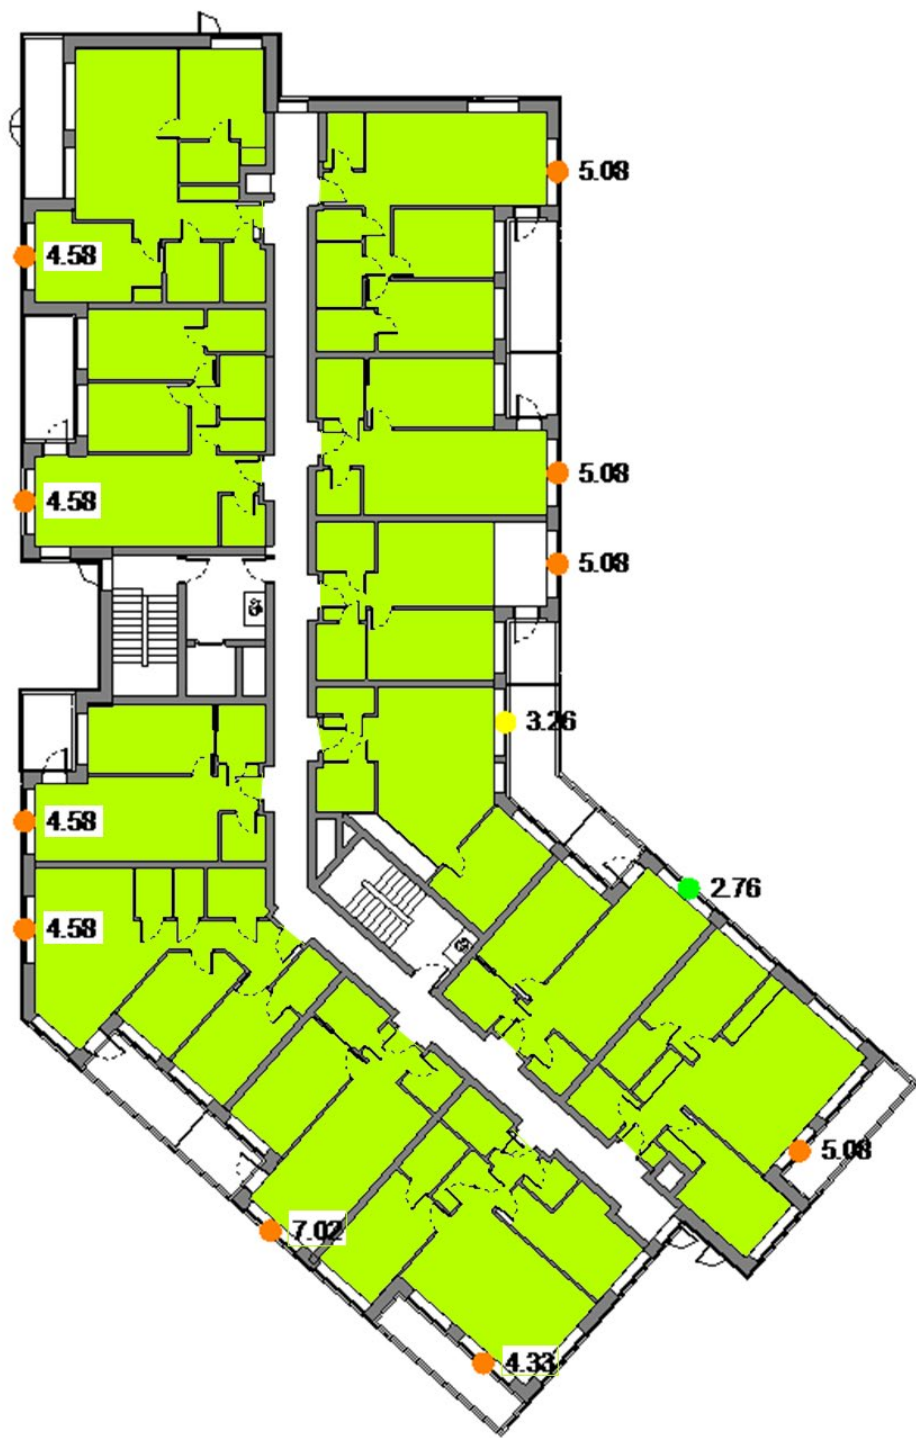
Sunlight Analysis as illustrated below, determined all units on this block achieve the minimum recommendations.

Exposure2Sunlight

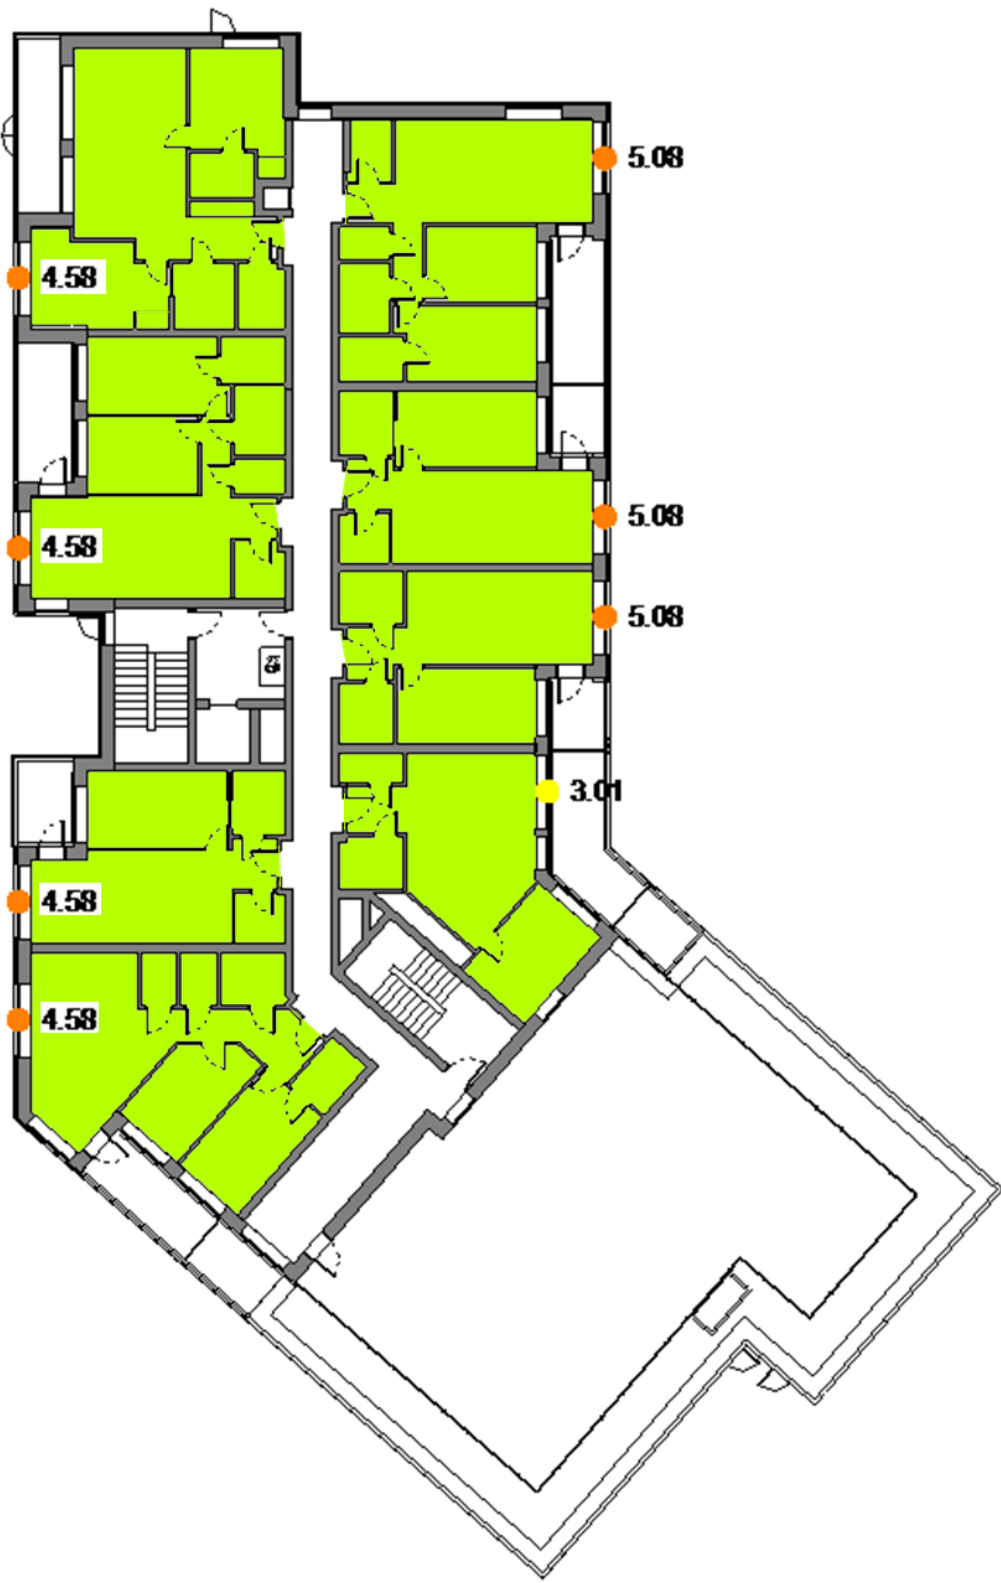
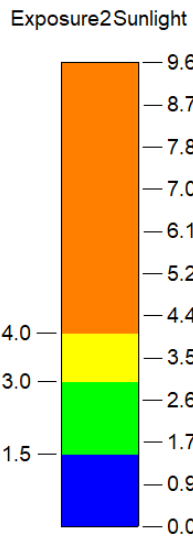
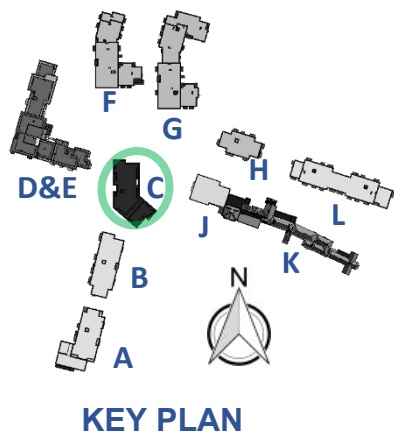
Block C – Sixth Floor

Sunlight Analysis as illustrated below, determined all units on this block achieve the minimum recommendations.

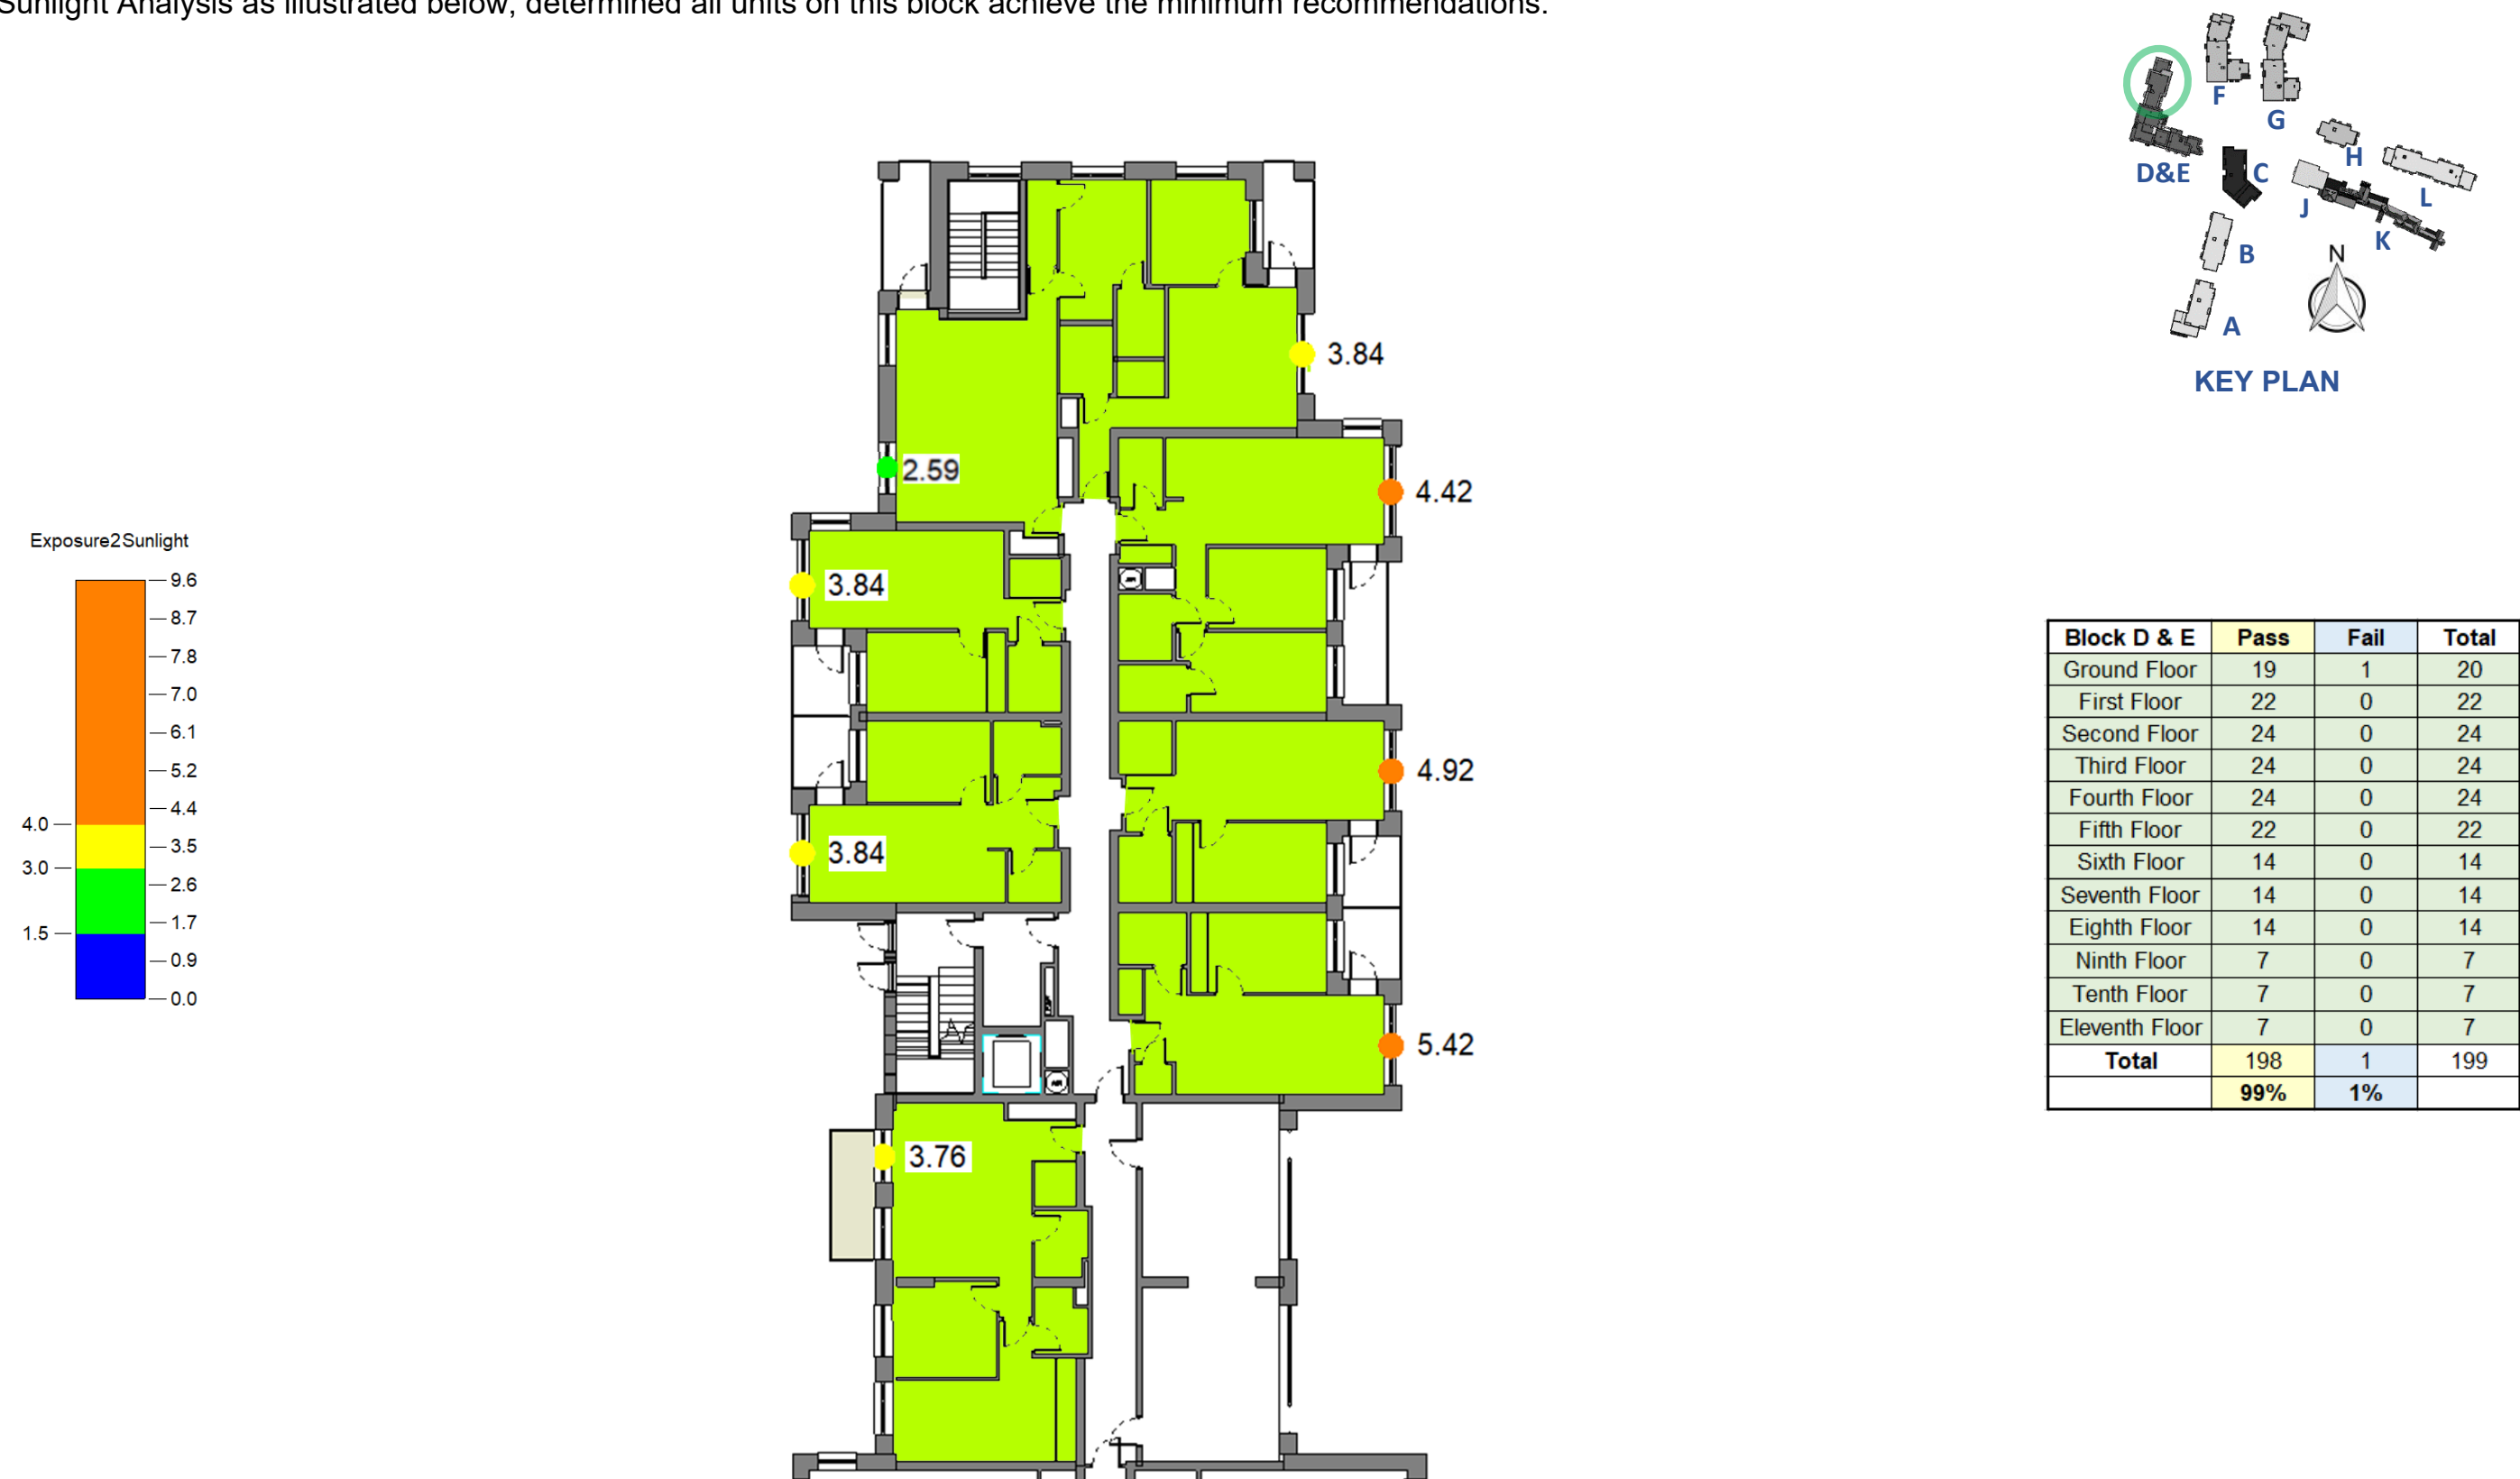
Block DE – Ground Floor

Sunlight Analysis as illustrated below, determined all units on this block achieve the minimum recommendations.
