St. Vincent's Hospital Fairview Redevelopment, Fairview Dublin 3

Daylight and Sunlight Analysis

IN2 Project No. D2116

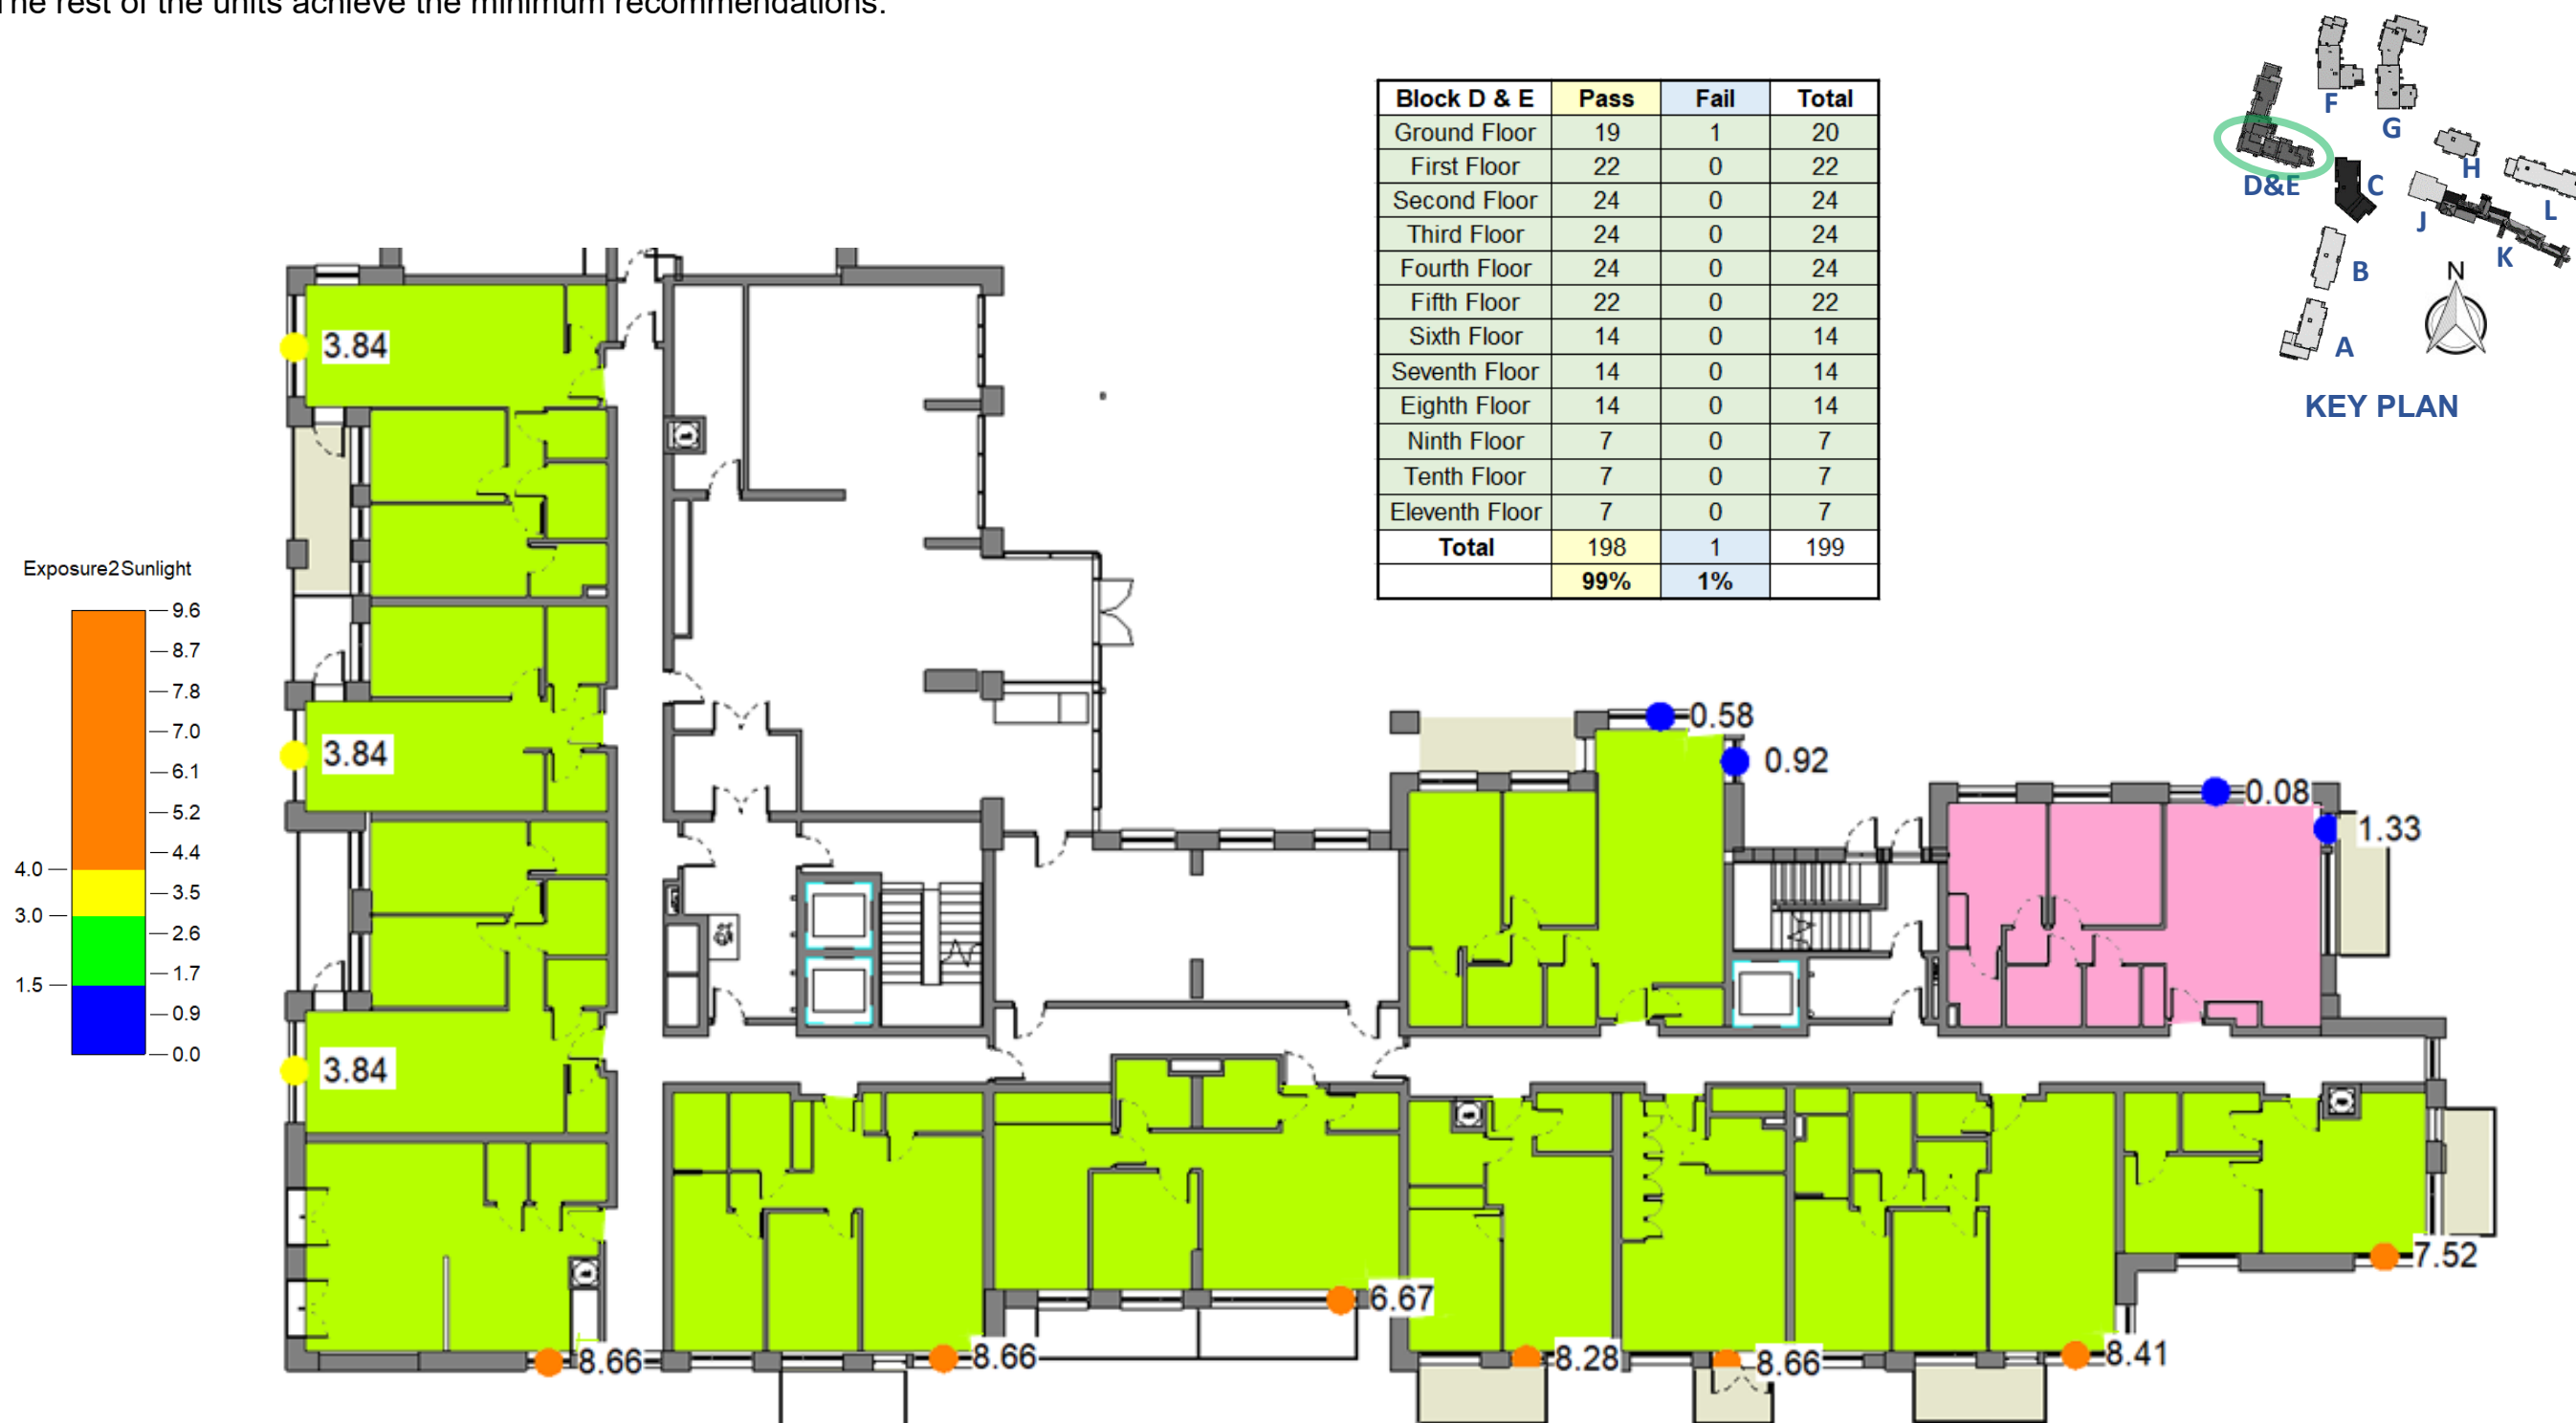
Sunlight Analysis as illustrated below, determined 1 unit on this block does not achieve the minimum recommendations.

The rest of the units achieve the minimum recommendations.

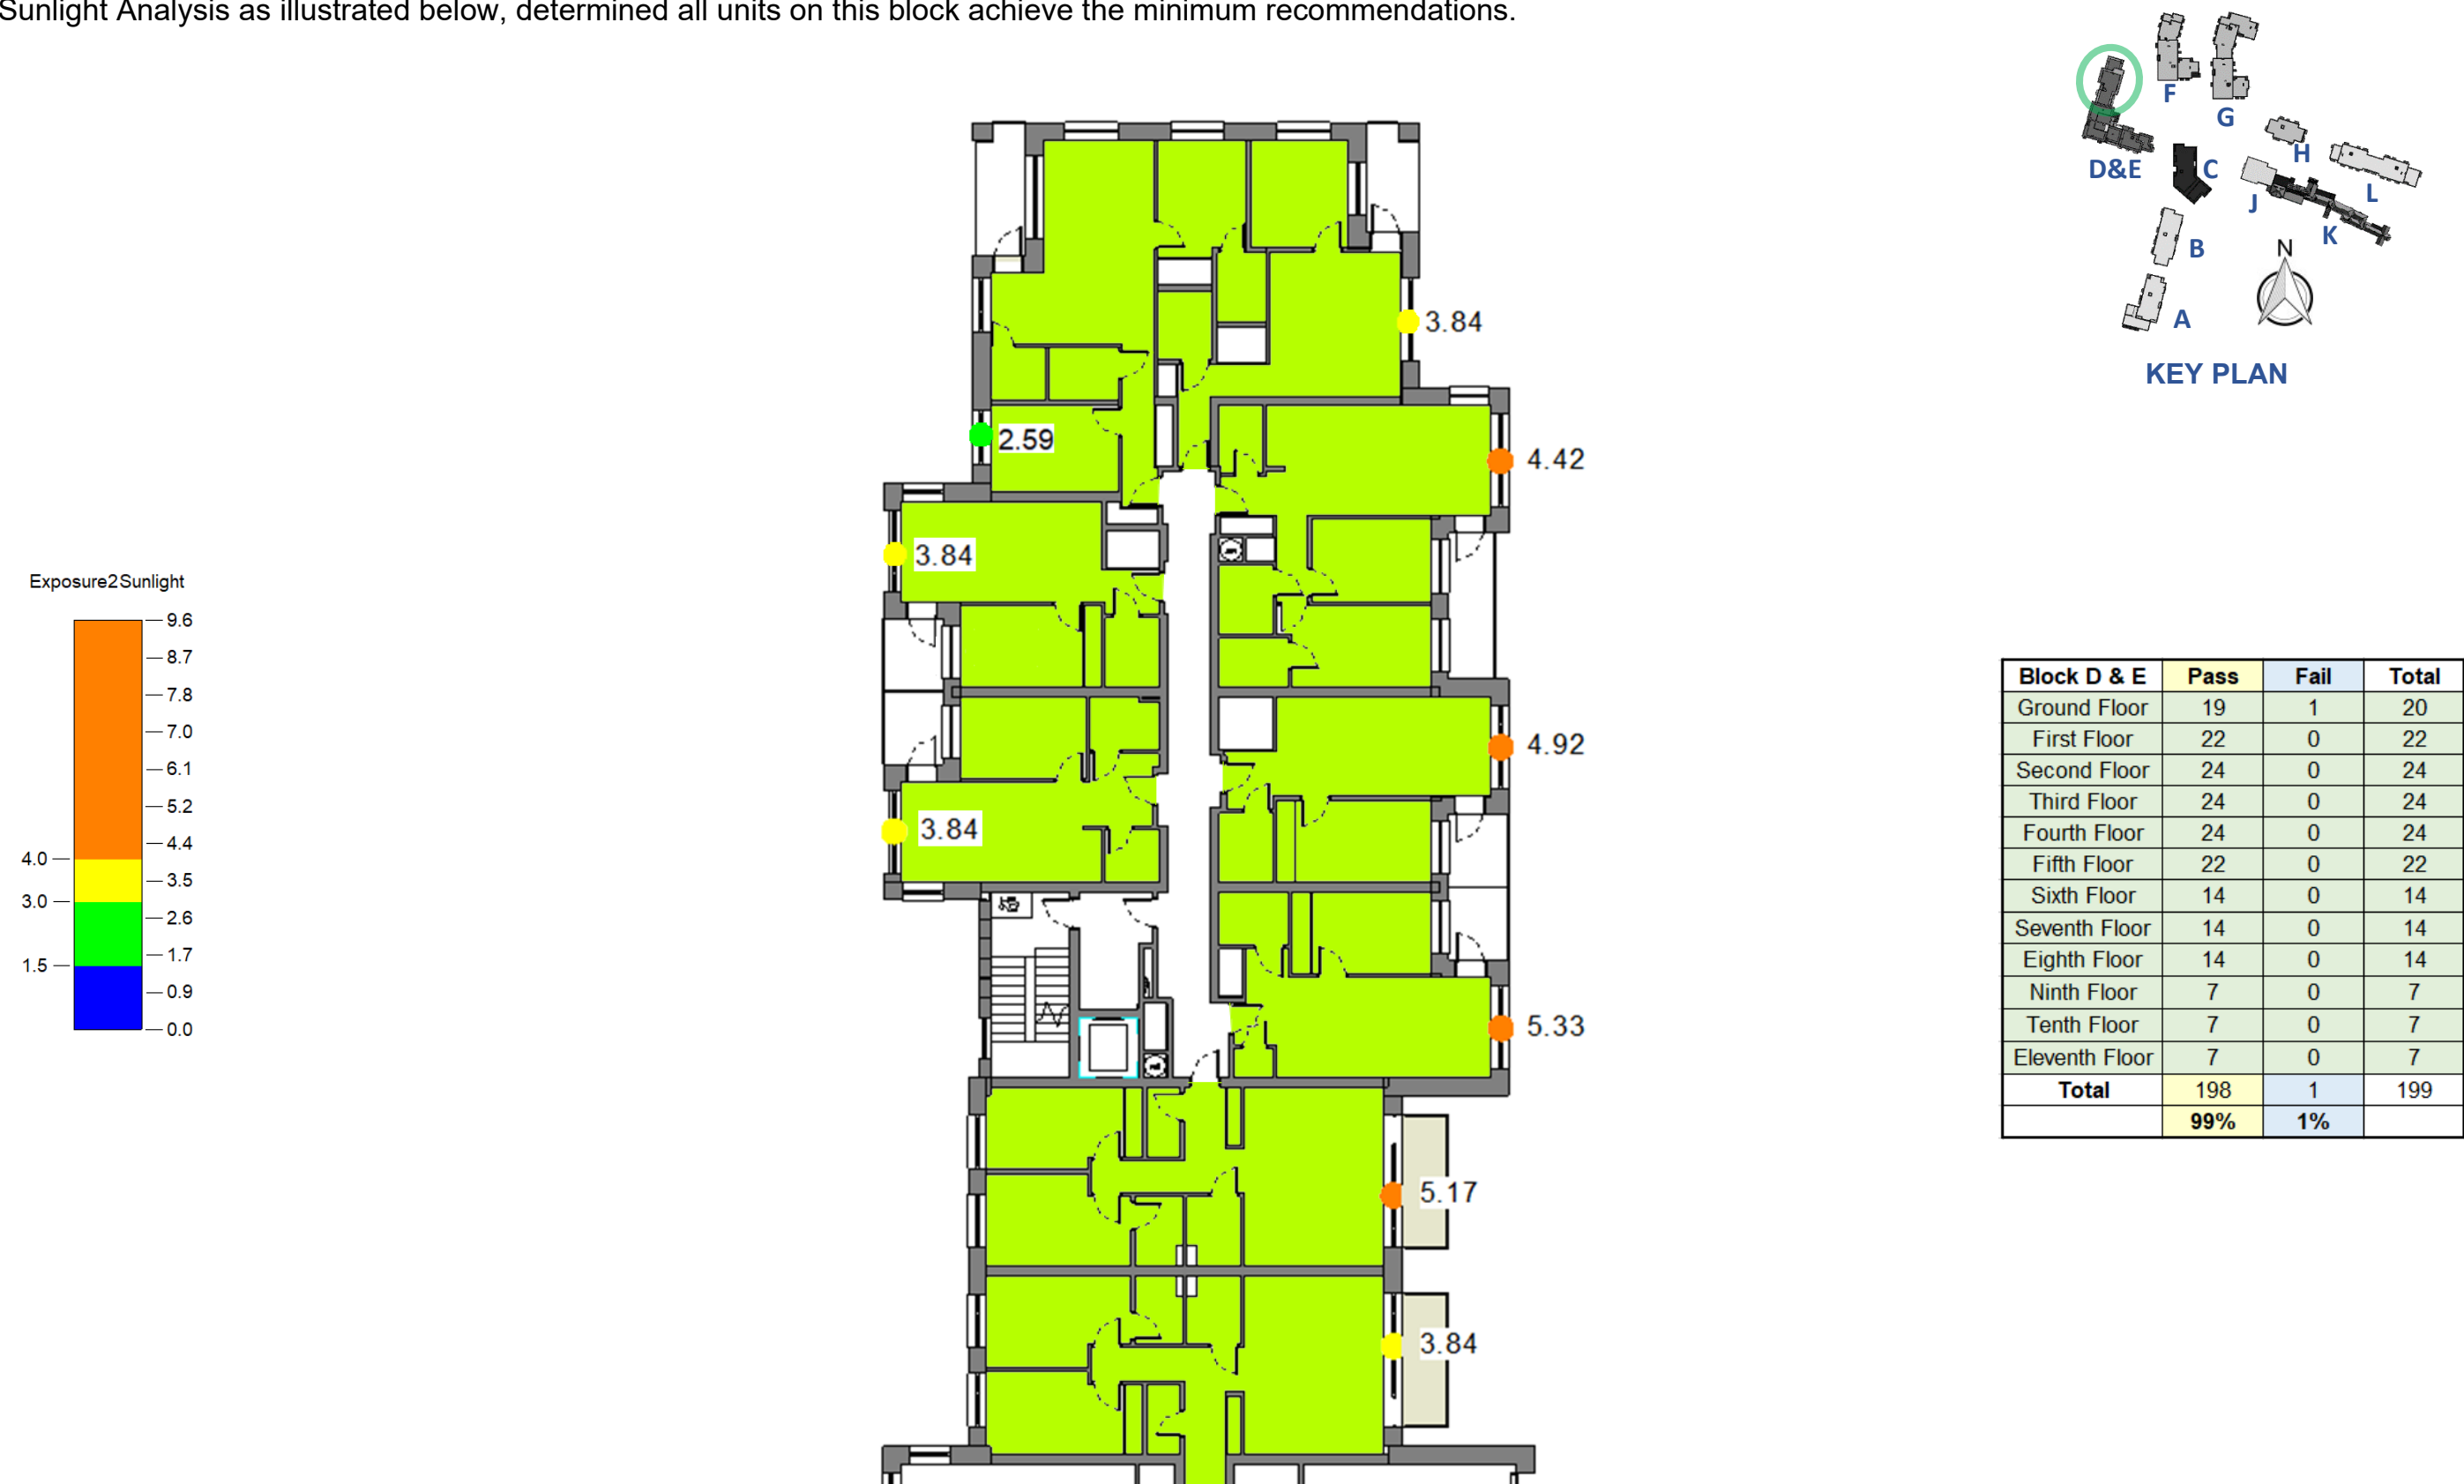
Block DE – First Floor

Sunlight Analysis as illustrated below, determined all units on this block achieve the minimum recommendations.

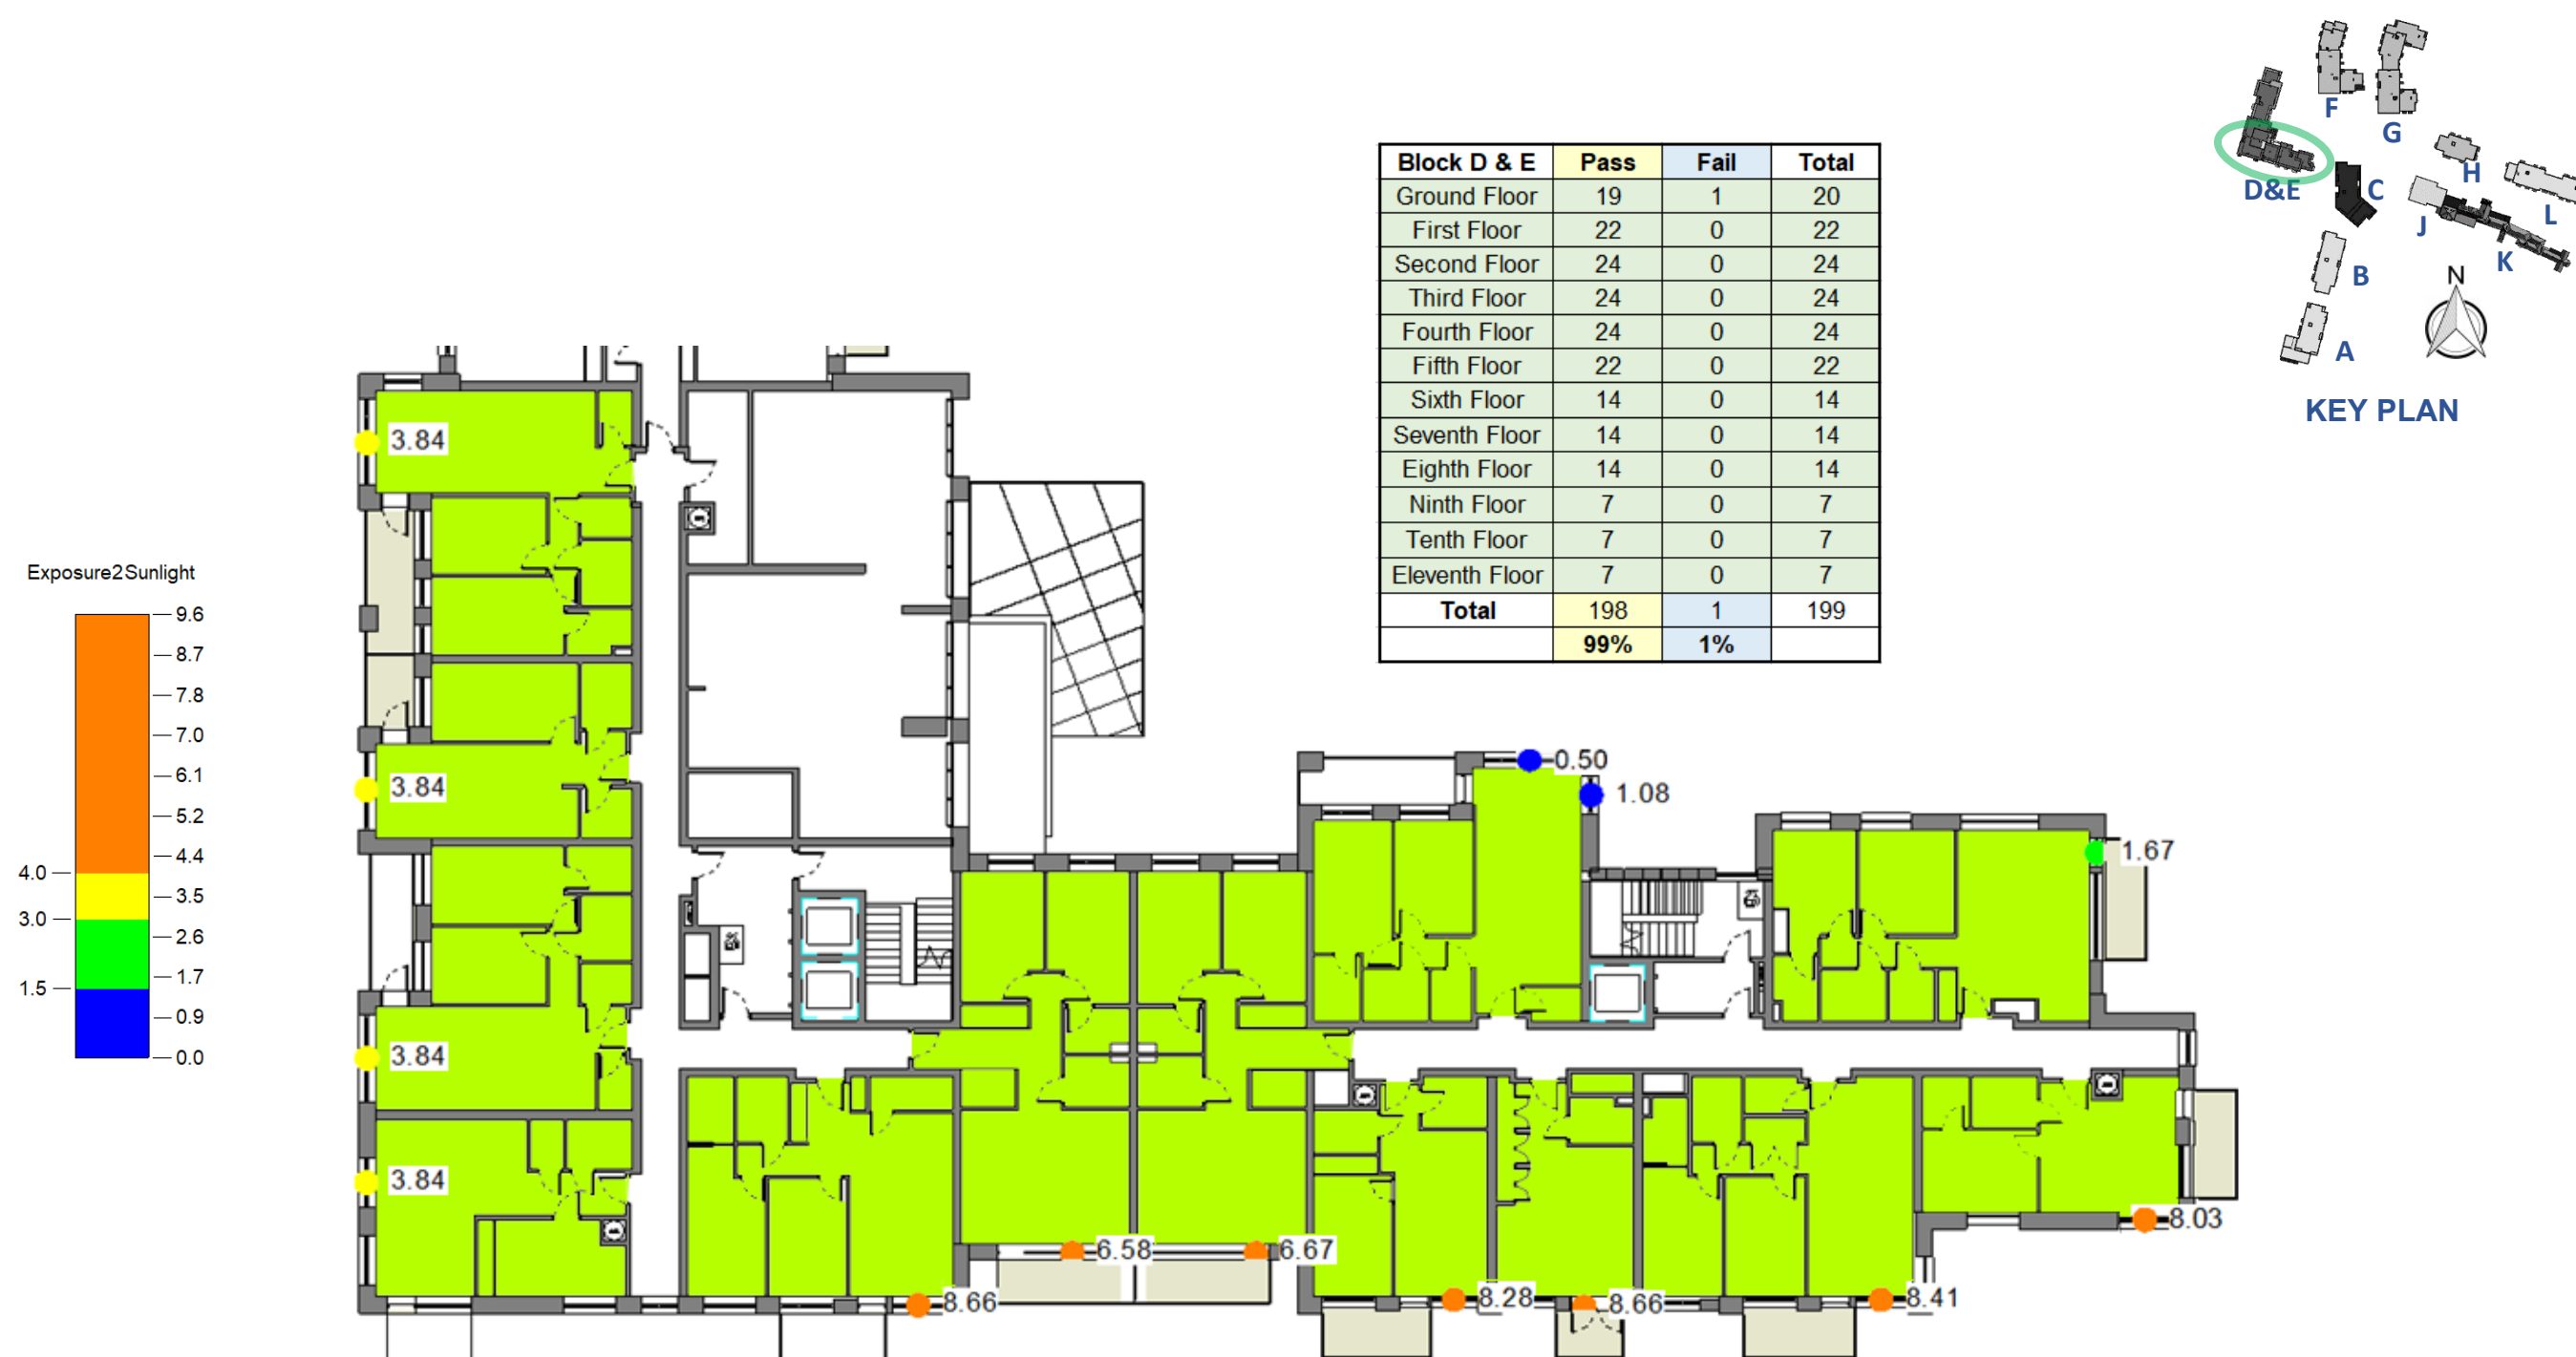
Block DE – First Floor

Sunlight Analysis as illustrated below, determined all units on this block achieve the minimum recommendations.

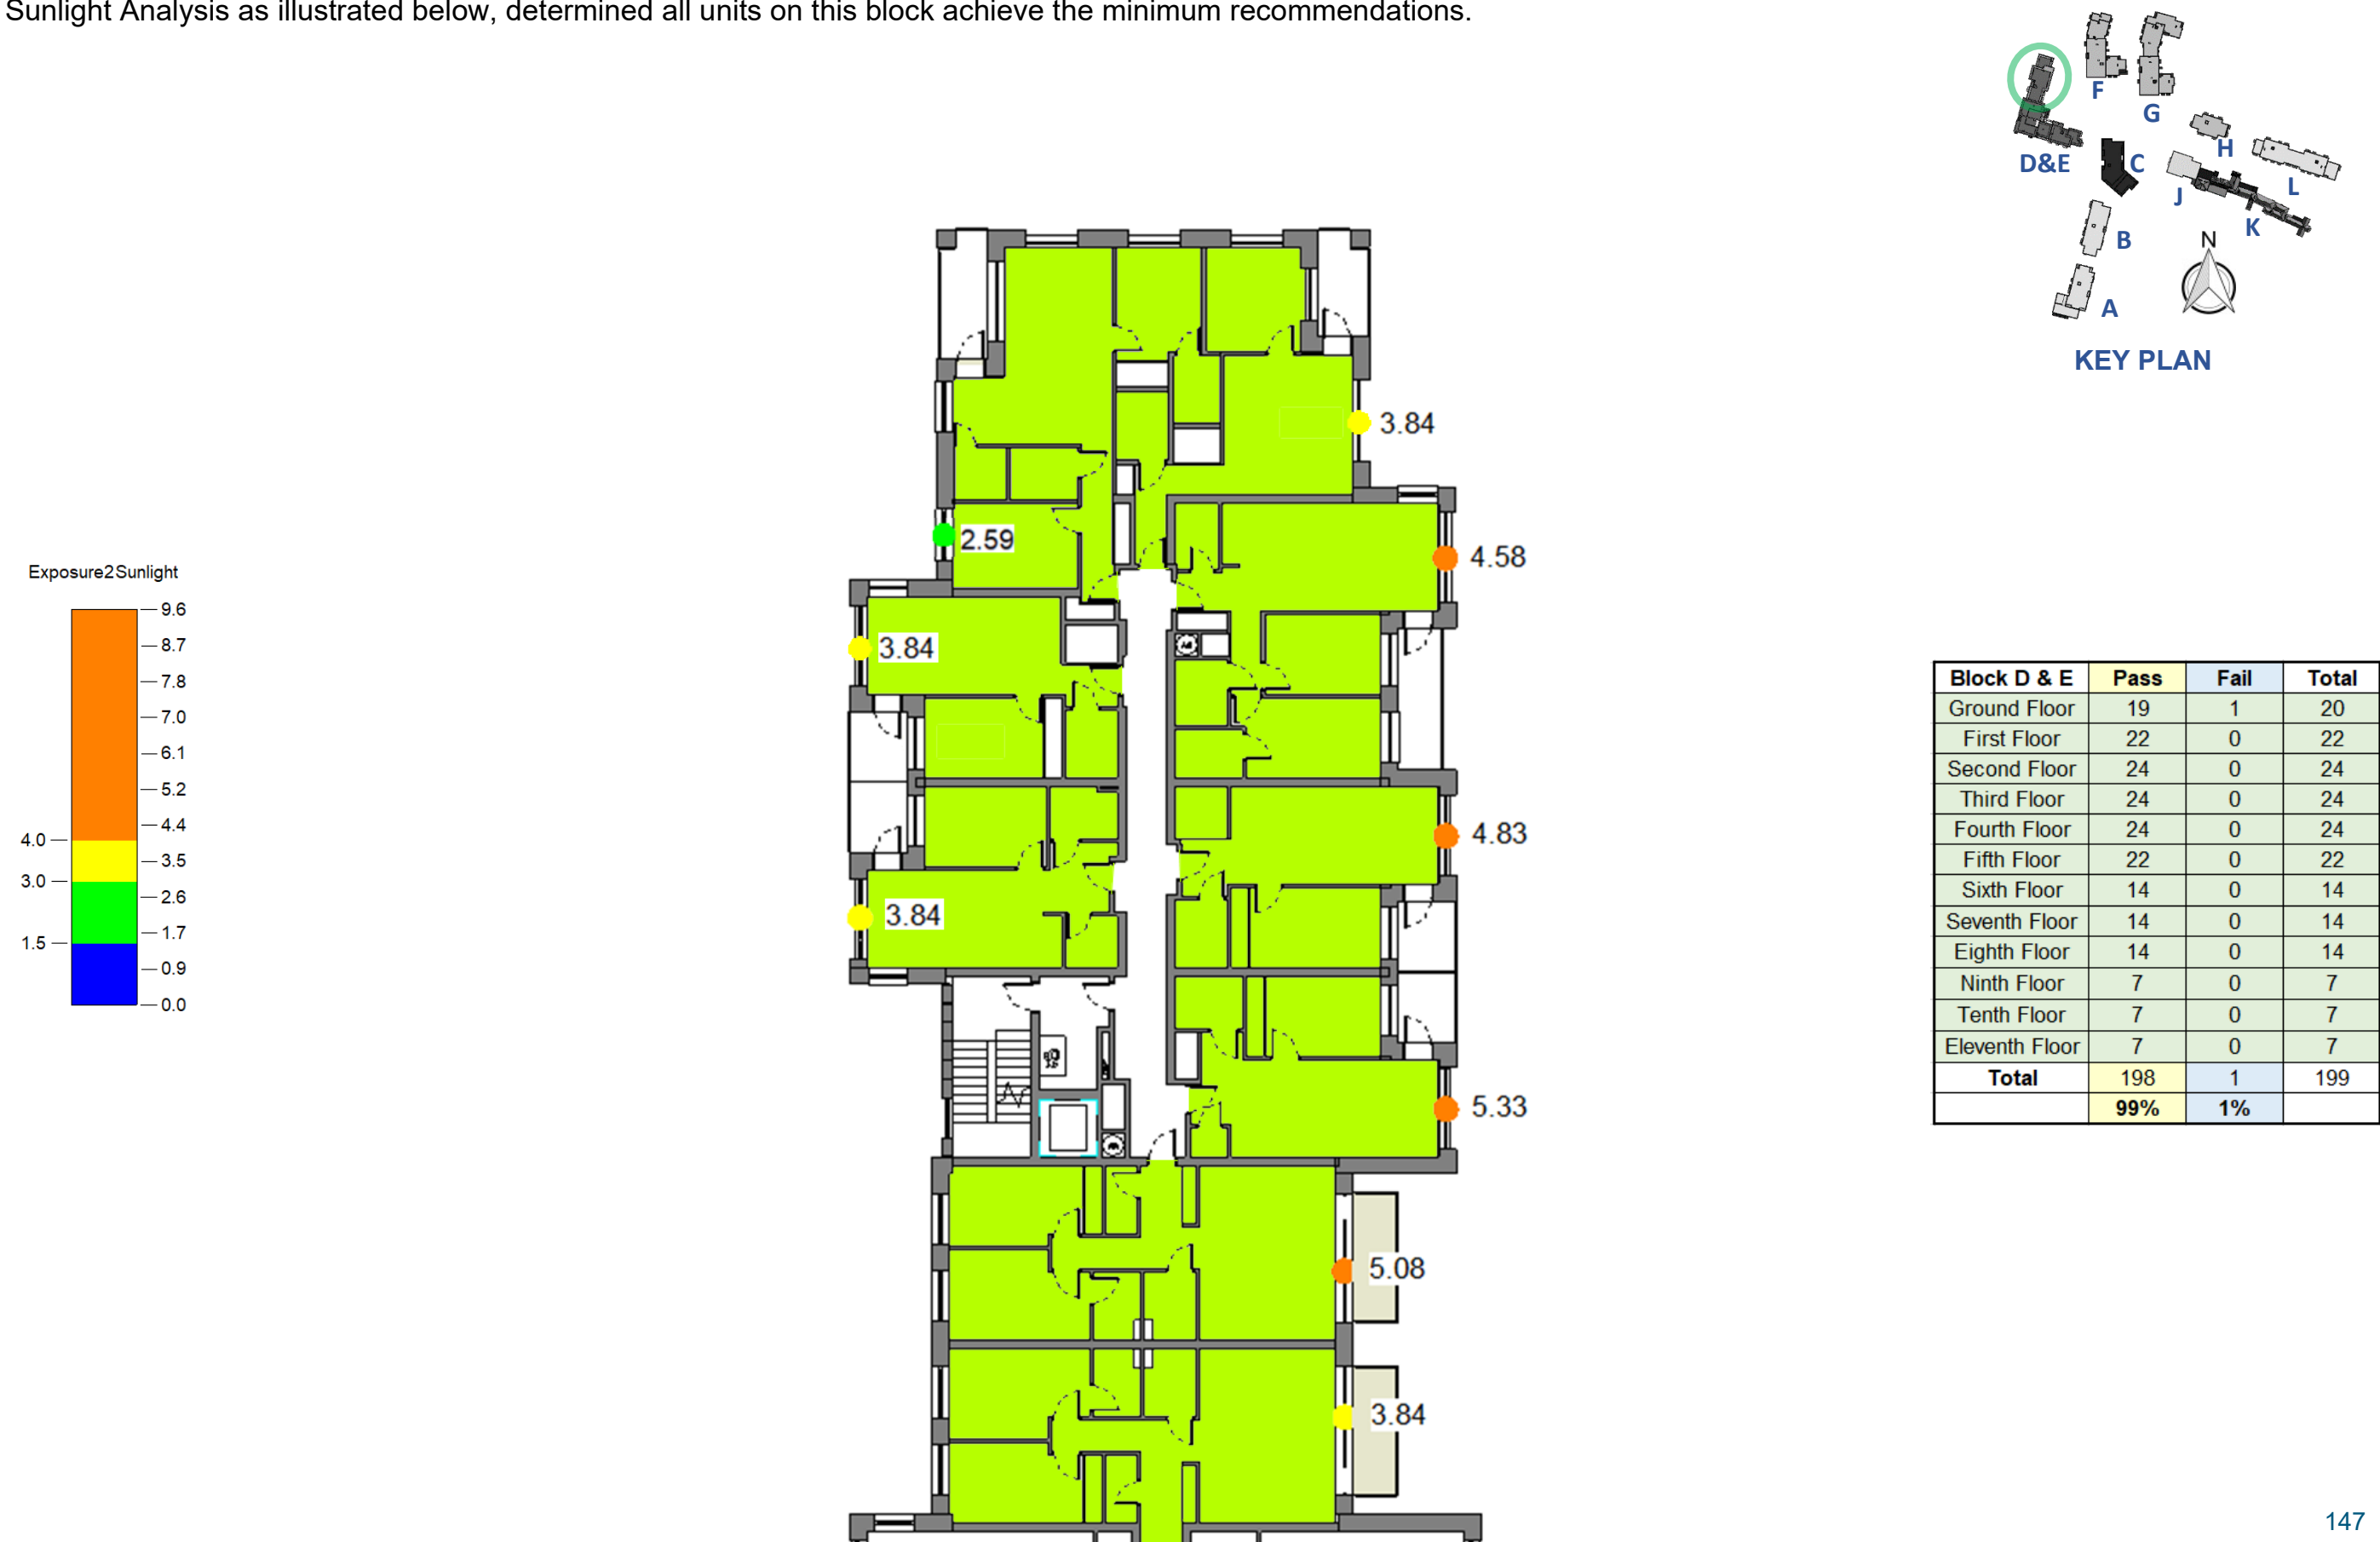
Block DE – Second Floor

Sunlight Analysis as illustrated below, determined all units on this block achieve the minimum recommendations.

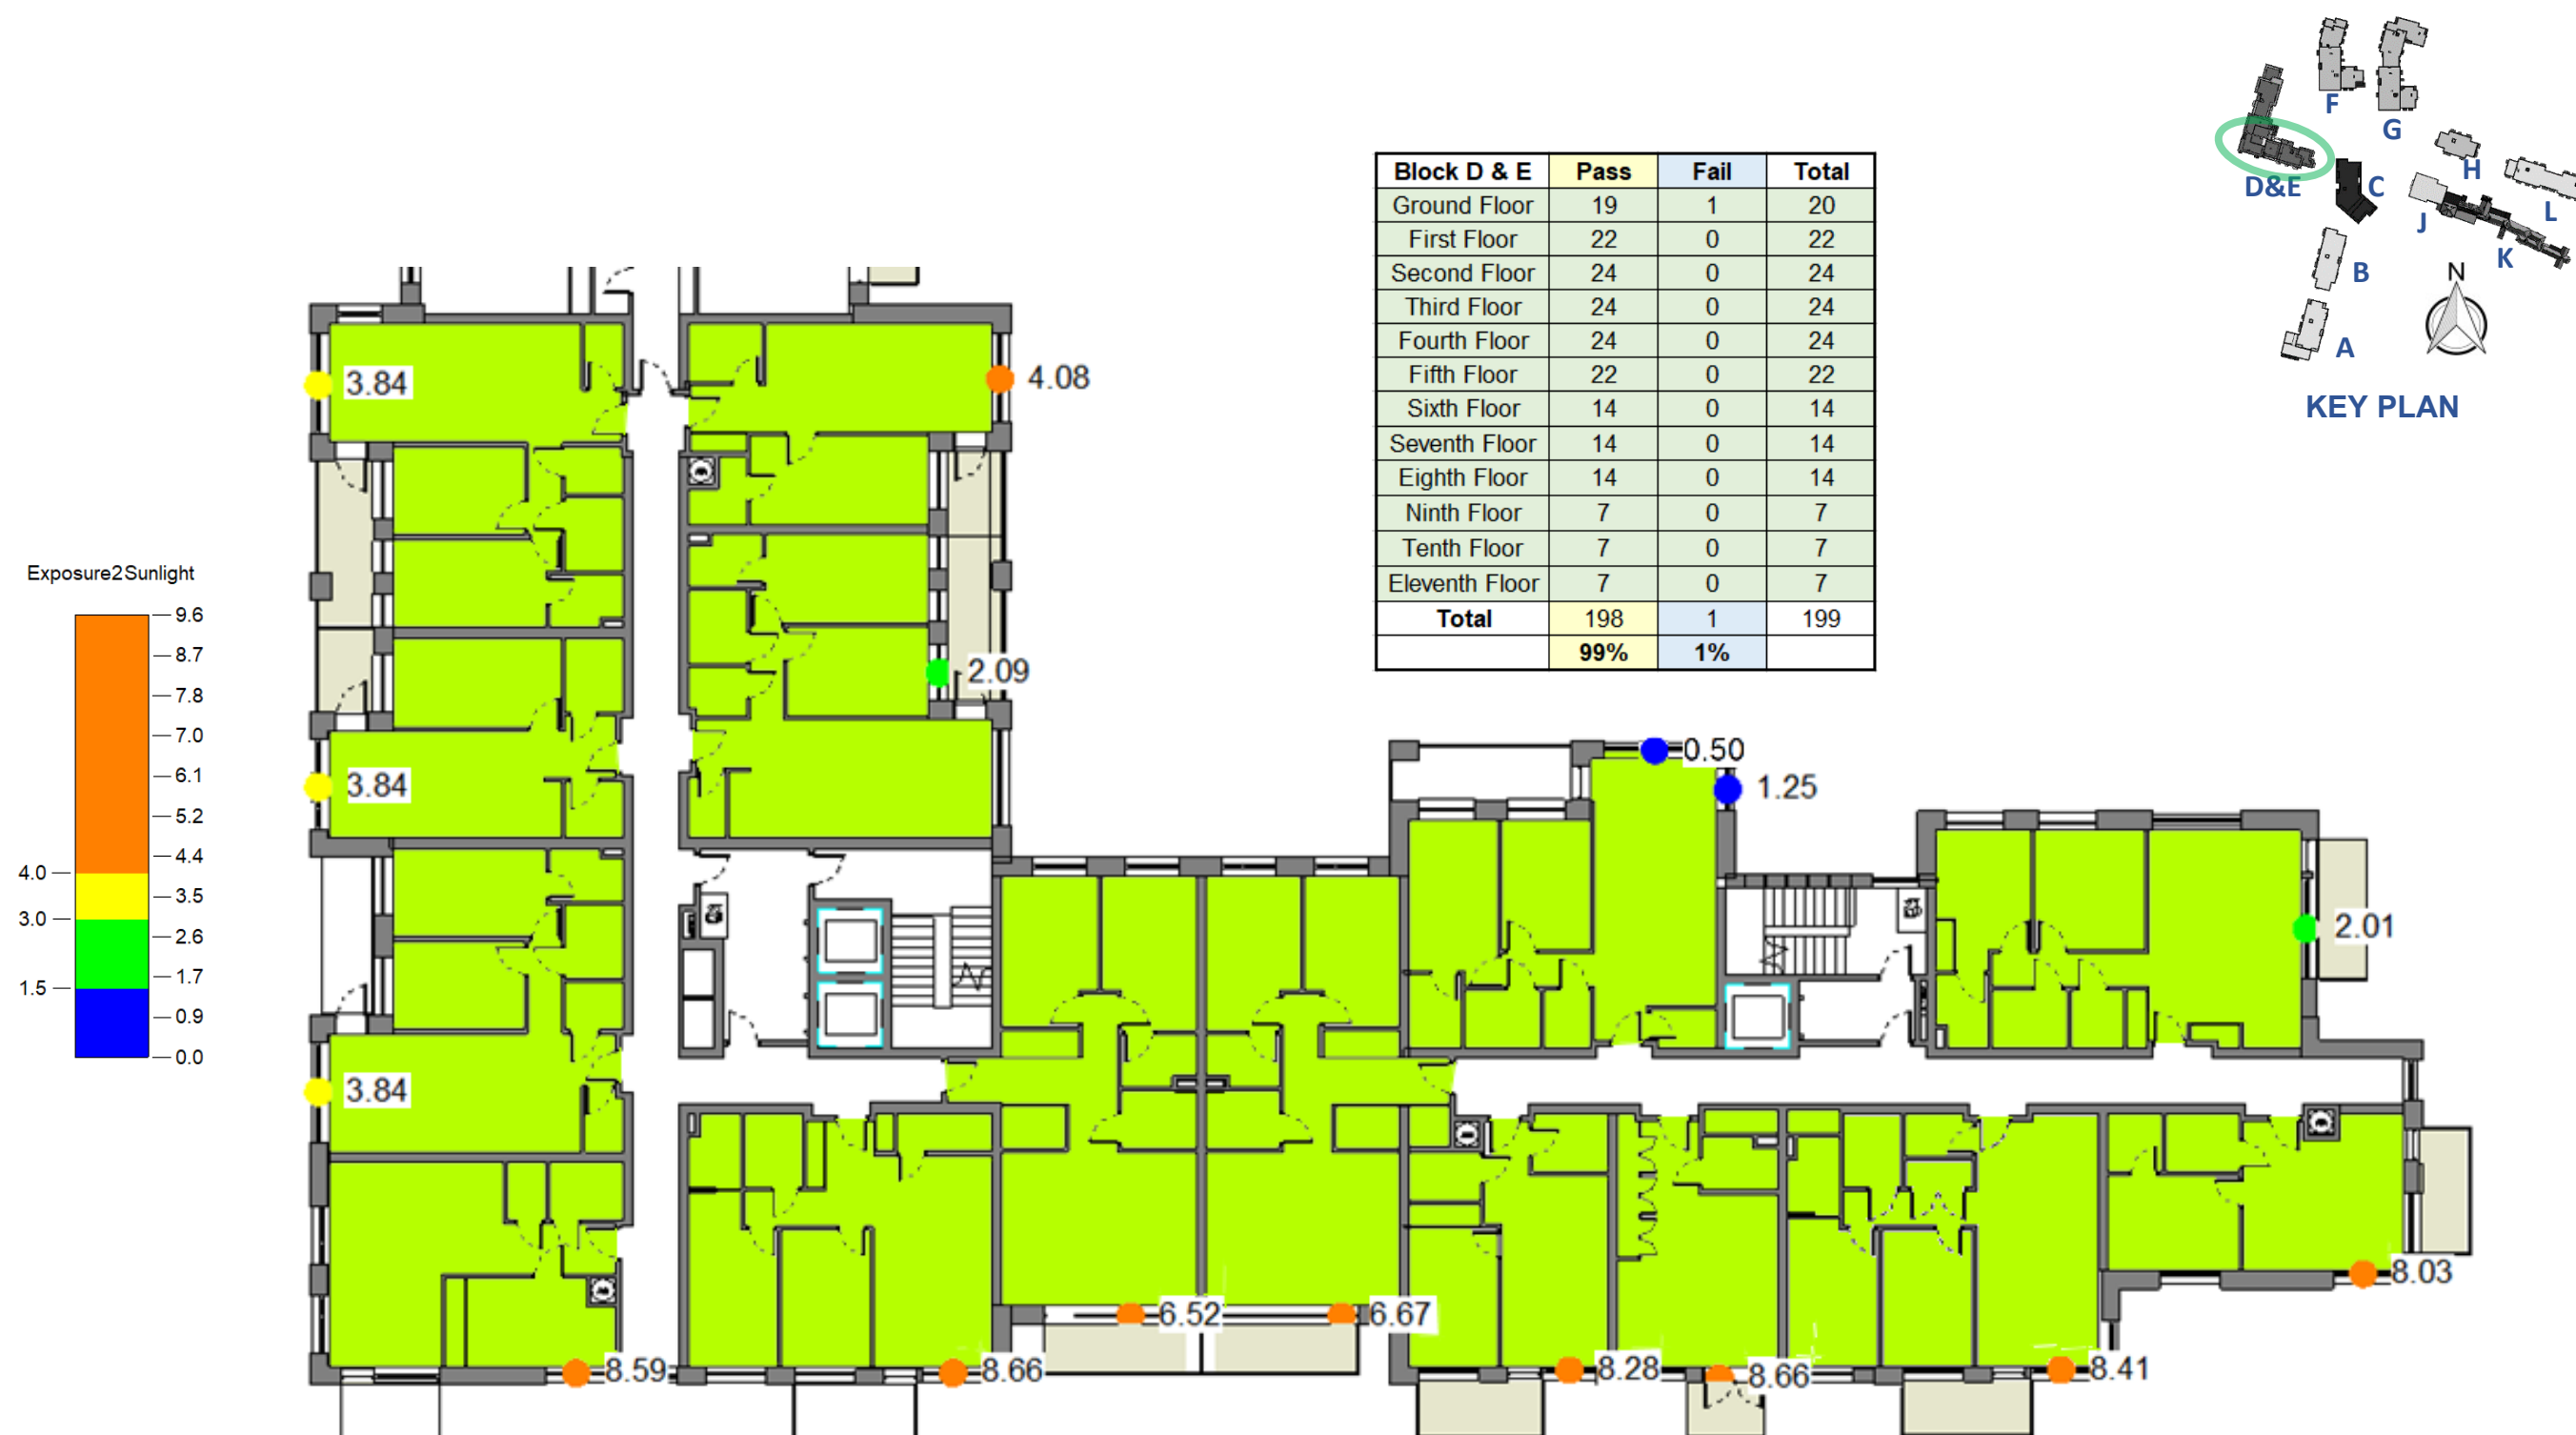
Block DE – Second Floor

Sunlight Analysis as illustrated below, determined all units on this block achieve the minimum recommendations.

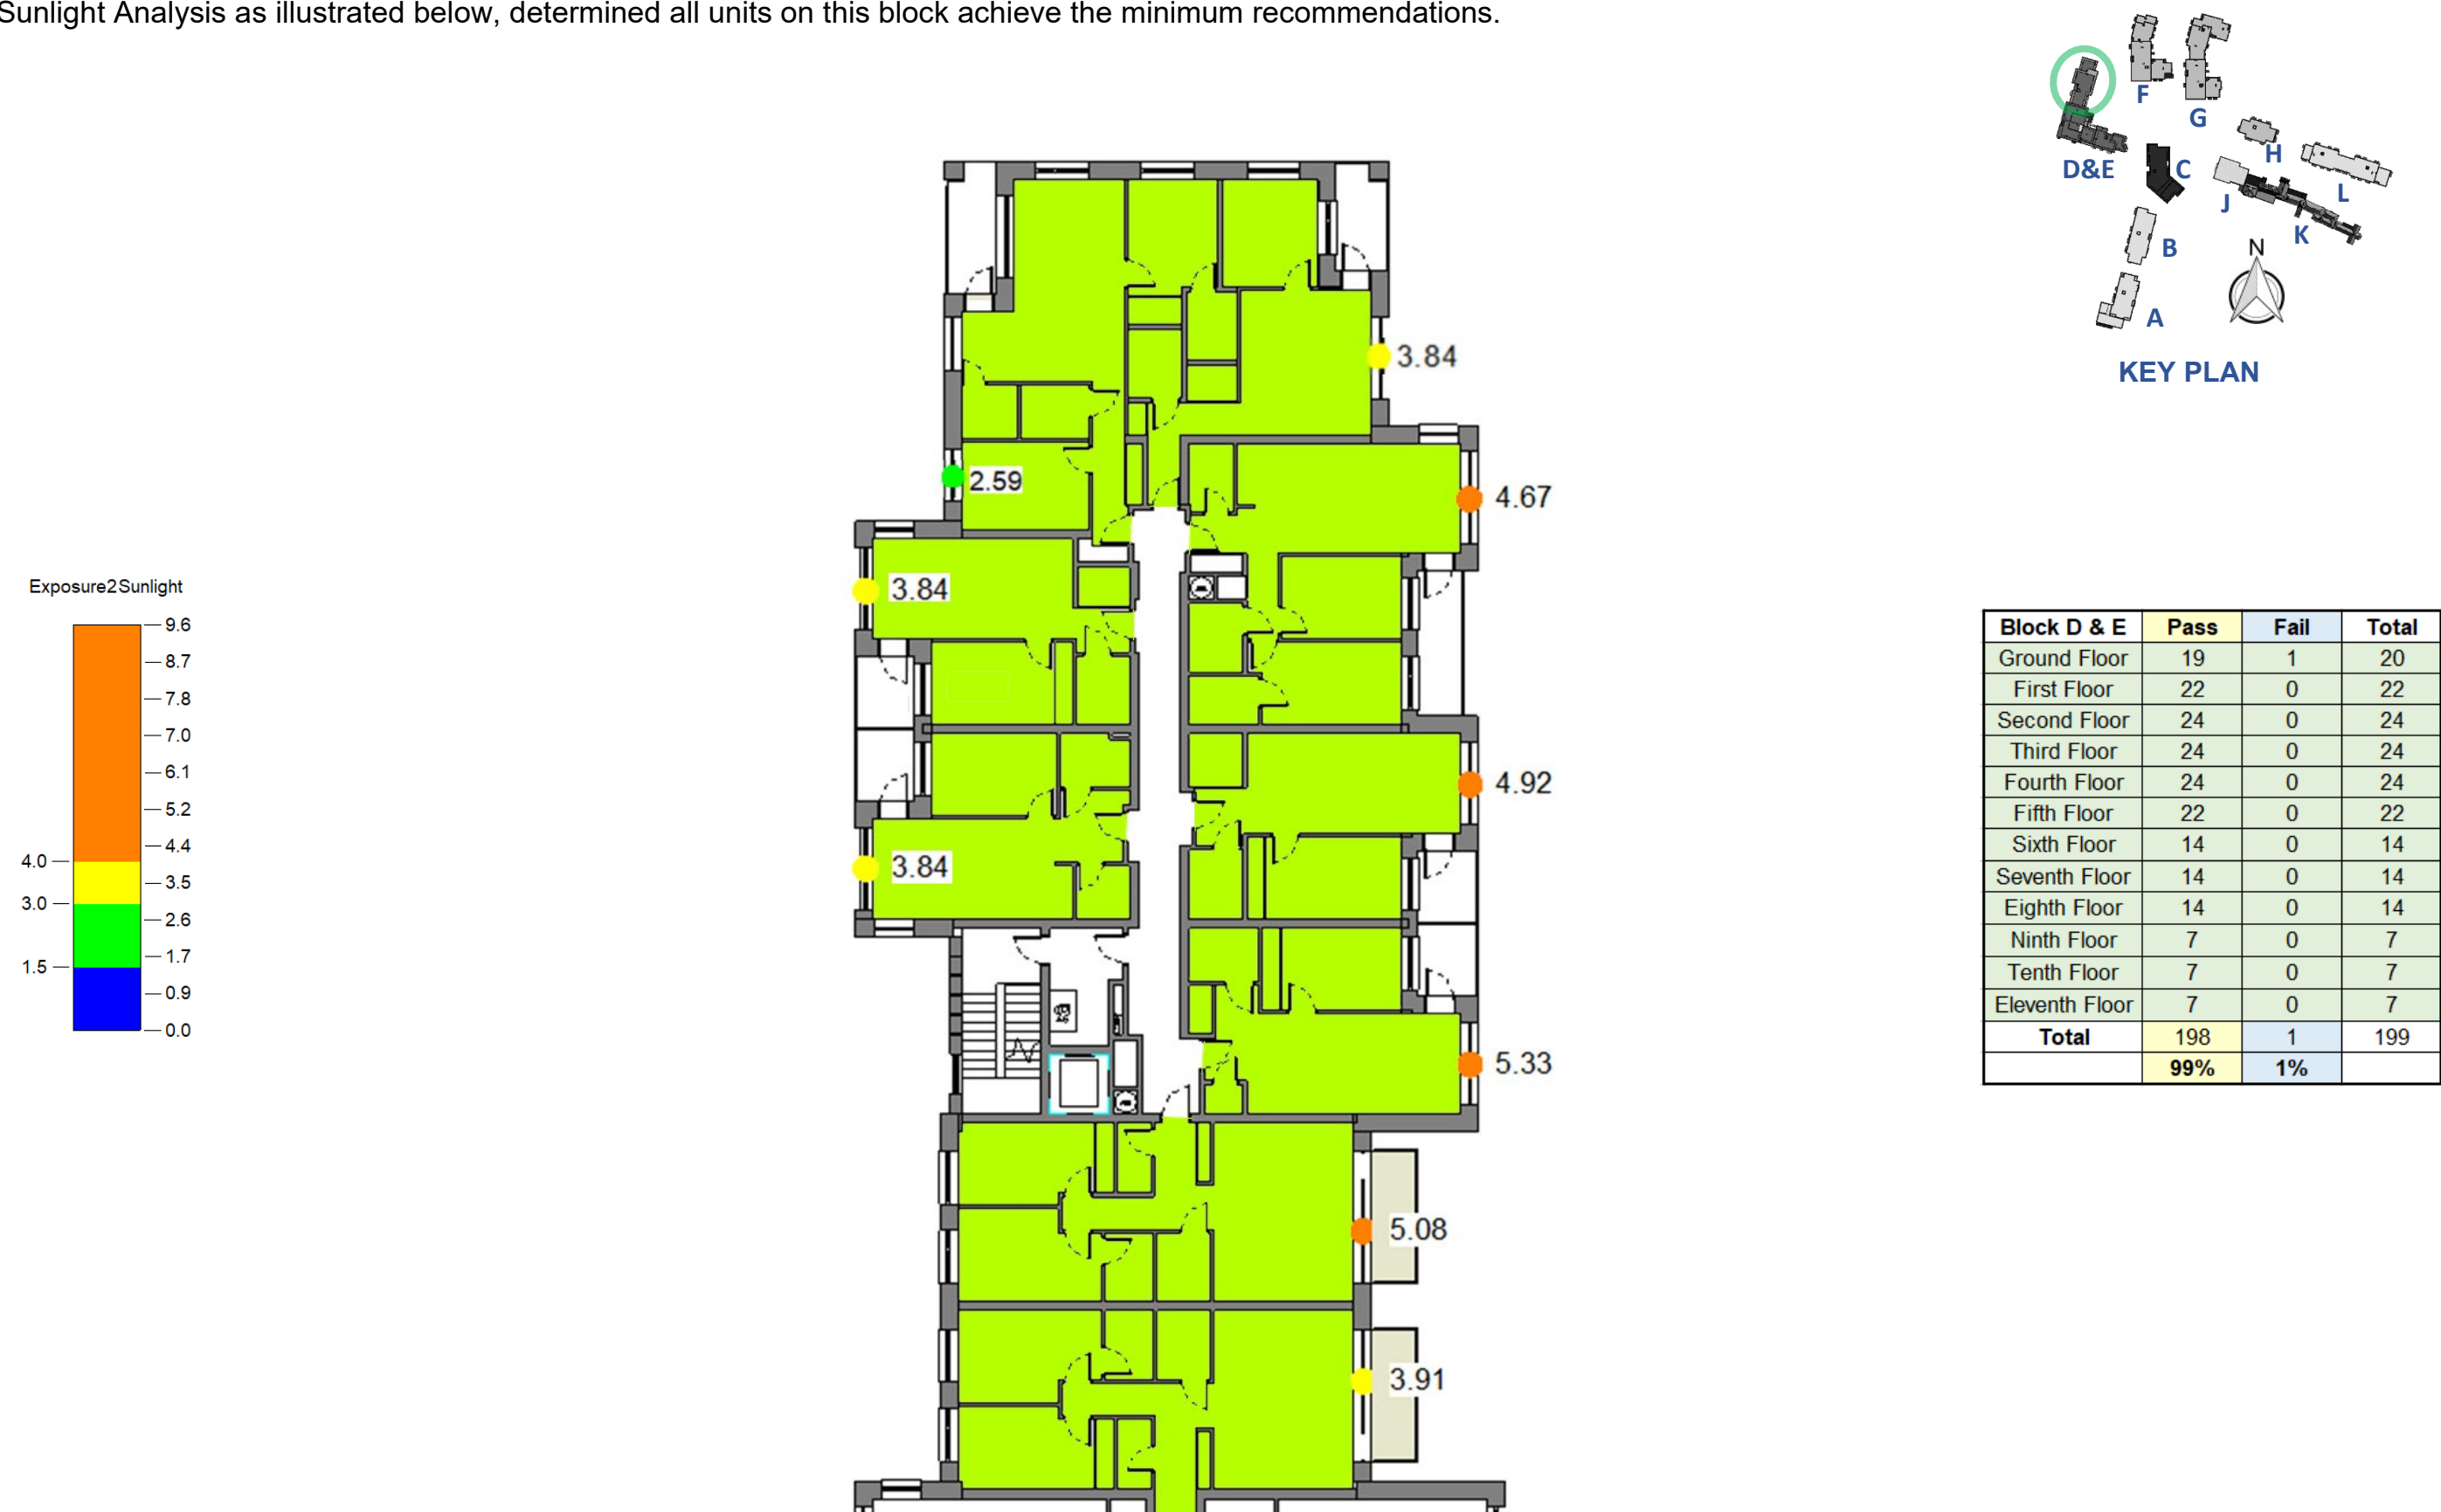
Block DE – Third Floor

Sunlight Analysis as illustrated below, determined all units on this block achieve the minimum recommendations.
