St. Vincent's Hospital Fairview Redevelopment, Fairview Dublin 3

Daylight and Sunlight Analysis

IN2 Project No. D2116

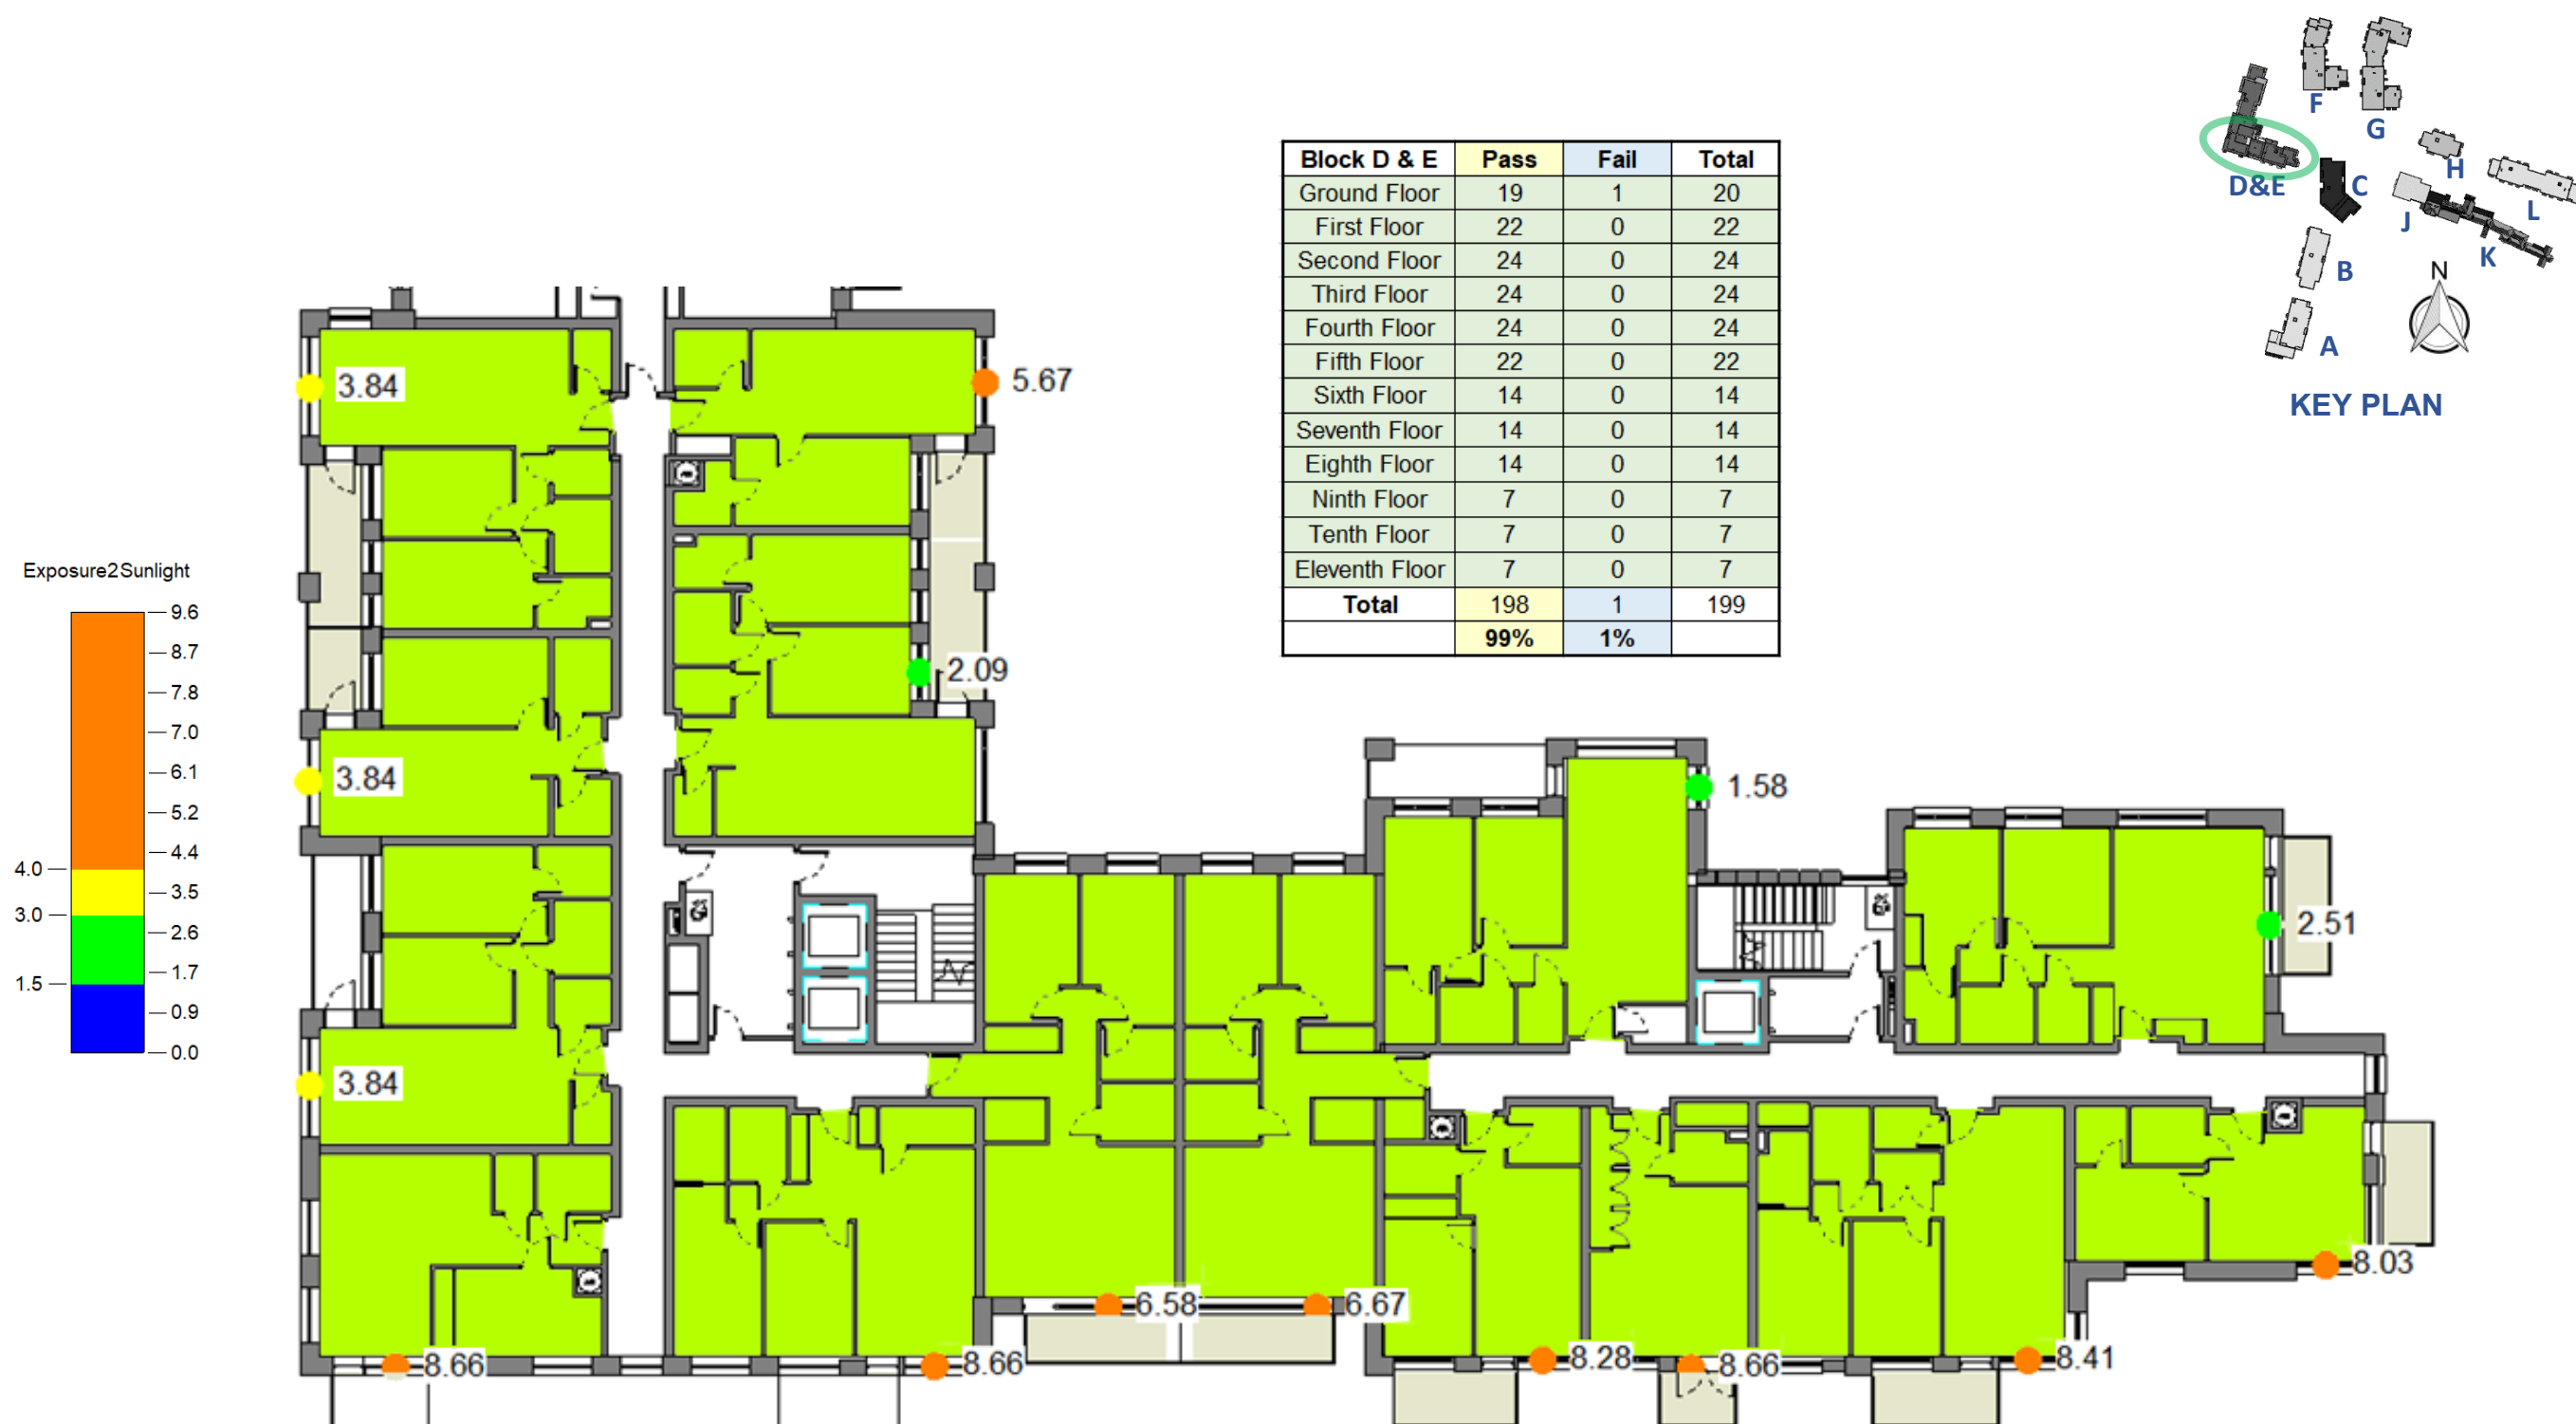
Block DE – Third Floor

Sunlight Analysis as illustrated below, determined all units on this block achieve the minimum recommendations.

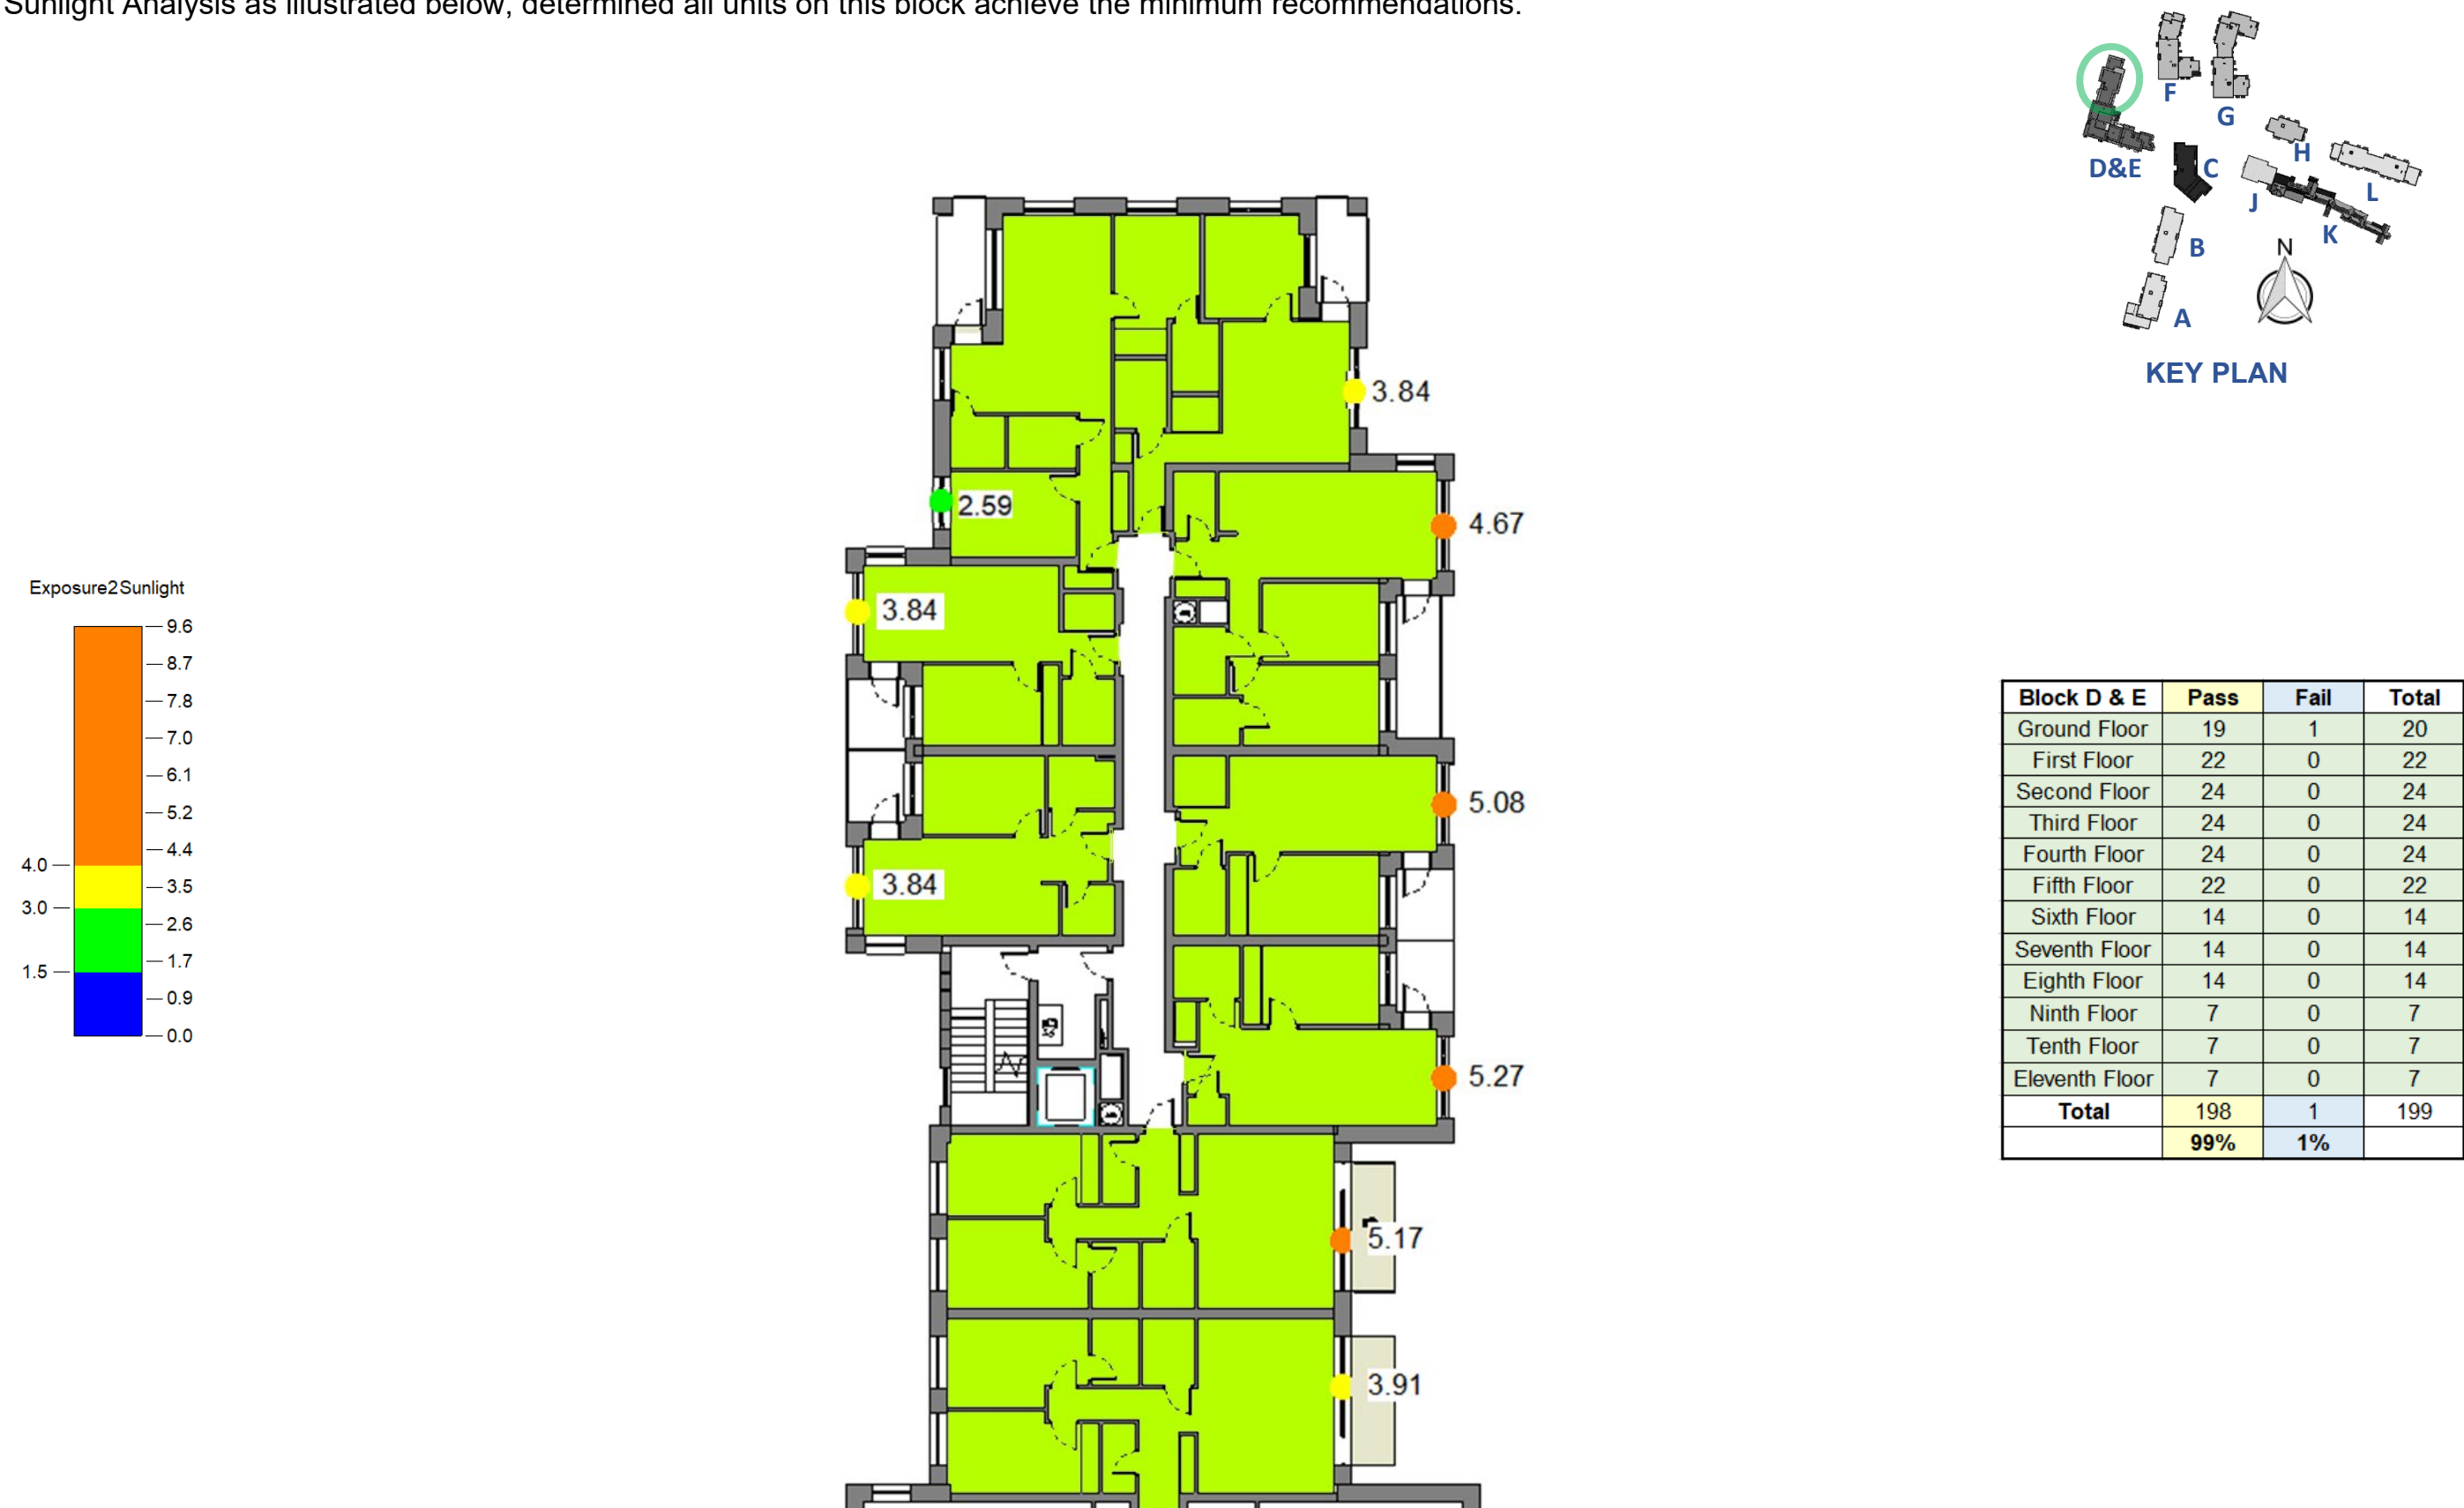
Block DE – Fourth Floor

Sunlight Analysis as illustrated below, determined all units on this block achieve the minimum recommendations.

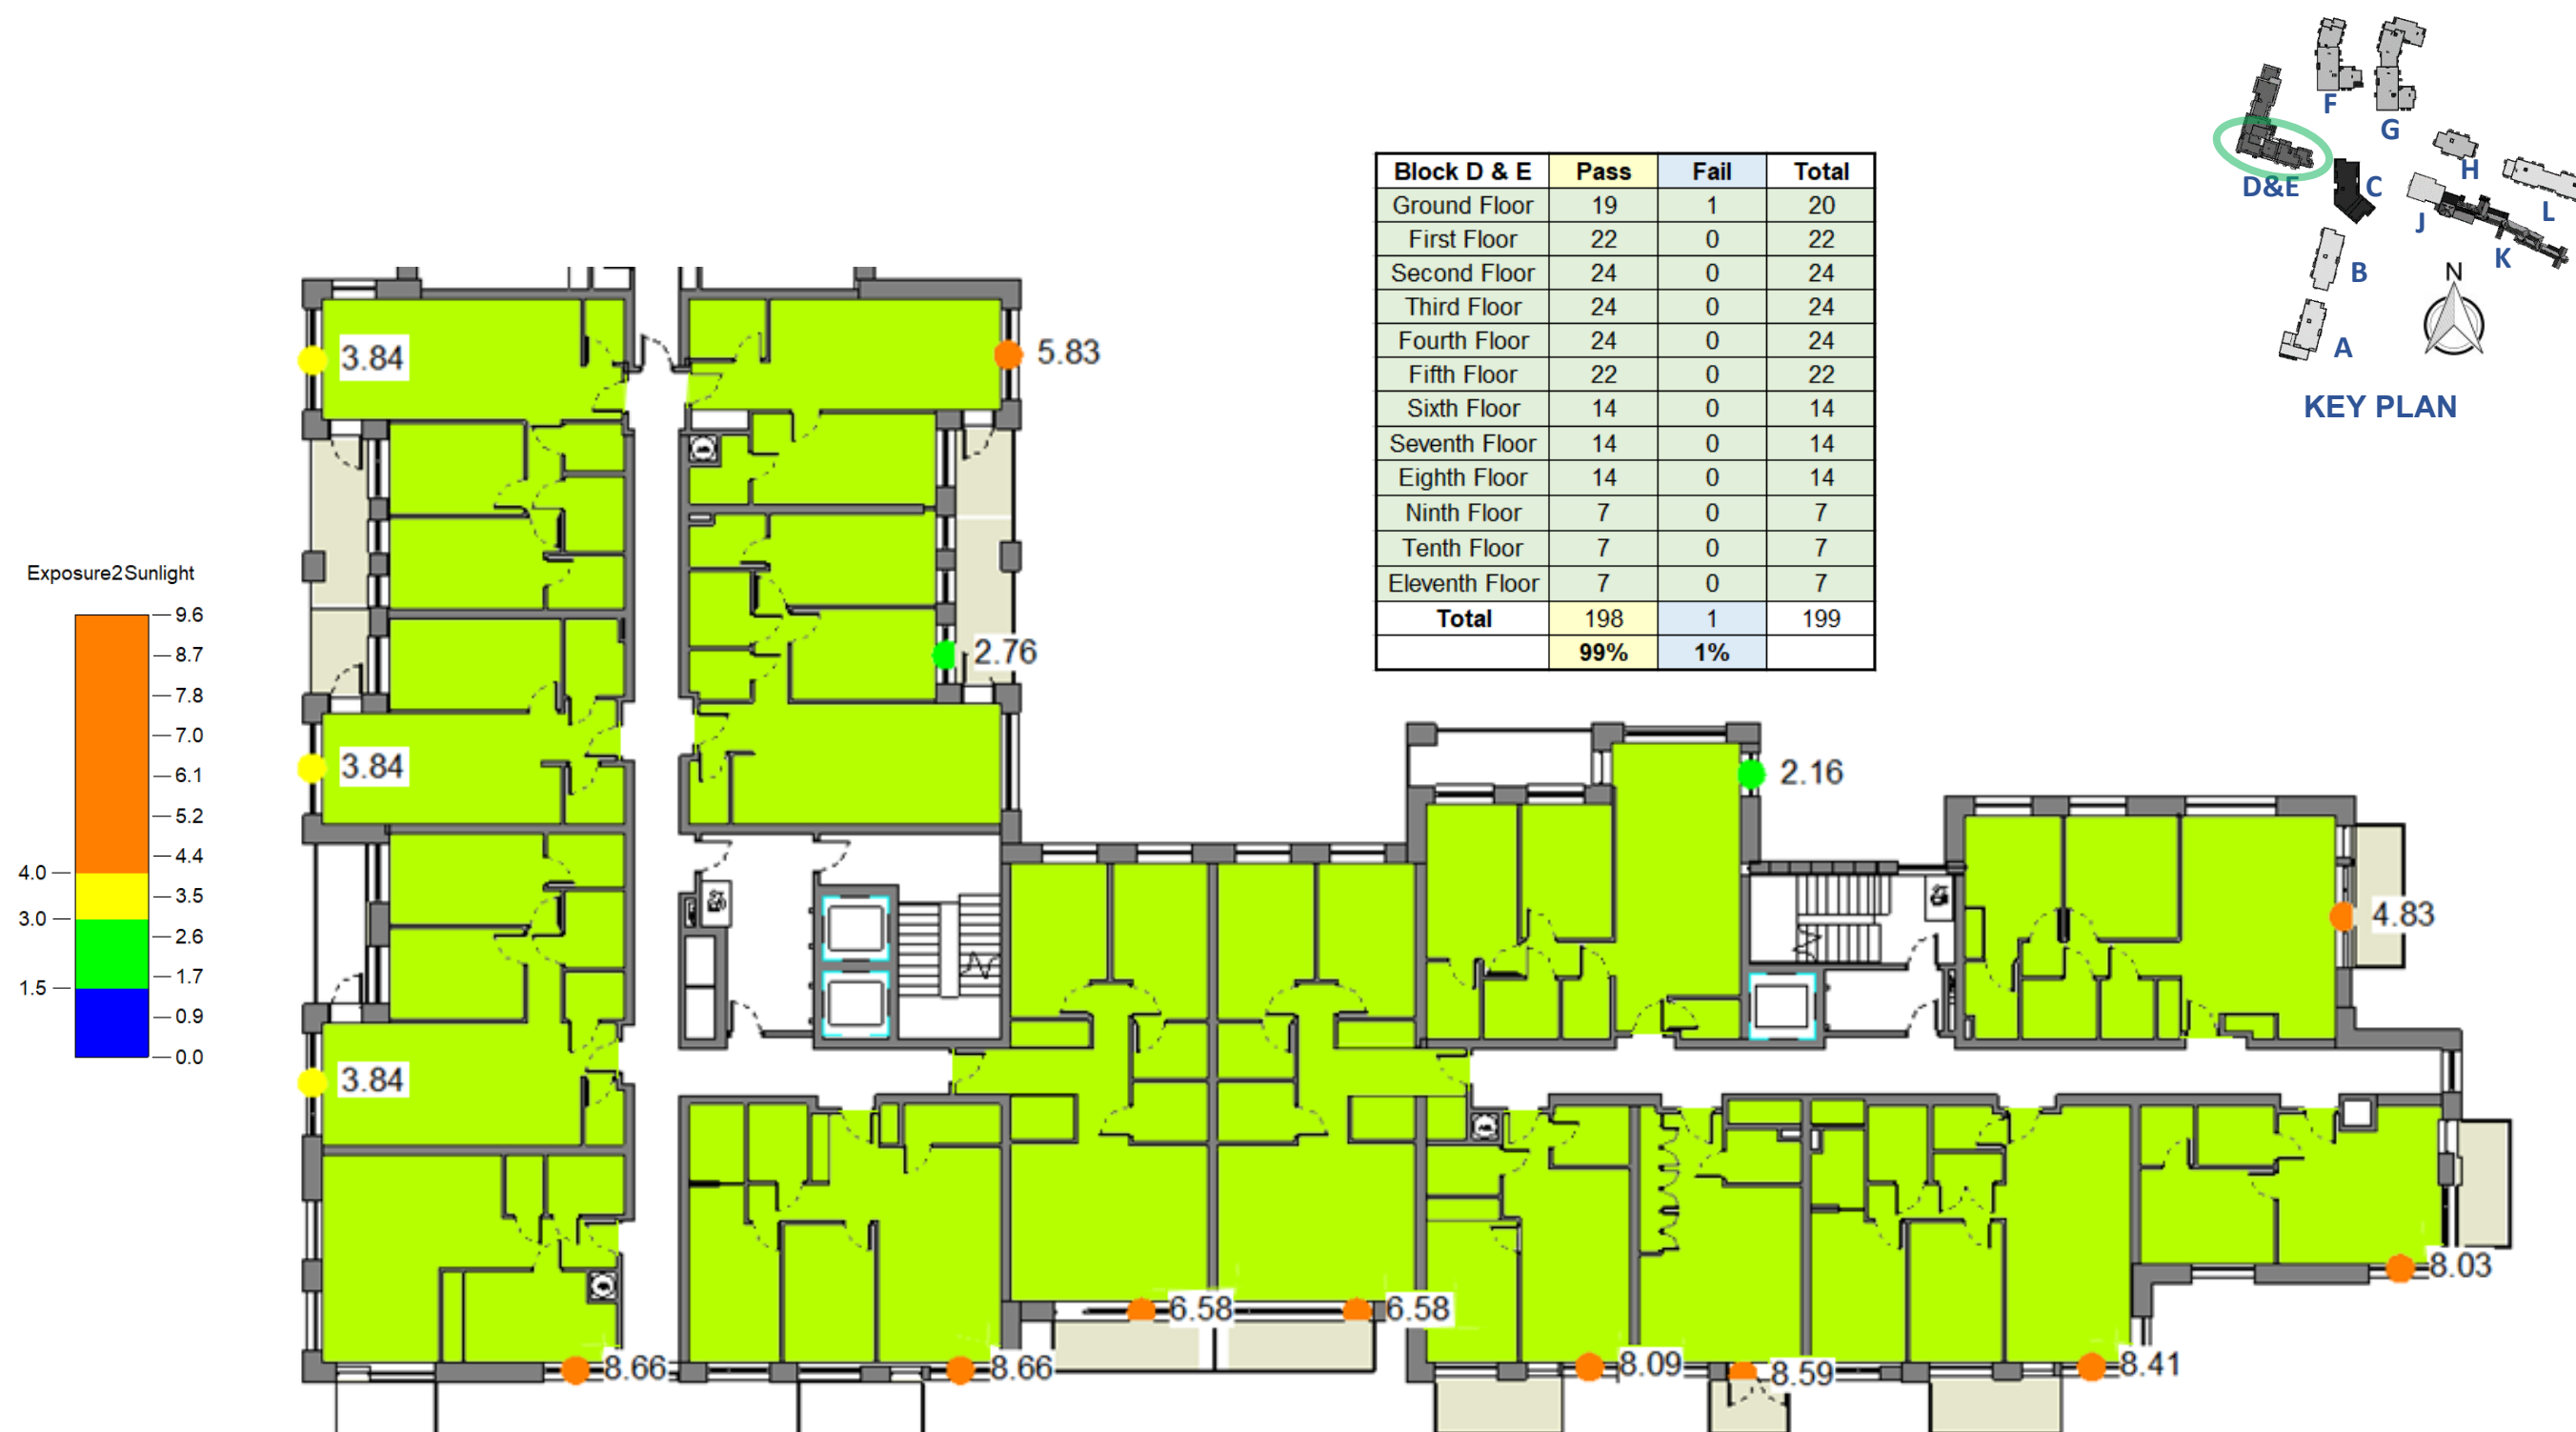
Block DE – Fourth Floor

Sunlight Analysis as illustrated below, determined all units on this block achieve the minimum recommendations.

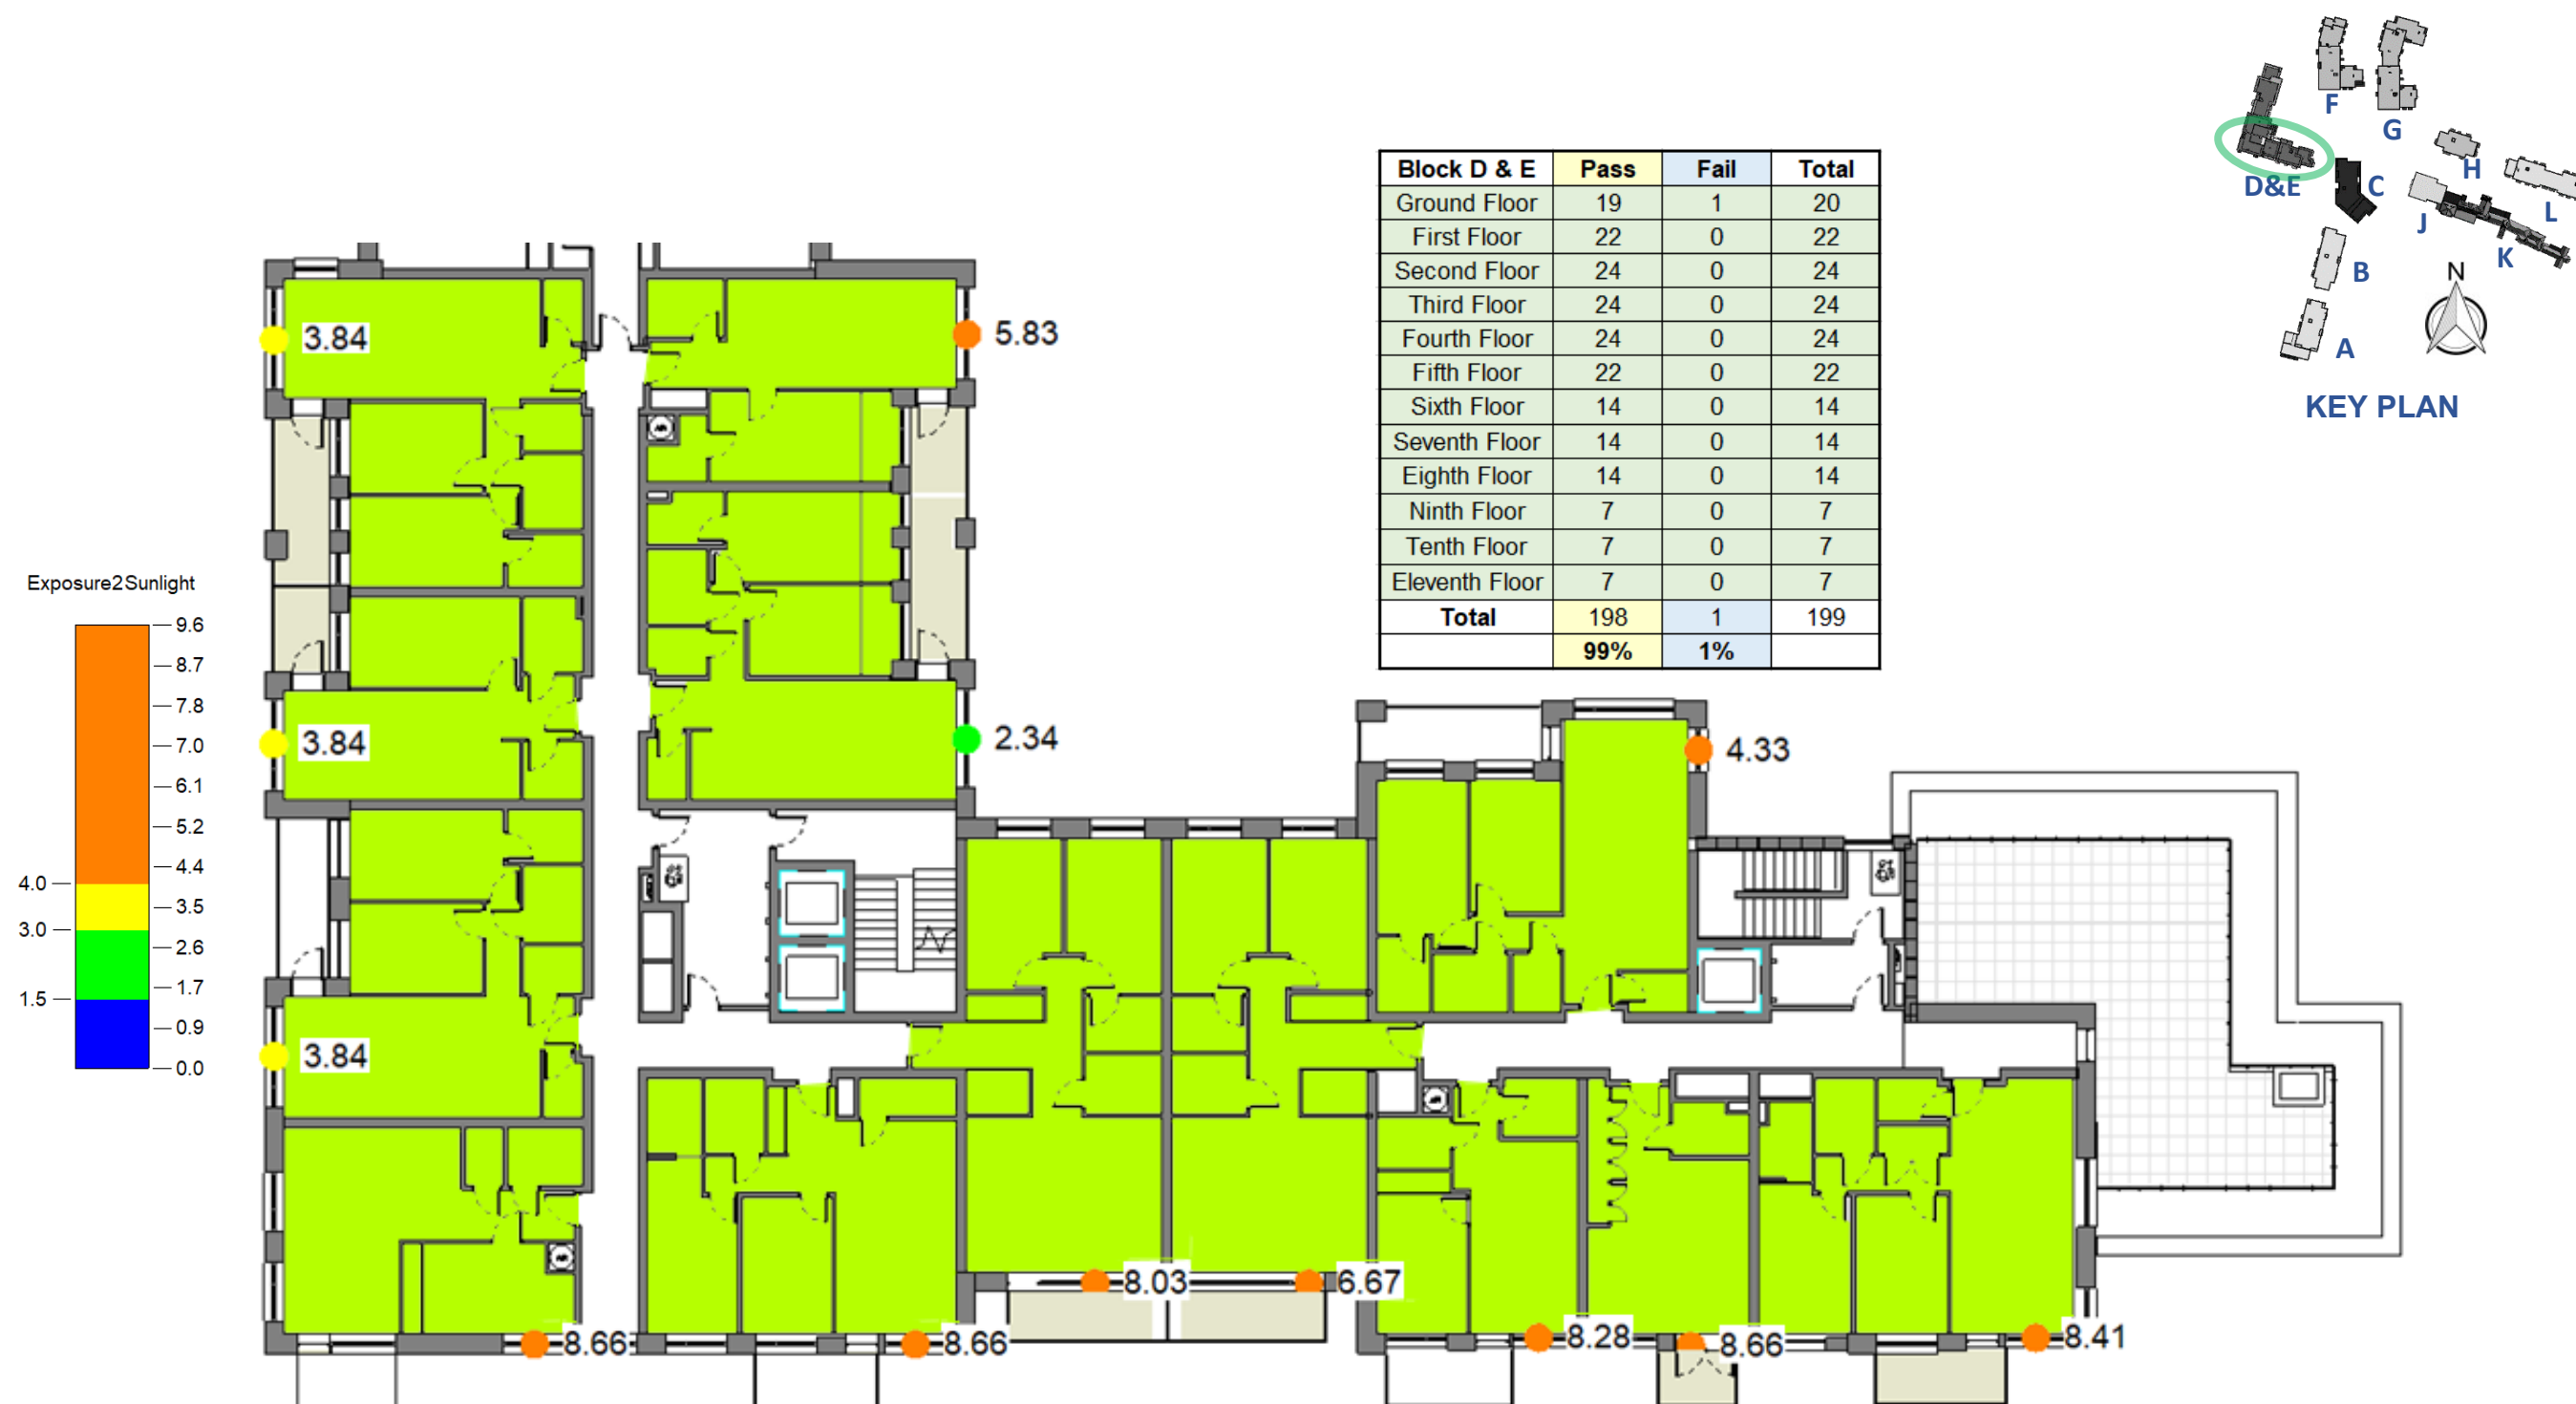
Block DE – Fifth Floor

Sunlight Analysis as illustrated below, determined all units on this block achieve the minimum recommendations.

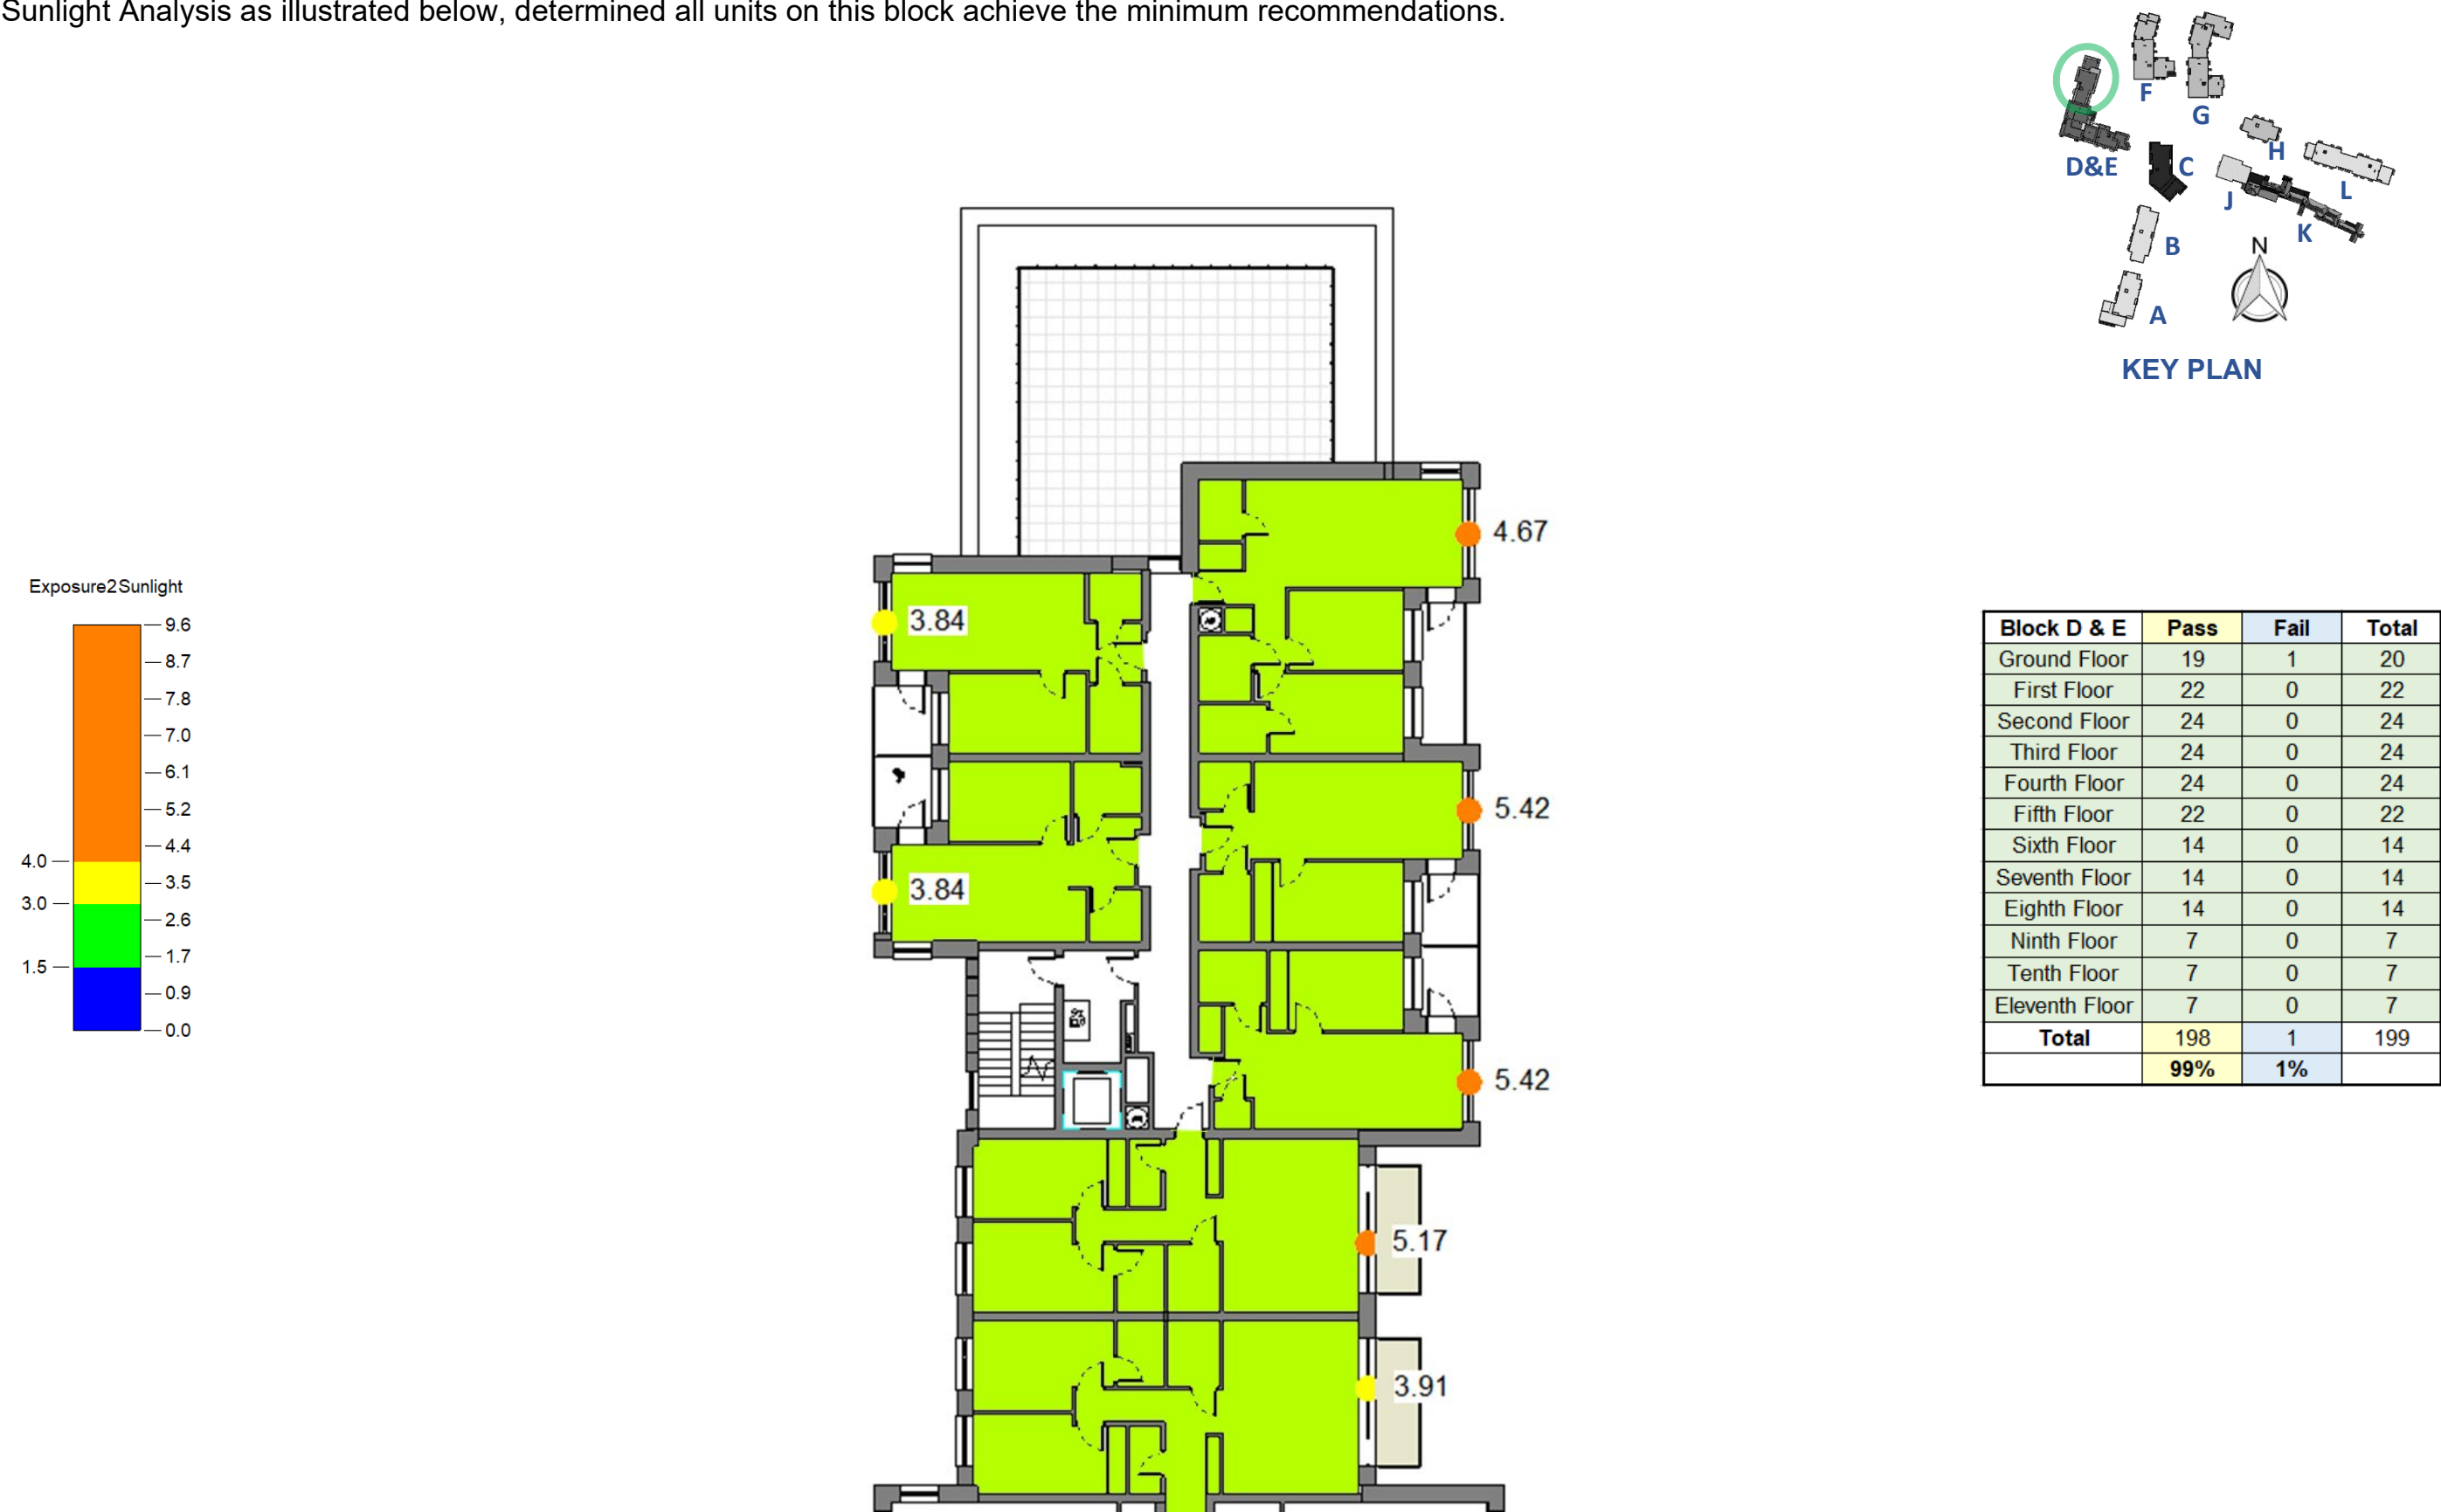
Block DE – Sixth Floor

Sunlight Analysis as illustrated below, determined all units on this block achieve the minimum recommendations.

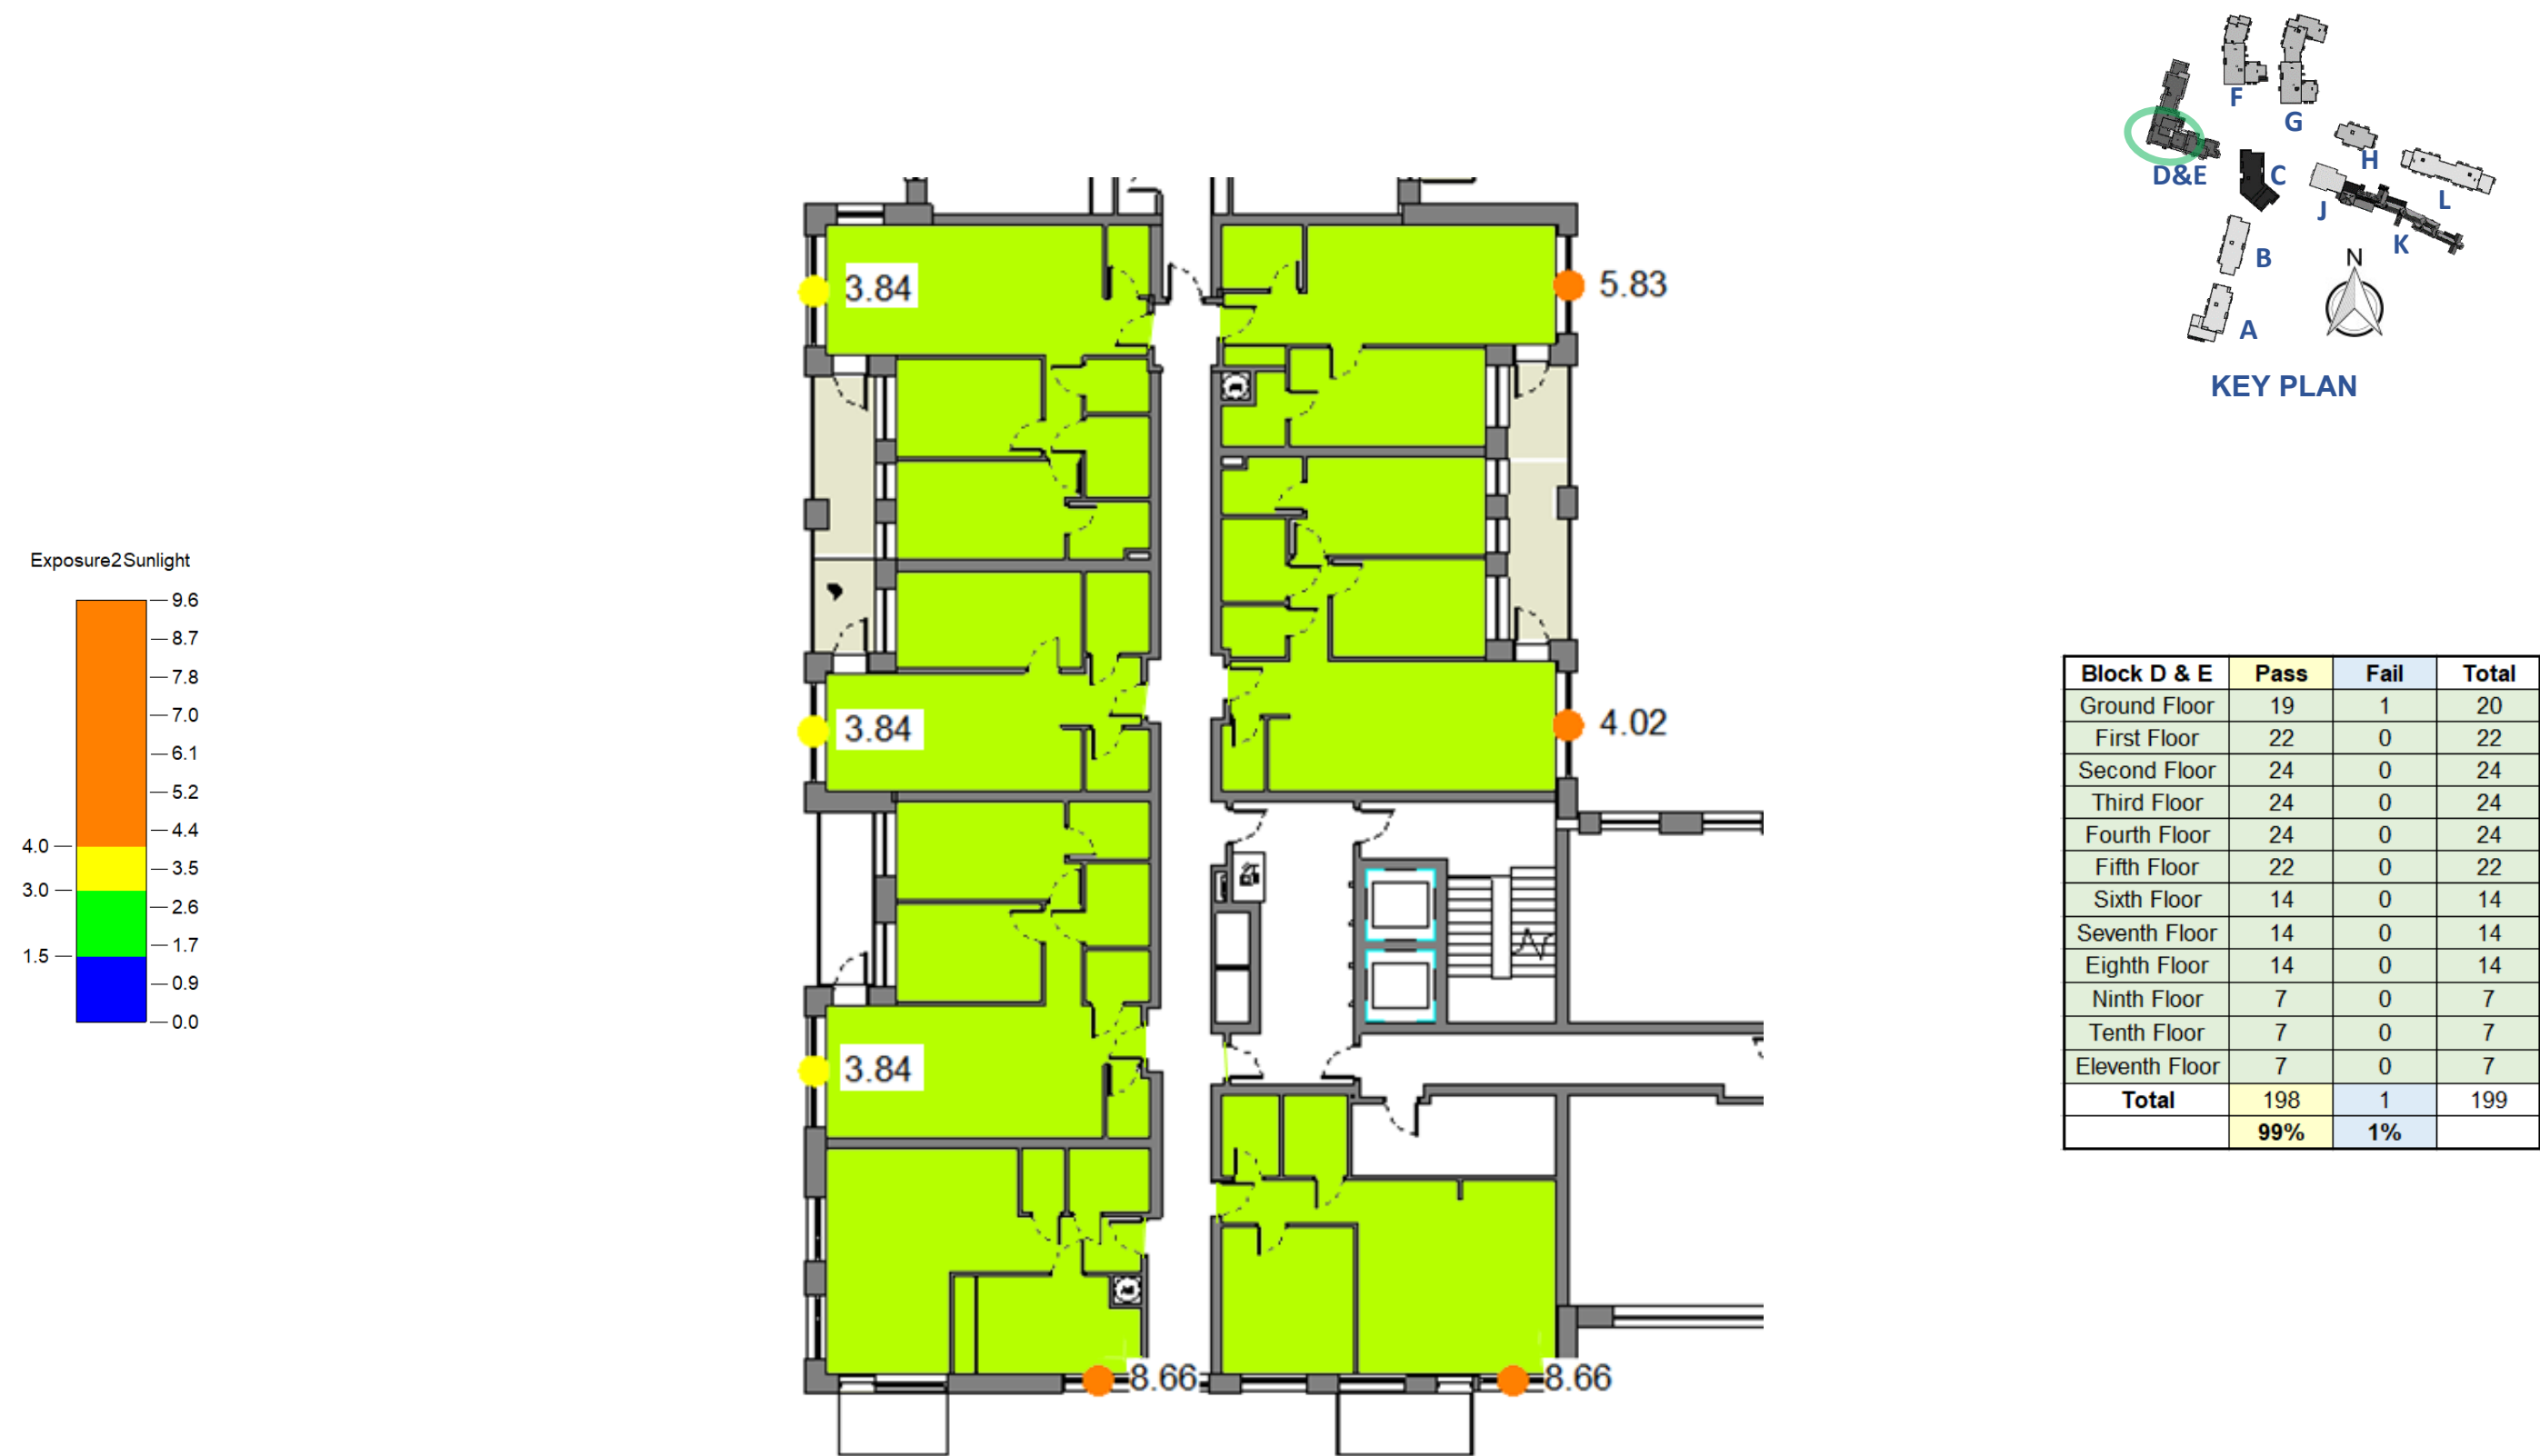
Block DE - Sixth Floor

Sunlight Analysis as illustrated below, determined all units on this block achieve the minimum recommendations.
