St. Vincent's Hospital Fairview Redevelopment, Fairview Dublin 3

Daylight and Sunlight Analysis

IN2 Project No. D2116

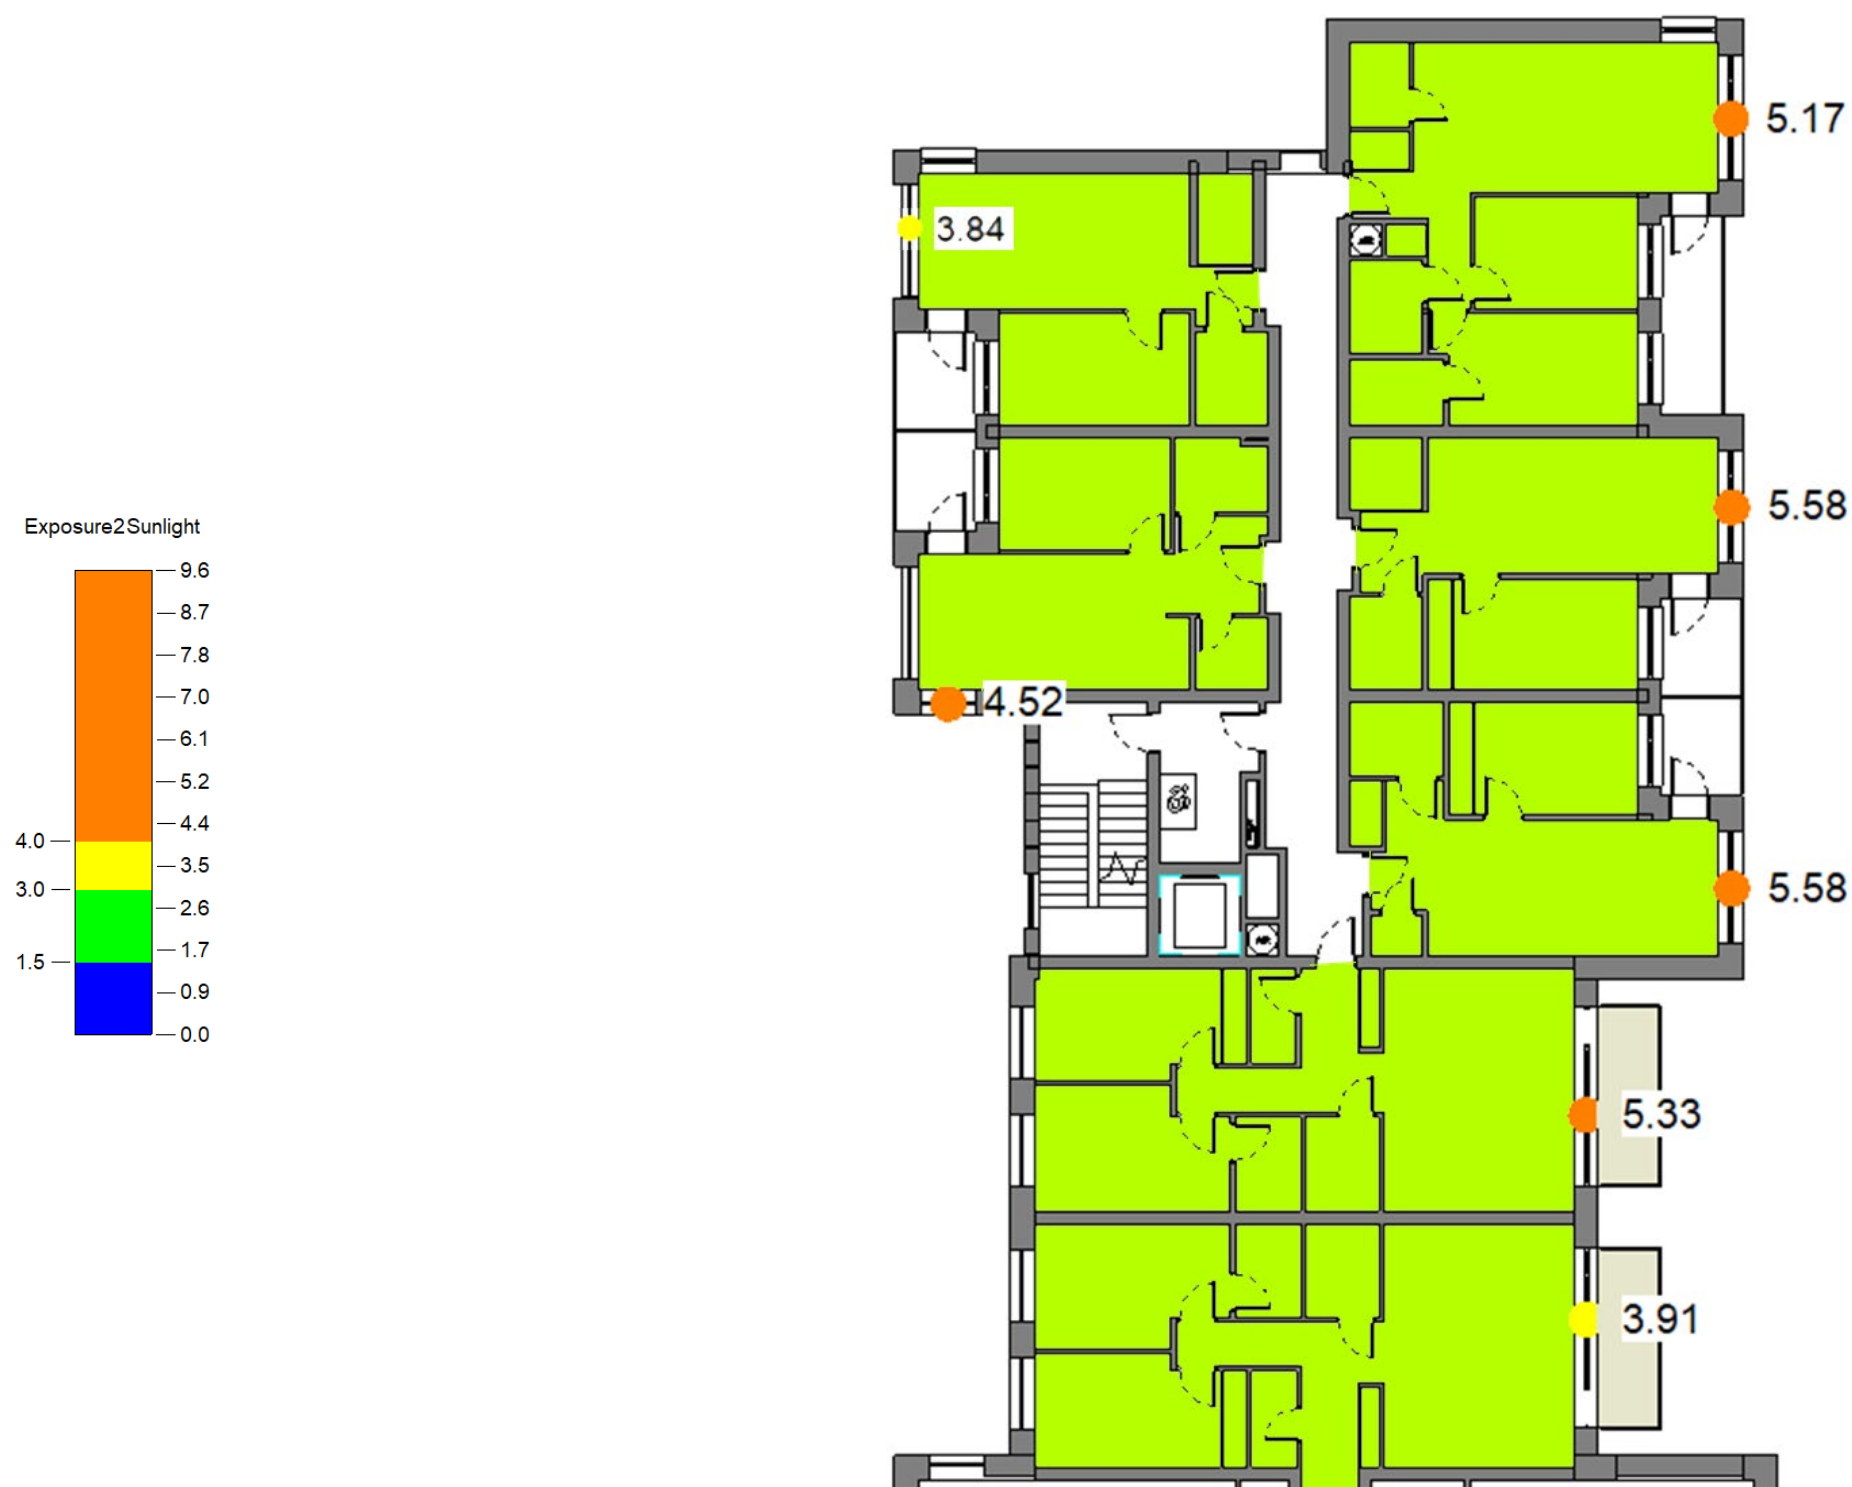
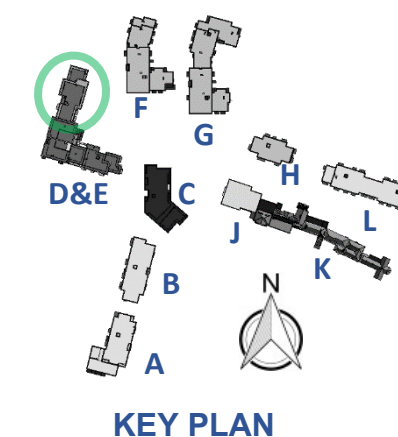
Block DE – Seventh Floor

Sunlight Analysis as illustrated below, determined all units on this block achieve the minimum recommendations.

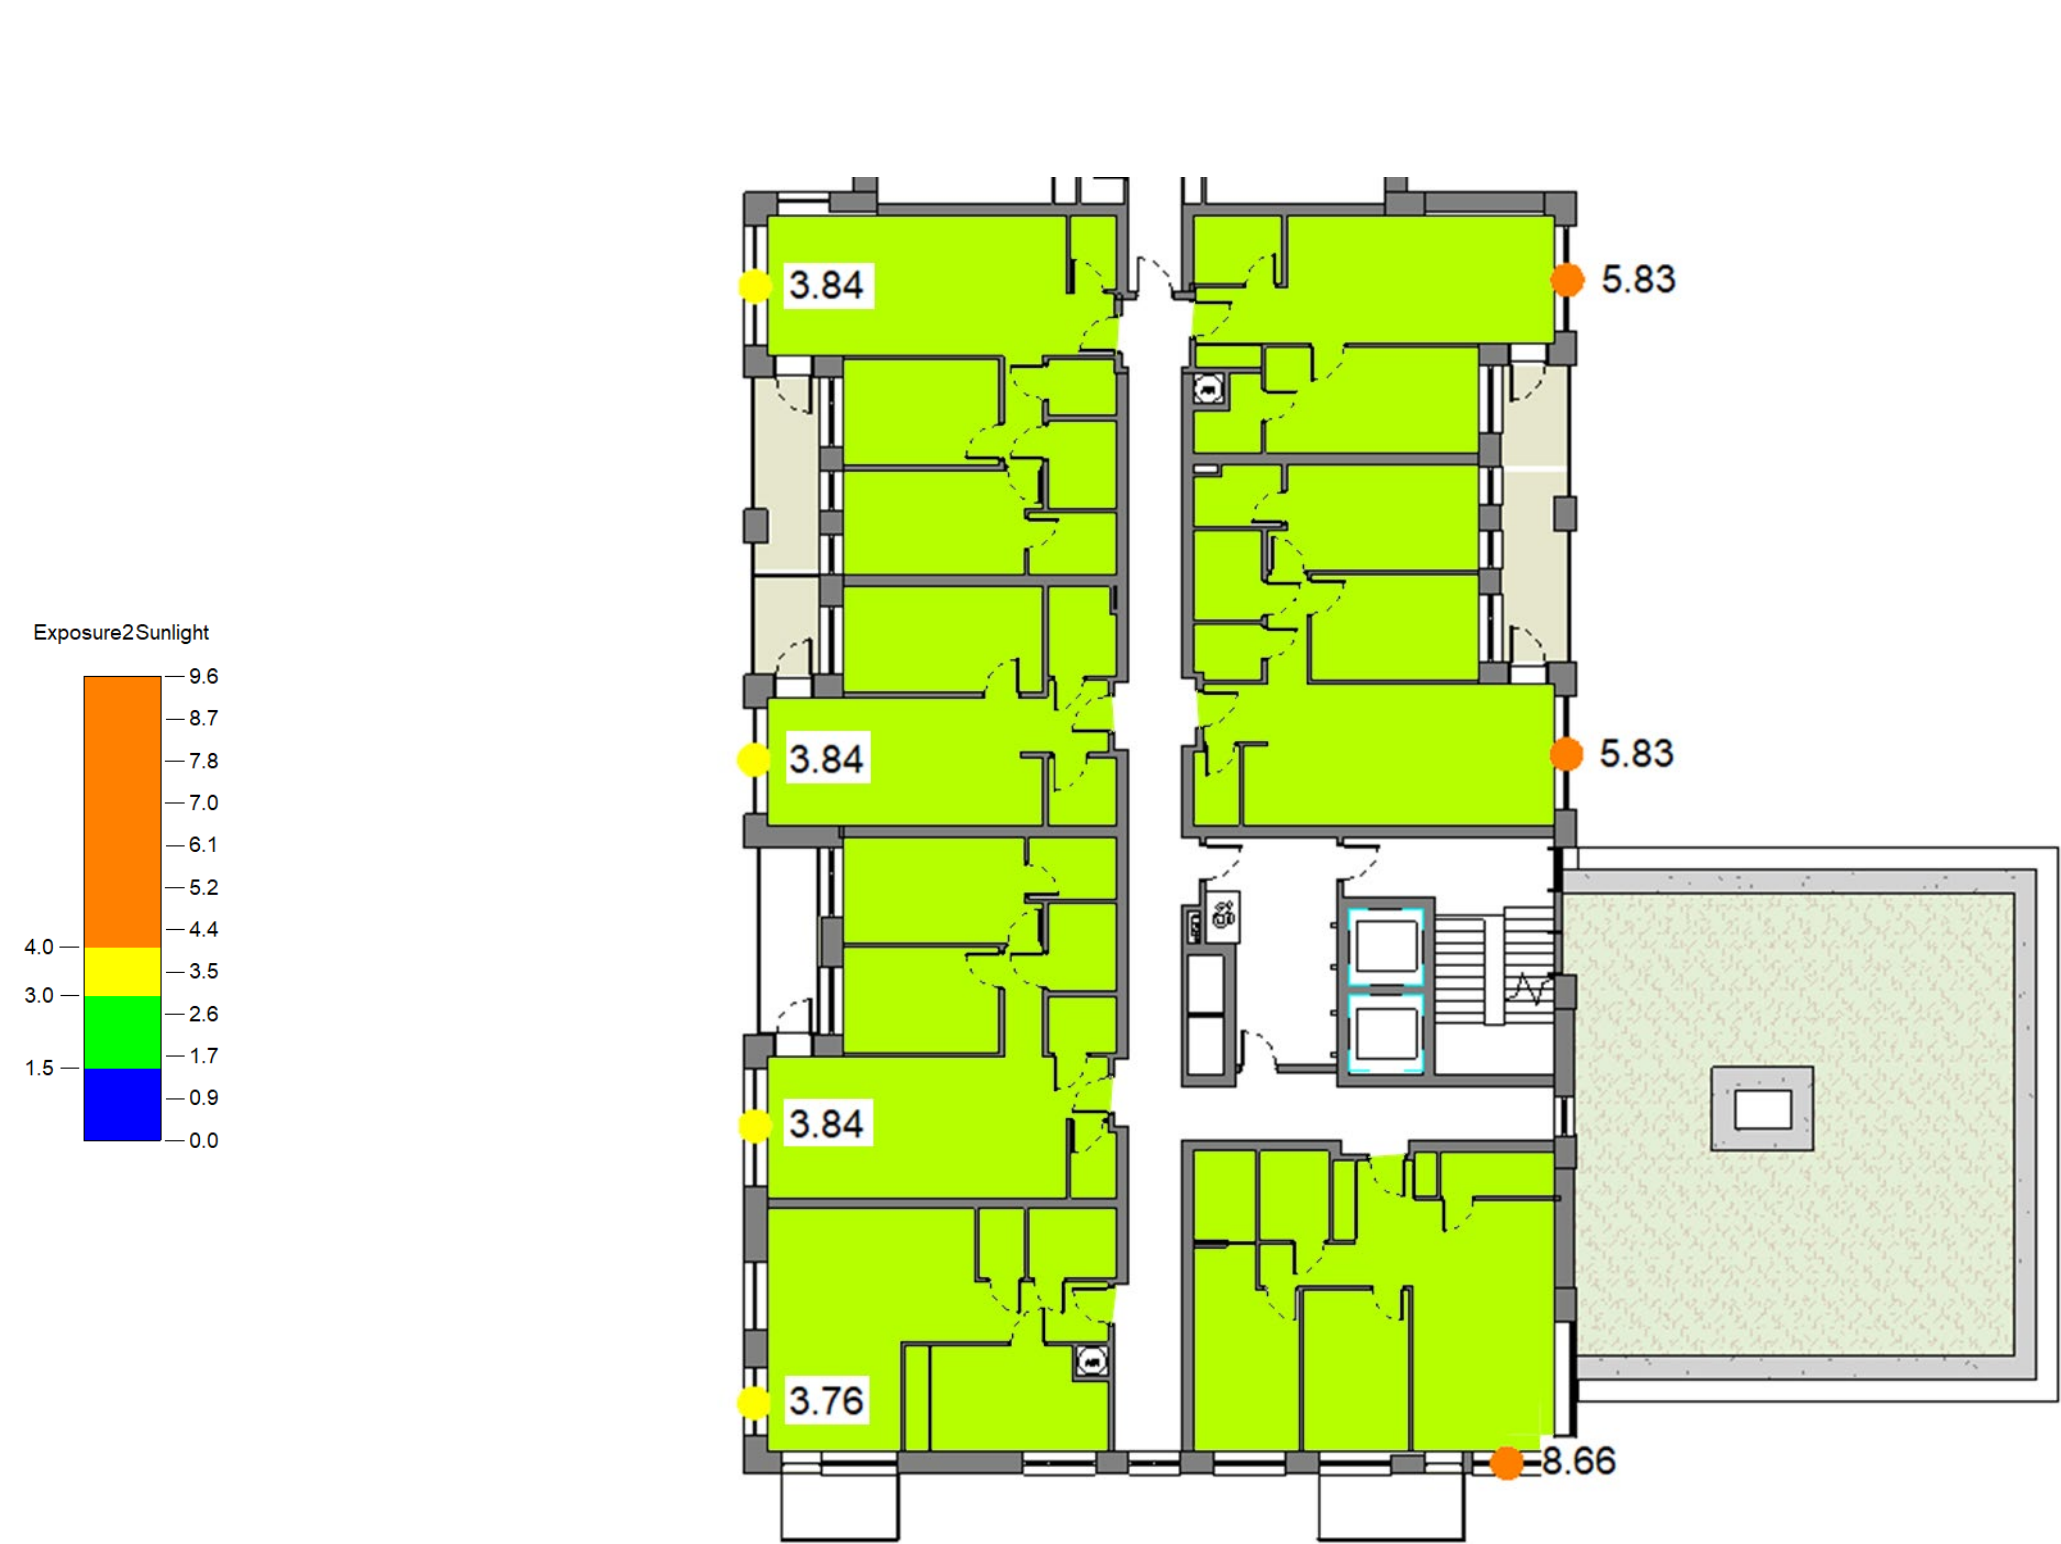
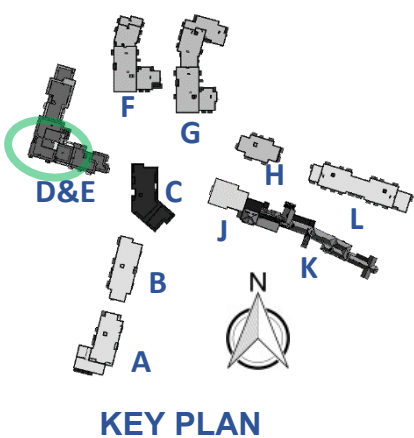
Block DE – Seventh Floor

Sunlight Analysis as illustrated below, determined all units on this block achieve the minimum recommendations.

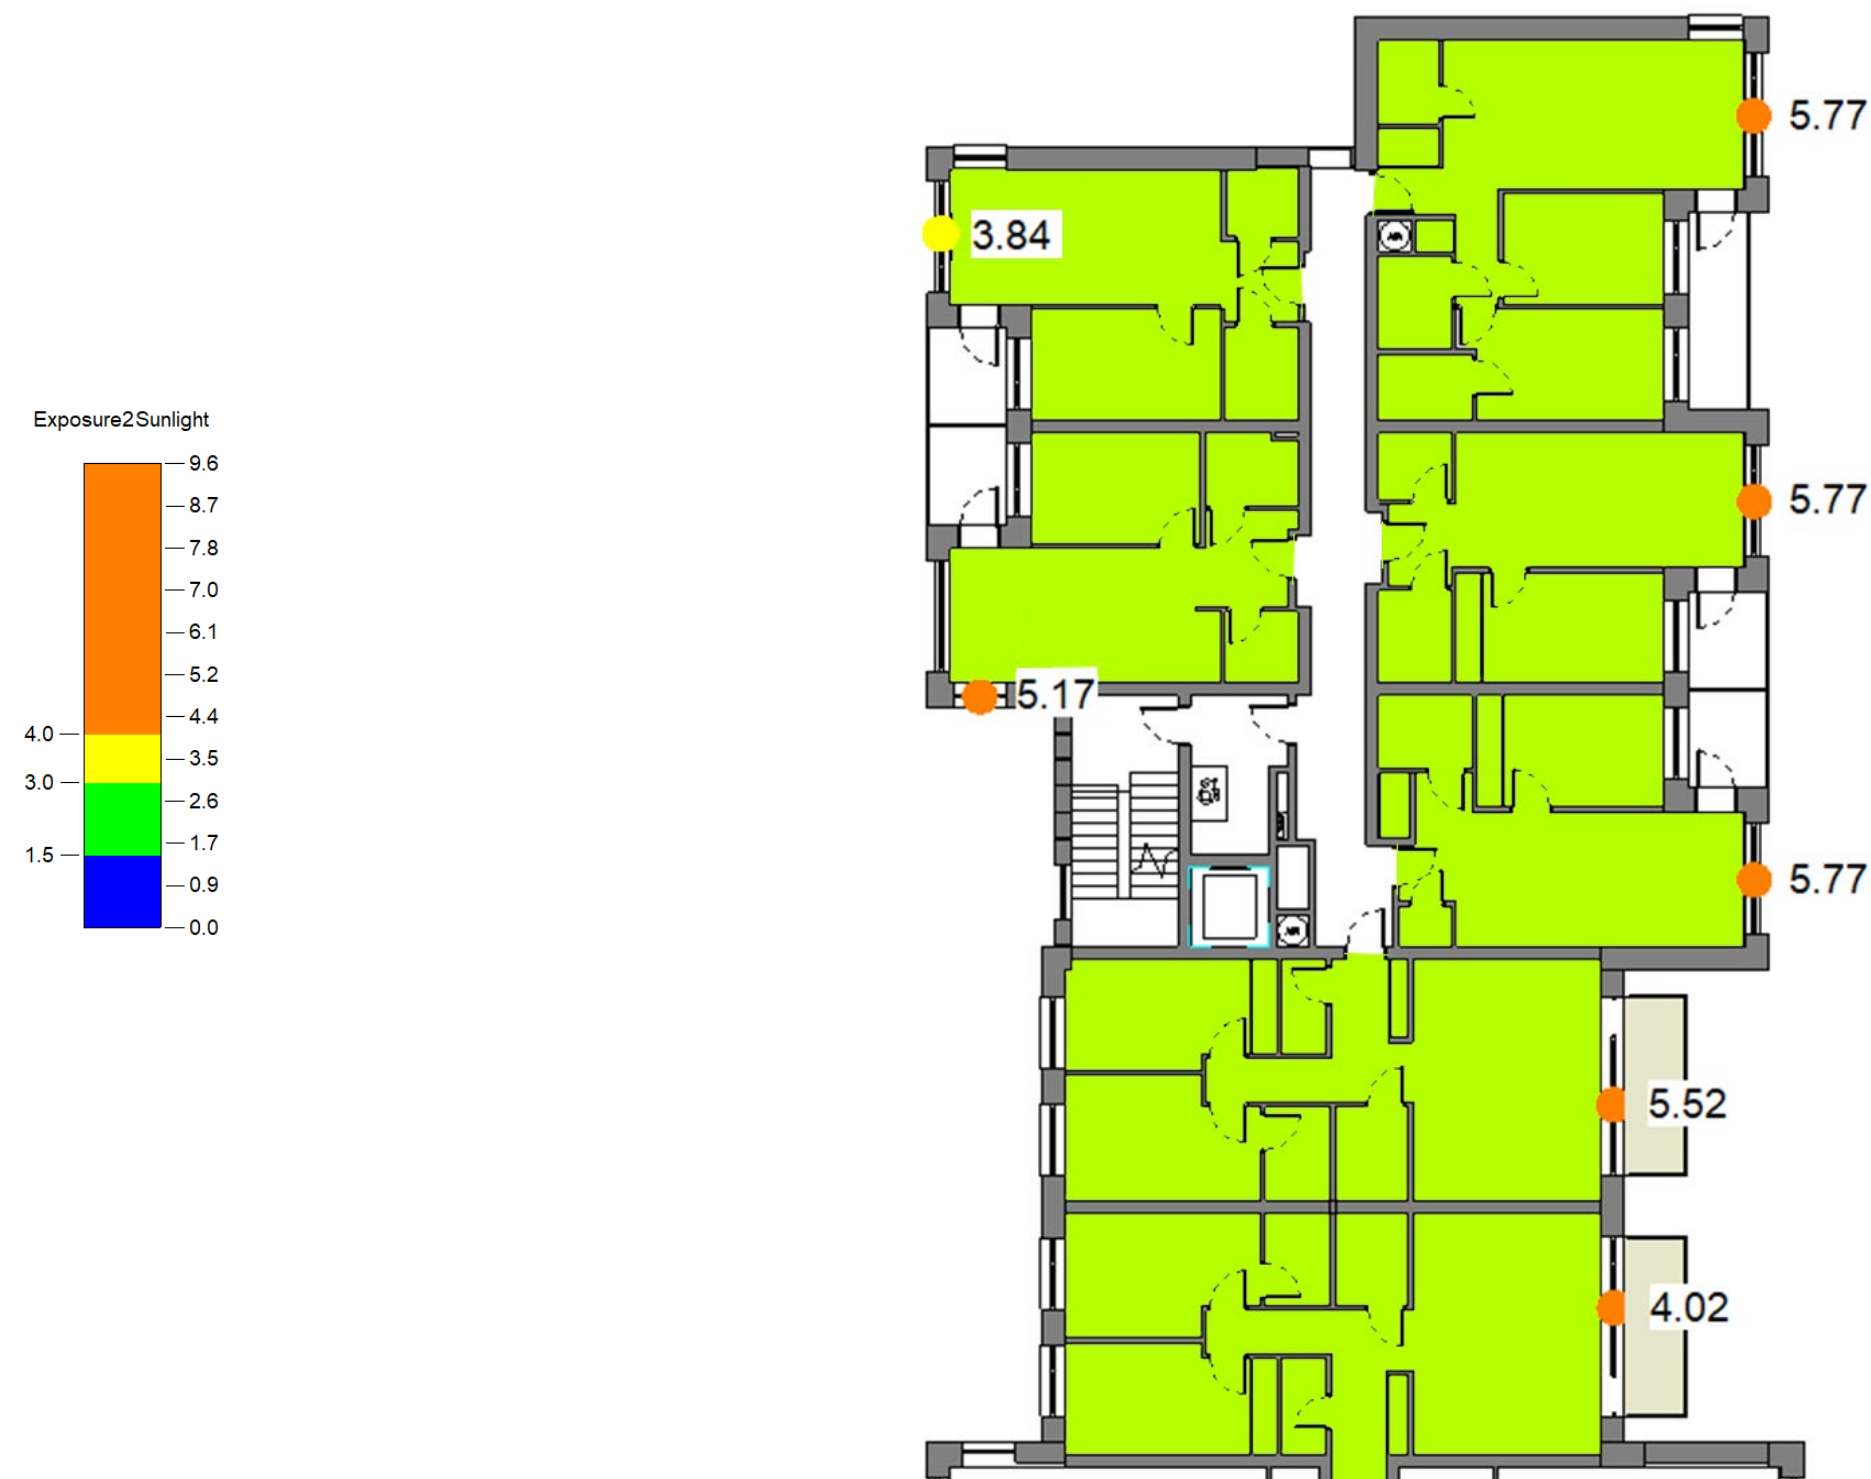
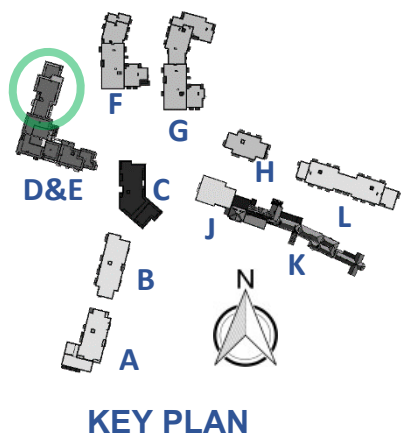
Block DE – Eighth Floor

Sunlight Analysis as illustrated below, determined all units on this block achieve the minimum recommendations.

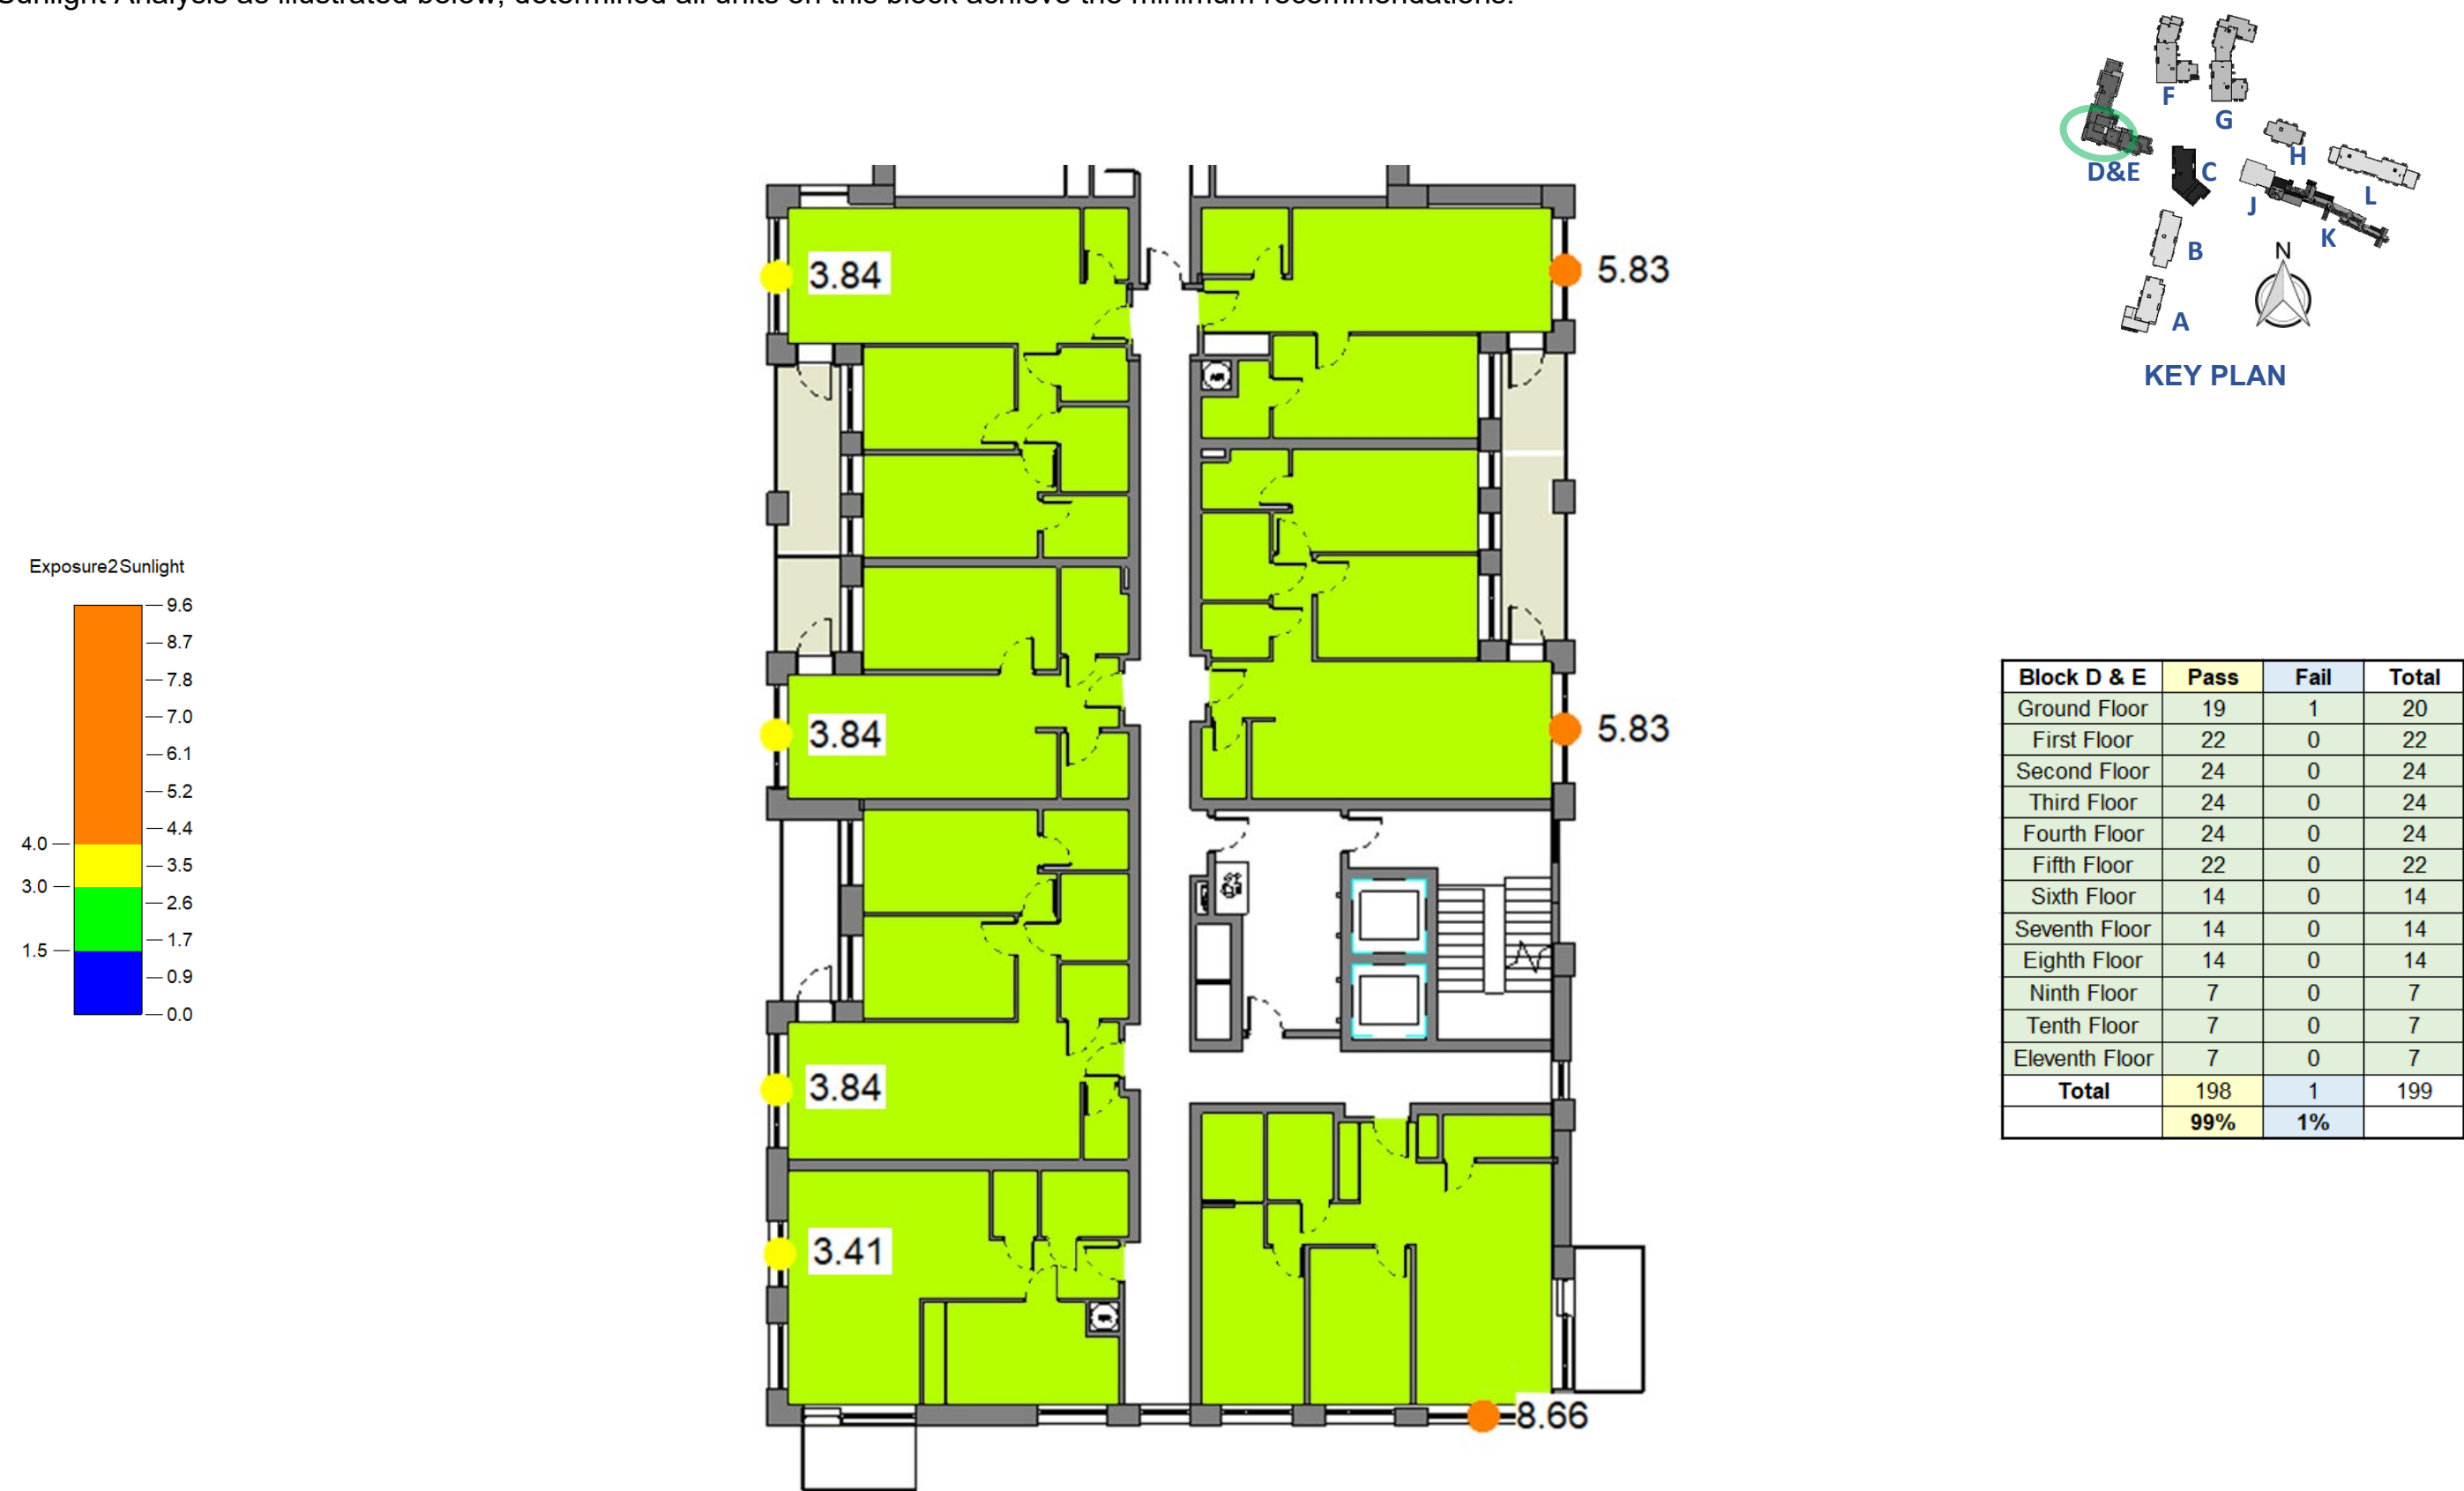
Block DE – Eighth Floor

Sunlight Analysis as illustrated below, determined all units on this block achieve the minimum recommendations.

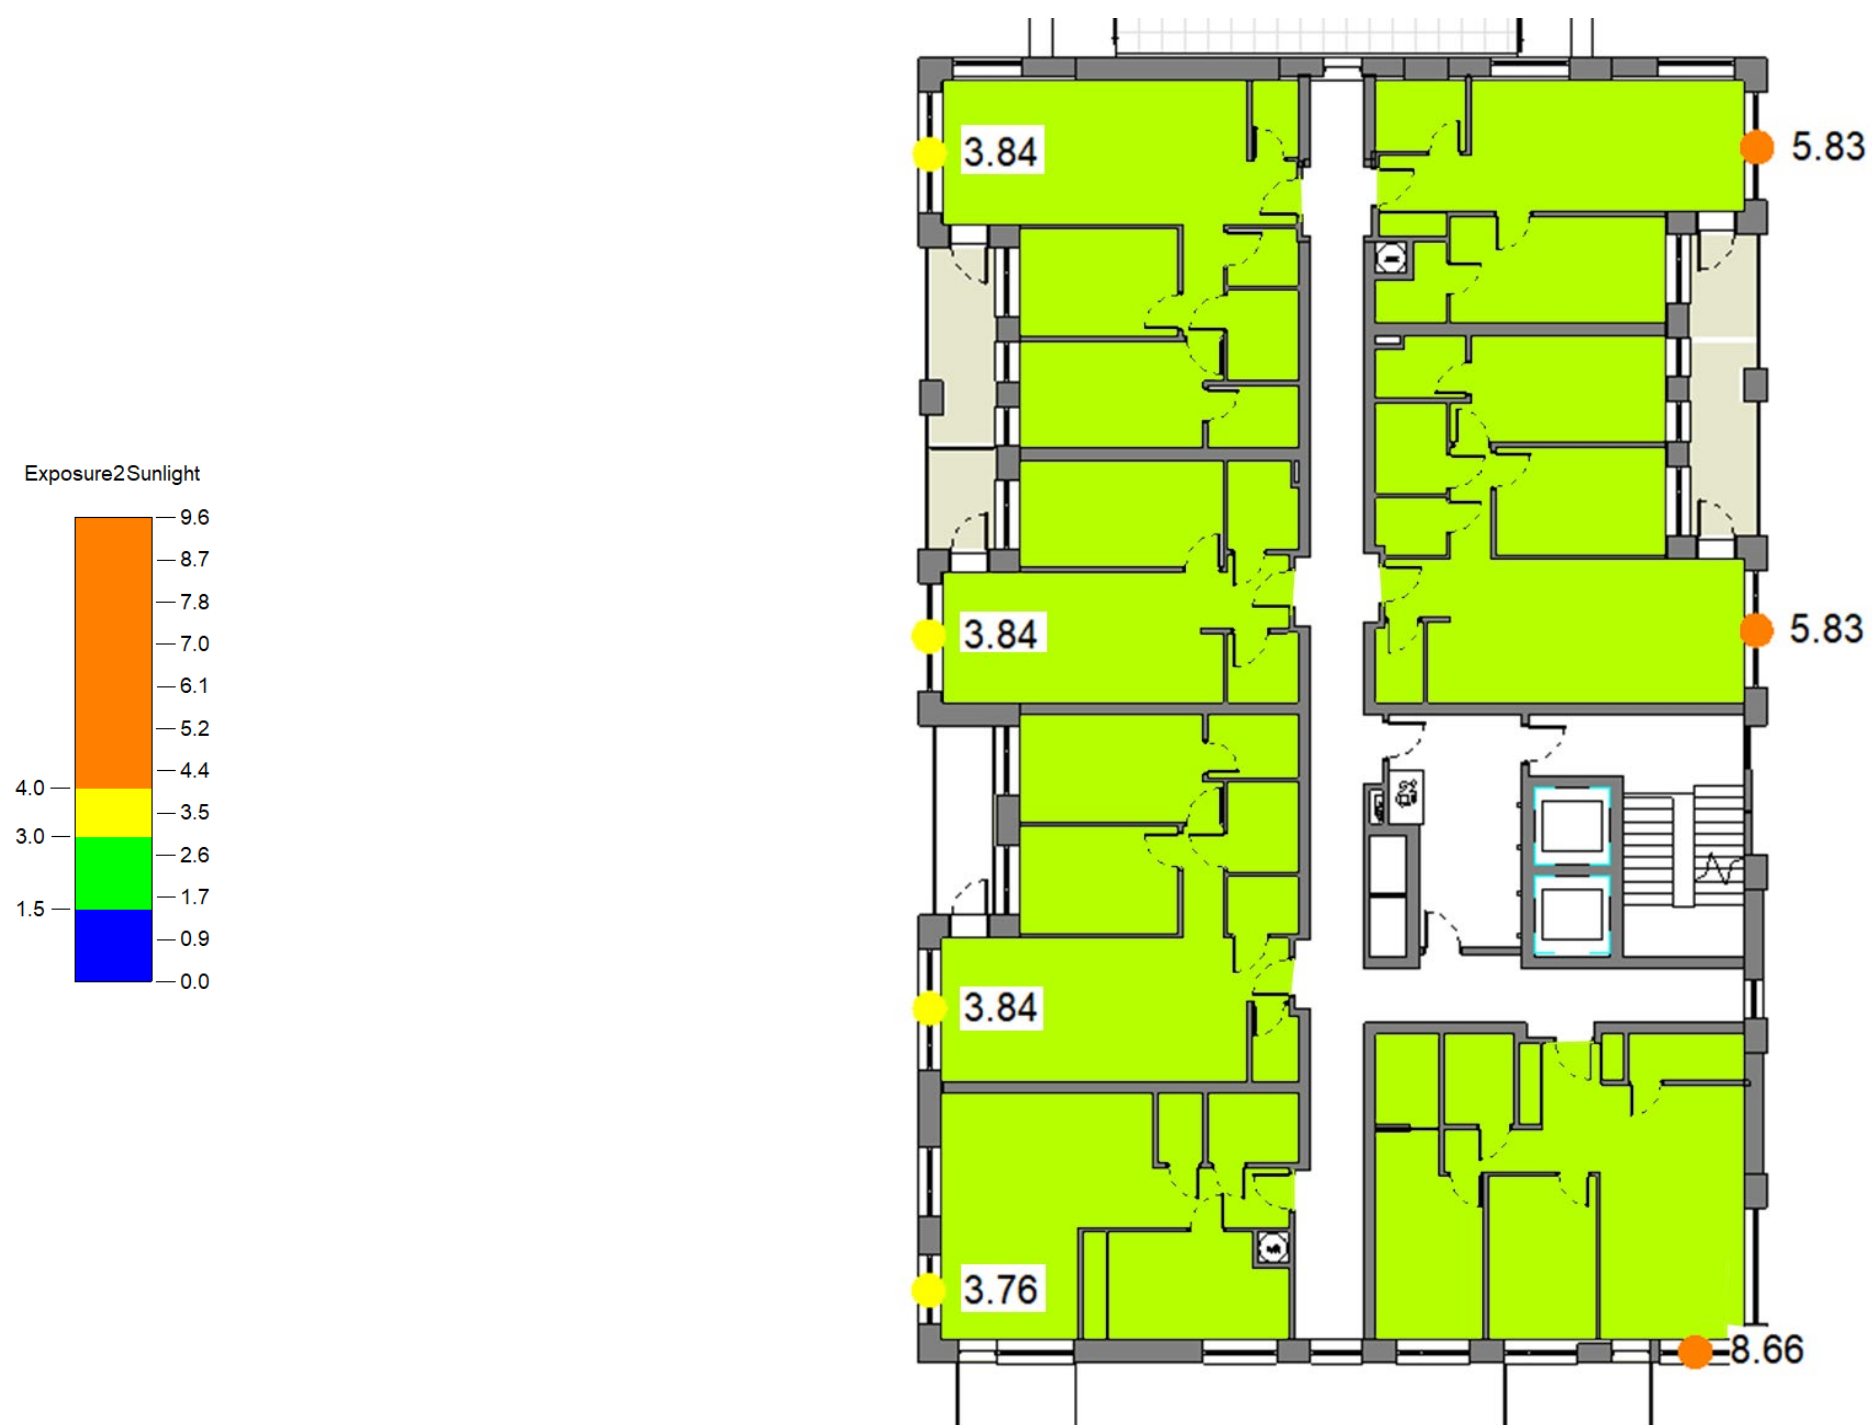
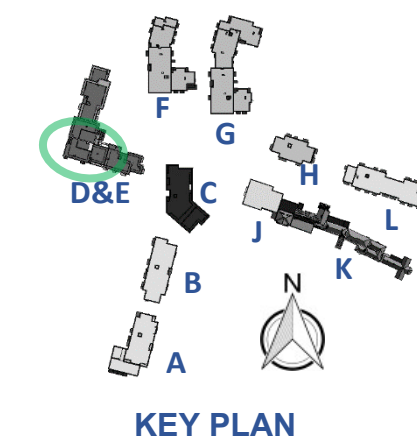
Block DE – Ninth Floor

Sunlight Analysis as illustrated below, determined all units on this block achieve the minimum recommendations.

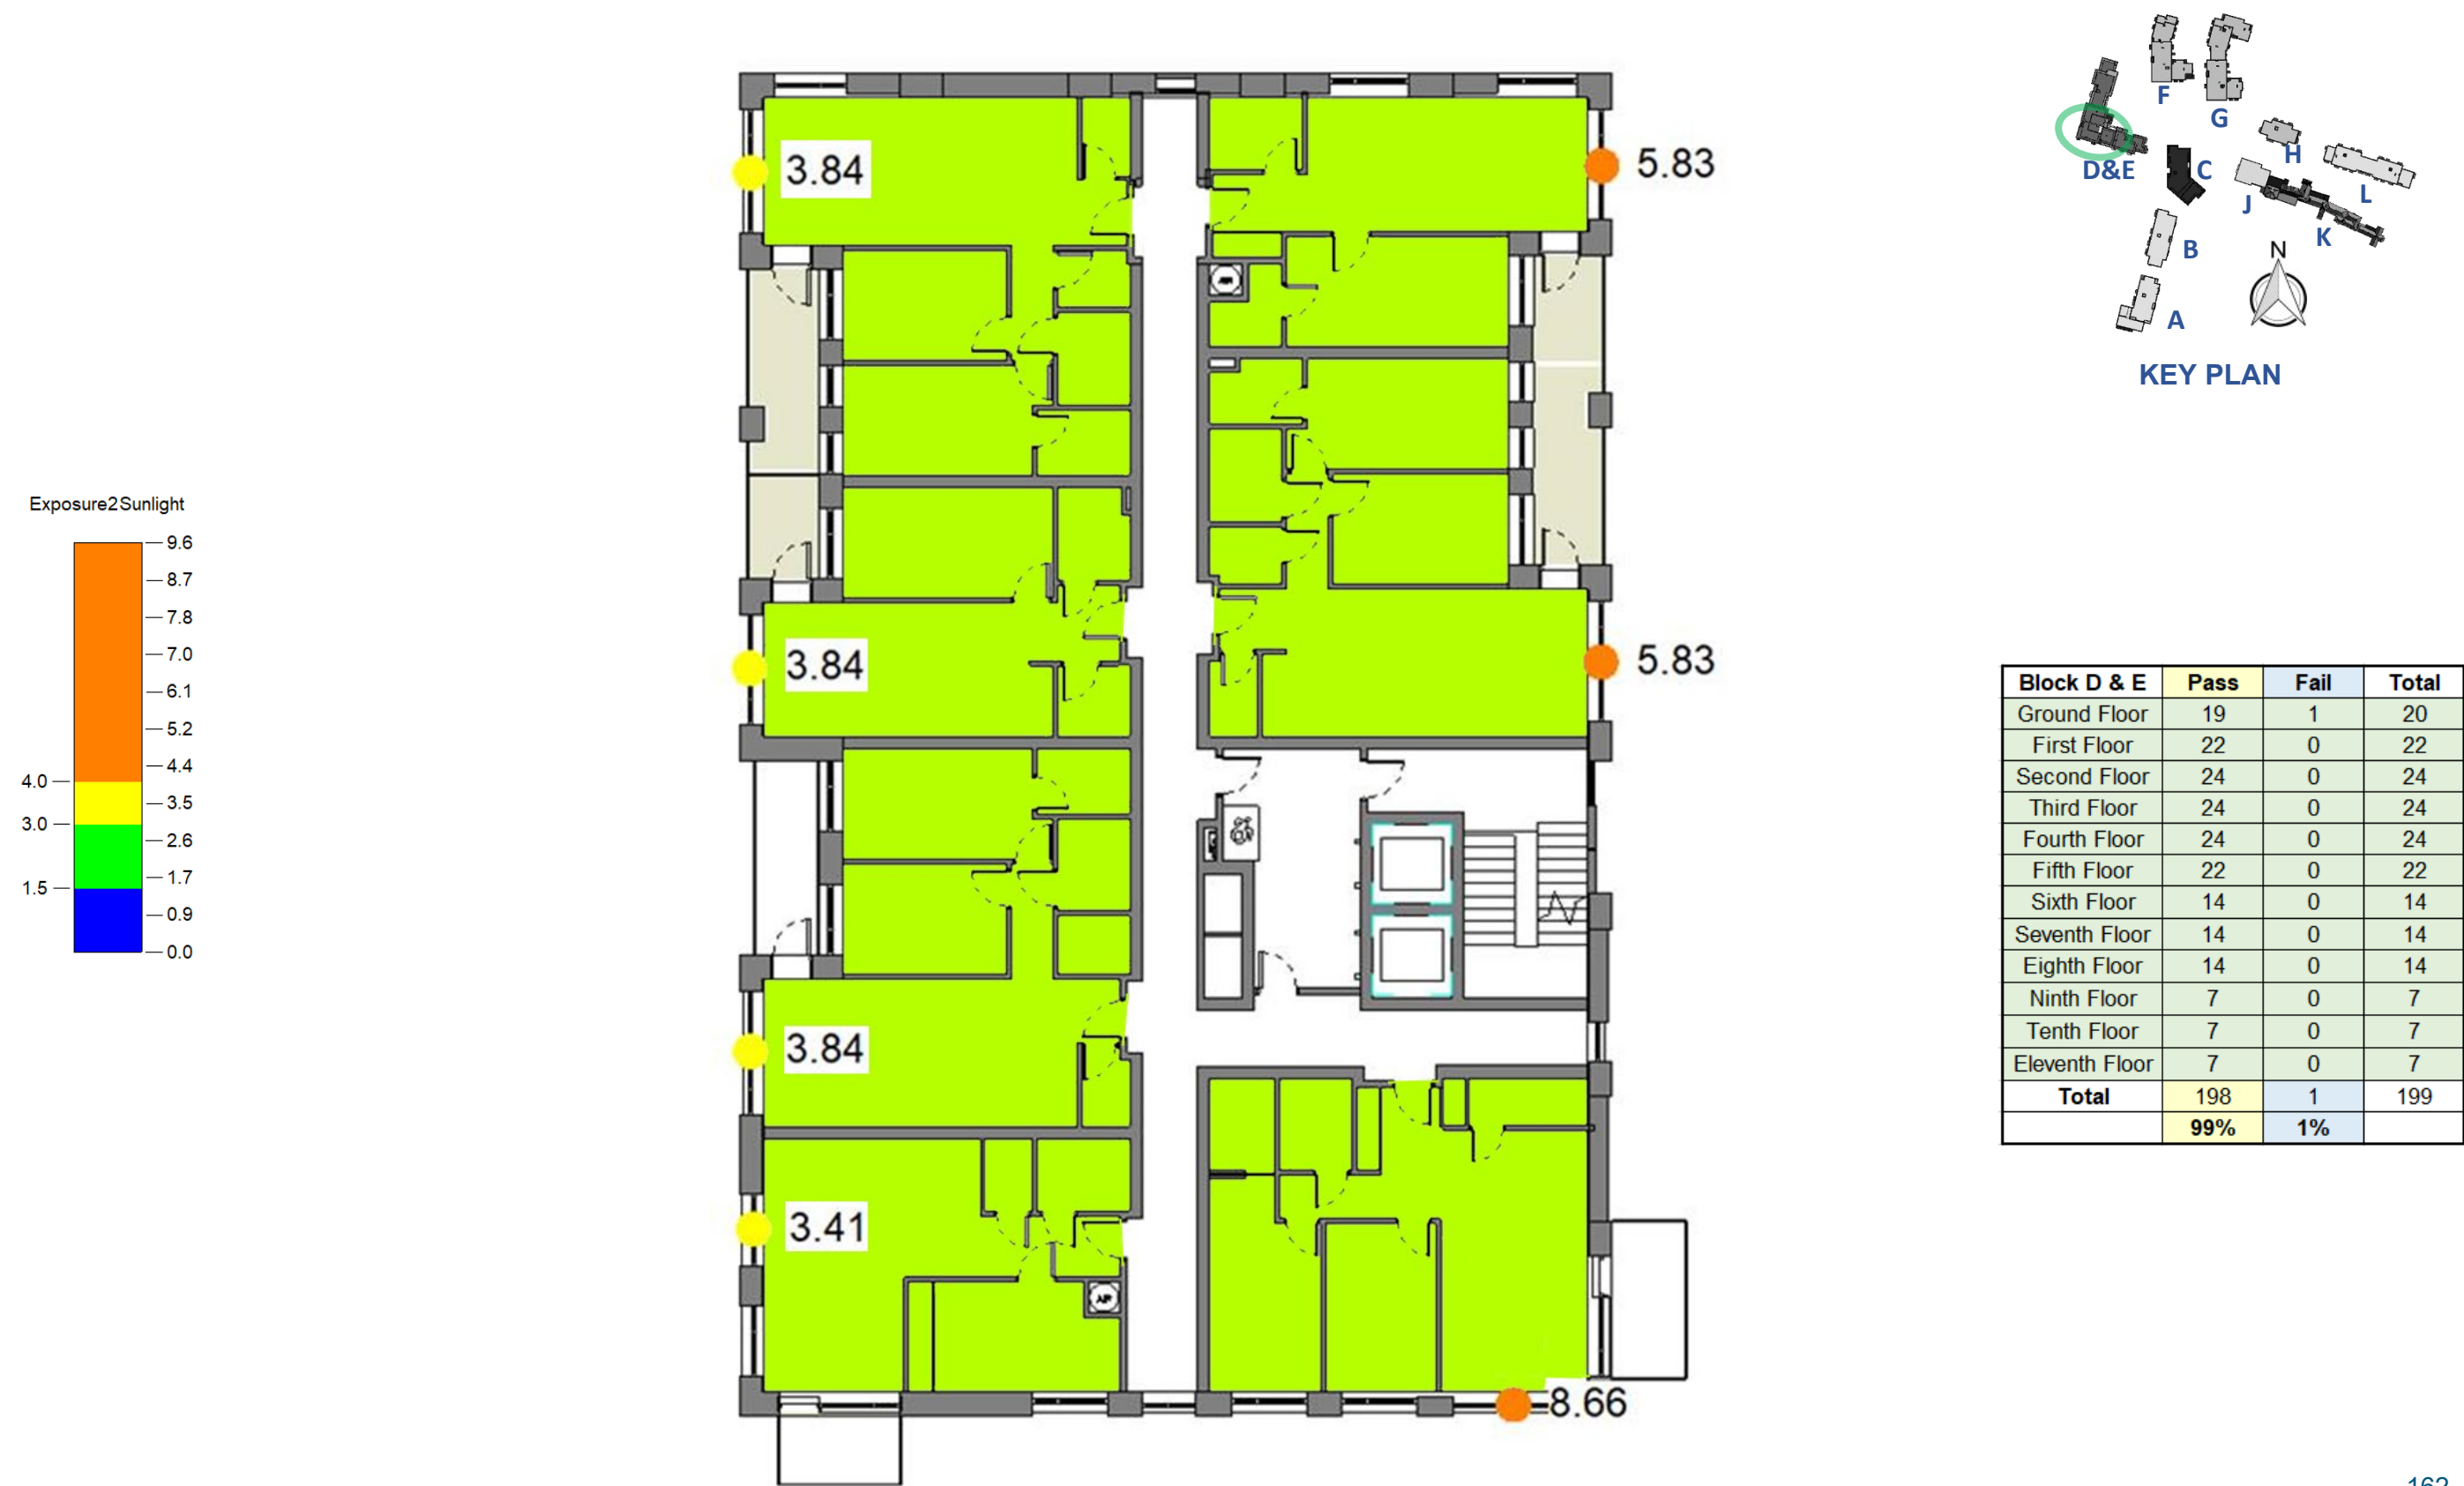
Block DE – Tenth Floor

Sunlight Analysis as illustrated below, determined all units on this block achieve the minimum recommendations.

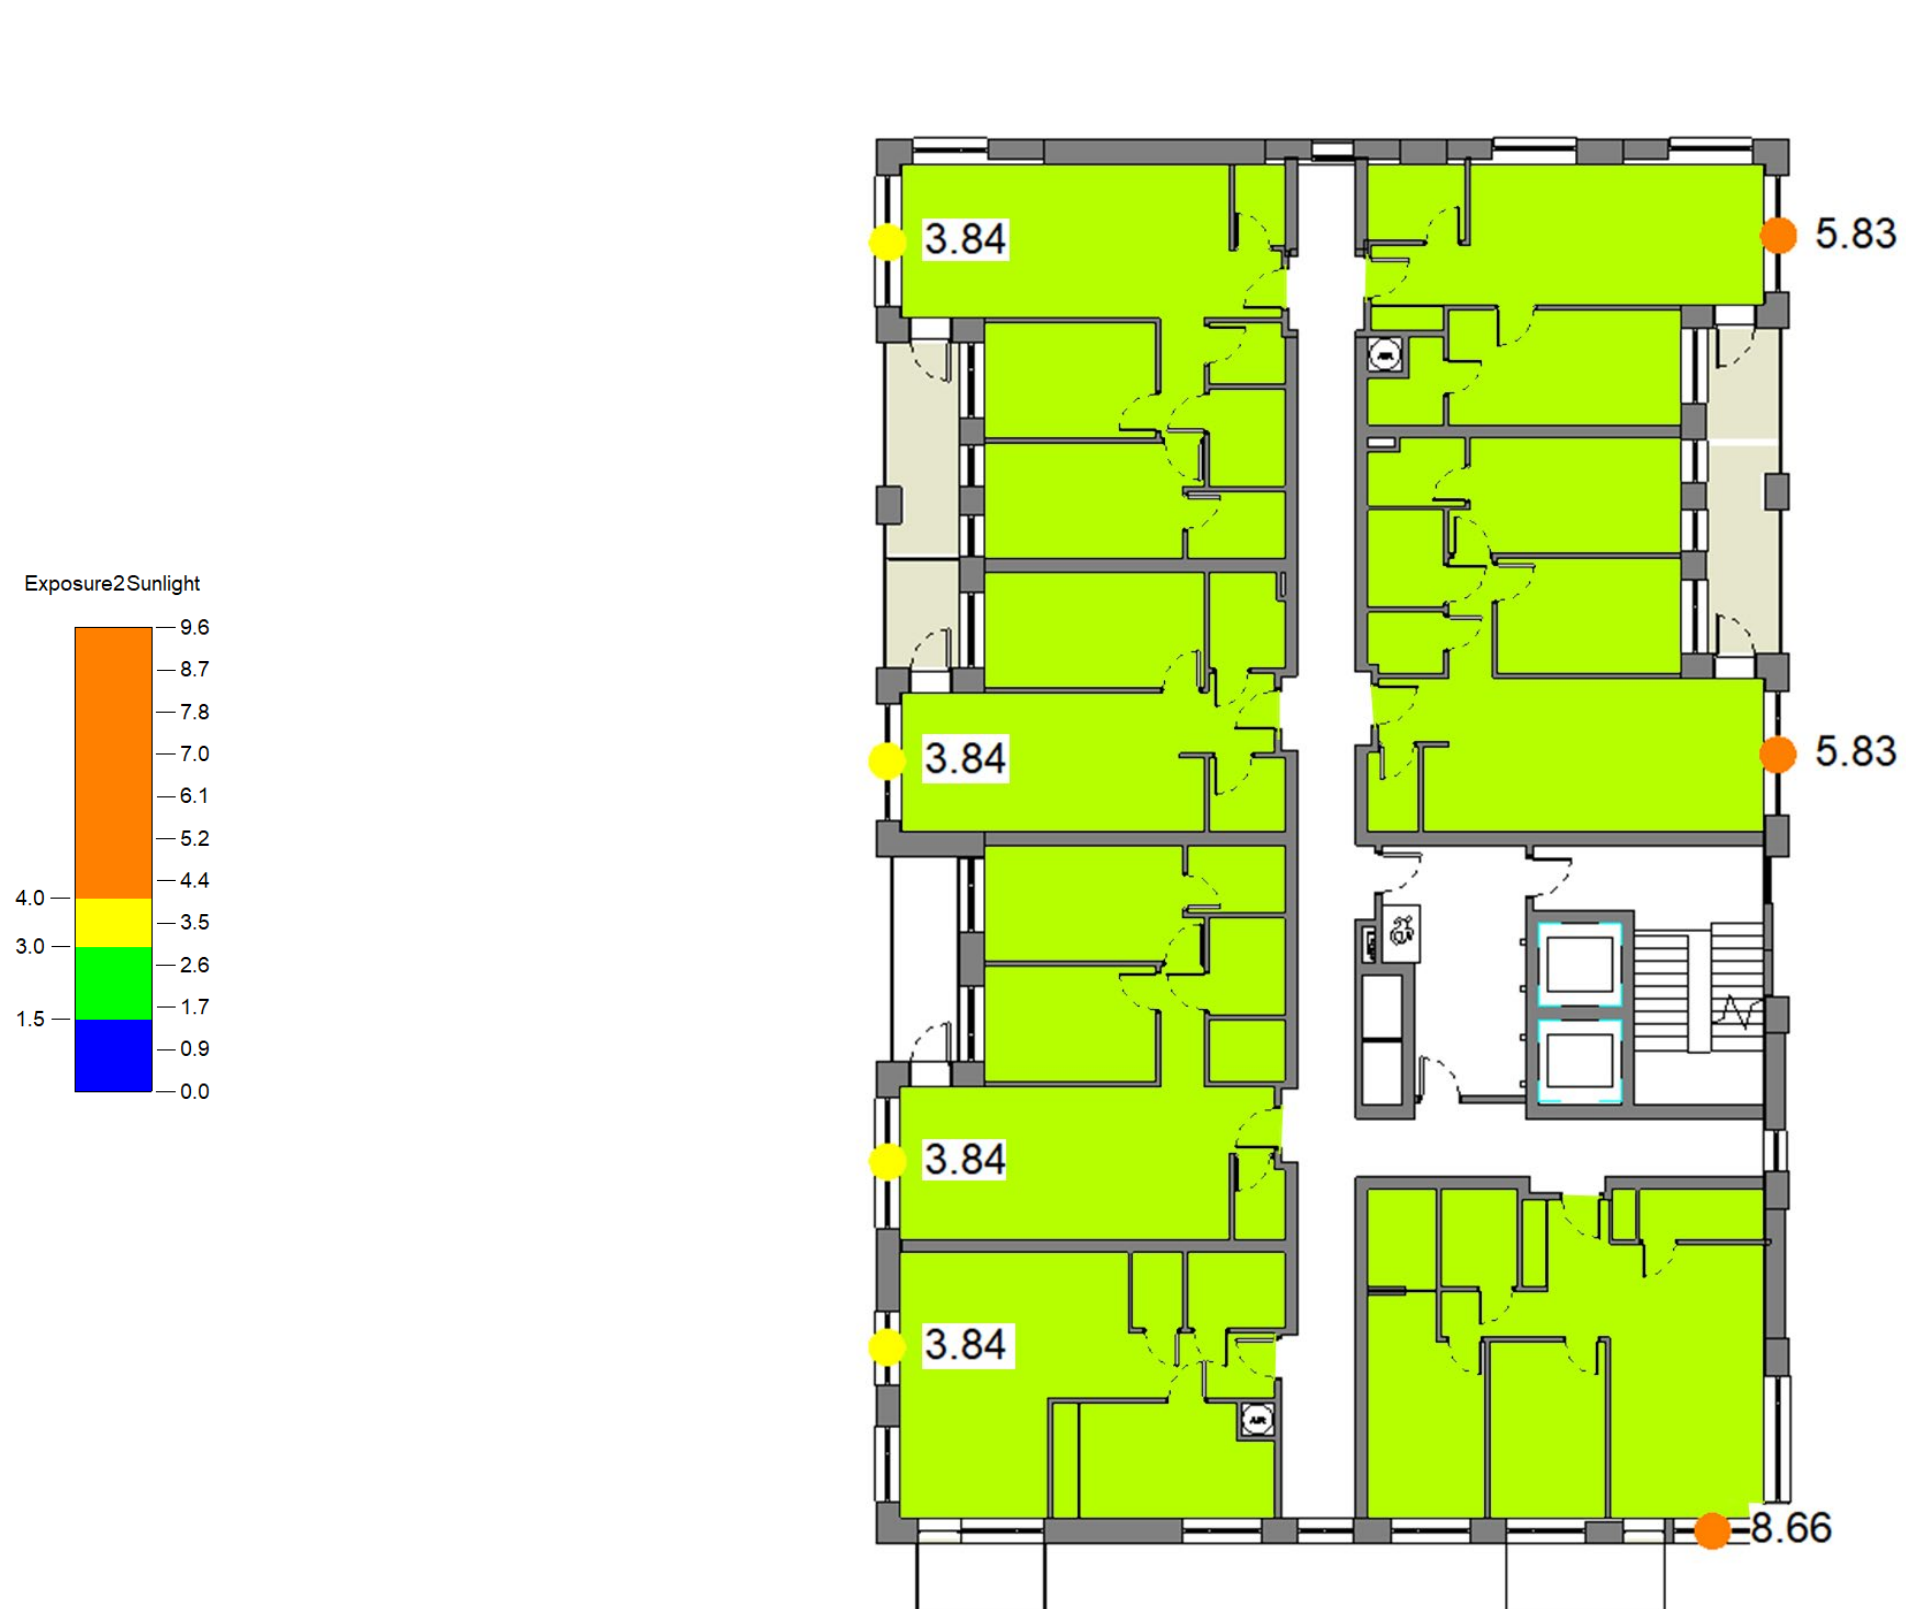
Block DE – Eleventh Floor

Sunlight Analysis as illustrated below, determined all units on this block achieve the minimum recommendations.
