St. Vincent's Hospital Fairview Redevelopment, Fairview Dublin 3

Daylight and Sunlight Analysis

IN2 Project No. D2116

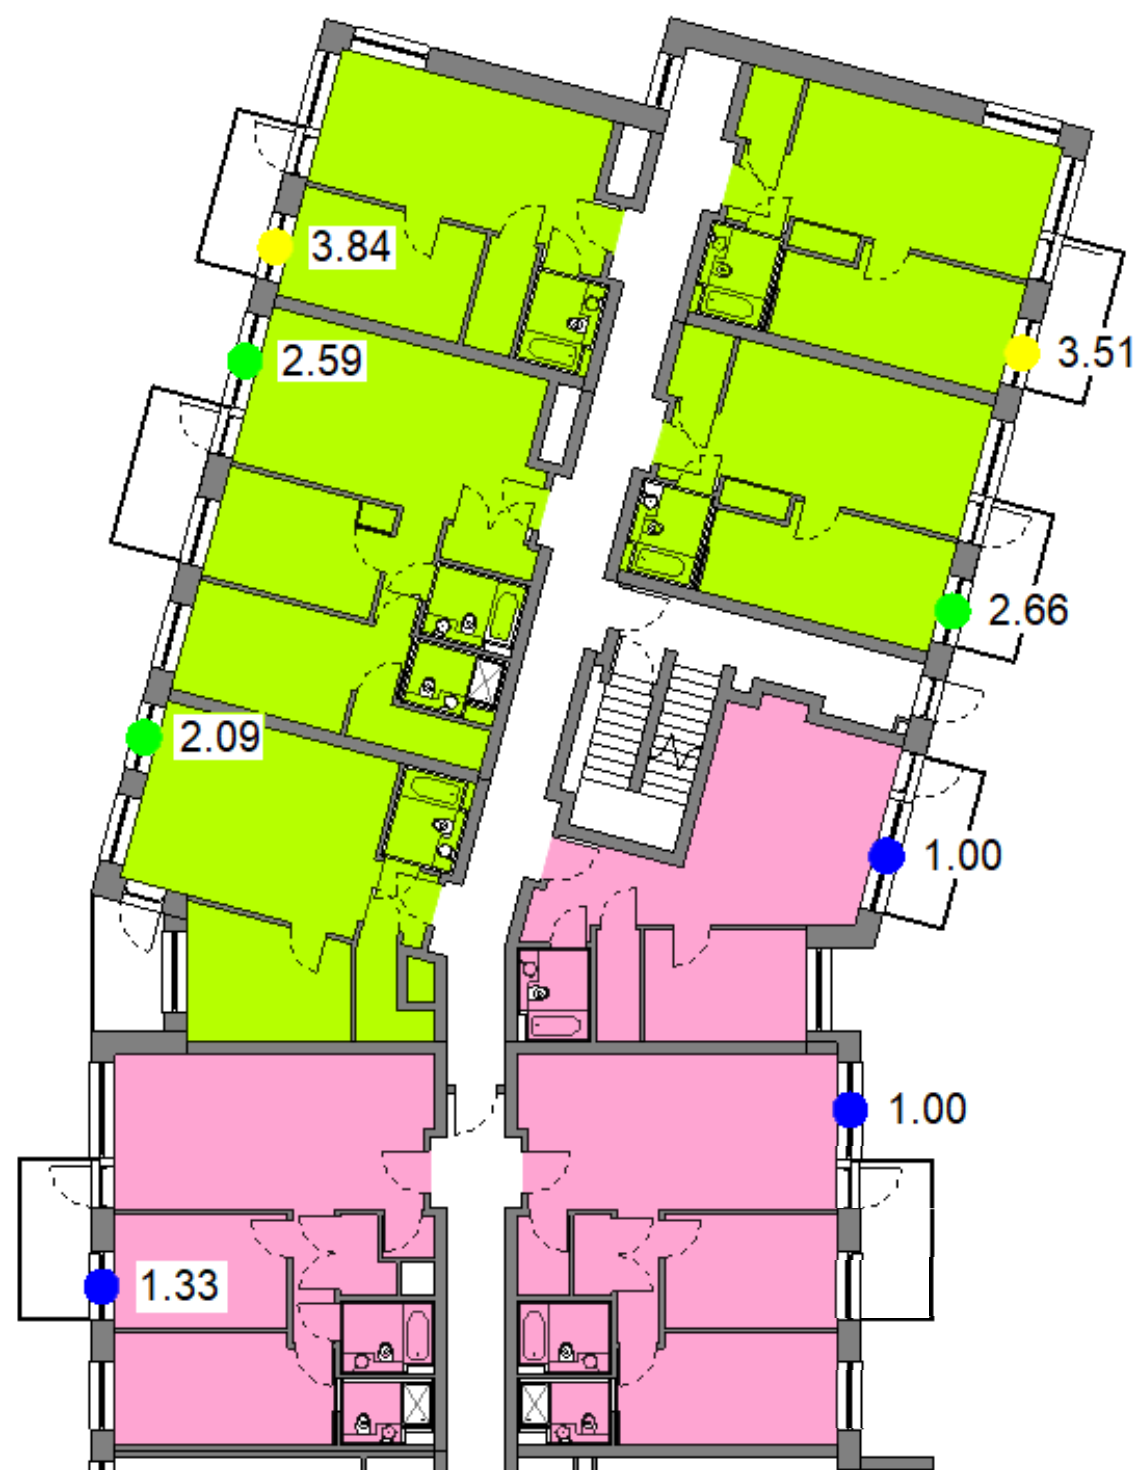
Sunlight Analysis as illustrated below, determined 3 units on this block do not achieve the minimum recommendations.

The rest of the units achieve the minimum recommendations.

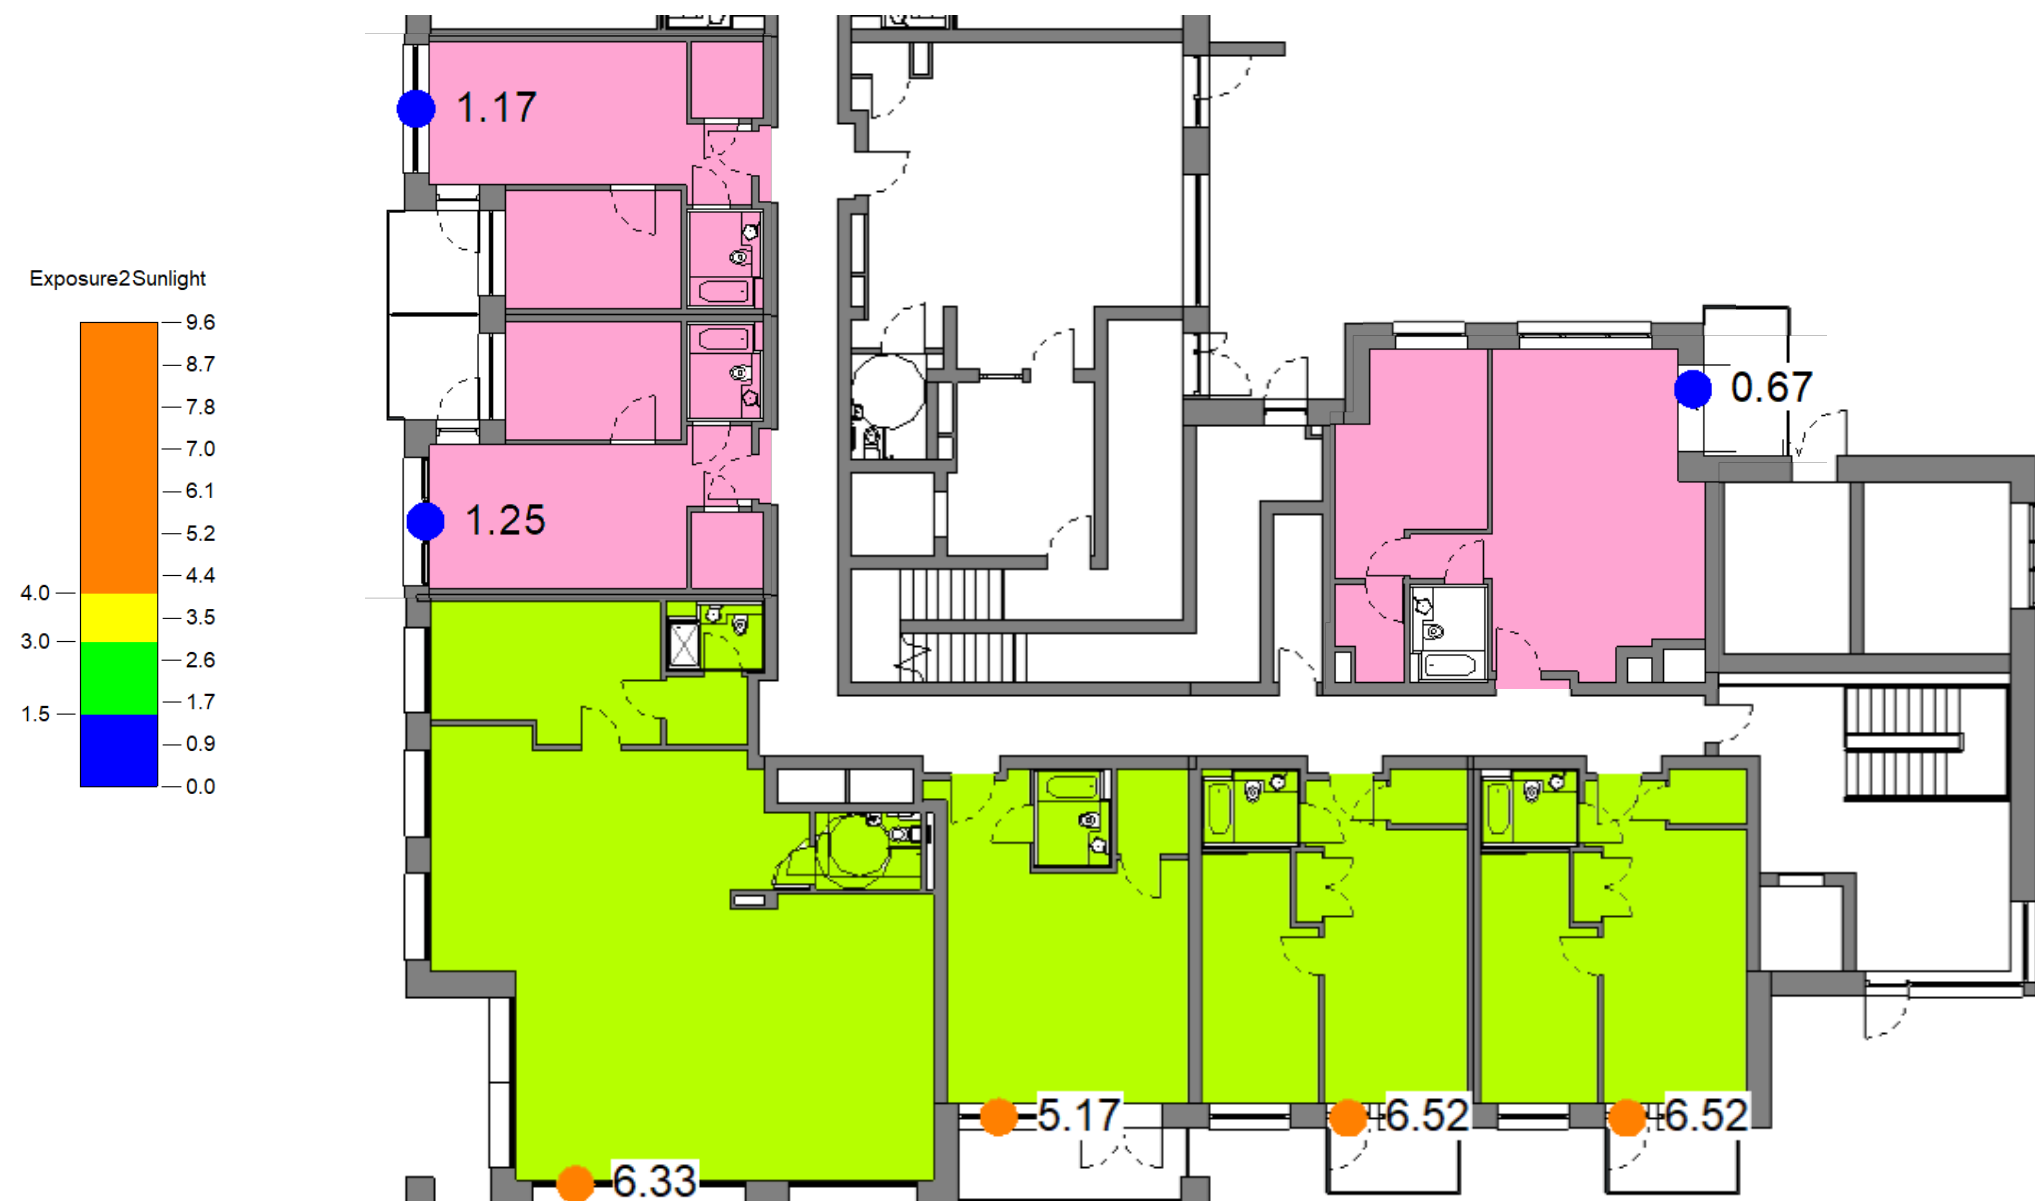
Sunlight Analysis as illustrated below, determined 2 units on this block do not achieve the minimum recommendations.

The rest of the units achieve the minimum recommendations.

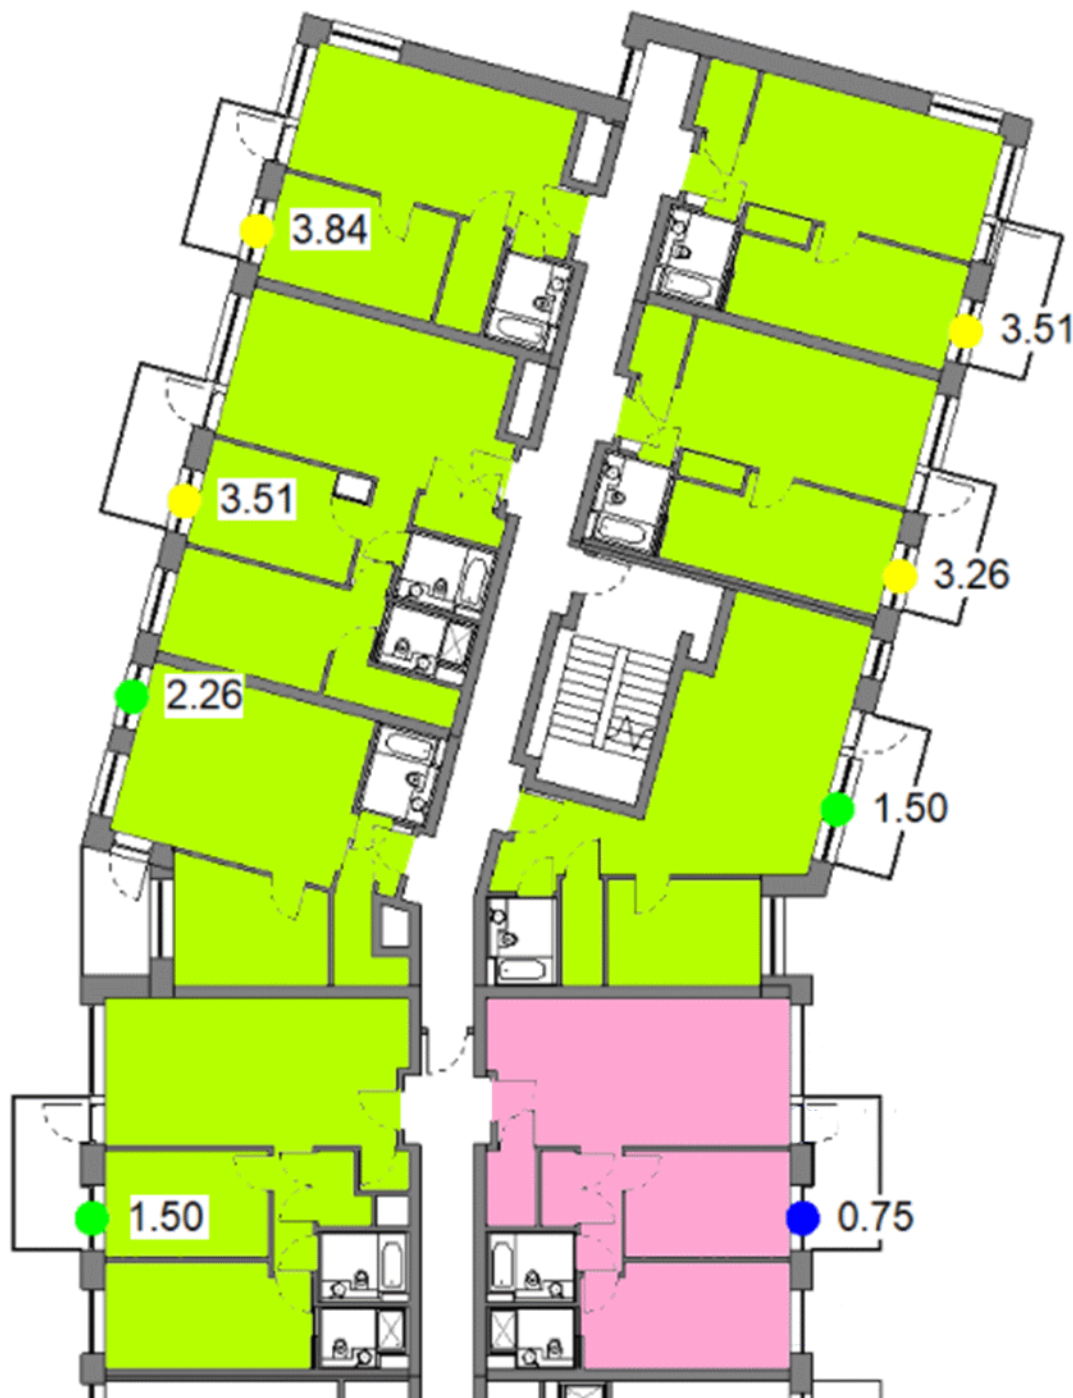
Block F – First Floor

Sunlight Analysis as illustrated below, determined 1 unit on this block does not achieve the minimum recommendations.
The rest of the units achieve the minimum recommendations.

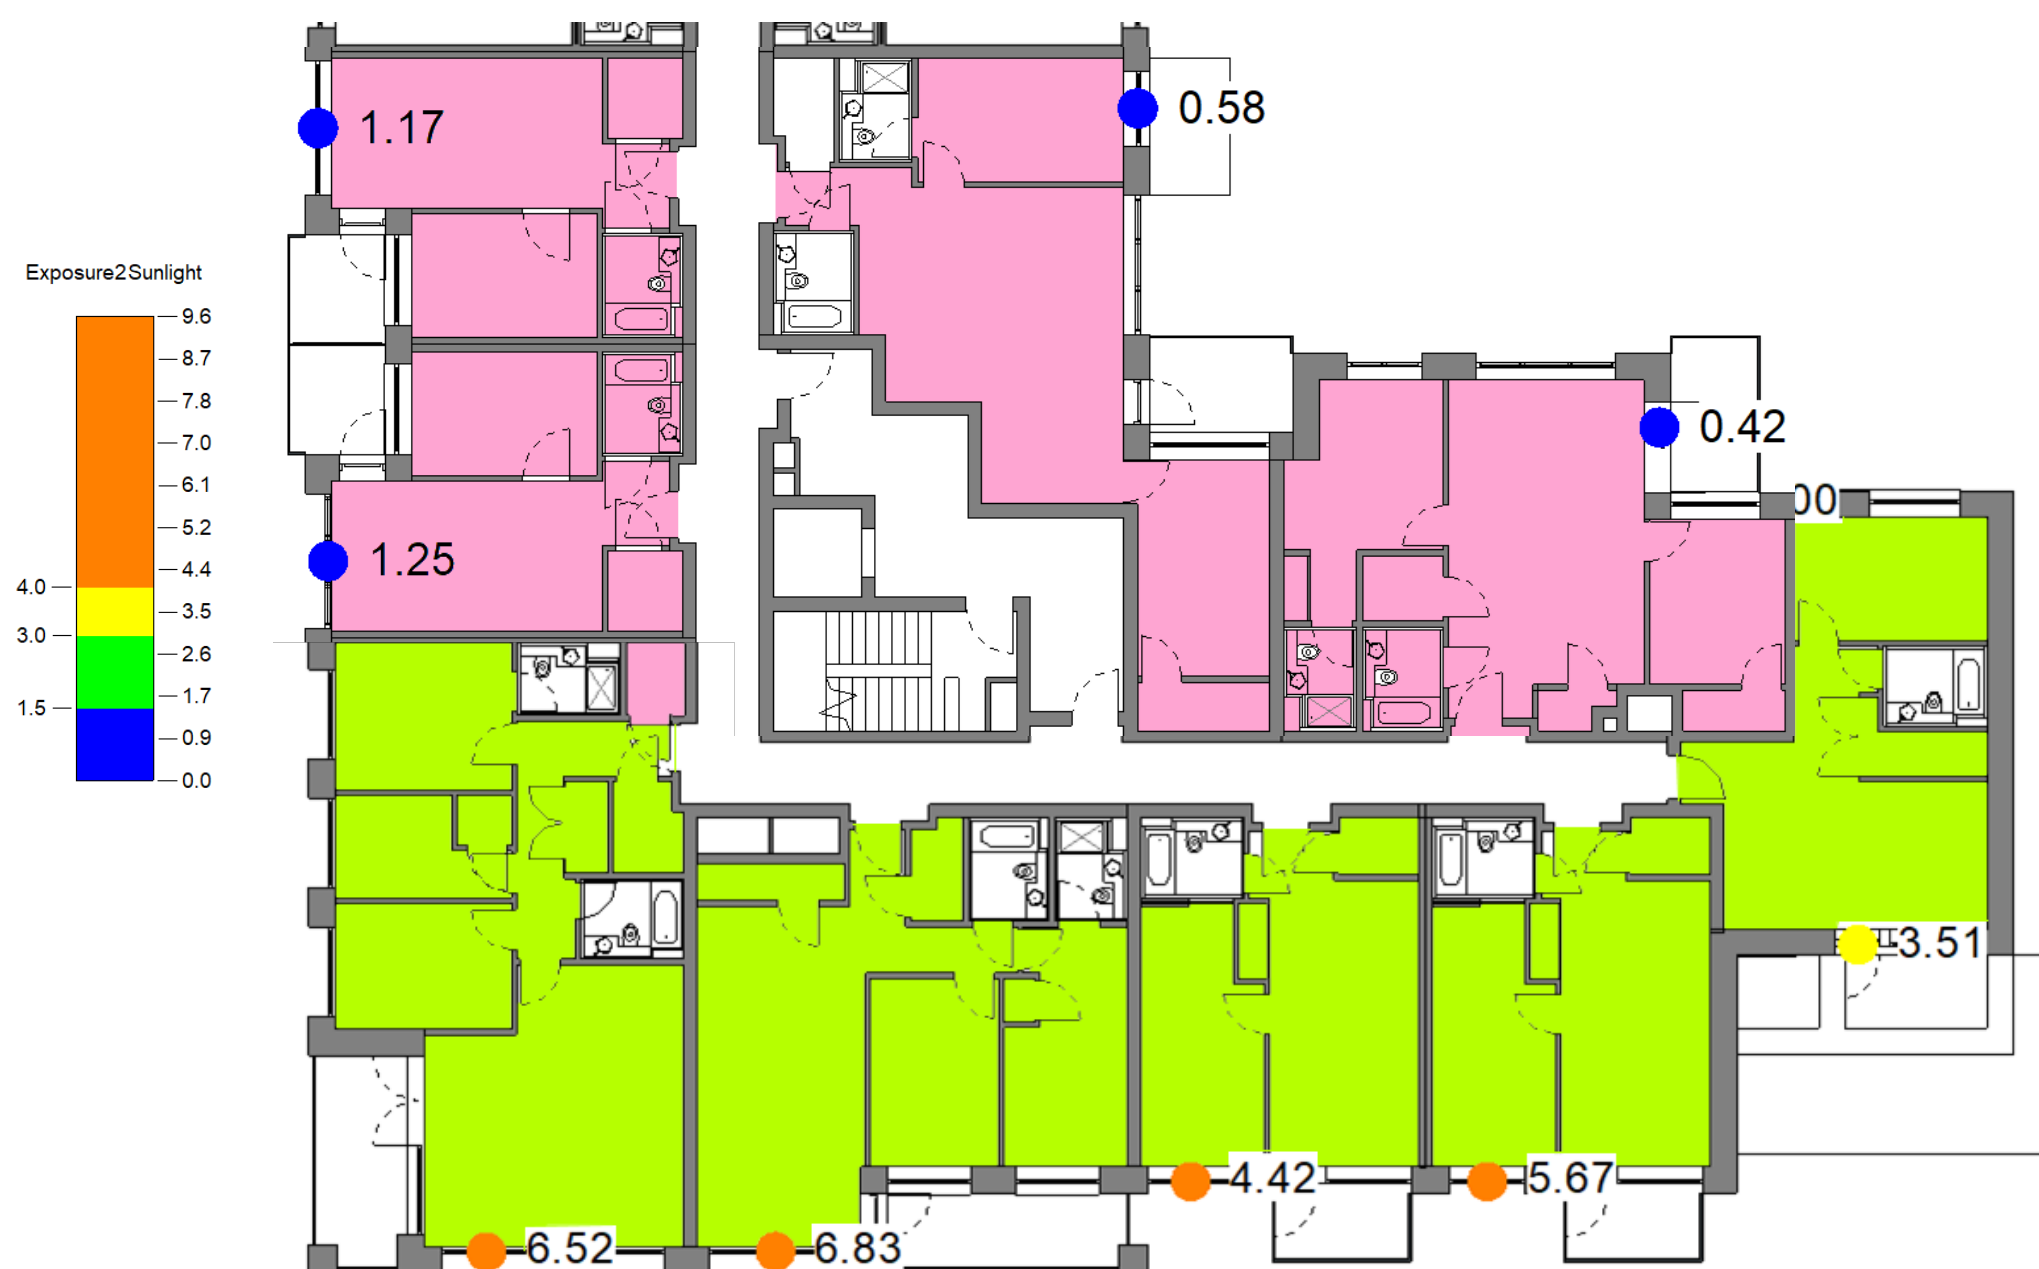
Sunlight Analysis as illustrated below, determined 4 units on this block do not achieve the minimum recommendations.

The rest of the units achieve the minimum recommendations.

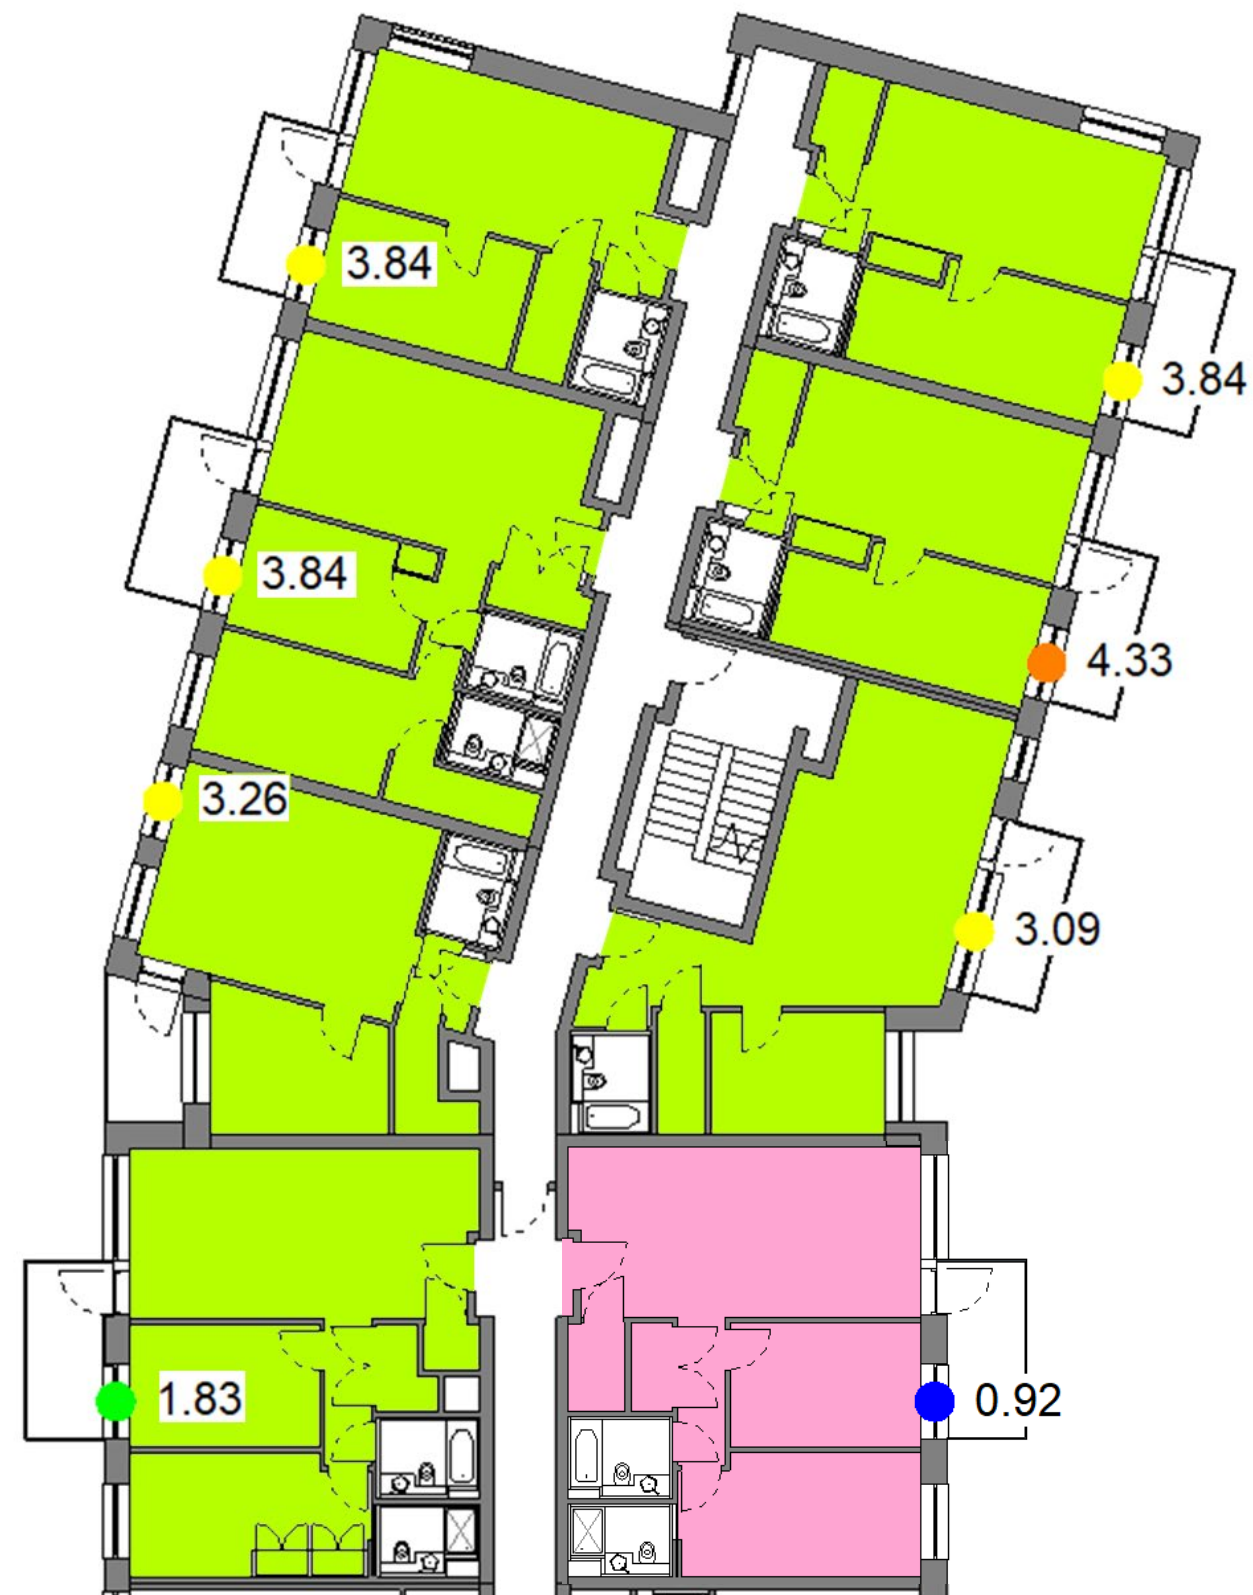
Sunlight Analysis as illustrated below, determined 1 unit on this block does not achieve the minimum recommendations.

The rest of the units achieve the minimum recommendations.

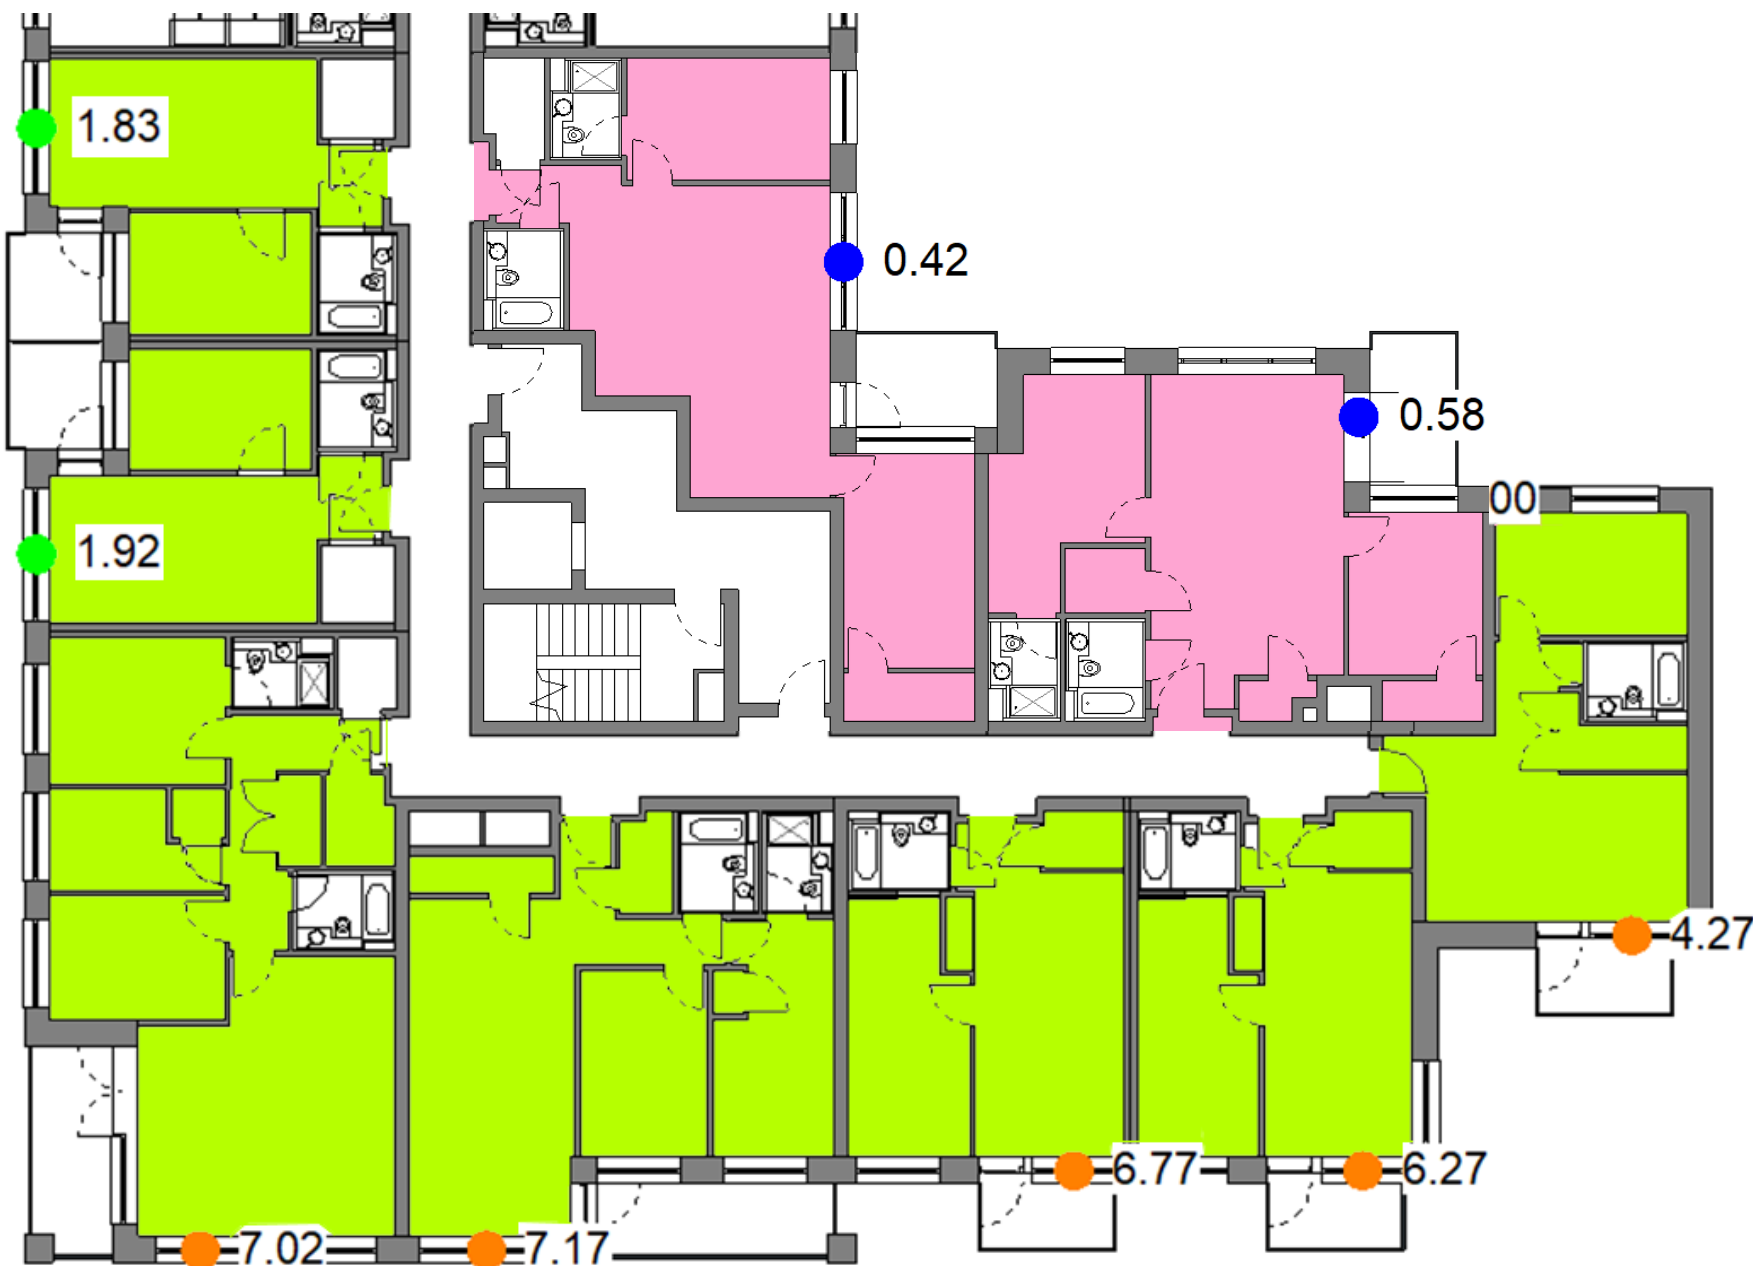
Sunlight Analysis as illustrated below, determined 2 units on this block do not achieve the minimum recommendations.

The rest of the units achieve the minimum recommendations.

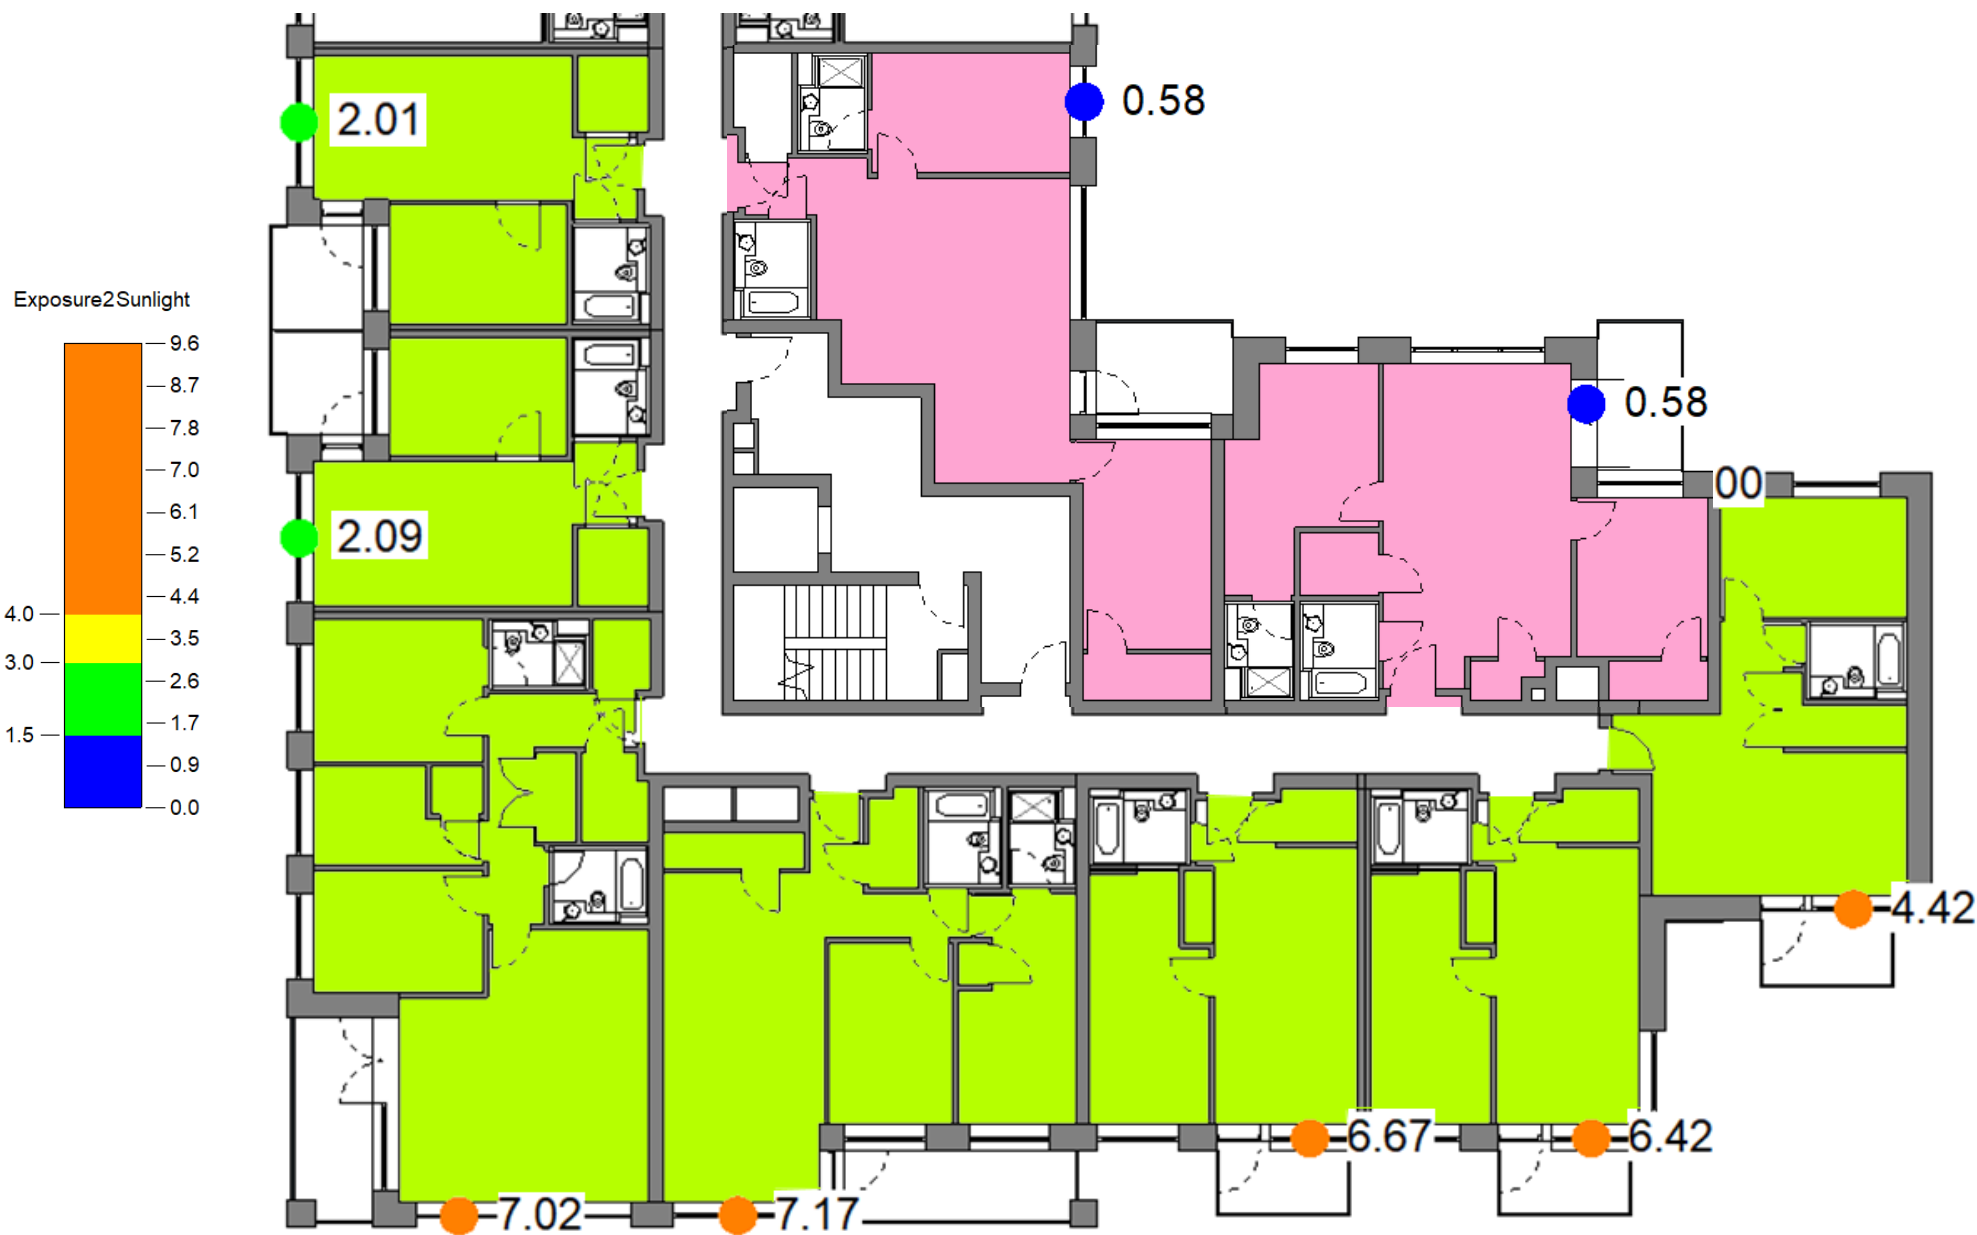
Sunlight Analysis as illustrated below, determined 2 units on this block do not achieve the minimum recommendations.

The rest of the units achieve the minimum recommendations.

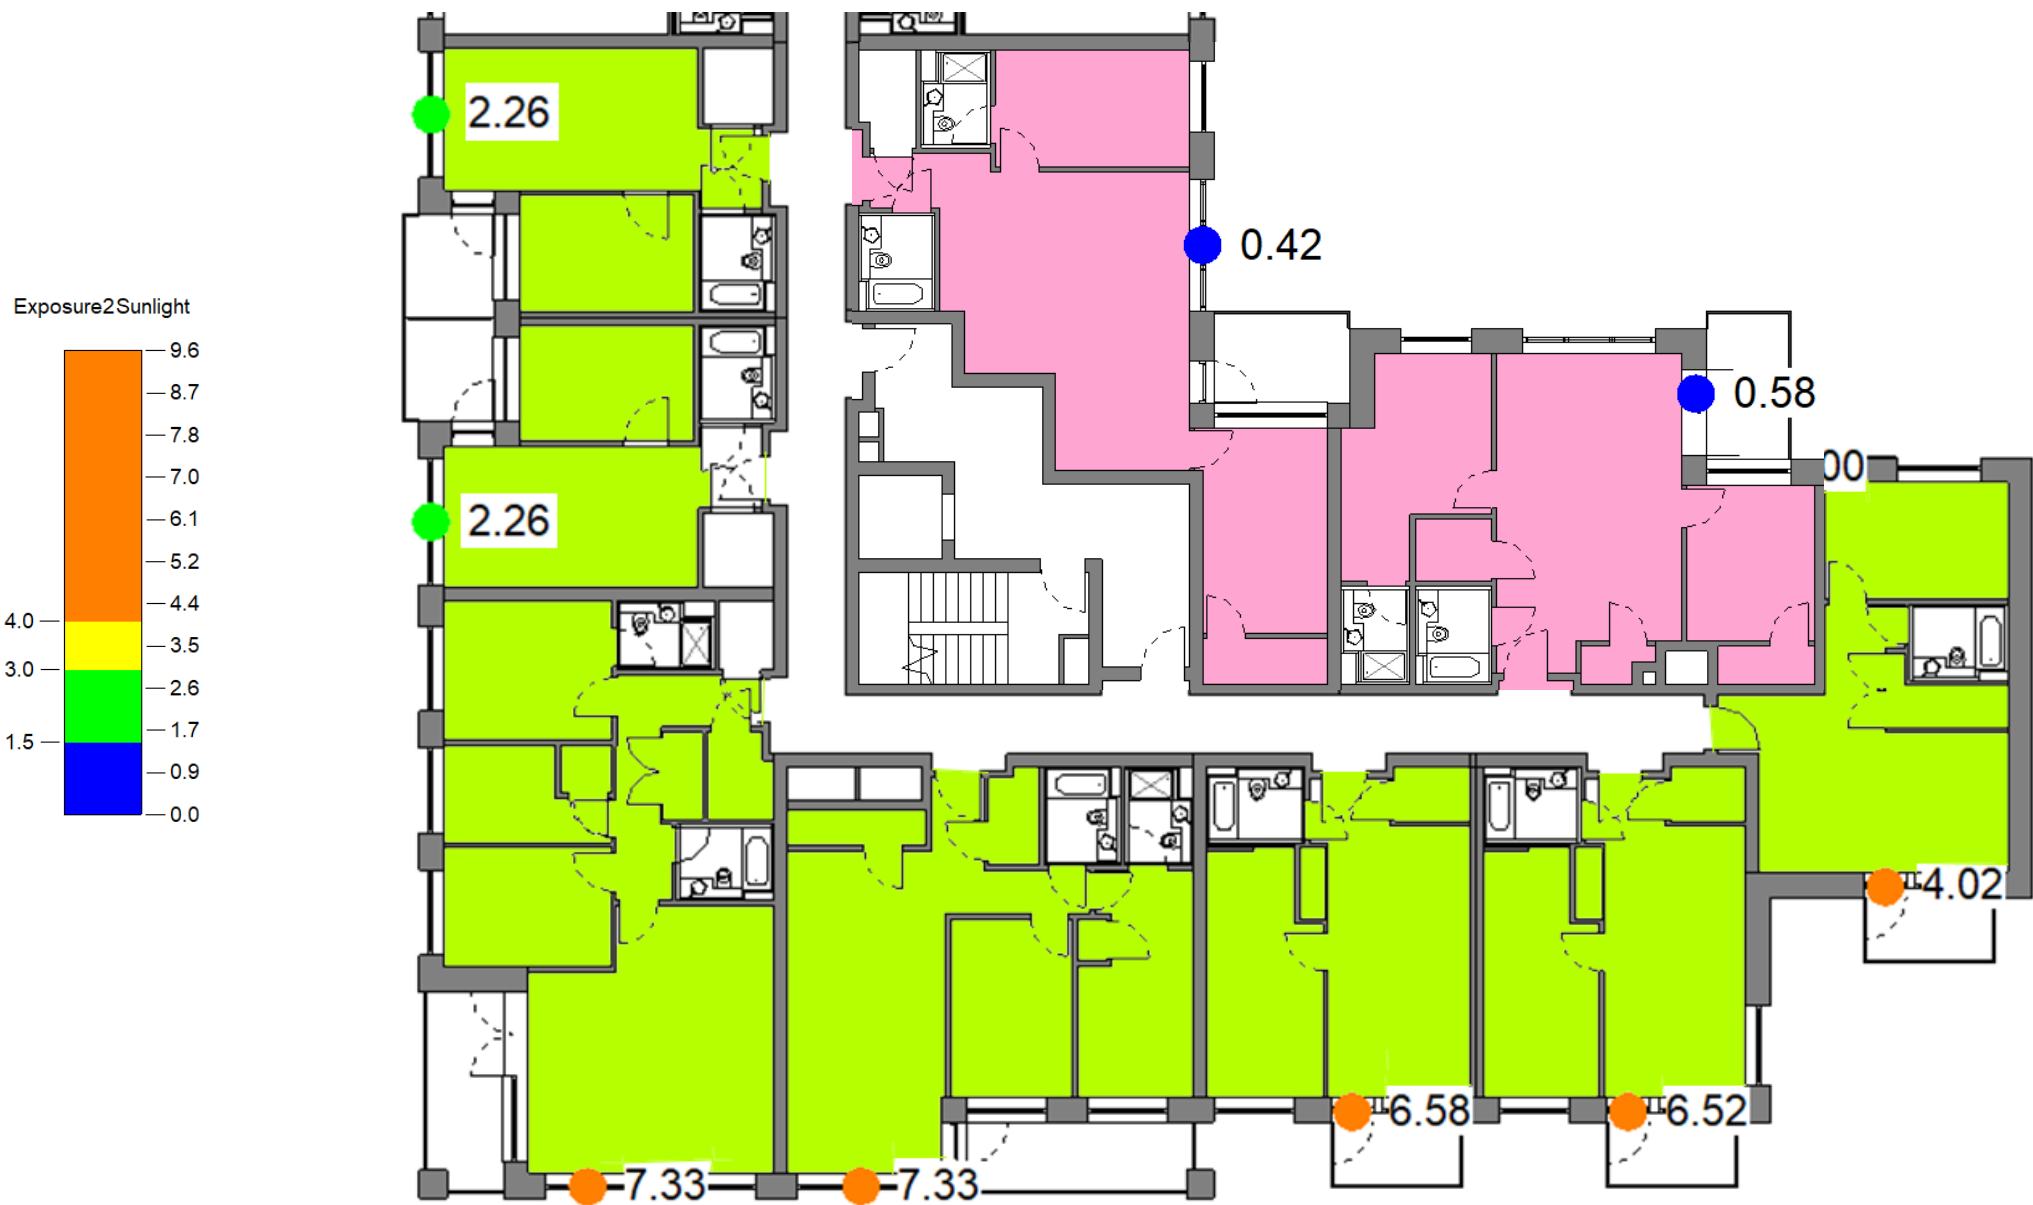
Block F – Fourth Floor

Sunlight Analysis as illustrated below, determined 2 units on this block do not achieve the minimum recommendations.
The rest of the units achieve the minimum recommendations.

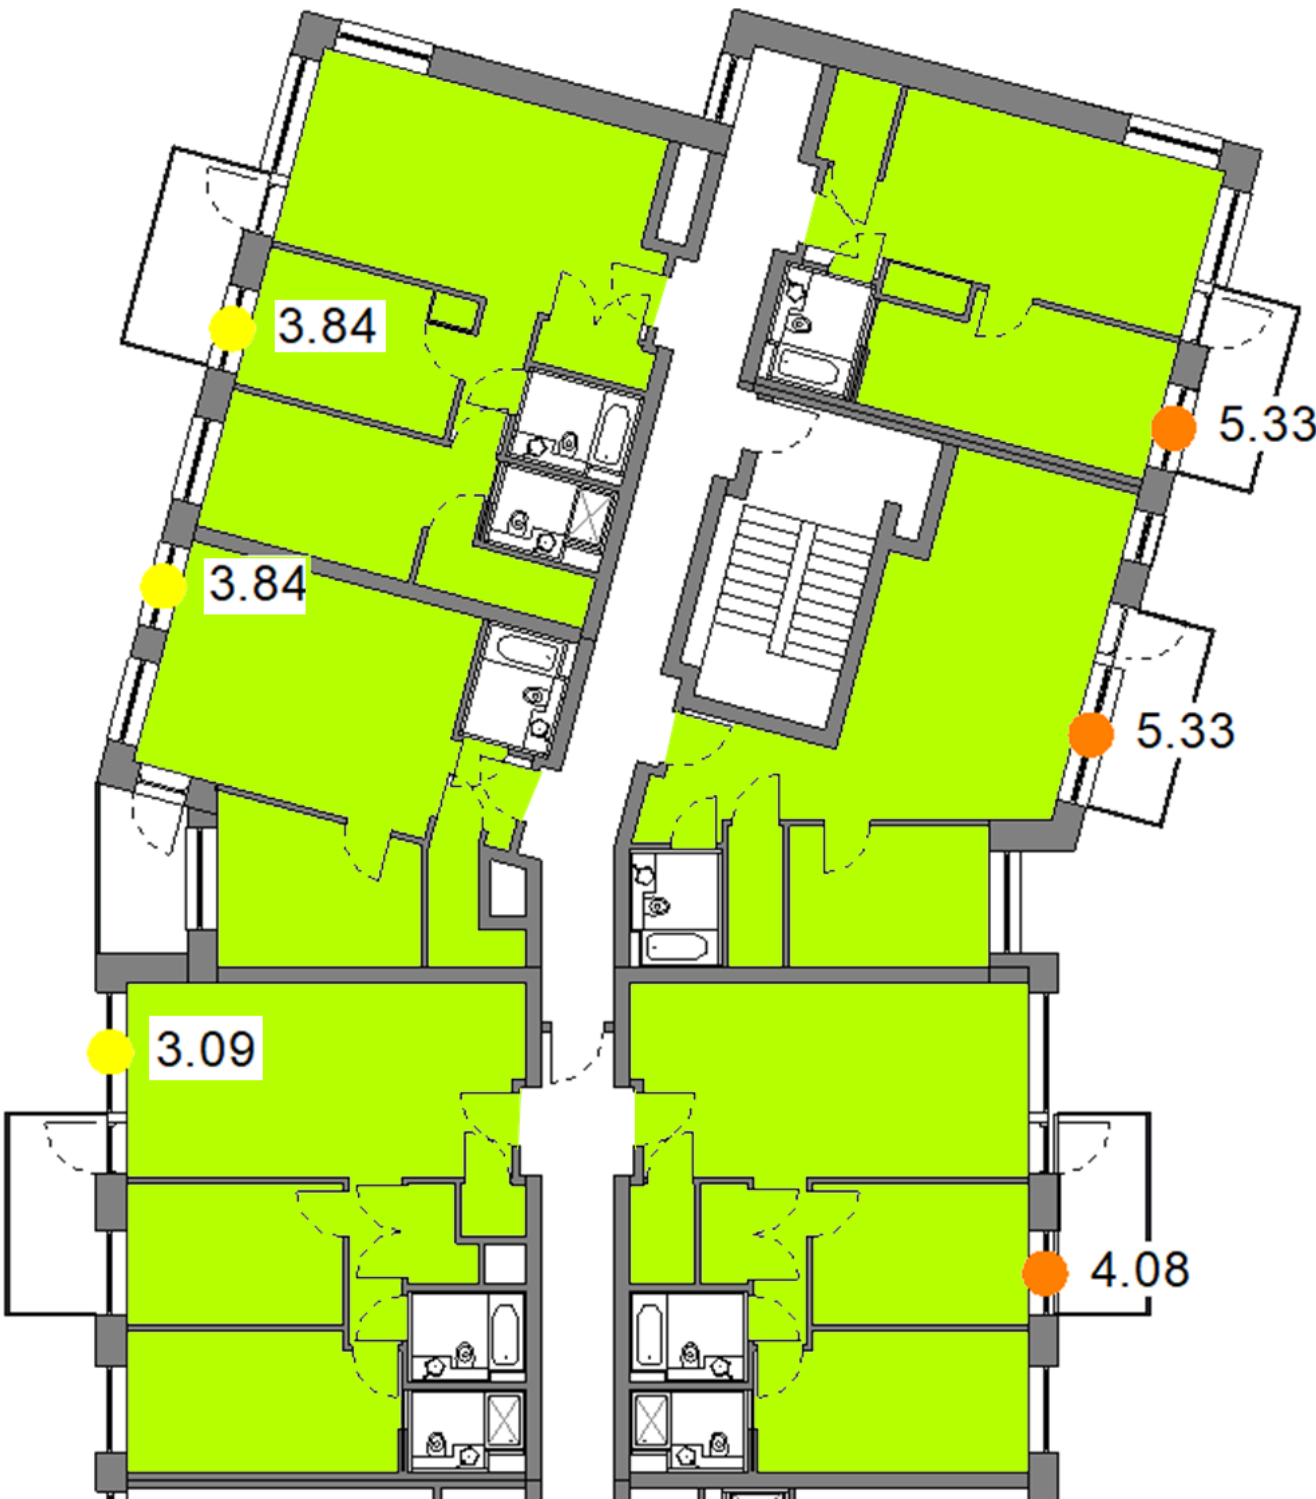
Block F – Fifth Floor

Sunlight Analysis as illustrated below, determined all units on this block achieve the minimum recommendations.

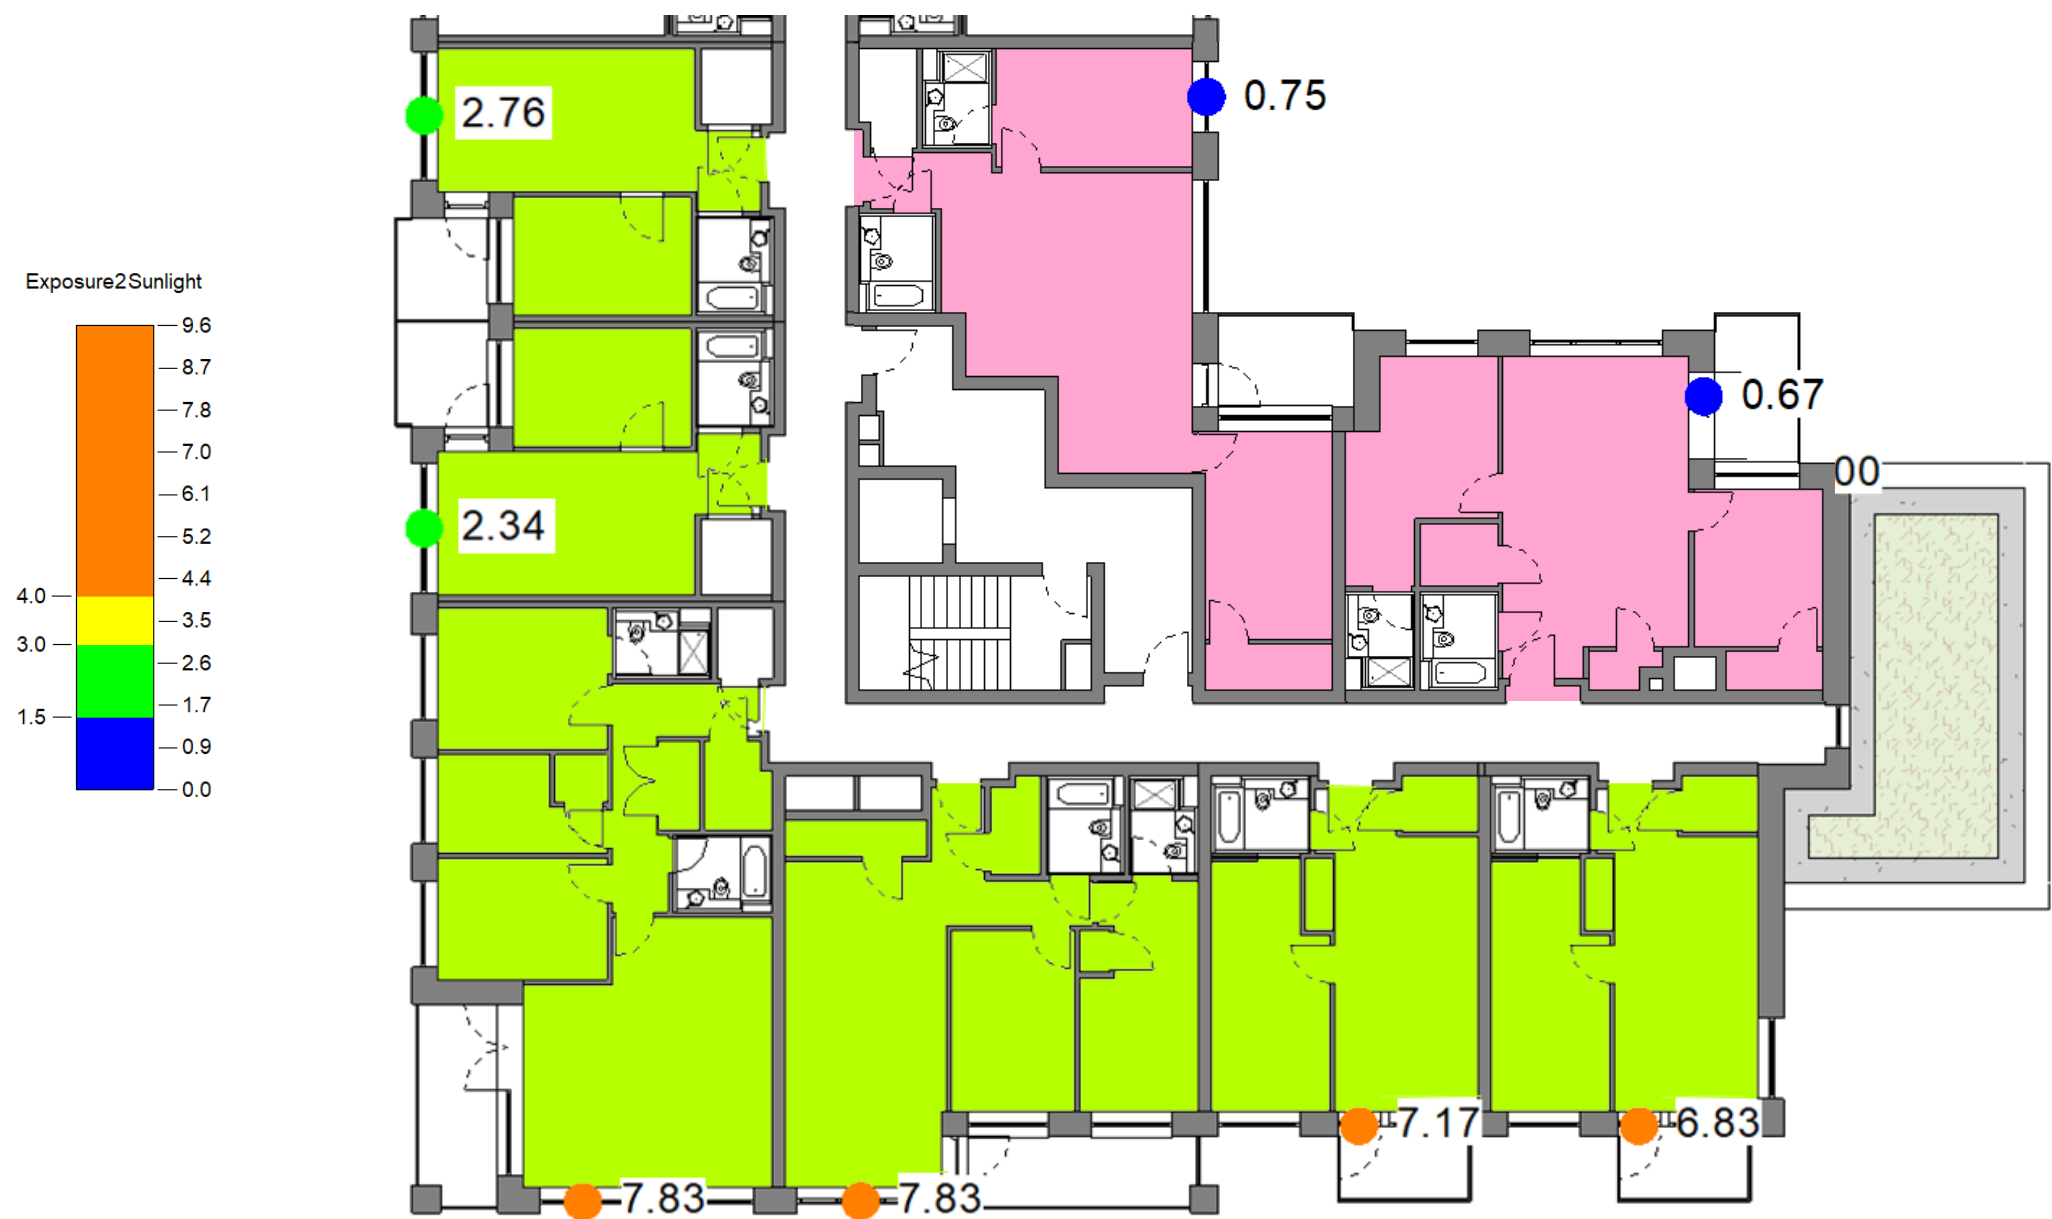
Block F – Fifth Floor

Sunlight Analysis as illustrated below, determined 2 units on this block do not achieve the minimum recommendations.
The rest of the units achieve the minimum recommendations.
