St. Vincent's Hospital Fairview Redevelopment, Fairview Dublin 3

Daylight and Sunlight Analysis

IN2 Project No. D2116

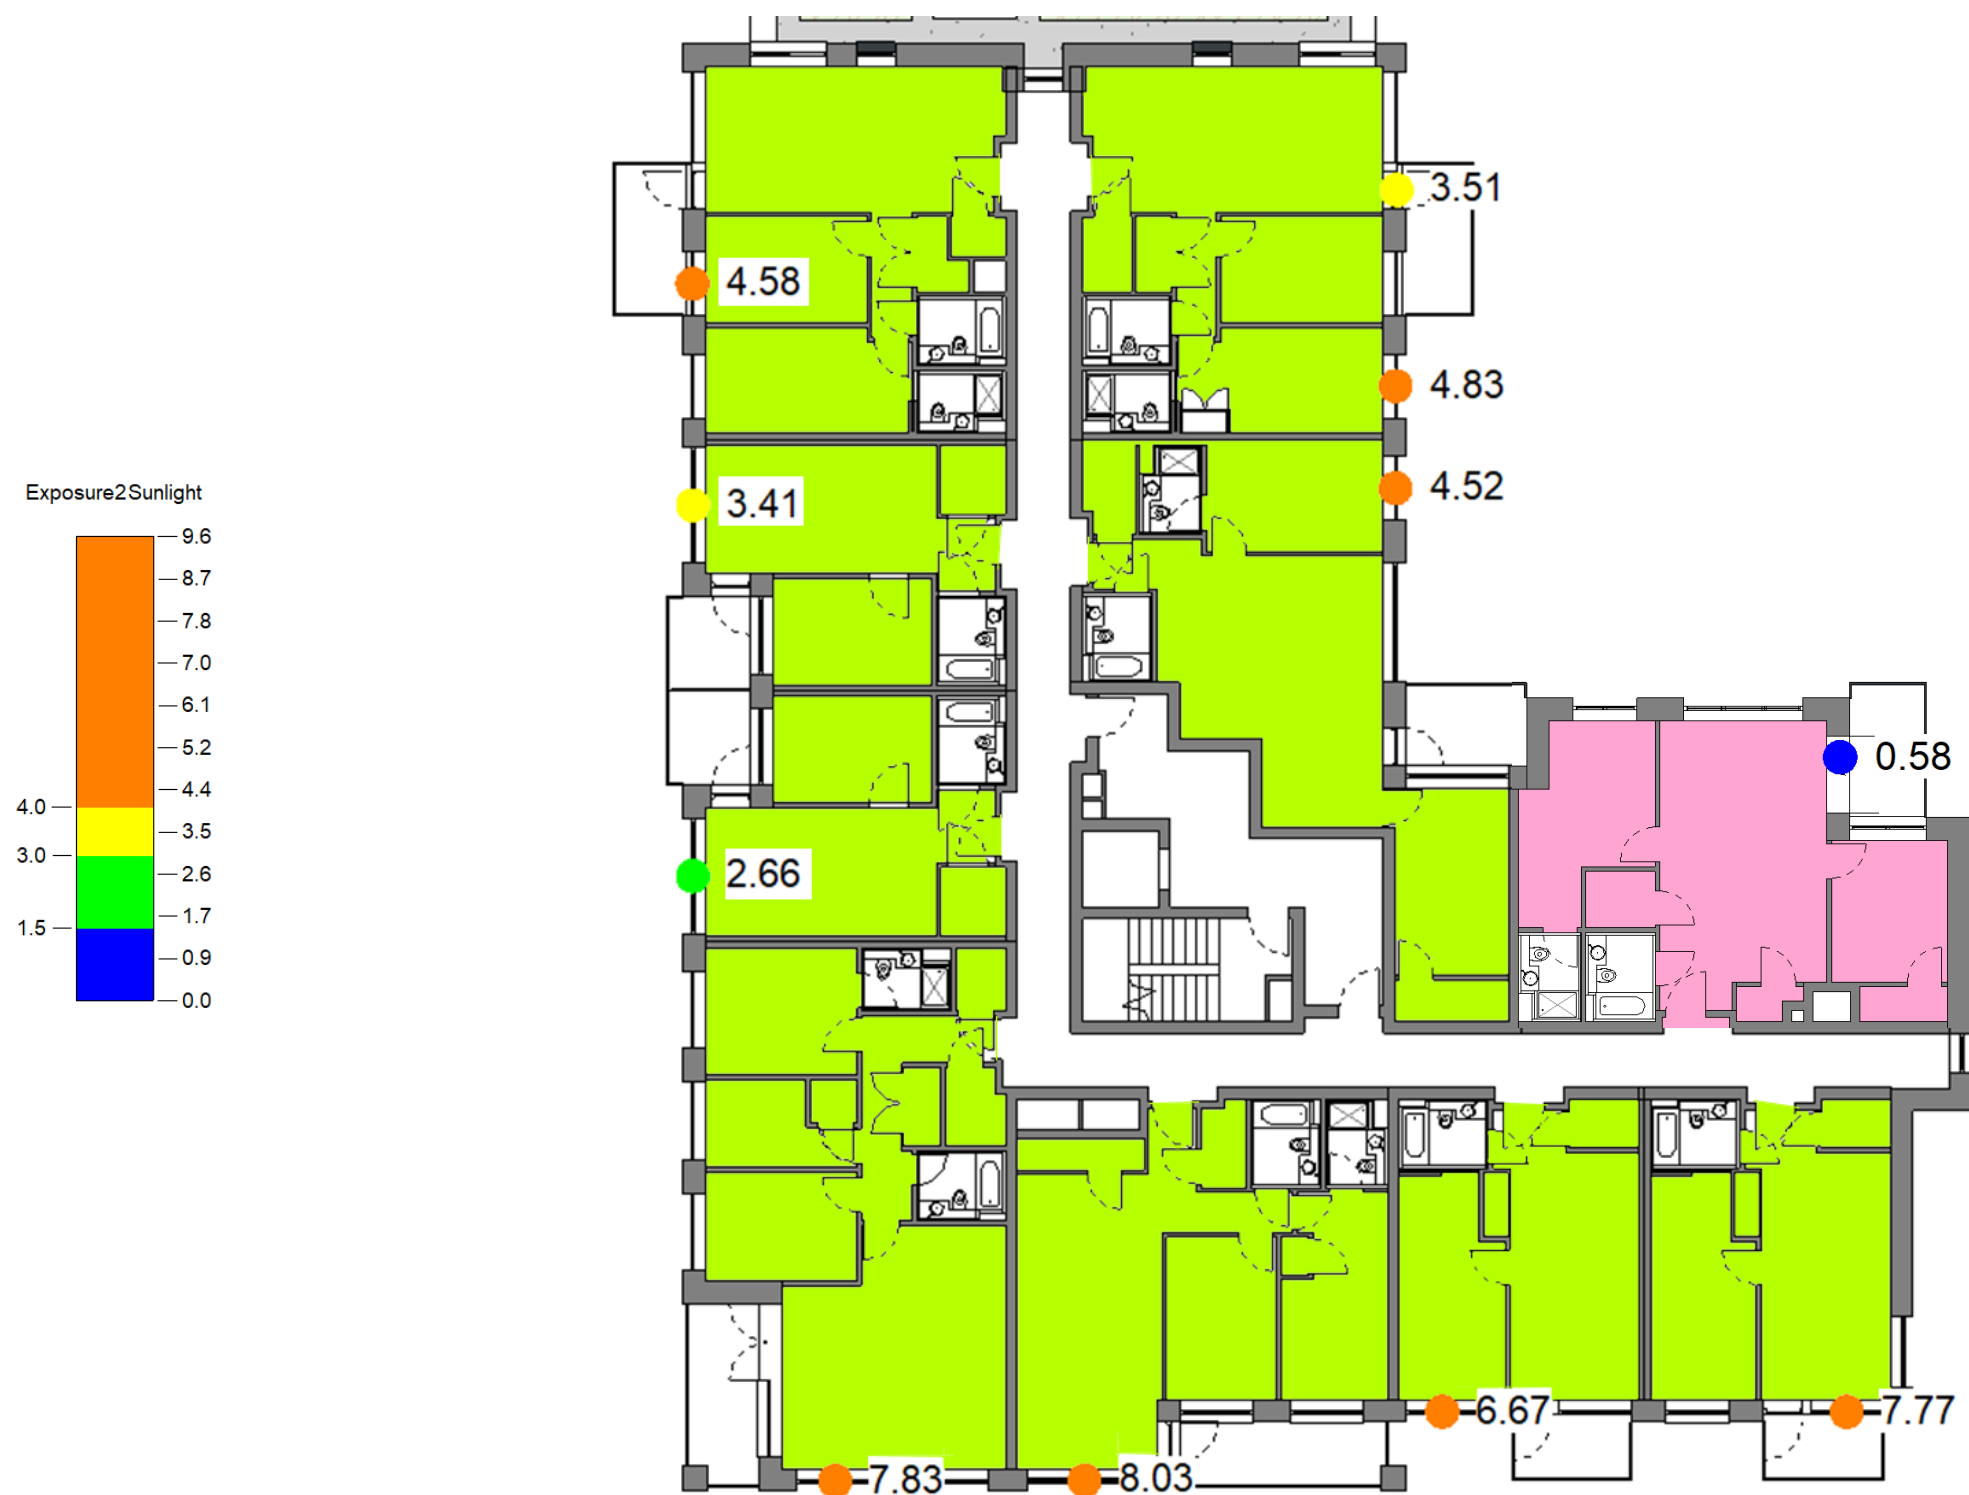
Block F – Sixth Floor

Sunlight Analysis as illustrated below, determined 1 unit on this block does not achieve the minimum recommendations.
The rest of the units achieve the minimum recommendations.

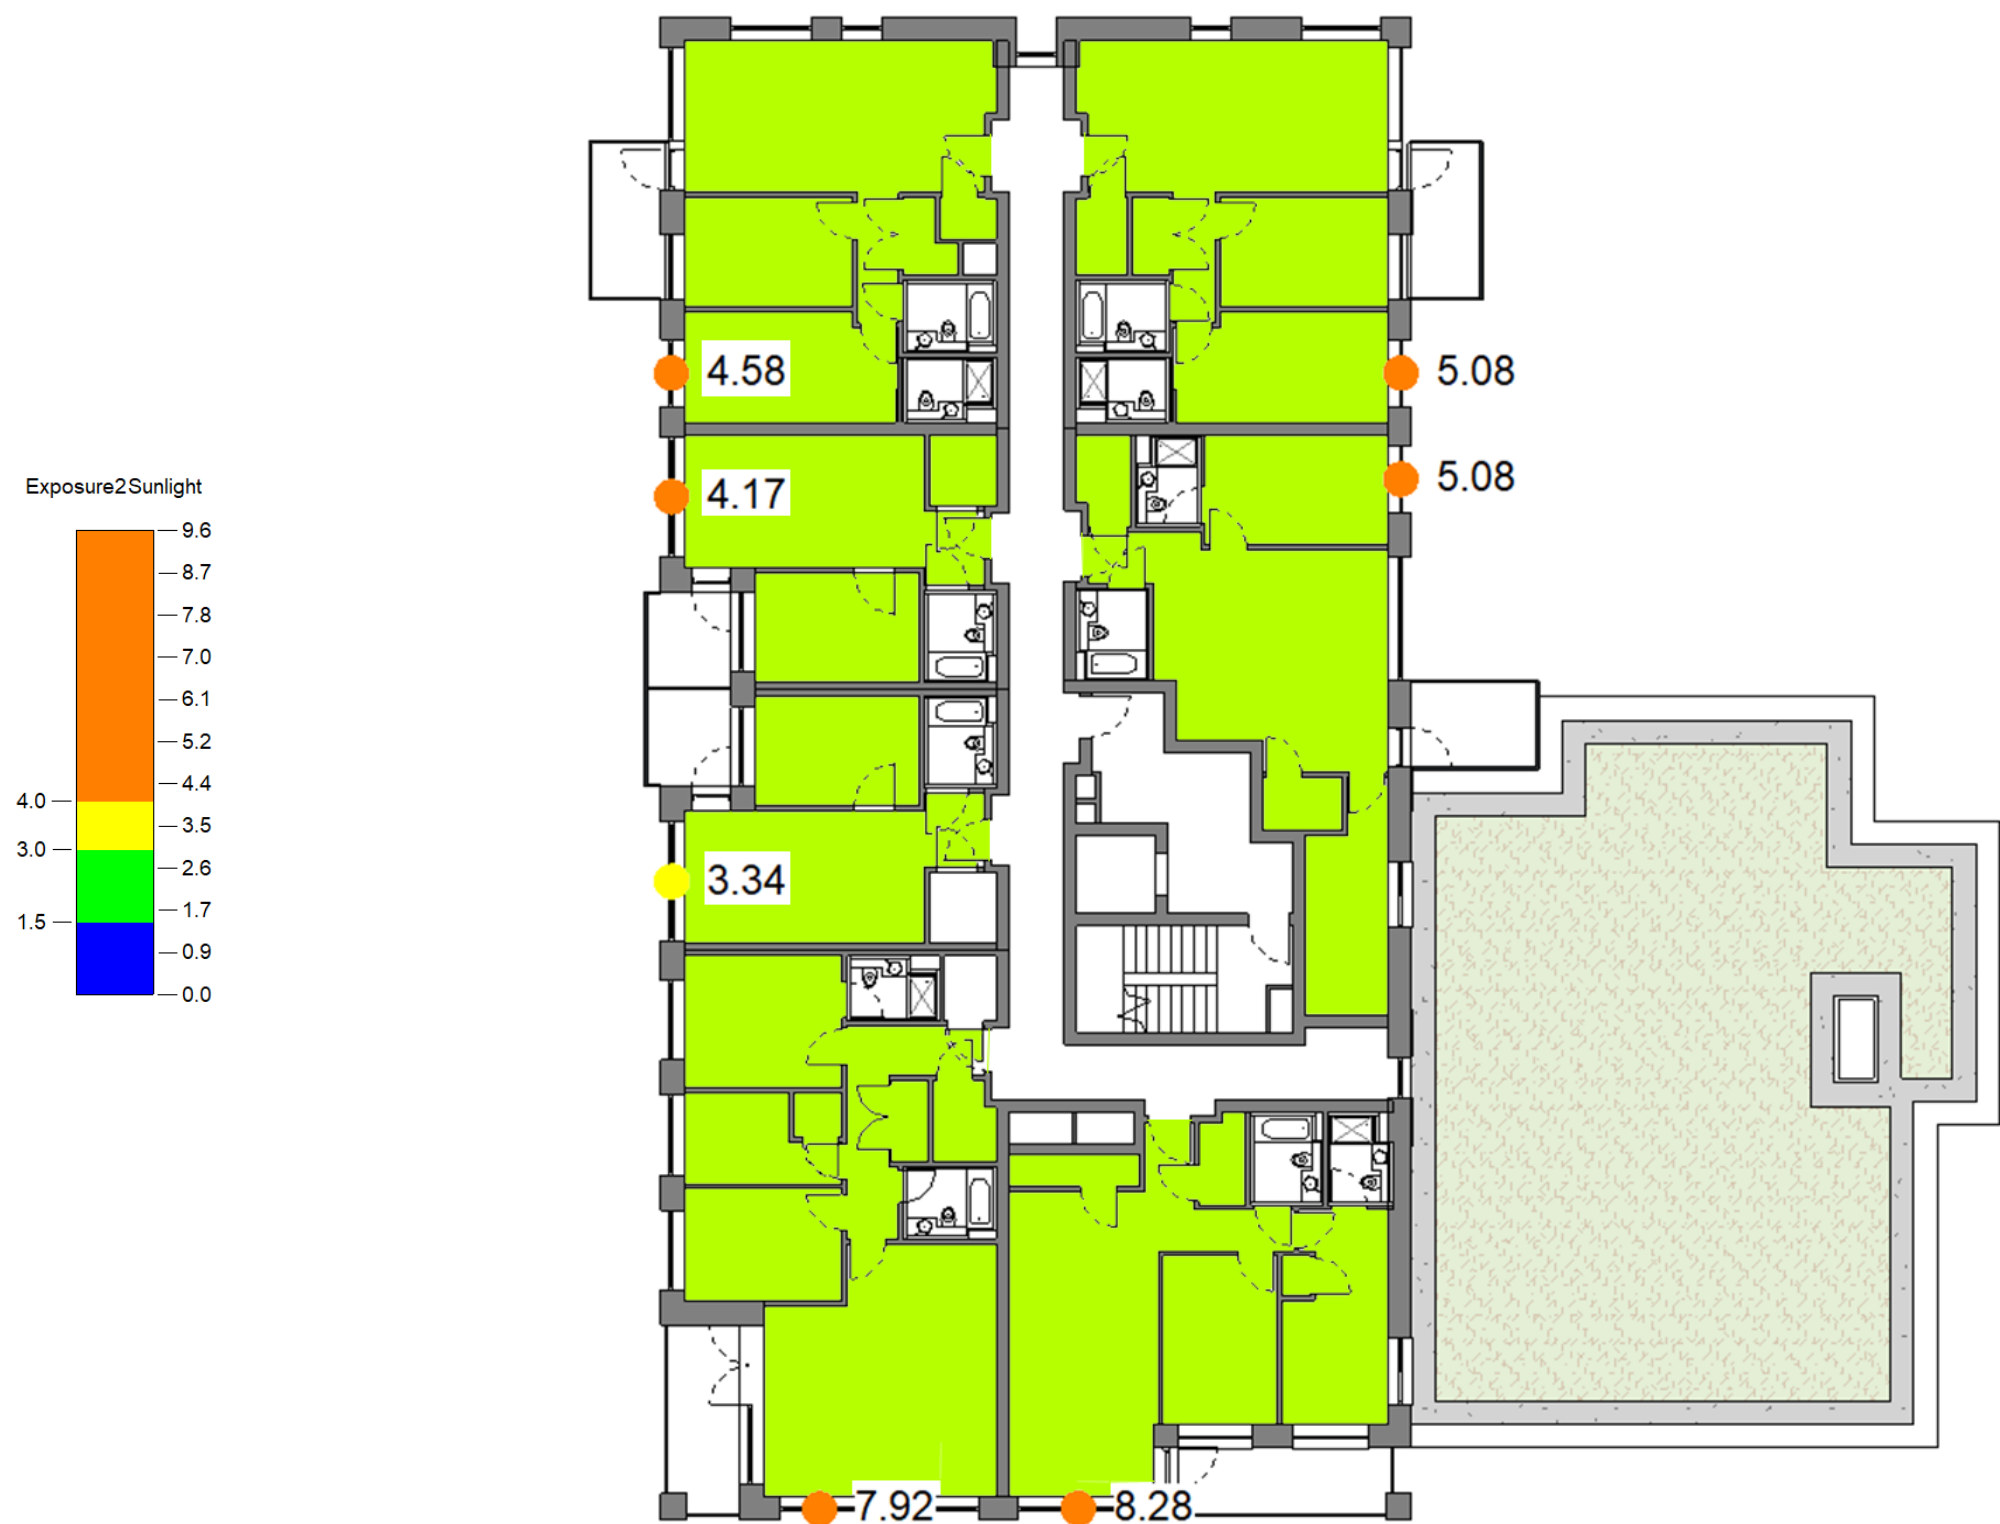
Block F – Seventh Floor

Sunlight Analysis as illustrated below, determined all units on this block achieve the minimum recommendations.

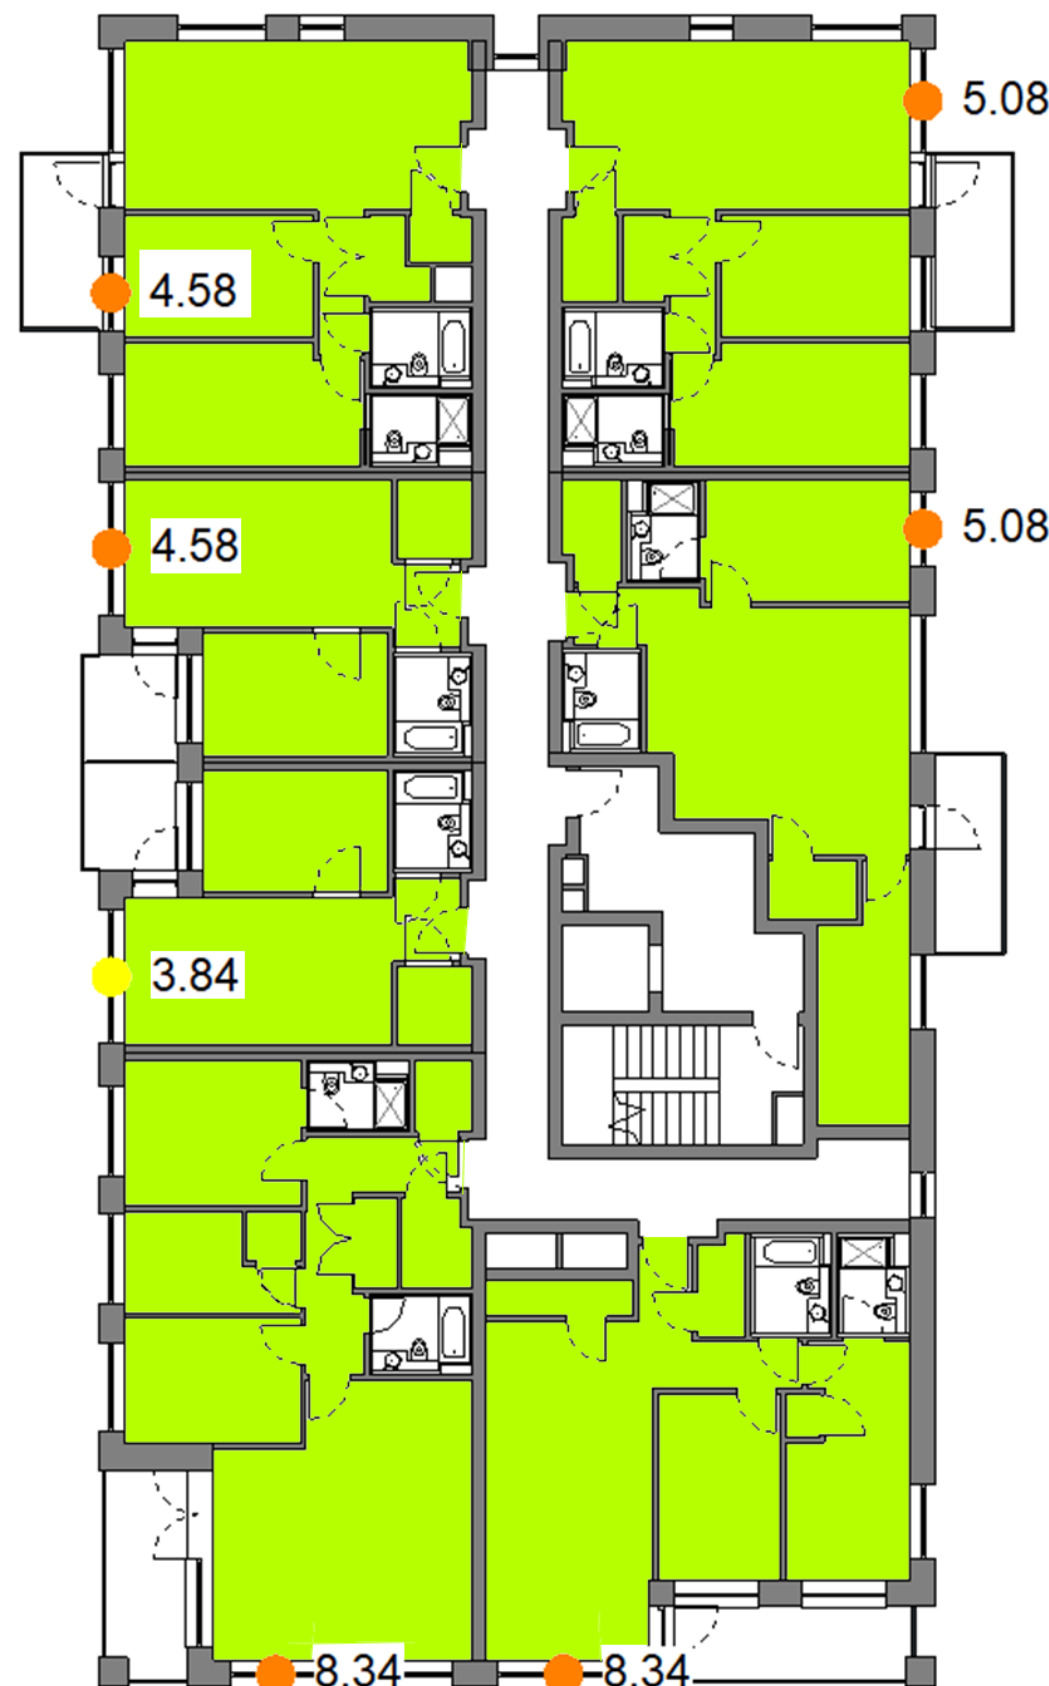
Sunlight Analysis as illustrated below, determined all units on this block achieve the minimum recommendations.

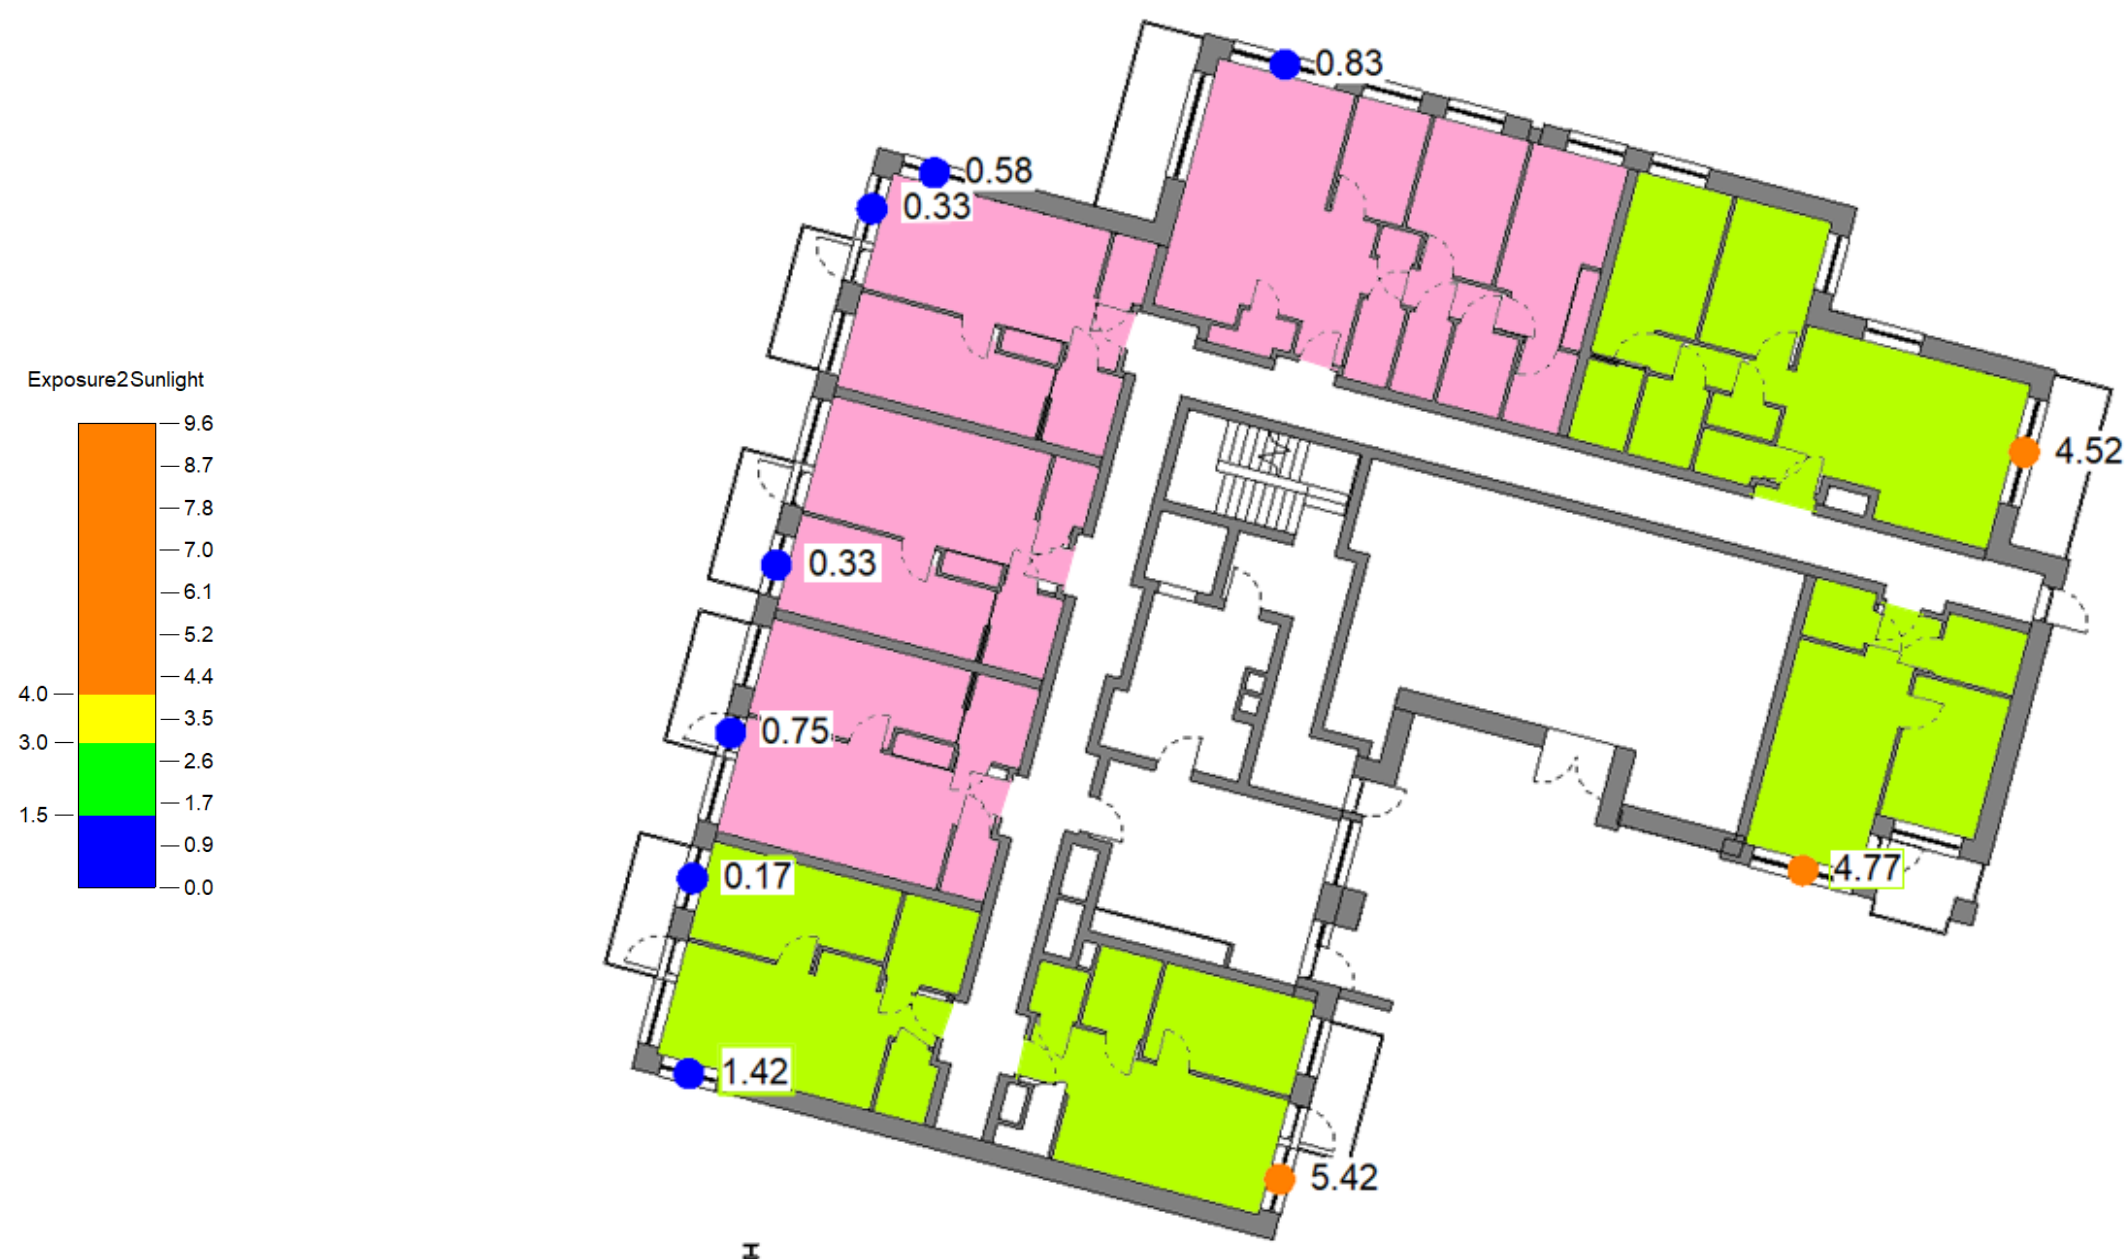
Sunlight Analysis as illustrated below, determined 4 units on this block do not achieve the minimum recommendations.

The rest of the units achieve the minimum recommendations.

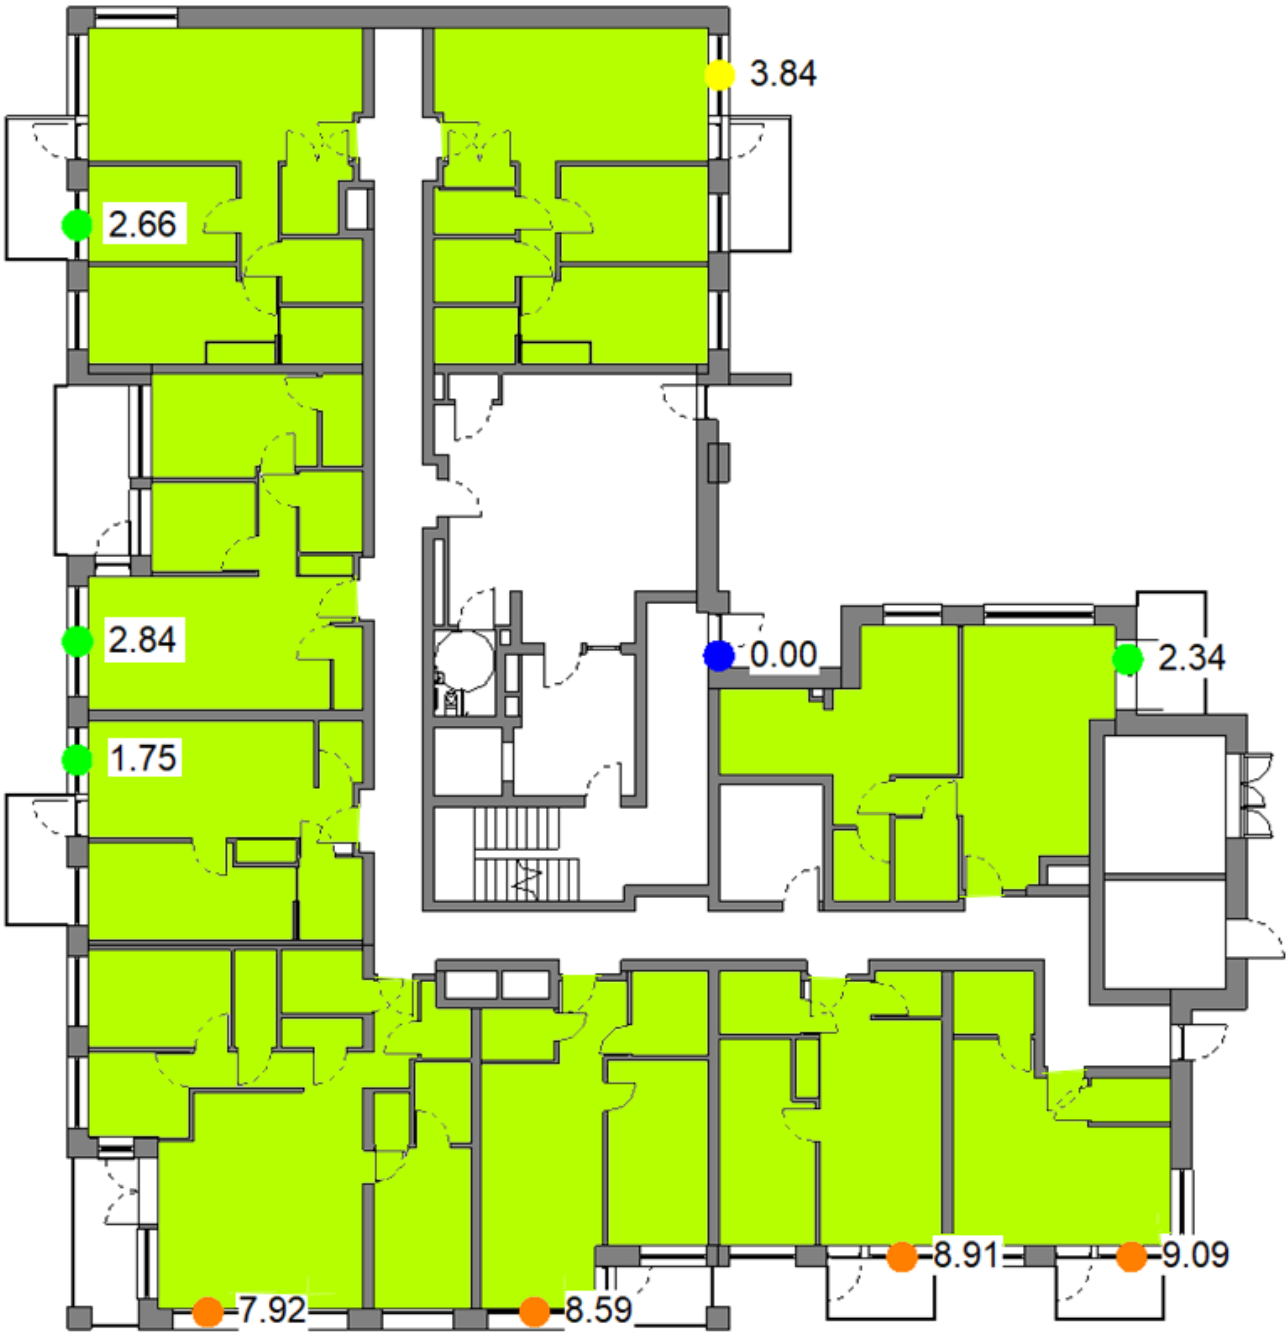
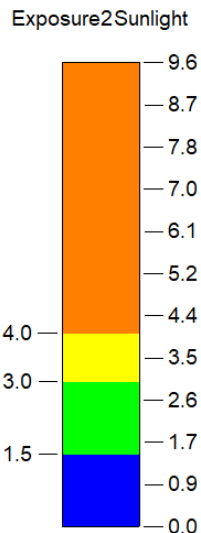
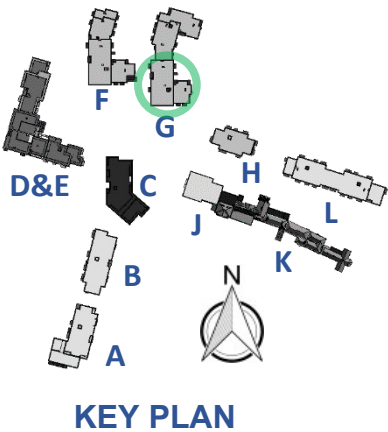
Block G – Ground Floor

Sunlight Analysis as illustrated below, determined all units on this block achieve the minimum recommendations.

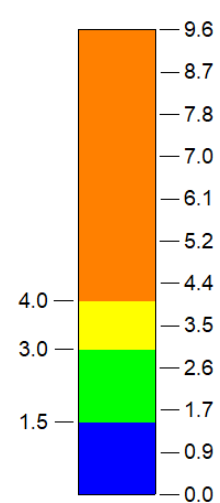
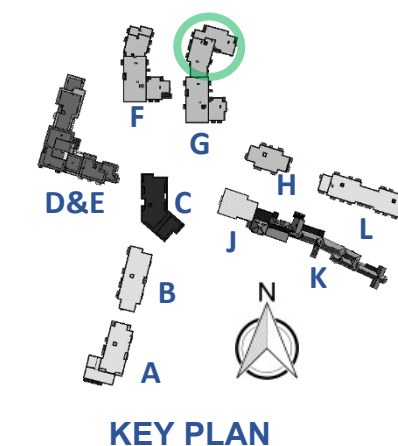
Sunlight Analysis as illustrated below, determined 3 units on this block do not achieve the minimum recommendations.

The rest of the units achieve the minimum recommendations.

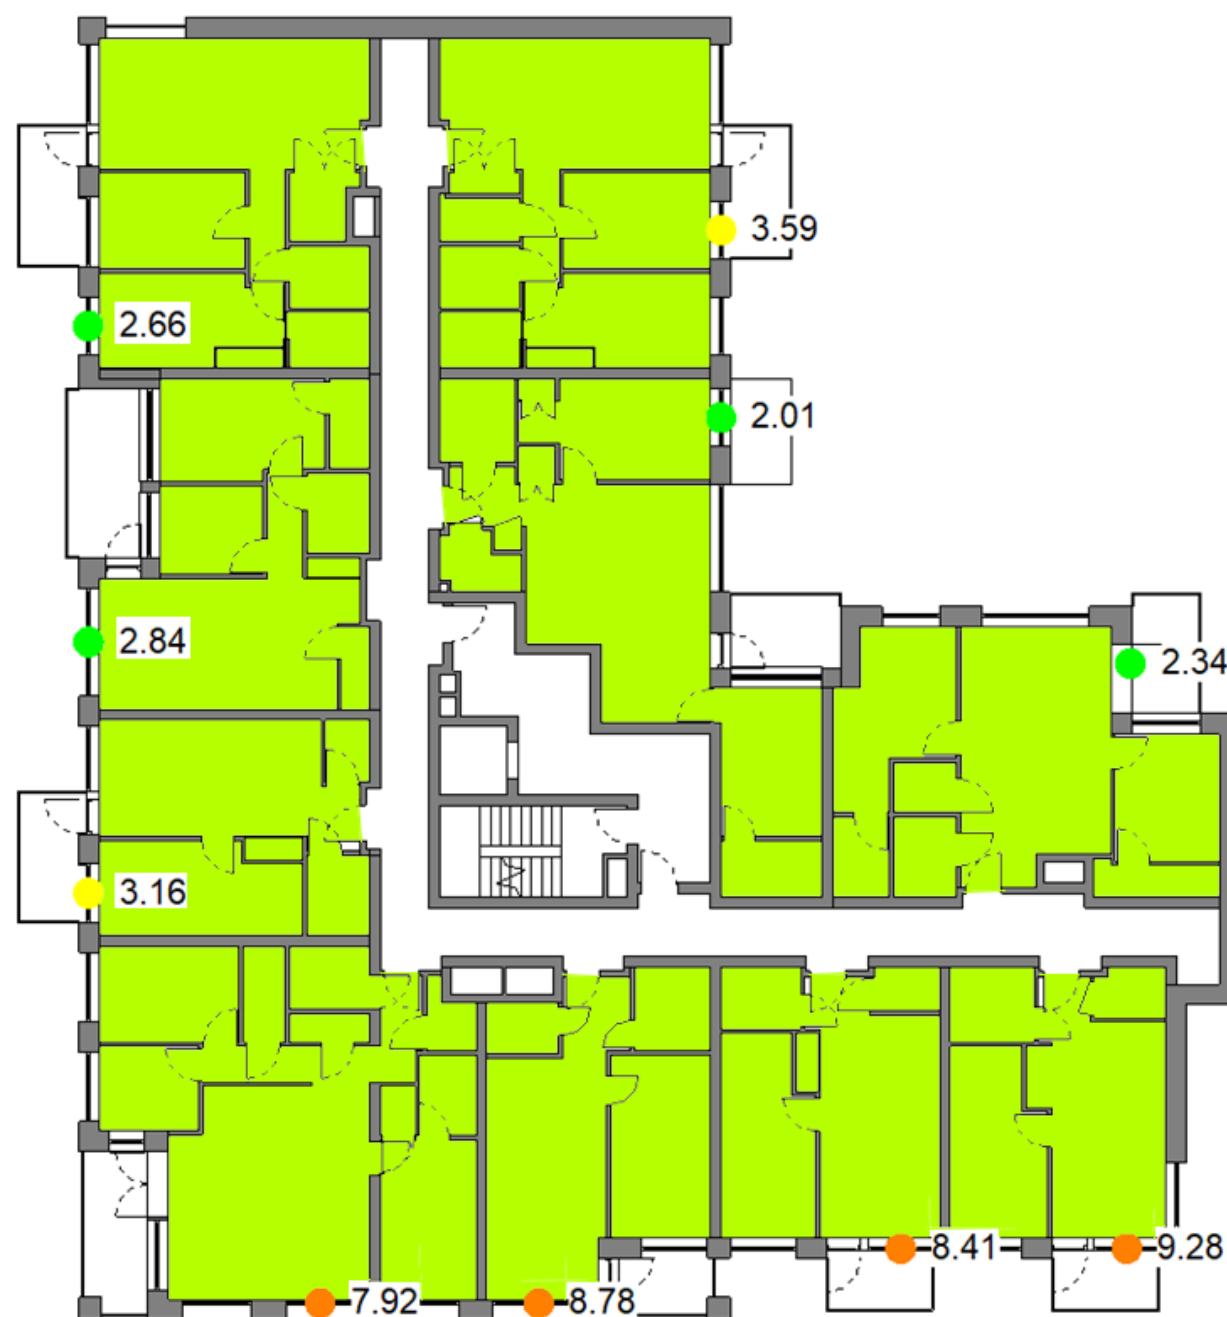
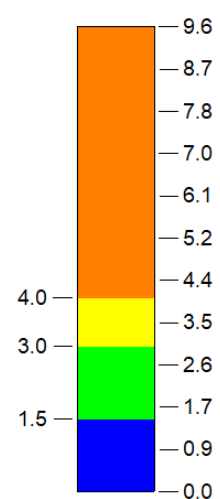
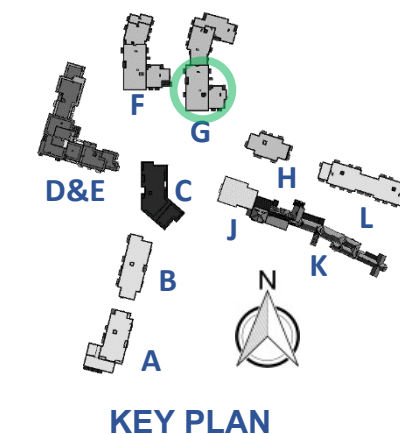
Sunlight Analysis as illustrated below, determined all units on this block achieve the minimum recommendations.

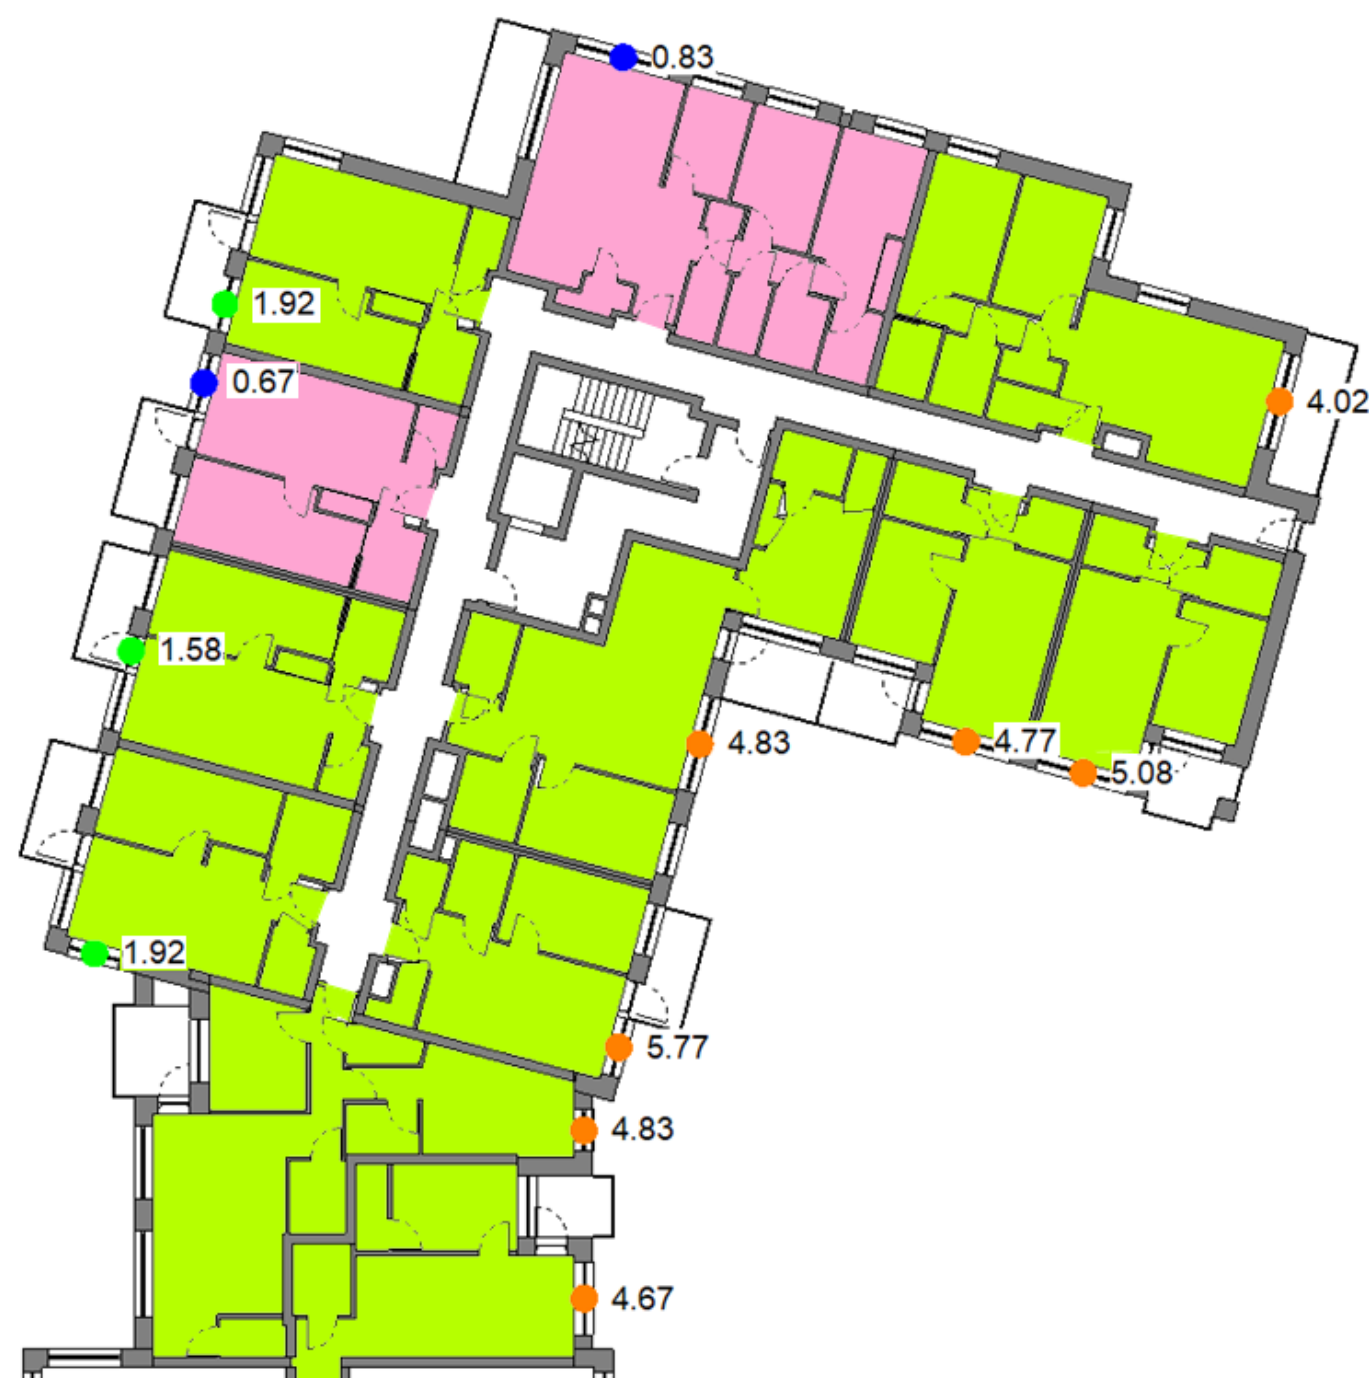
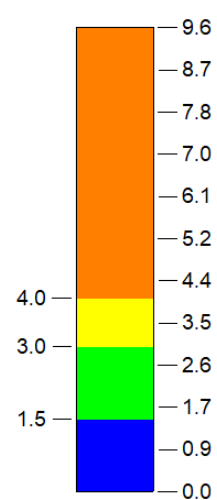
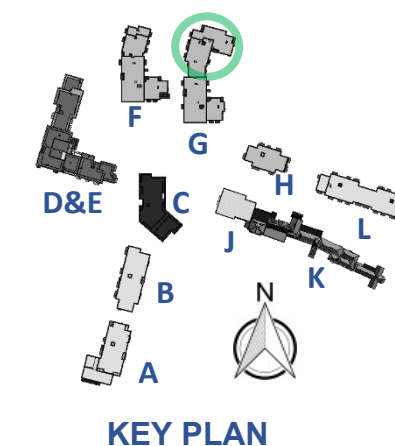
Sunlight Analysis as illustrated below, determined 2 units on this block do not achieve the minimum recommendations.

The rest of the units achieve the minimum recommendations.

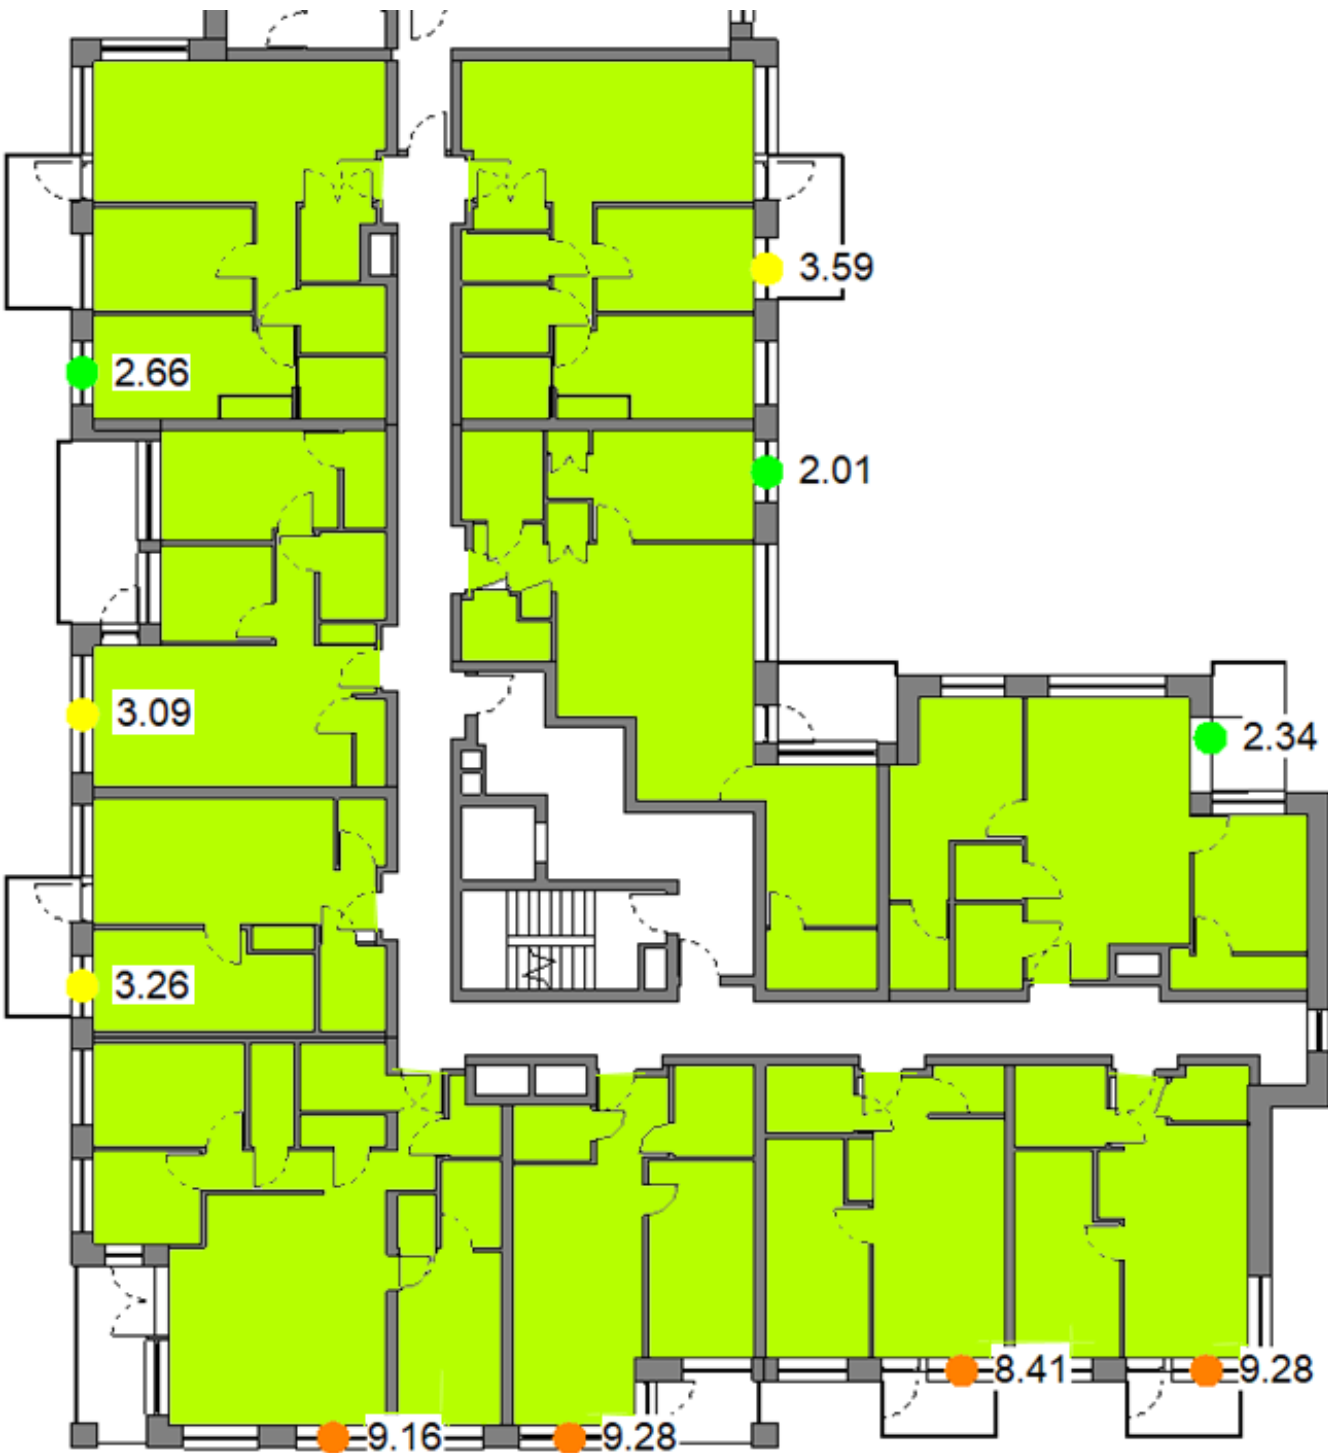
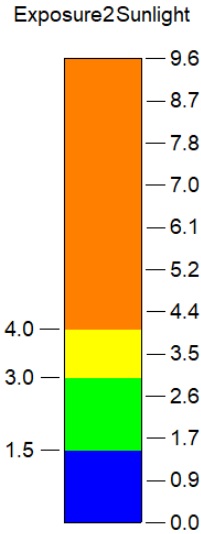
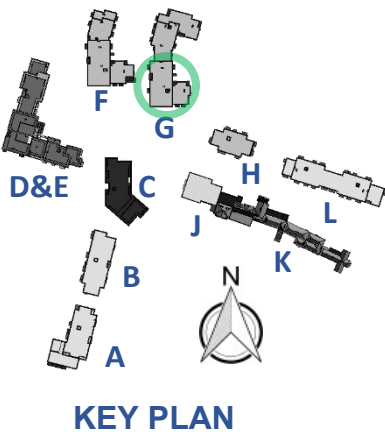
Block G – Second Floor

Sunlight Analysis as illustrated below, determined all units on this block achieve the minimum recommendations.

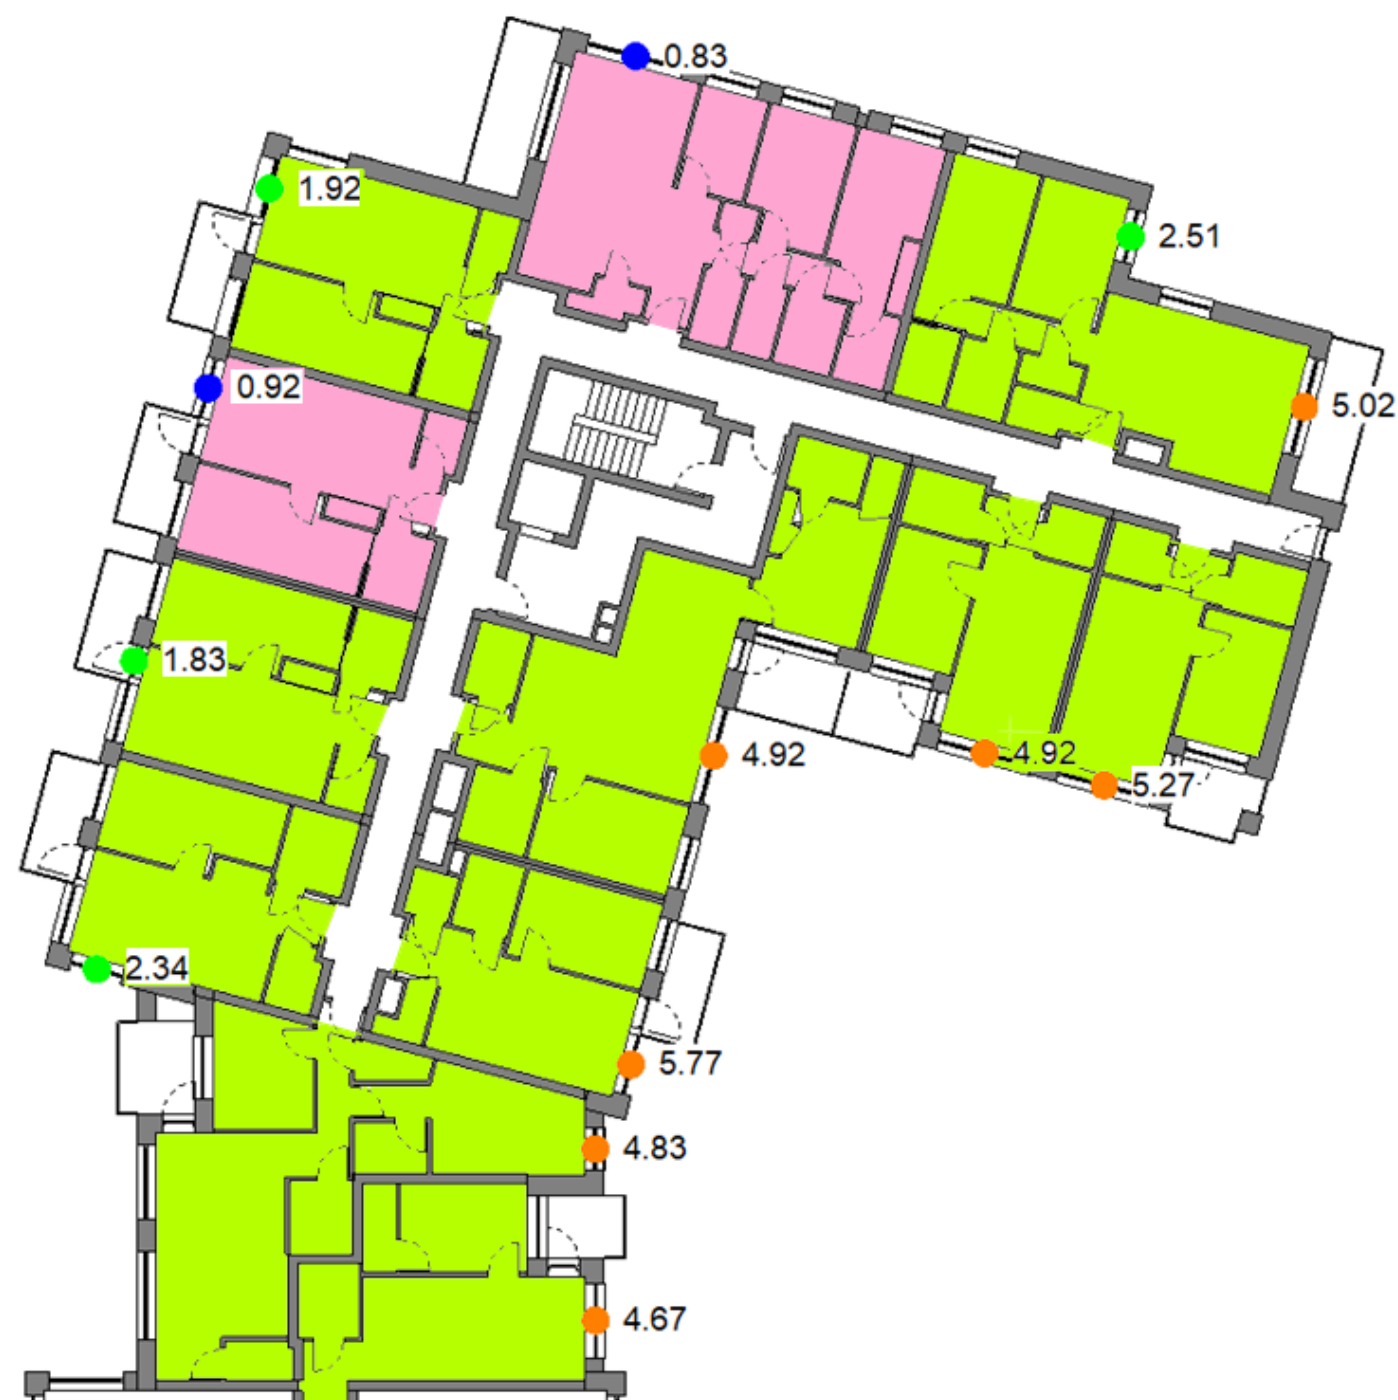
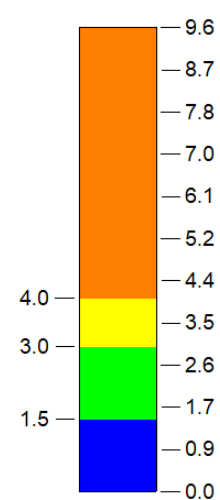
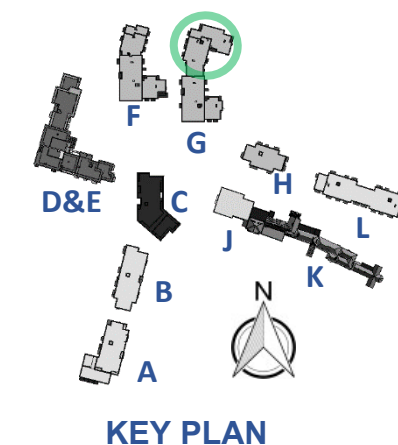
Sunlight Analysis as illustrated below, determined 2 units on this block do not achieve the minimum recommendations.

The rest of the units achieve the minimum recommendations.
