St. Vincent's Hospital Fairview Redevelopment, Fairview Dublin 3

Daylight and Sunlight Analysis

IN2 Project No. D2116

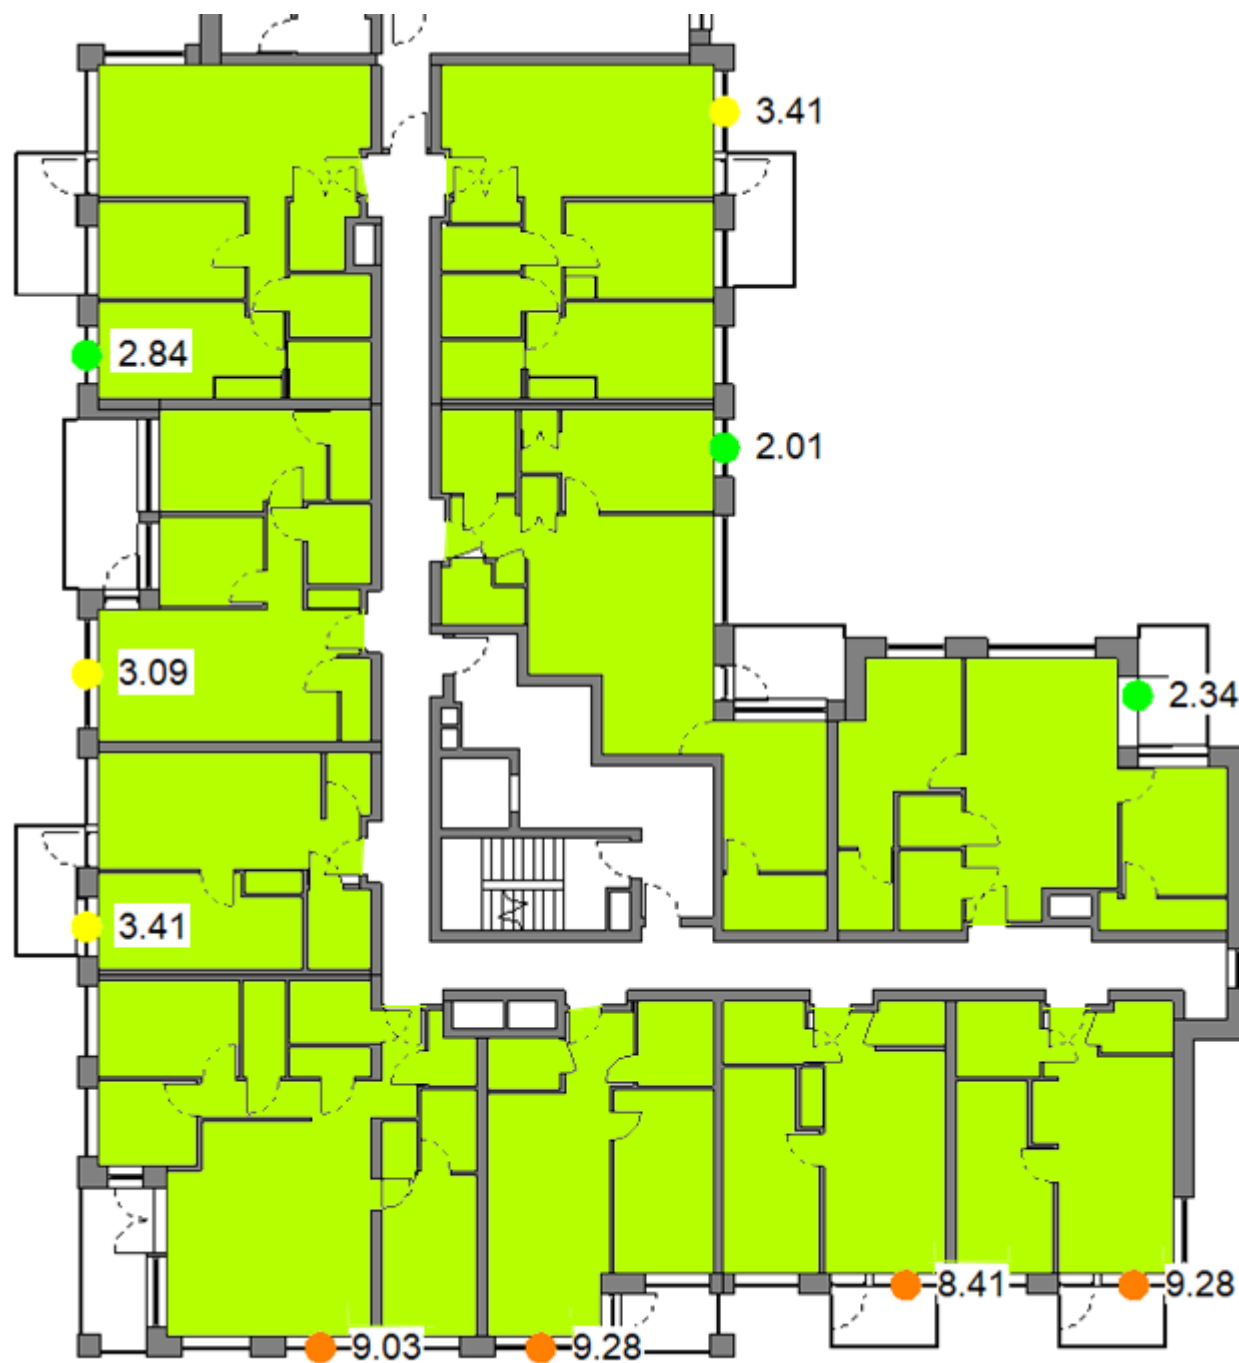
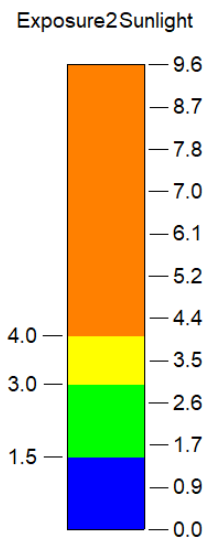
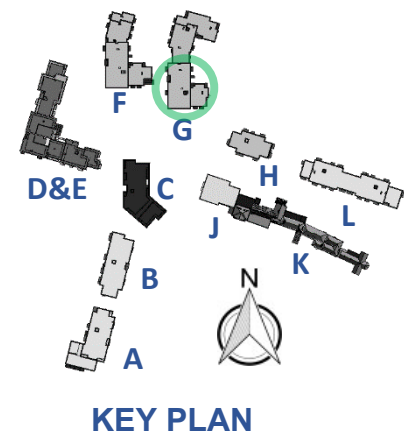
Block G – Third Floor

Sunlight Analysis as illustrated below, determined all units on this block achieve the minimum recommendations.

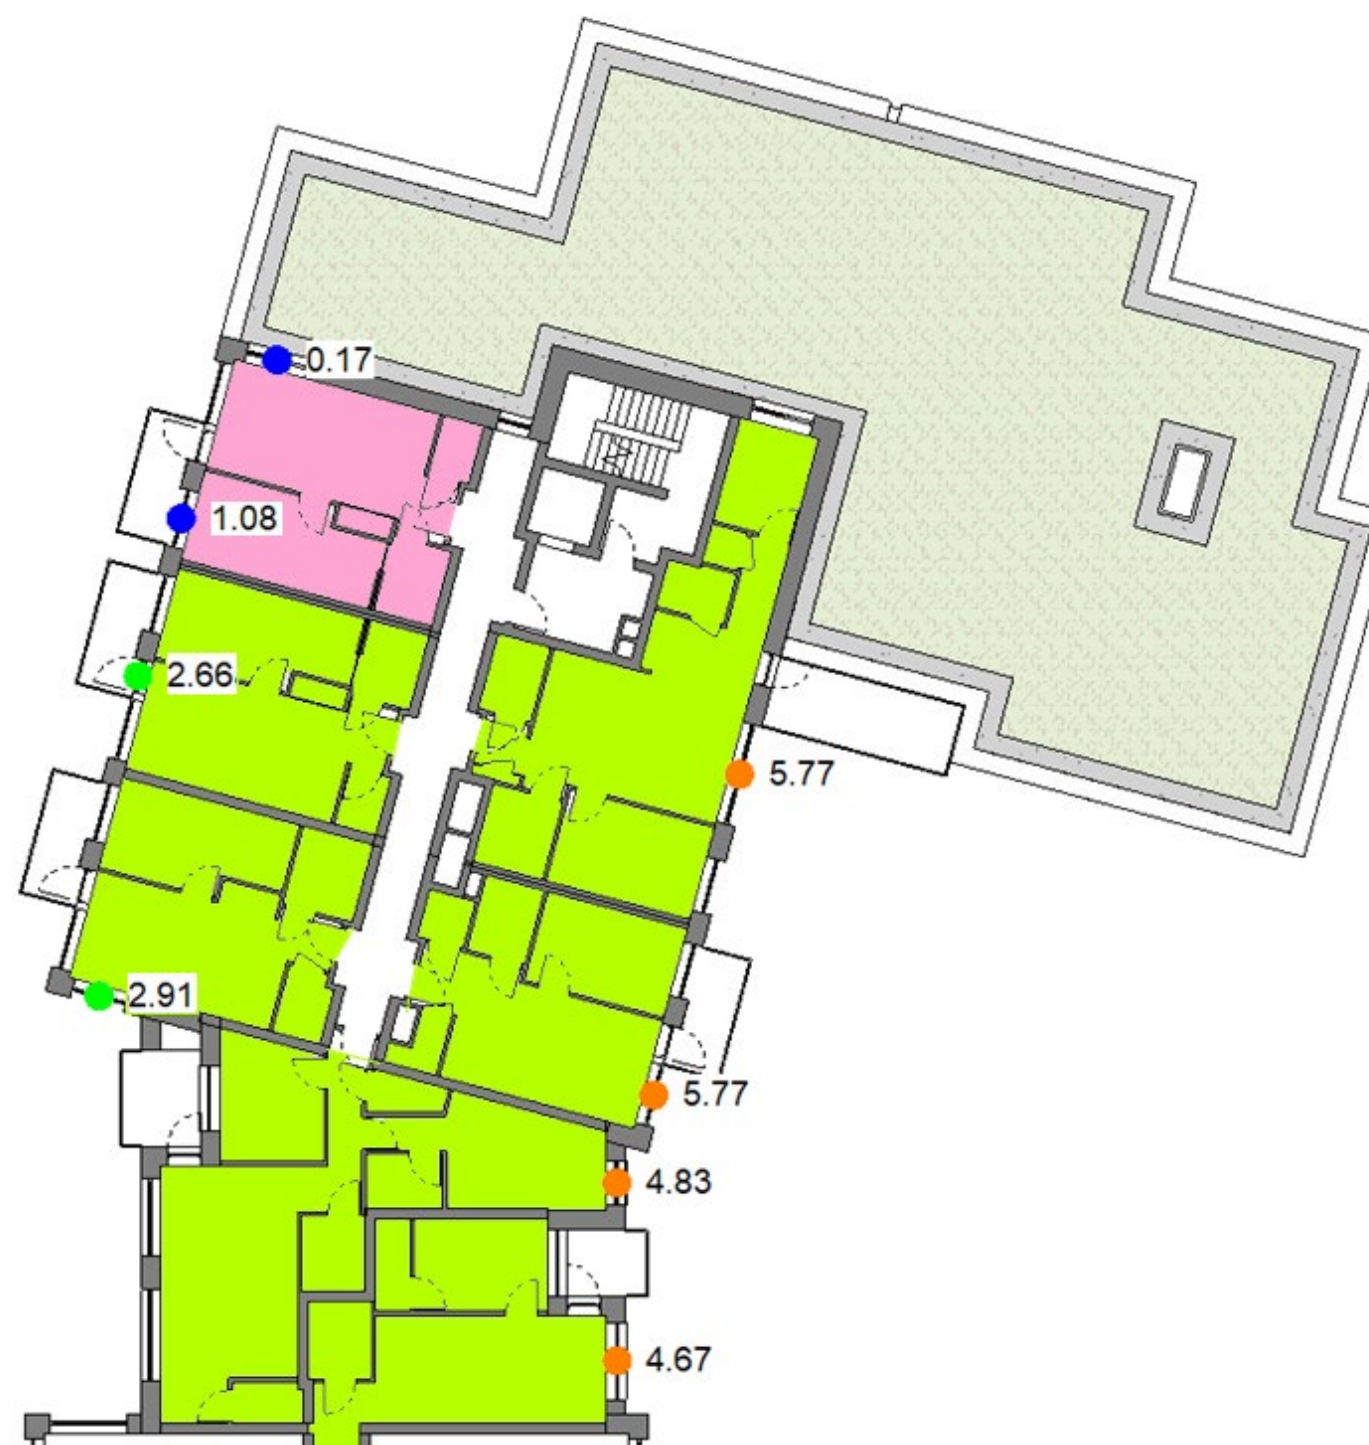
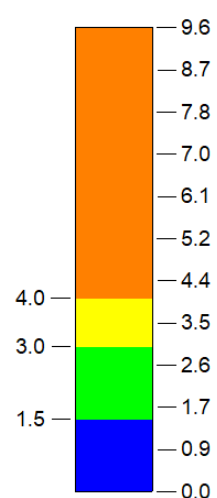
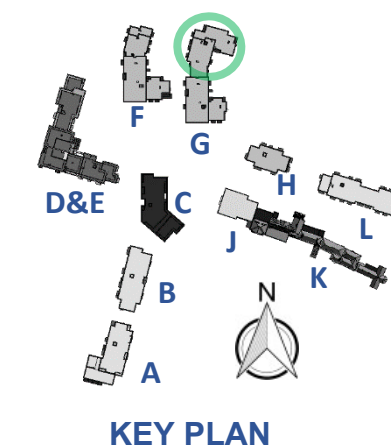
Sunlight Analysis as illustrated below, determined 1 unit on this block does not achieve the minimum recommendations.

The rest of the units achieve the minimum recommendations.

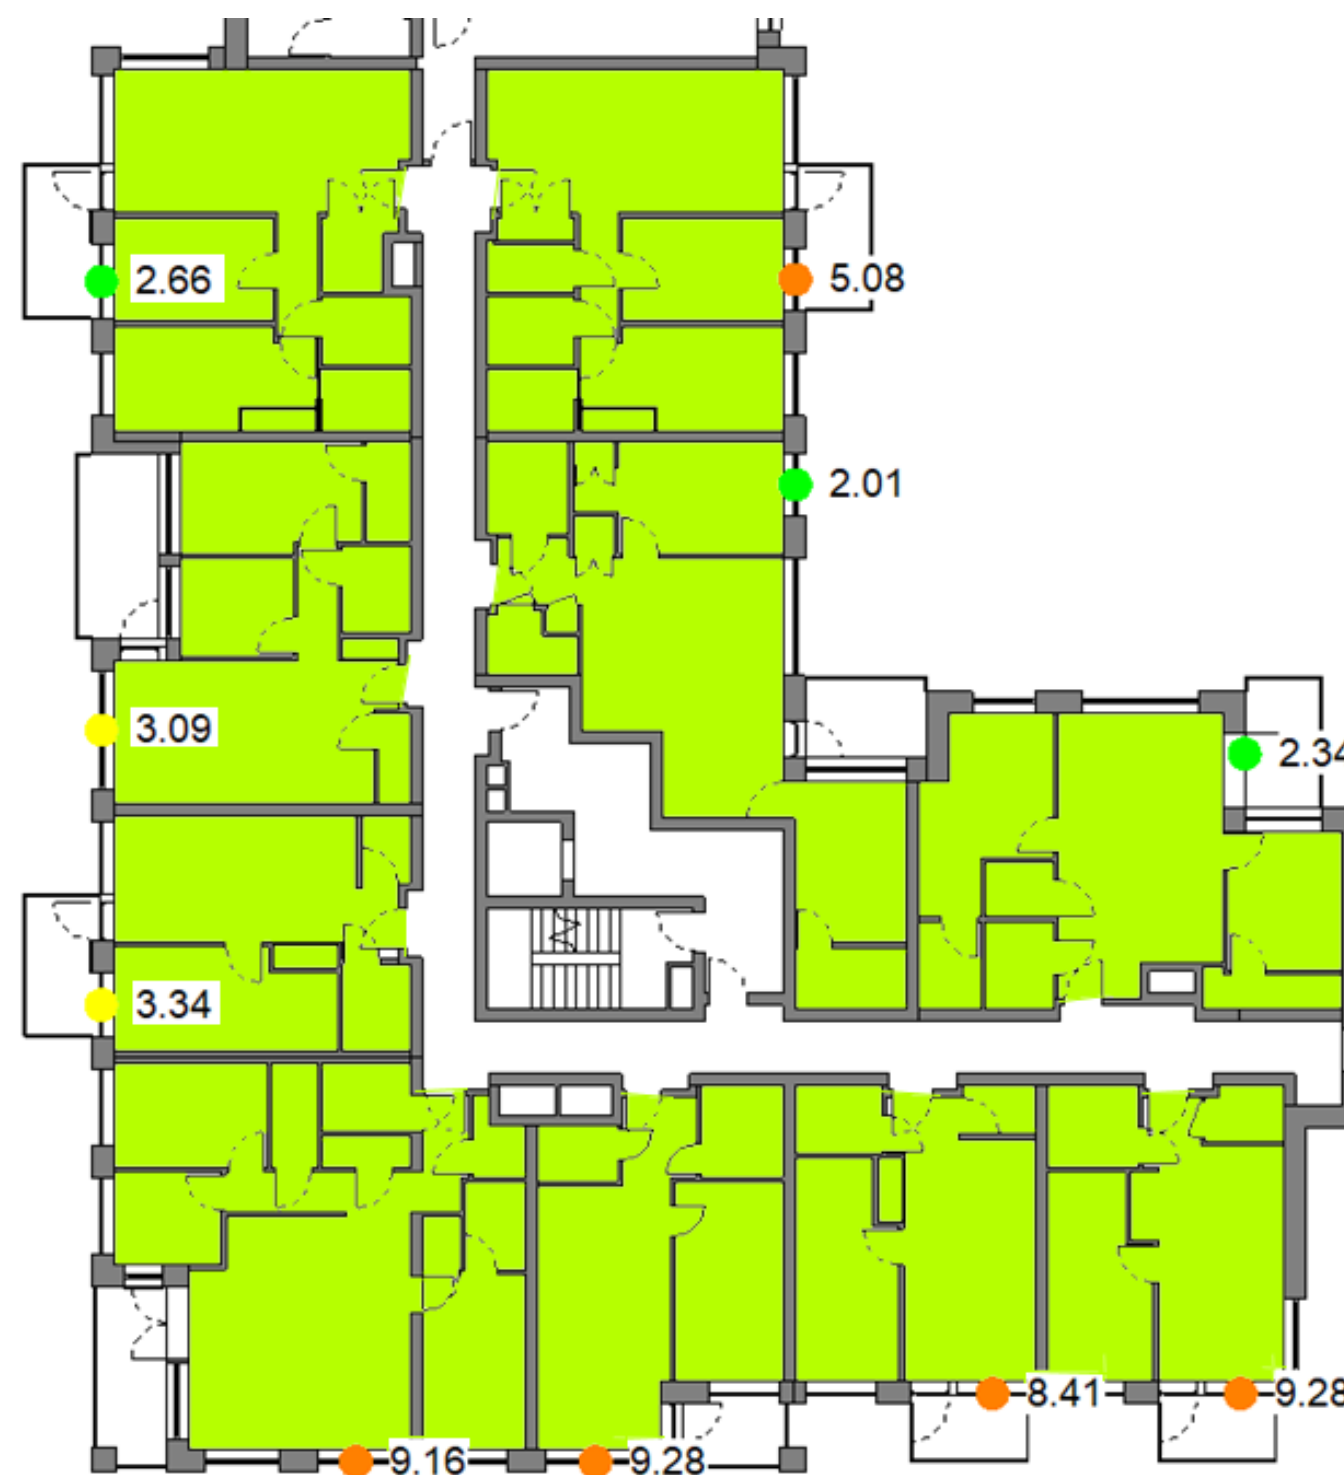
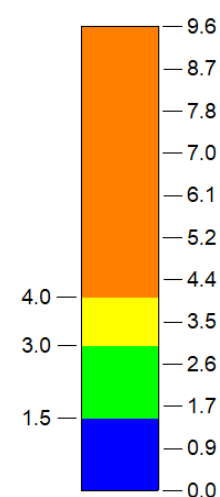
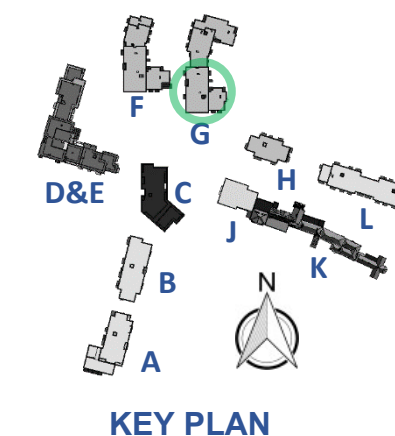
Sunlight Analysis as illustrated below, determined all units on this block achieve the minimum recommendations.

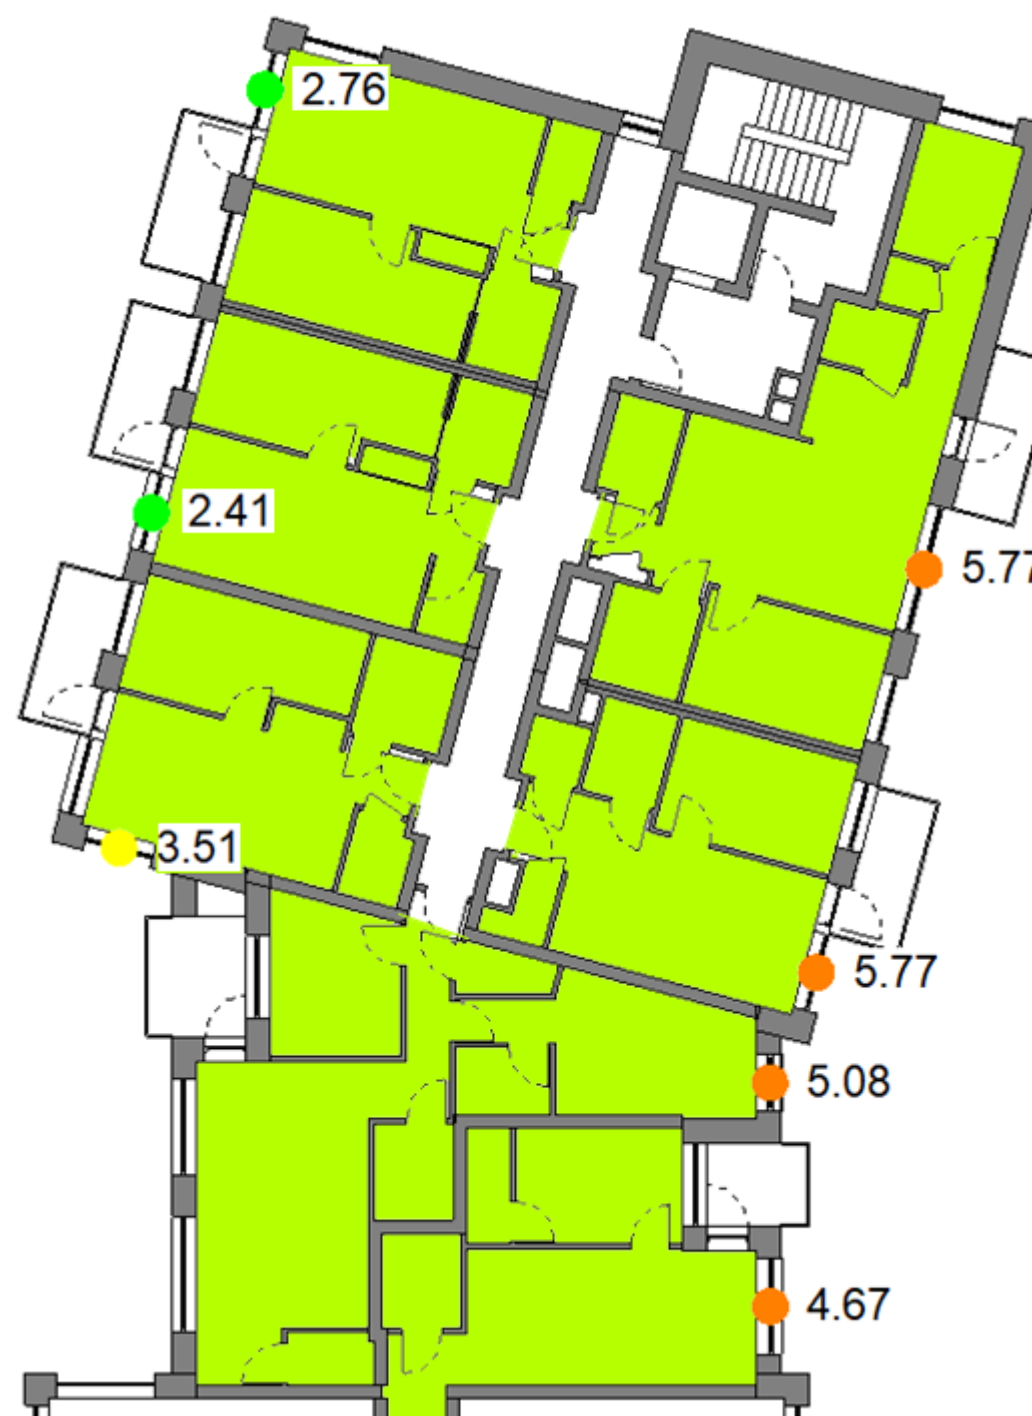
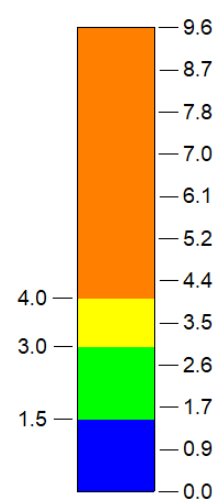
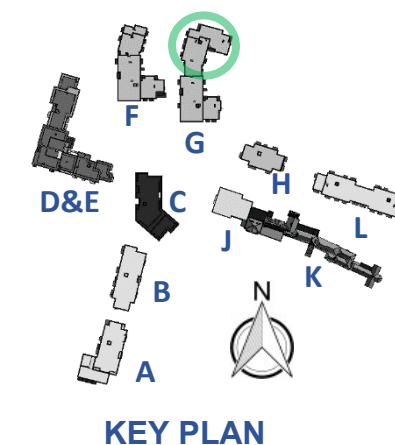
Sunlight Analysis as illustrated below, determined all units on this block achieve the minimum recommendations.

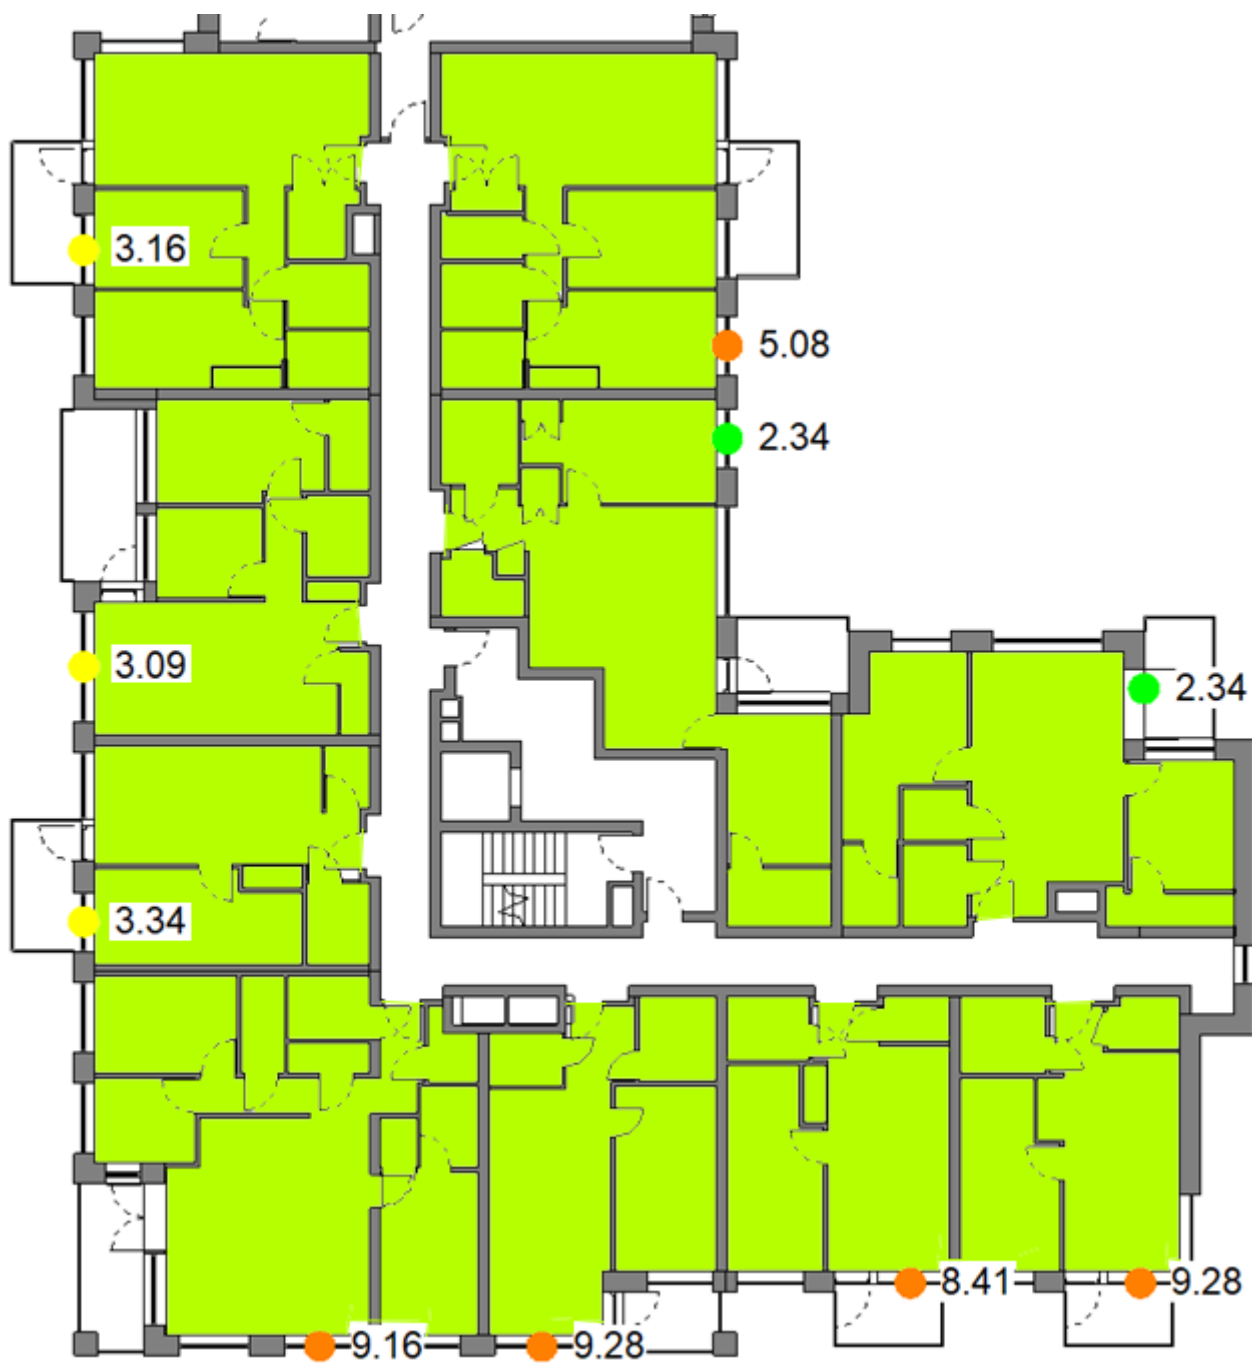
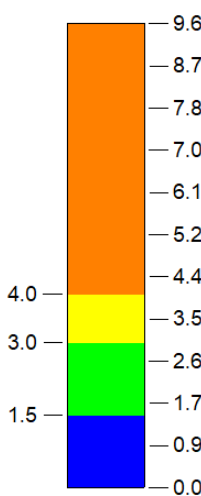
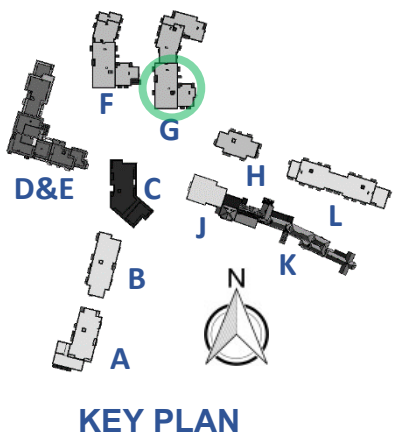
Sunlight Analysis as illustrated below, determined all units on this block achieve the minimum recommendations.

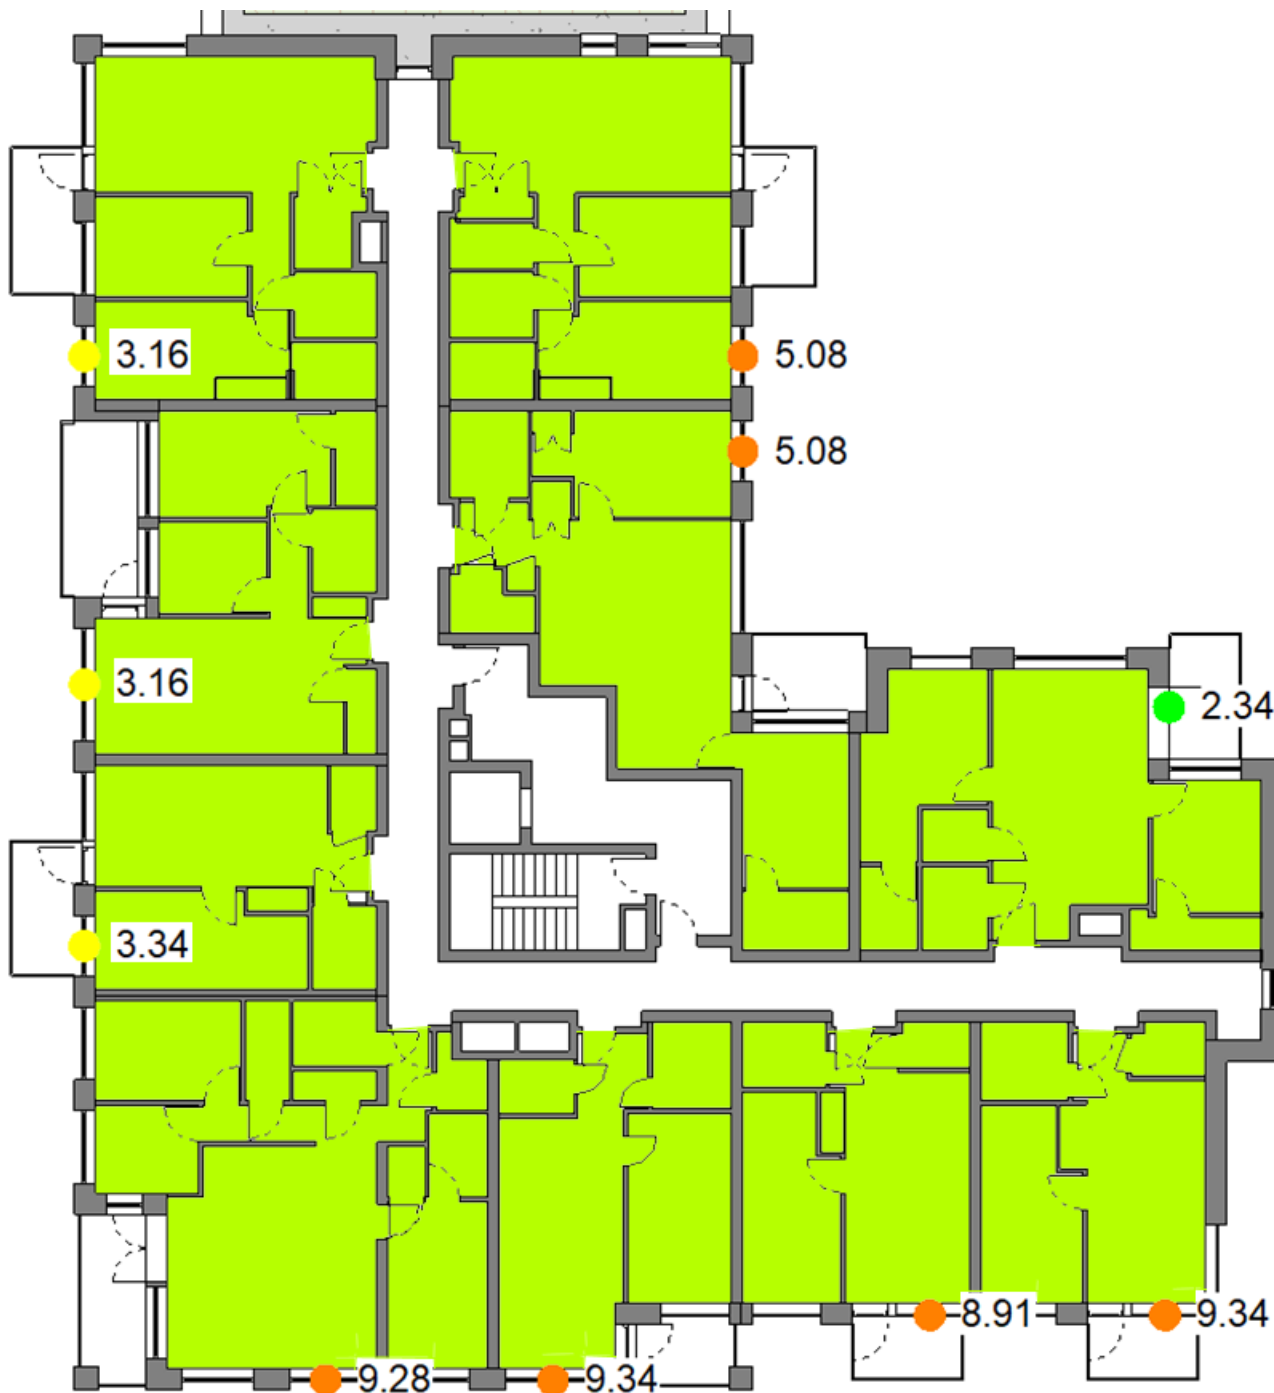
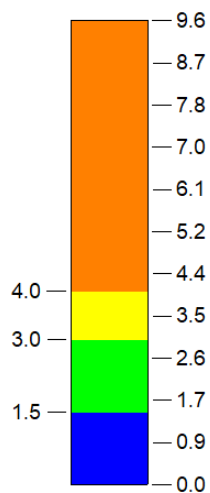
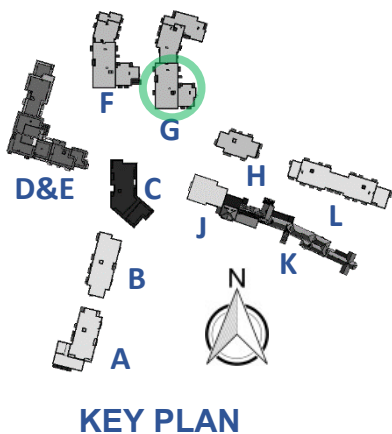
Block G – Sixth Floor

Sunlight Analysis as illustrated below, determined all units on this block achieve the minimum recommendations.

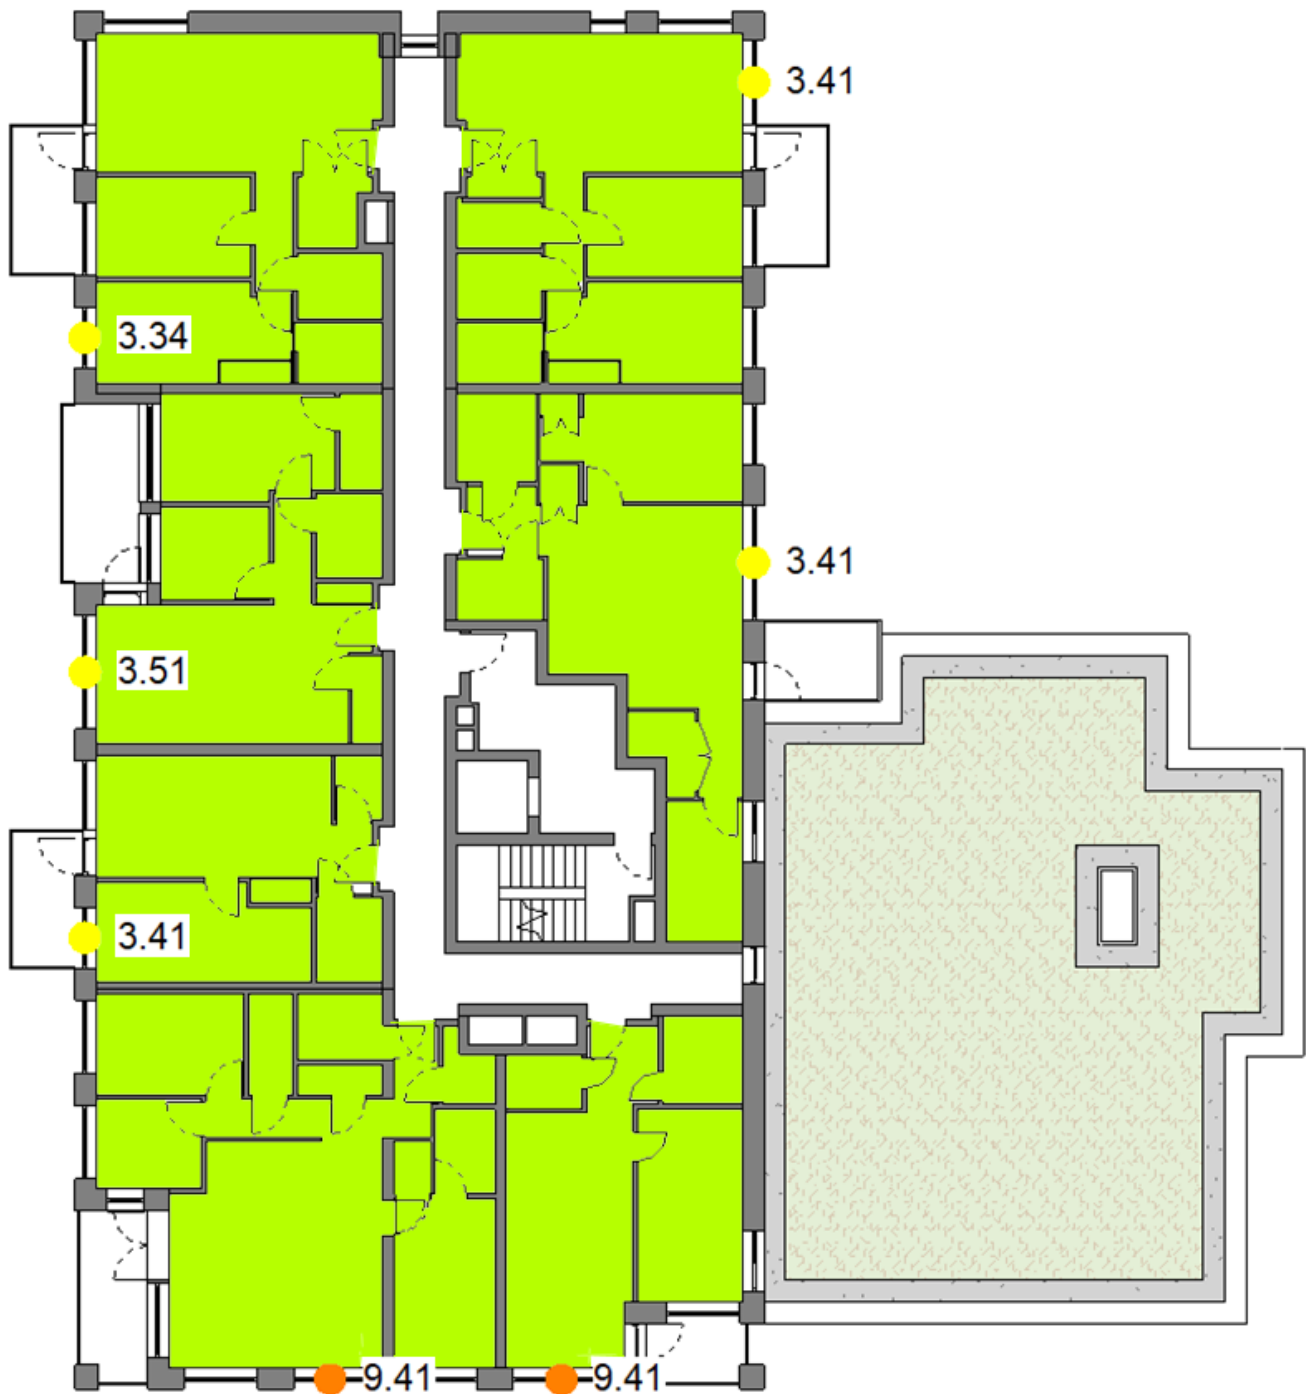
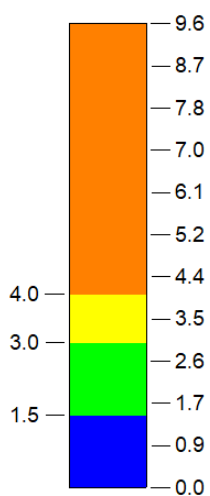
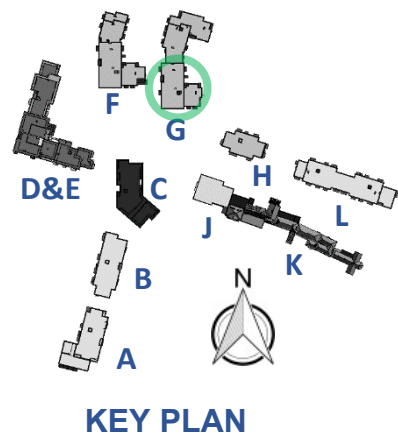
Sunlight Analysis as illustrated below, determined all units on this block achieve the minimum recommendations.

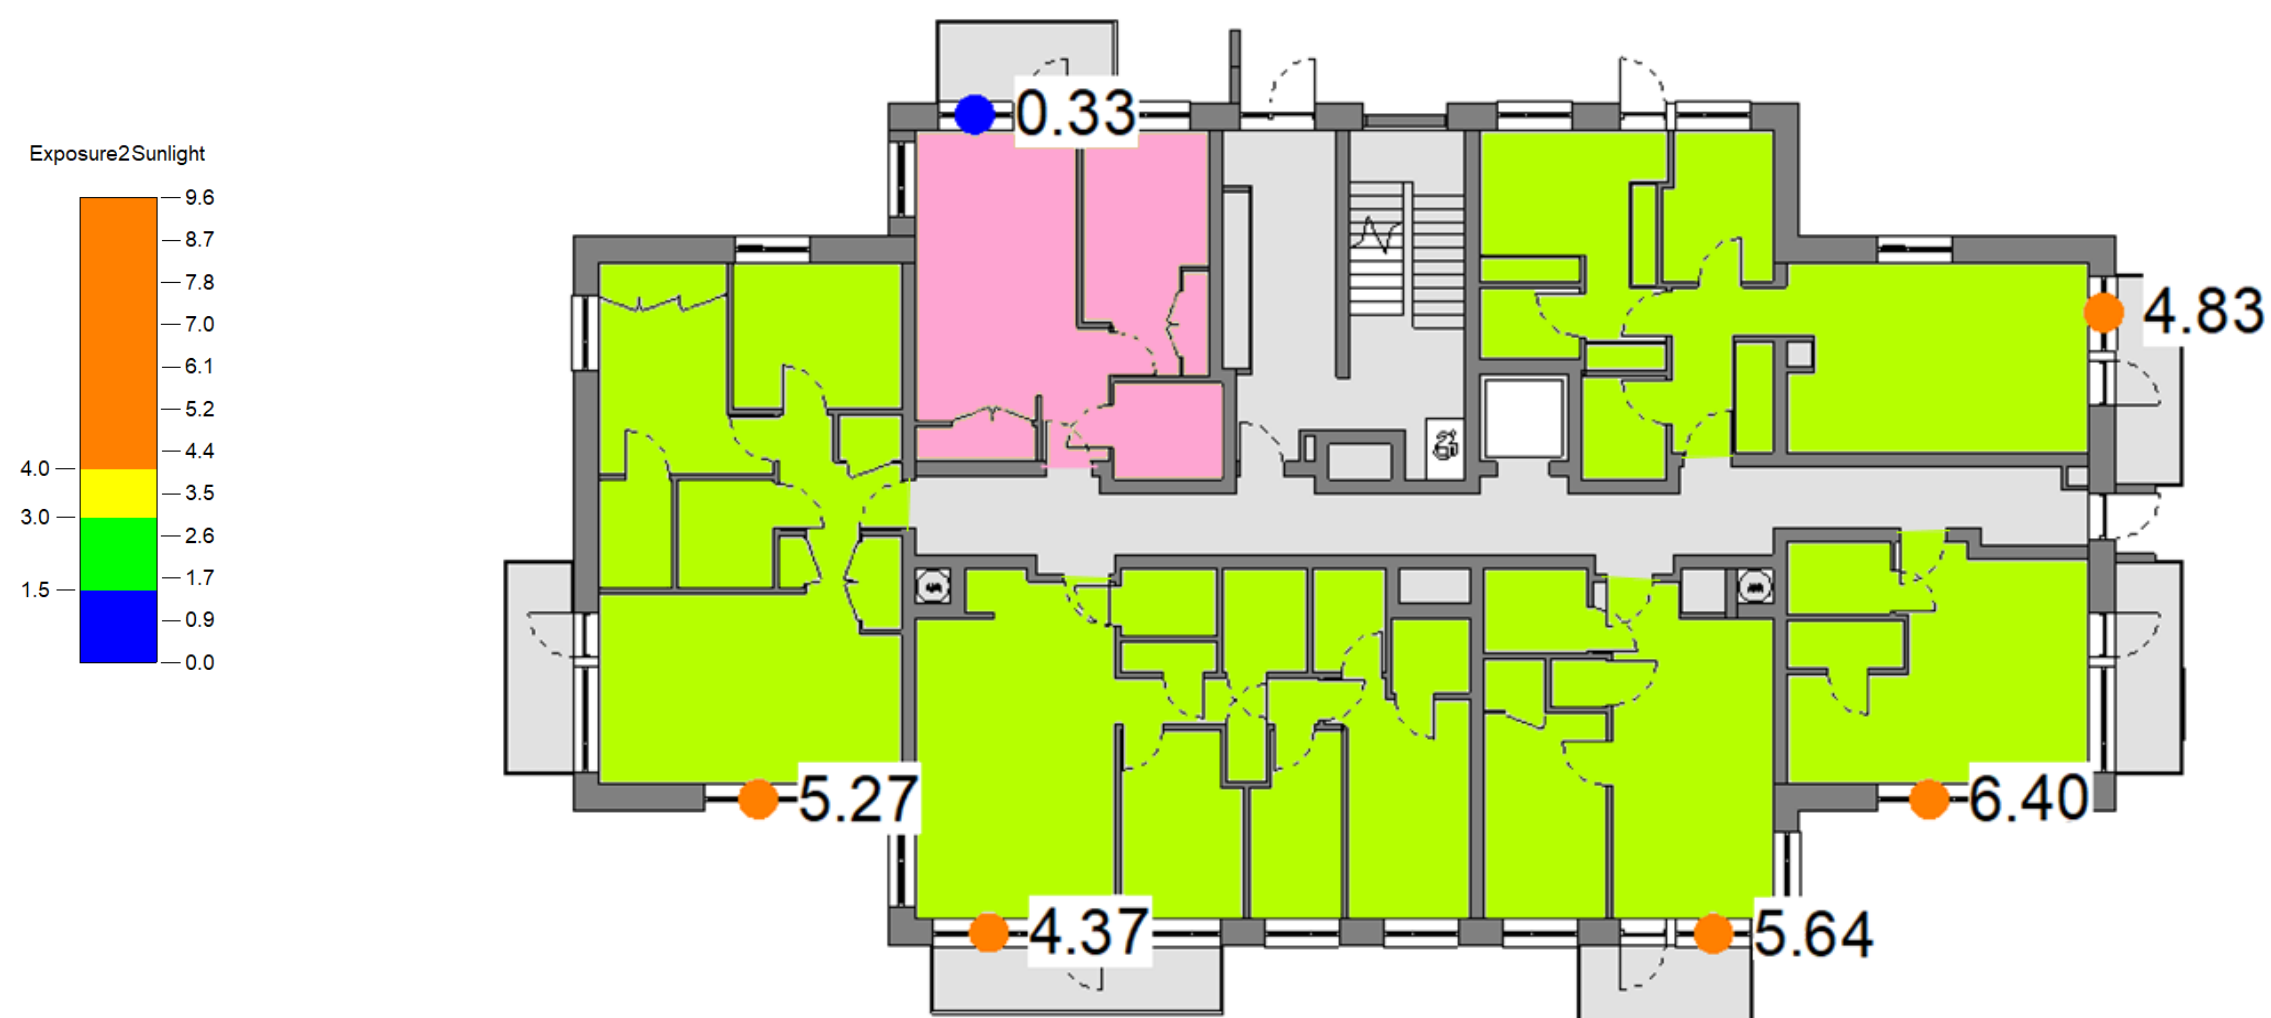
Sunlight Analysis as illustrated below, determined 1 unit on this block does not achieve the minimum recommendations.

The rest of the units achieve the minimum recommendations.

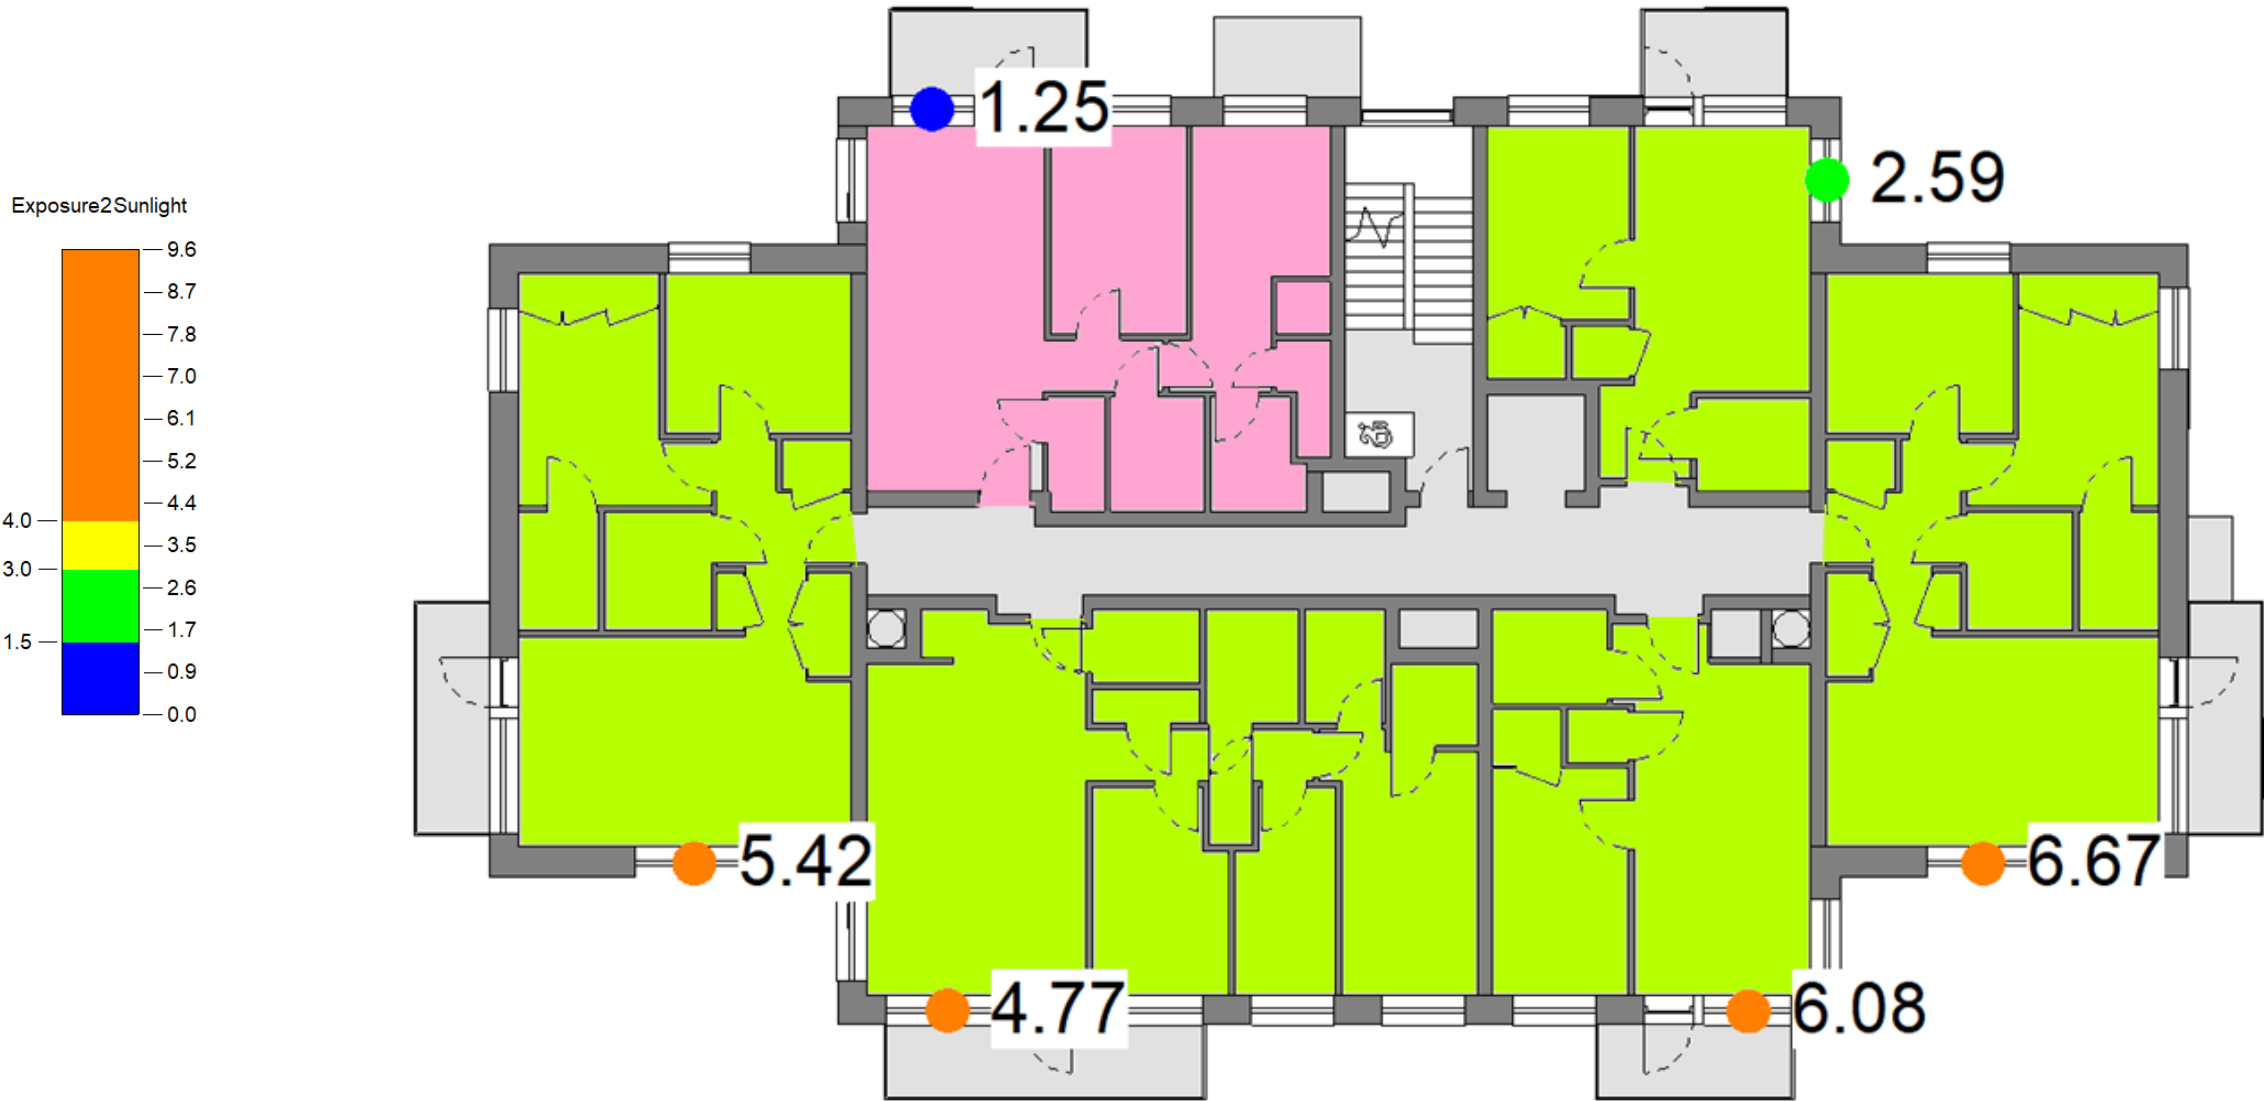
Block H – First Floor

Sunlight Analysis as illustrated below, determined 1 unit on this block does not achieve the minimum recommendations.
The rest of the units achieve the minimum recommendations.

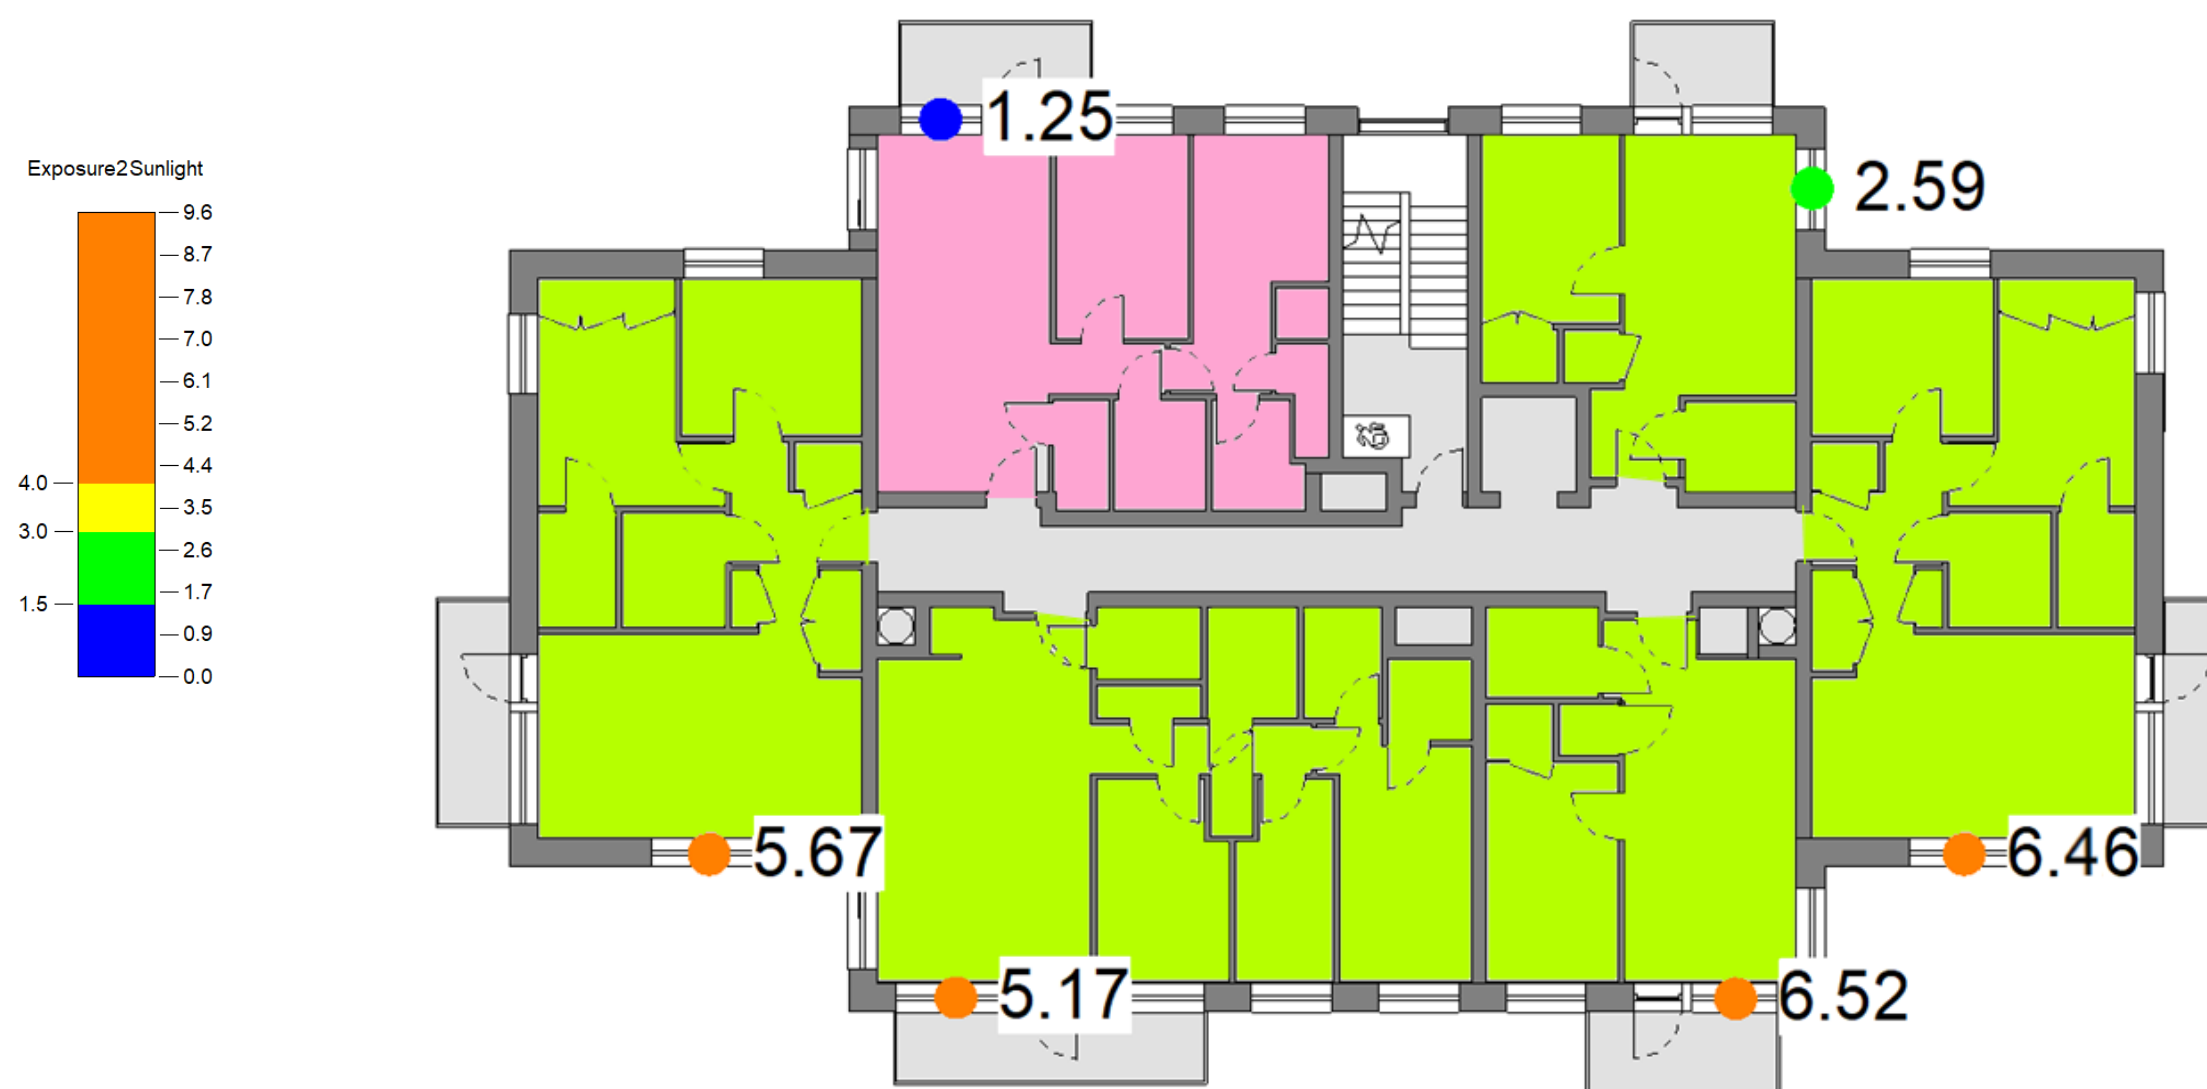
Sunlight Analysis as illustrated below, determined 1 unit on this block does not achieve the minimum recommendations.

The rest of the units achieve the minimum recommendations.
