St. Vincent's Hospital Fairview Redevelopment, Fairview Dublin 3

Daylight and Sunlight Analysis

IN2 Project No. D2116

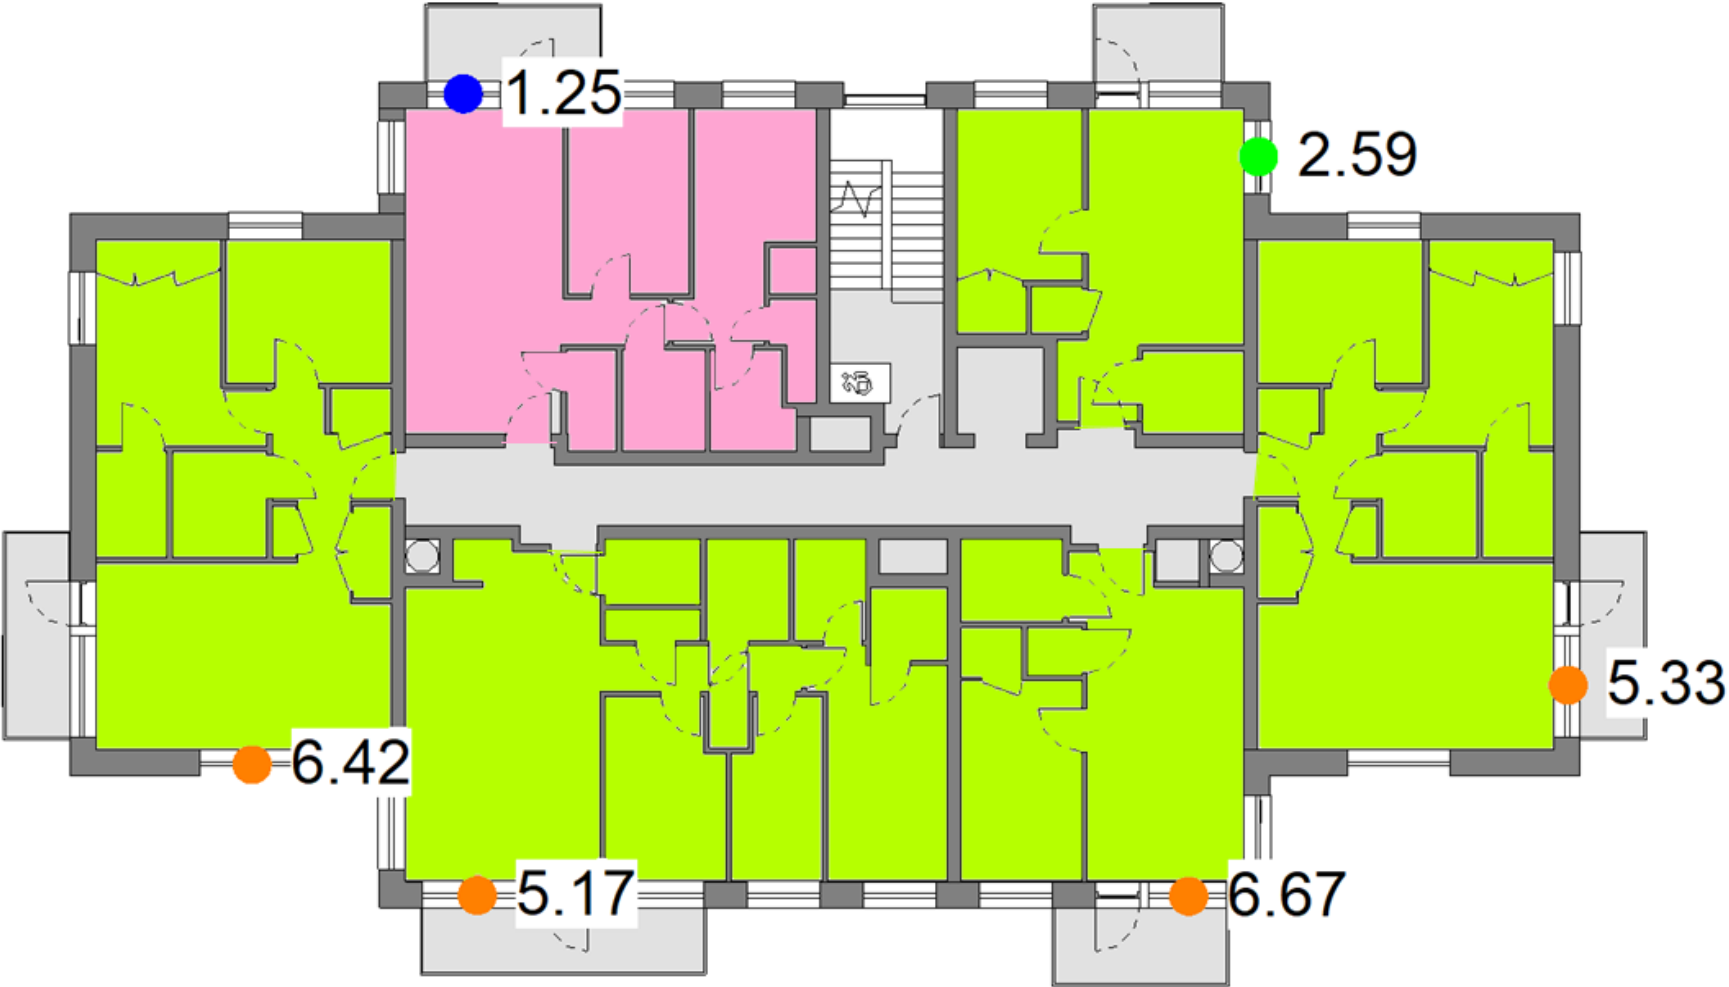
Sunlight Analysis as illustrated below, determined 1 unit on this block does not achieve the minimum recommendations.

The rest of the units achieve the minimum recommendations.

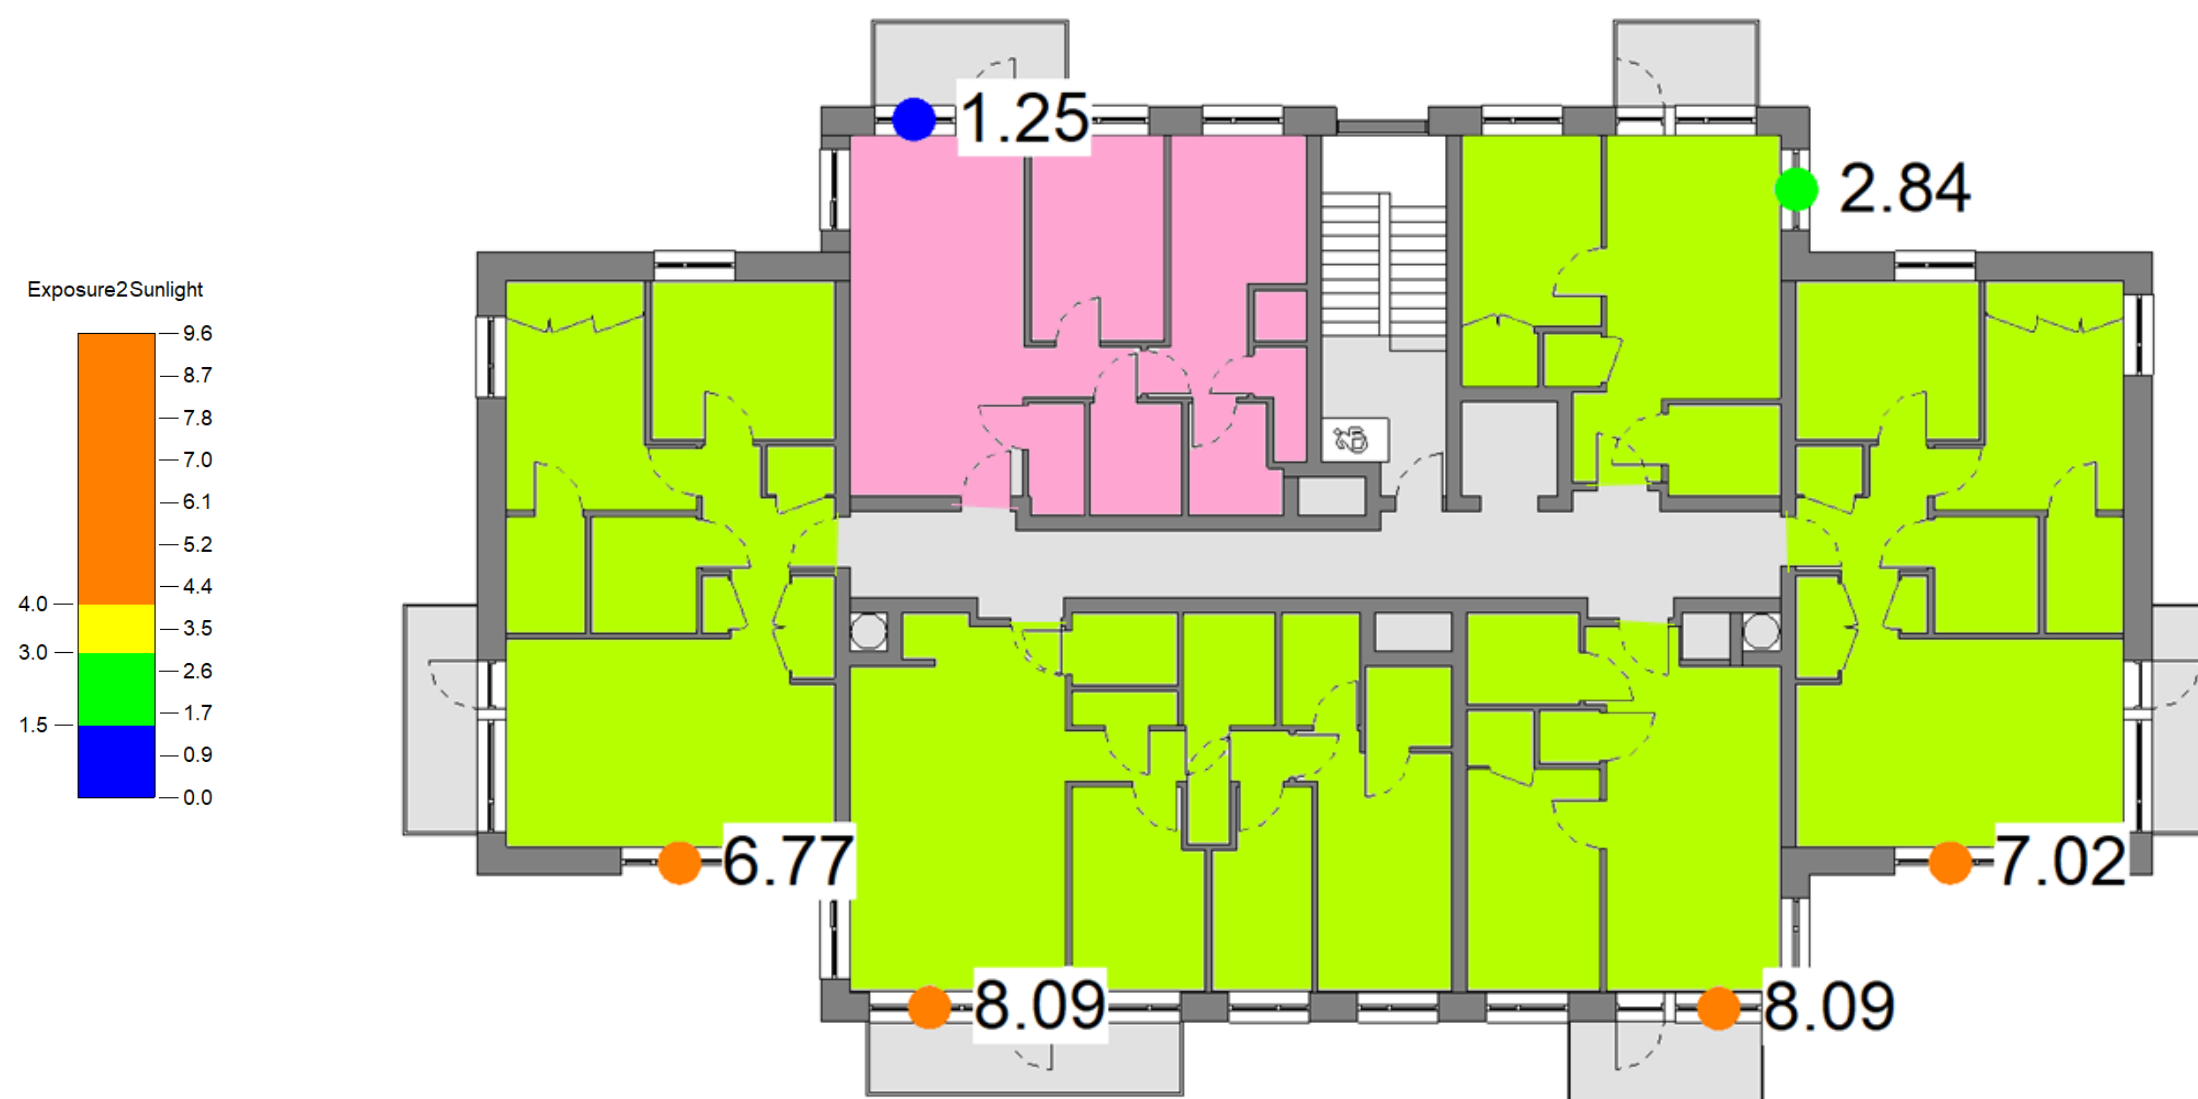
Sunlight Analysis as illustrated below, determined 1 unit on this block does not achieve the minimum recommendations.

The rest of the units achieve the minimum recommendations.

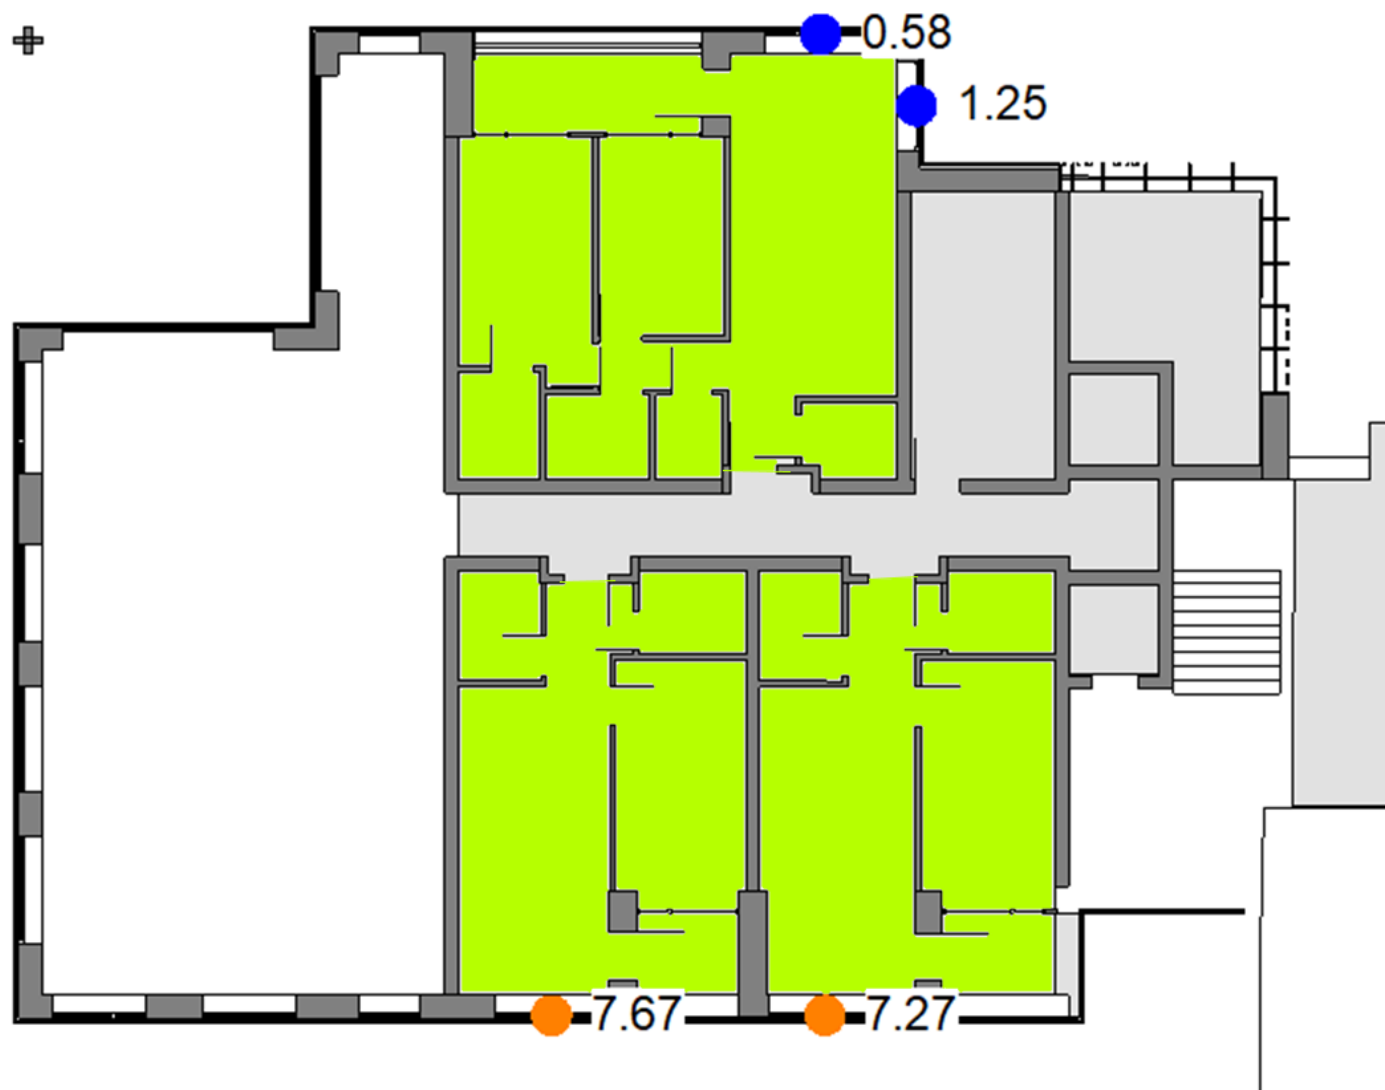
Block J – First Floor

Sunlight Analysis as illustrated below, determined all units on this block achieve the minimum recommendations.

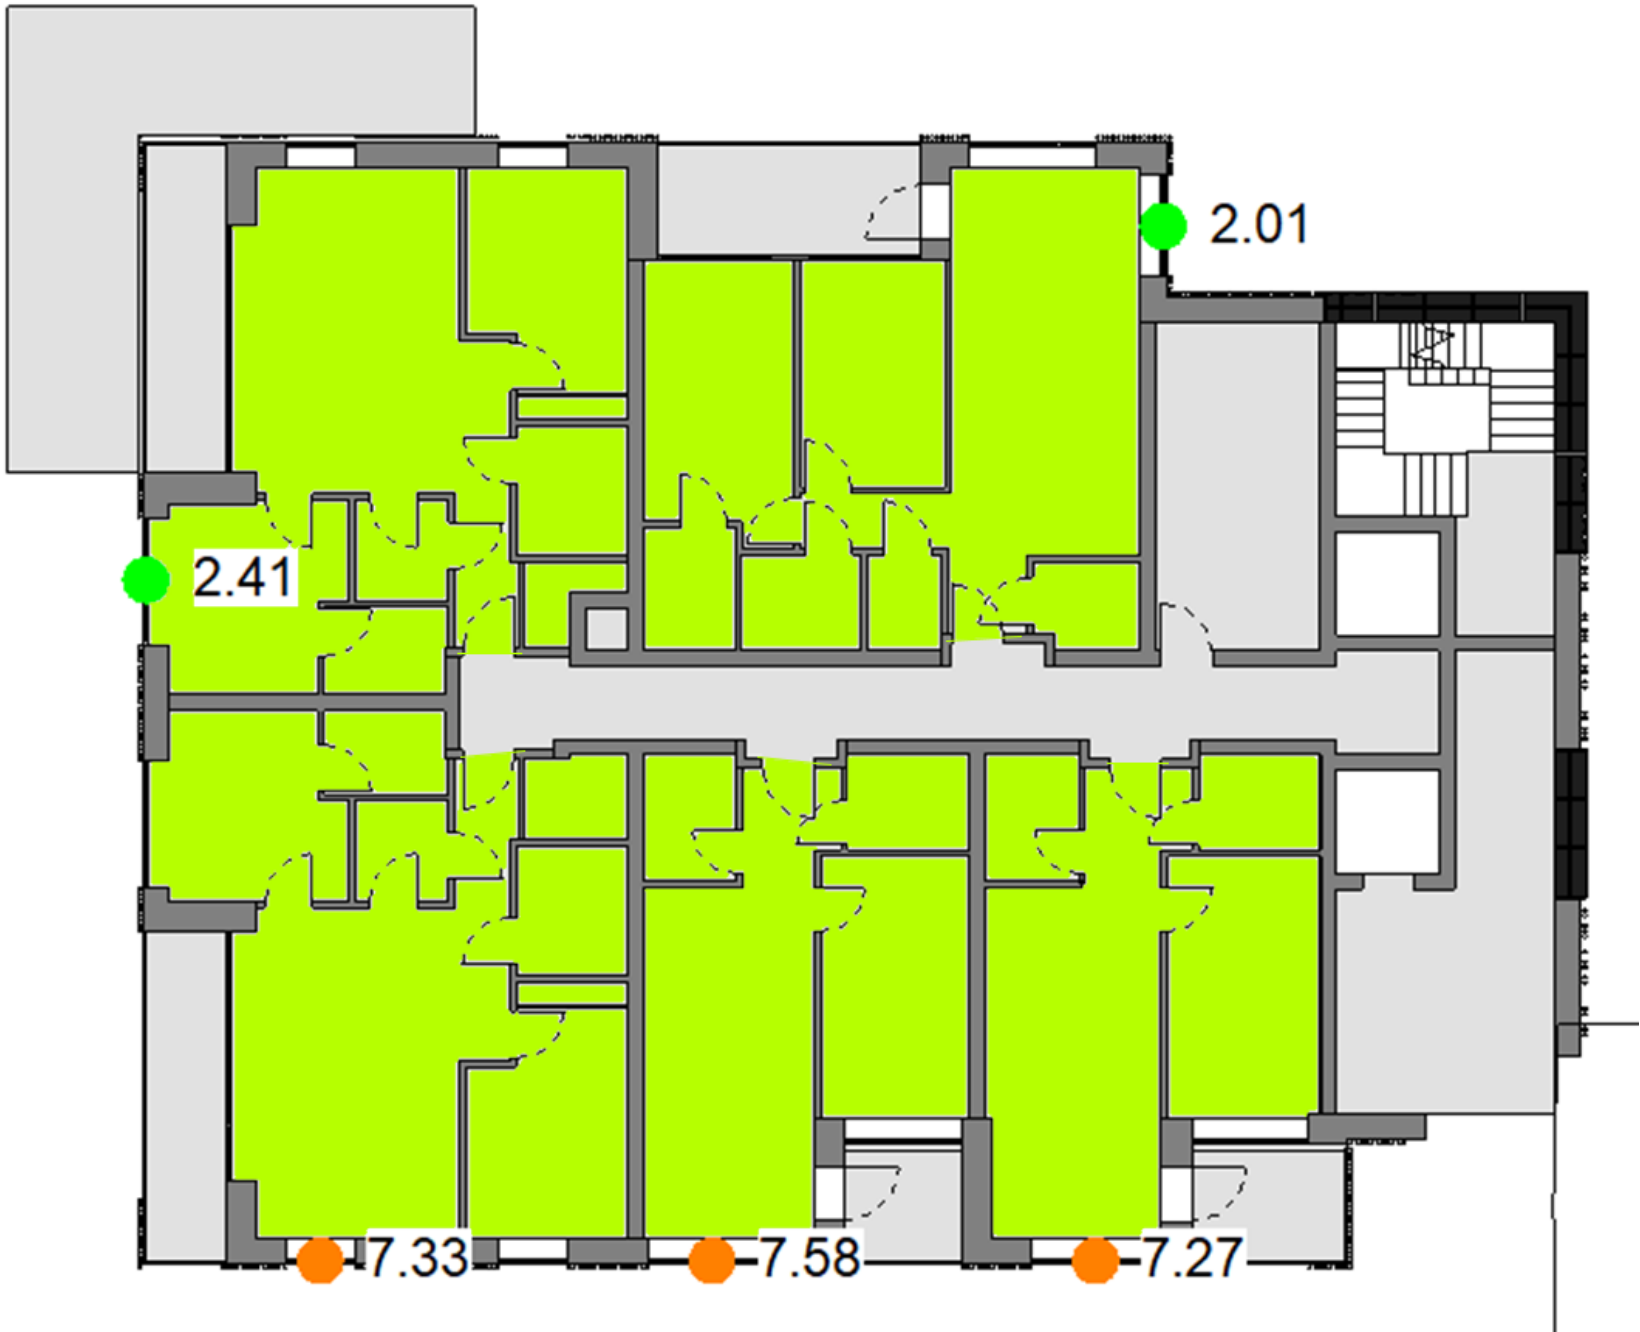
Block J – Second Floor

Sunlight Analysis as illustrated below, determined all units on this block achieve the minimum recommendations.

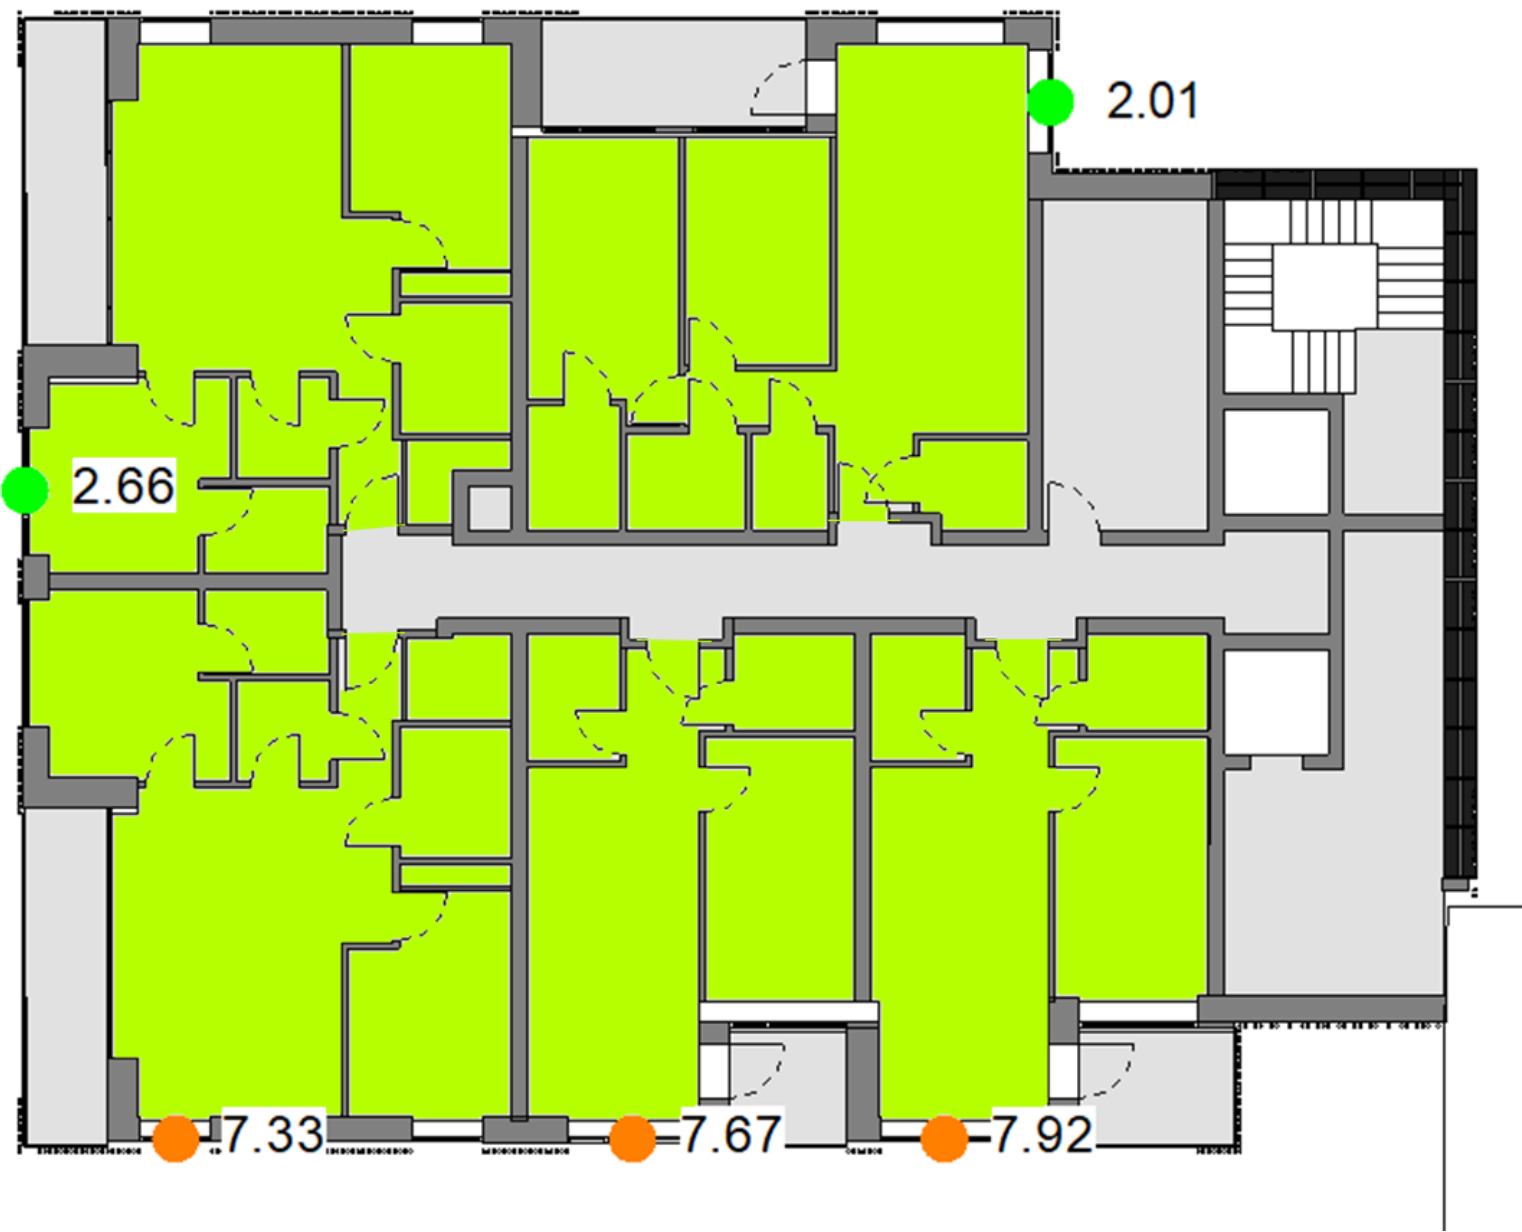
Sunlight Analysis as illustrated below, determined all units on this block achieve the minimum recommendations.

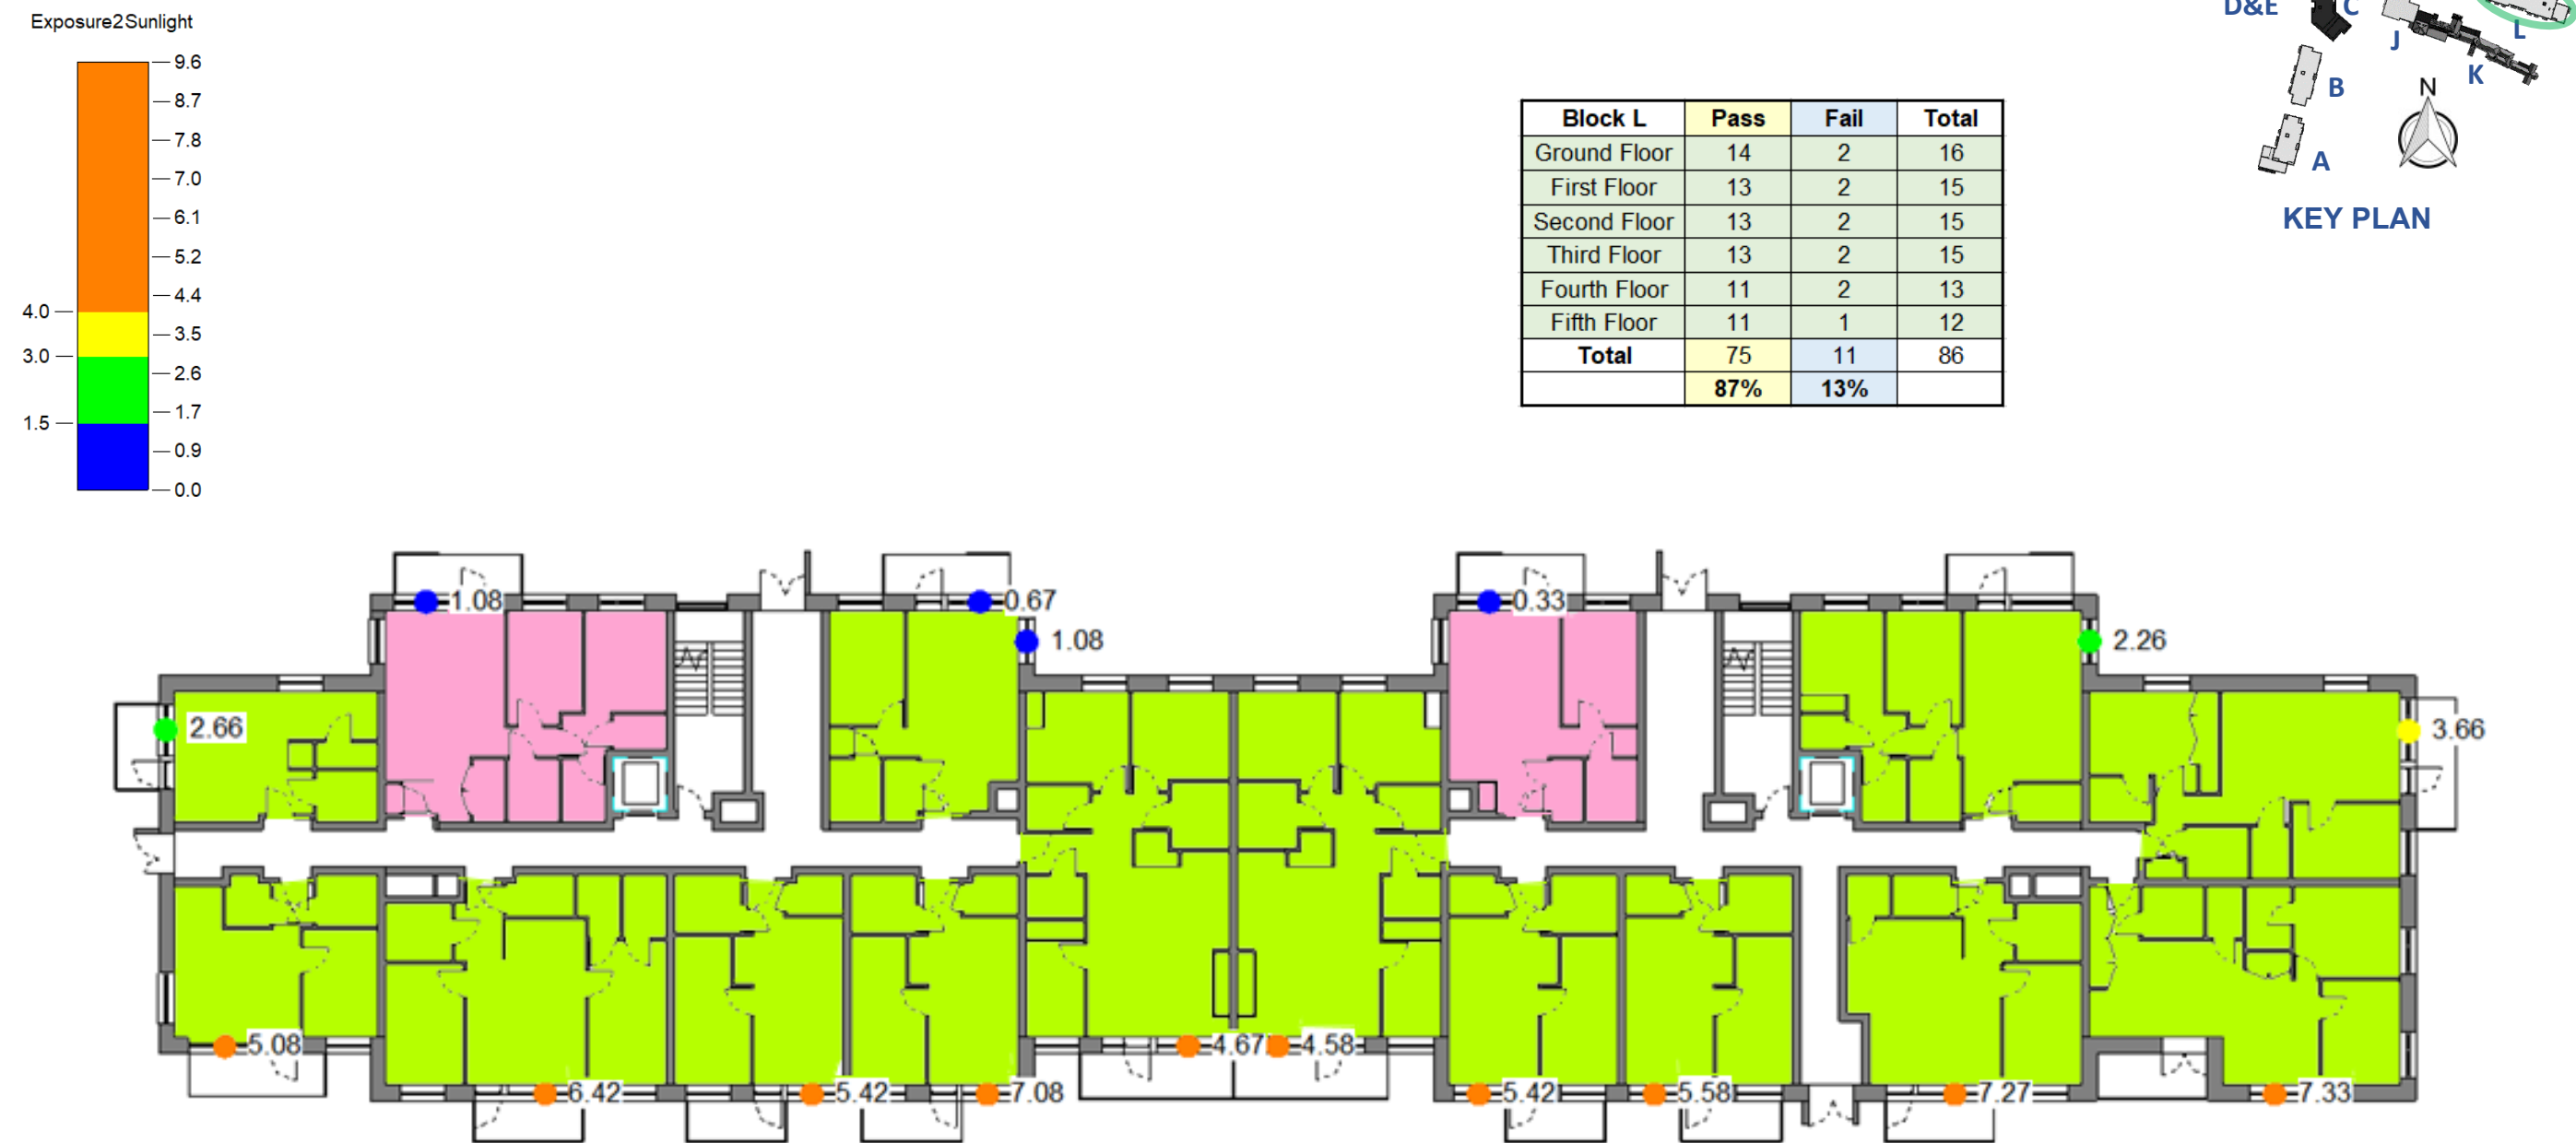
Sunlight Analysis as illustrated below, determined 2 units on this block do not achieve the minimum recommendations.

The rest of the units achieve the minimum recommendations.

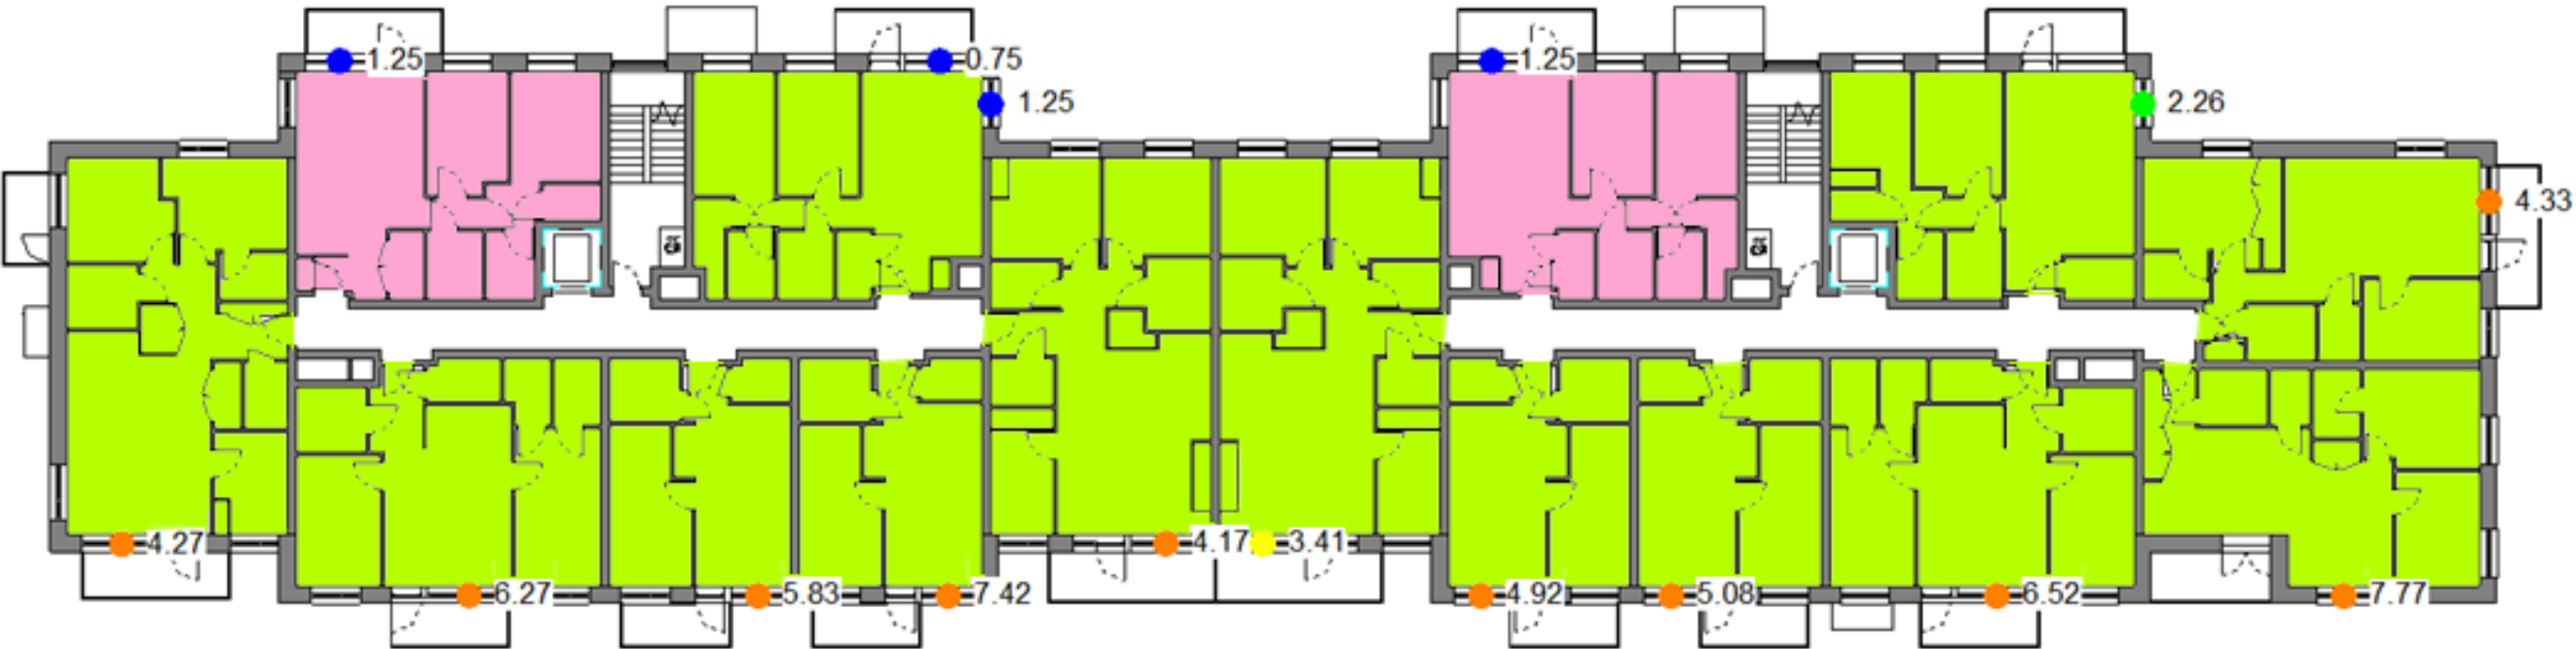
Sunlight Analysis as illustrated below, determined 2 units on this block do not achieve the minimum recommendations.

The rest of the units achieve the minimum recommendations.

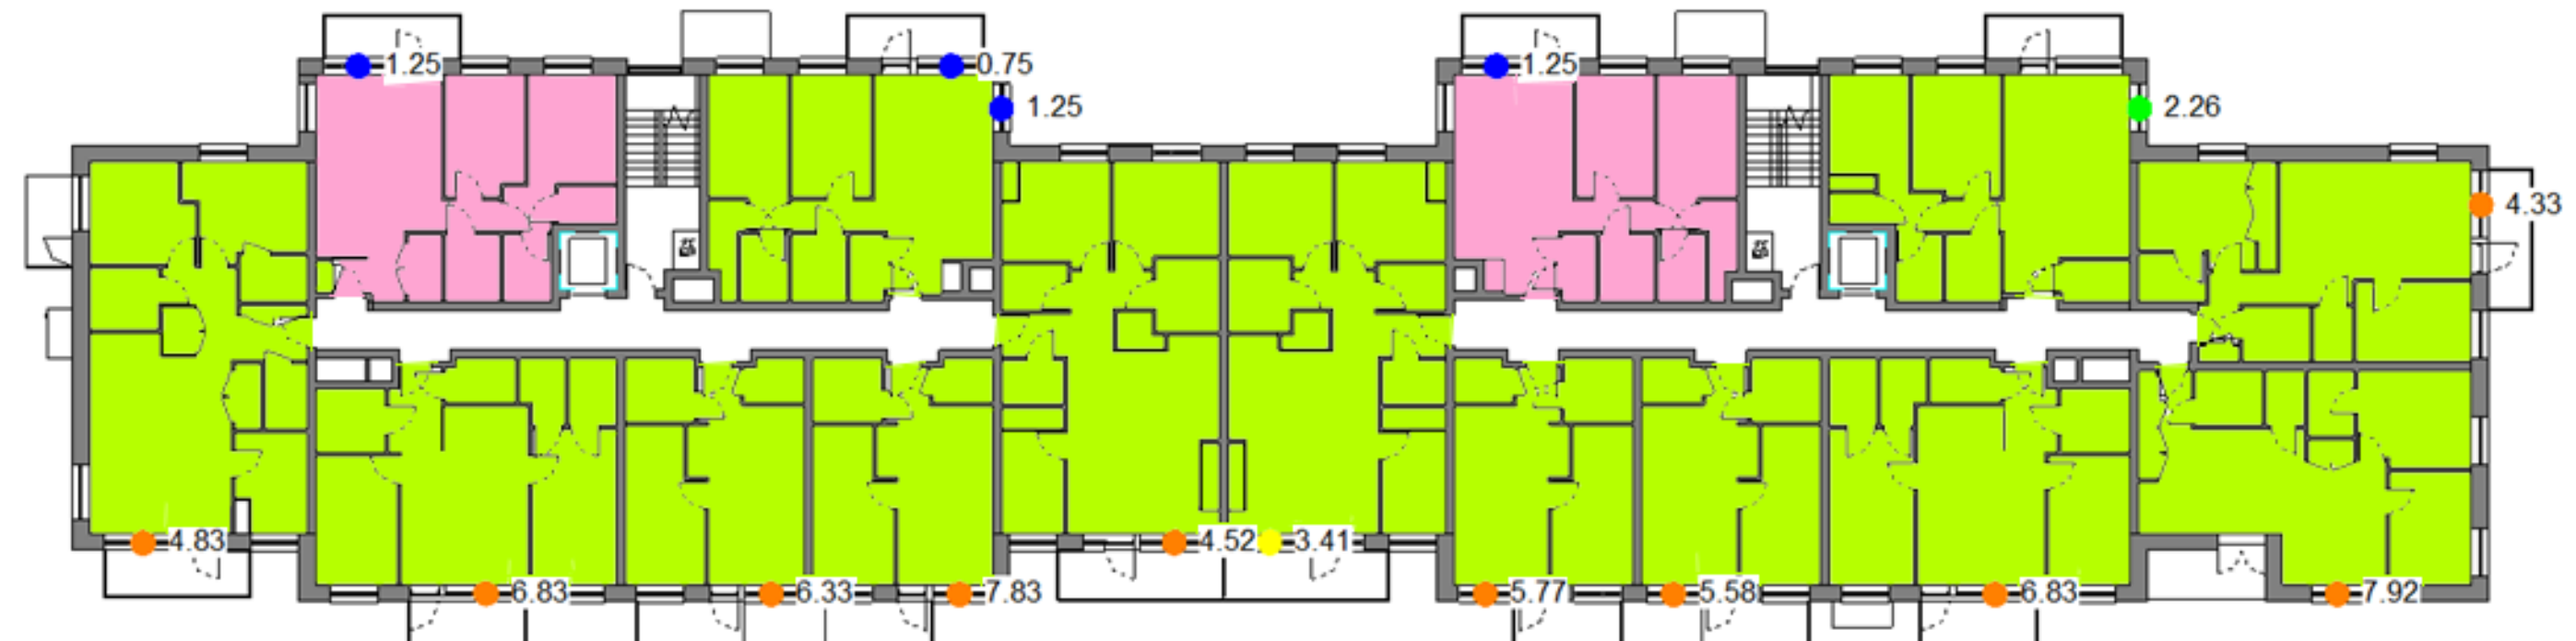
Sunlight Analysis as illustrated below, determined 2 units on this block do not achieve the minimum recommendations.

The rest of the units achieve the minimum recommendations.

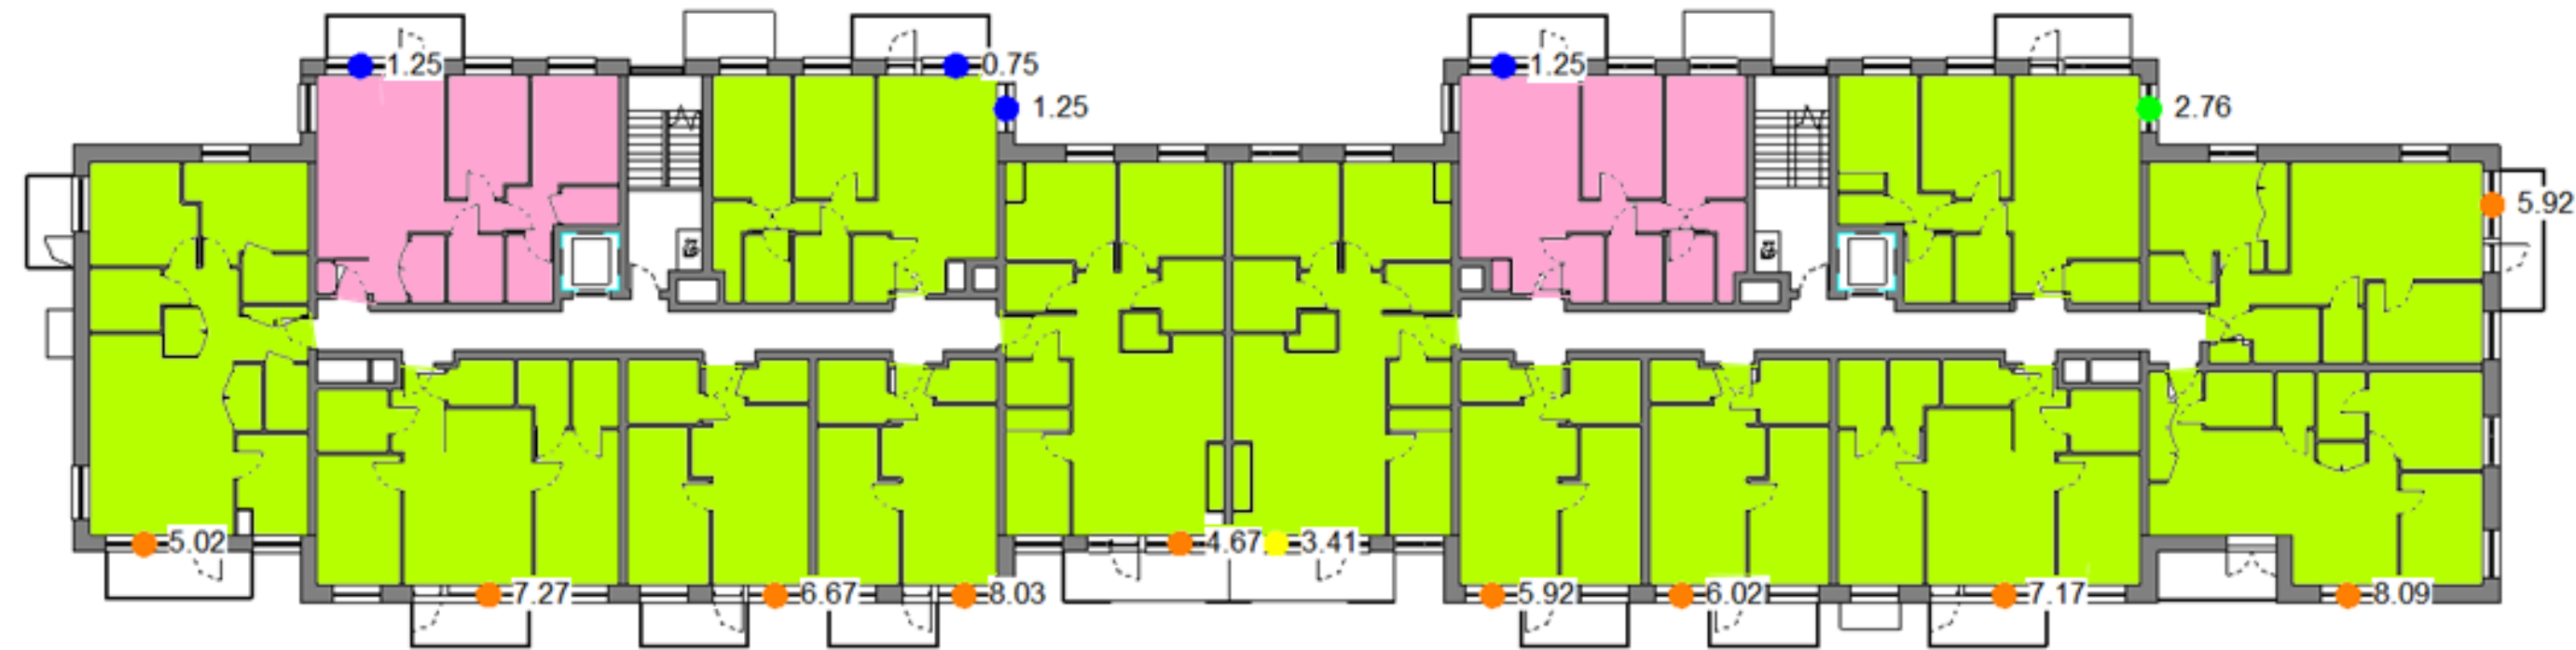
Sunlight Analysis as illustrated below, determined 2 units on this block do not achieve the minimum recommendations.

The rest of the units achieve the minimum recommendations.

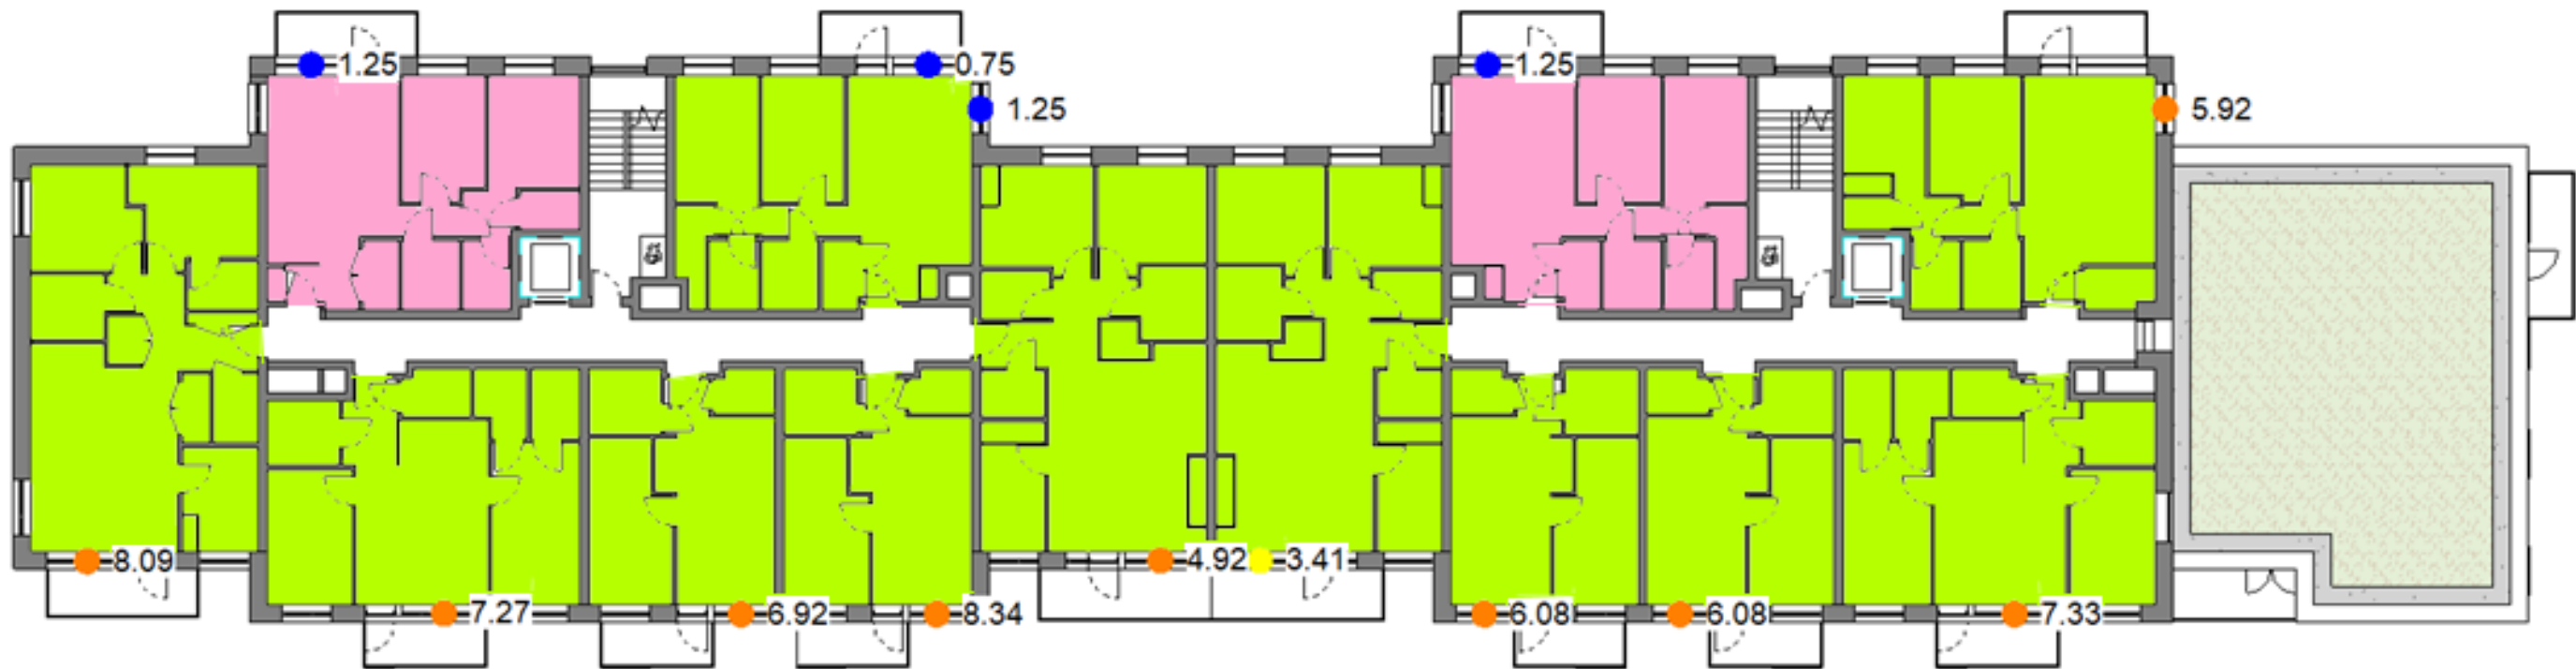
Sunlight Analysis as illustrated below, determined 2 units on this block do not achieve the minimum recommendations.

The rest of the units achieve the minimum recommendations.

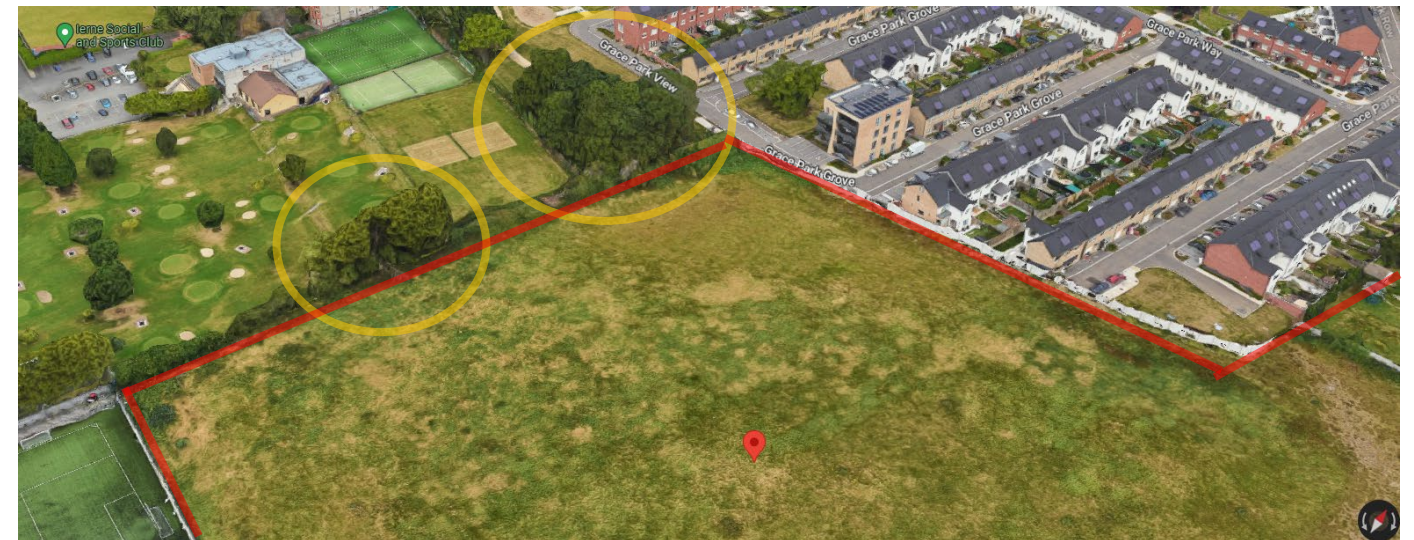
Fig C.1 –Google Image of large existing trees.

Figure C.1 below shows the google maps images of the neighbouring dense trees and figure C.2 shows the representation allowed for in the assessment of the SDA results based on 3D survey information acquired from a third party.

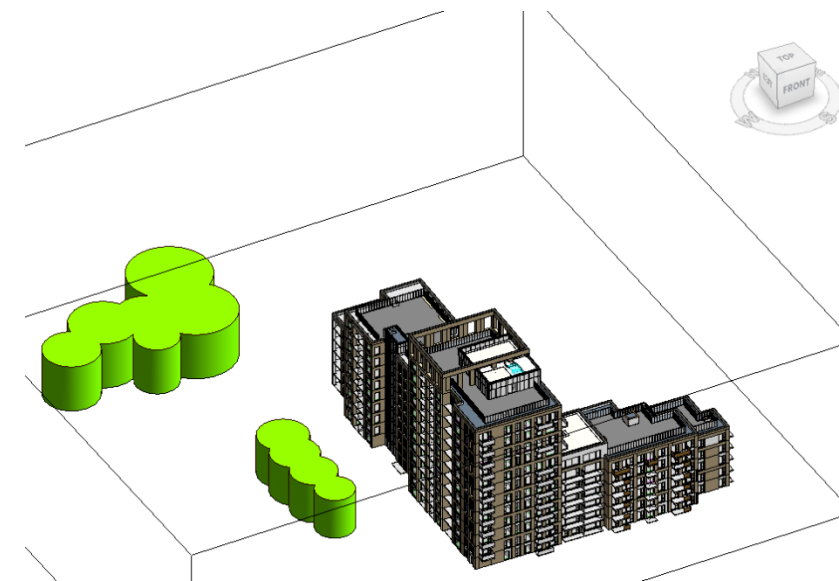
Fig C.2 –Modeled representation large existing trees for SDA assessment.
