St. Vincent's Hospital Fairview Redevelopment, Fairview Dublin 3

Daylight and Sunlight Analysis

IN2 Project No. D2116

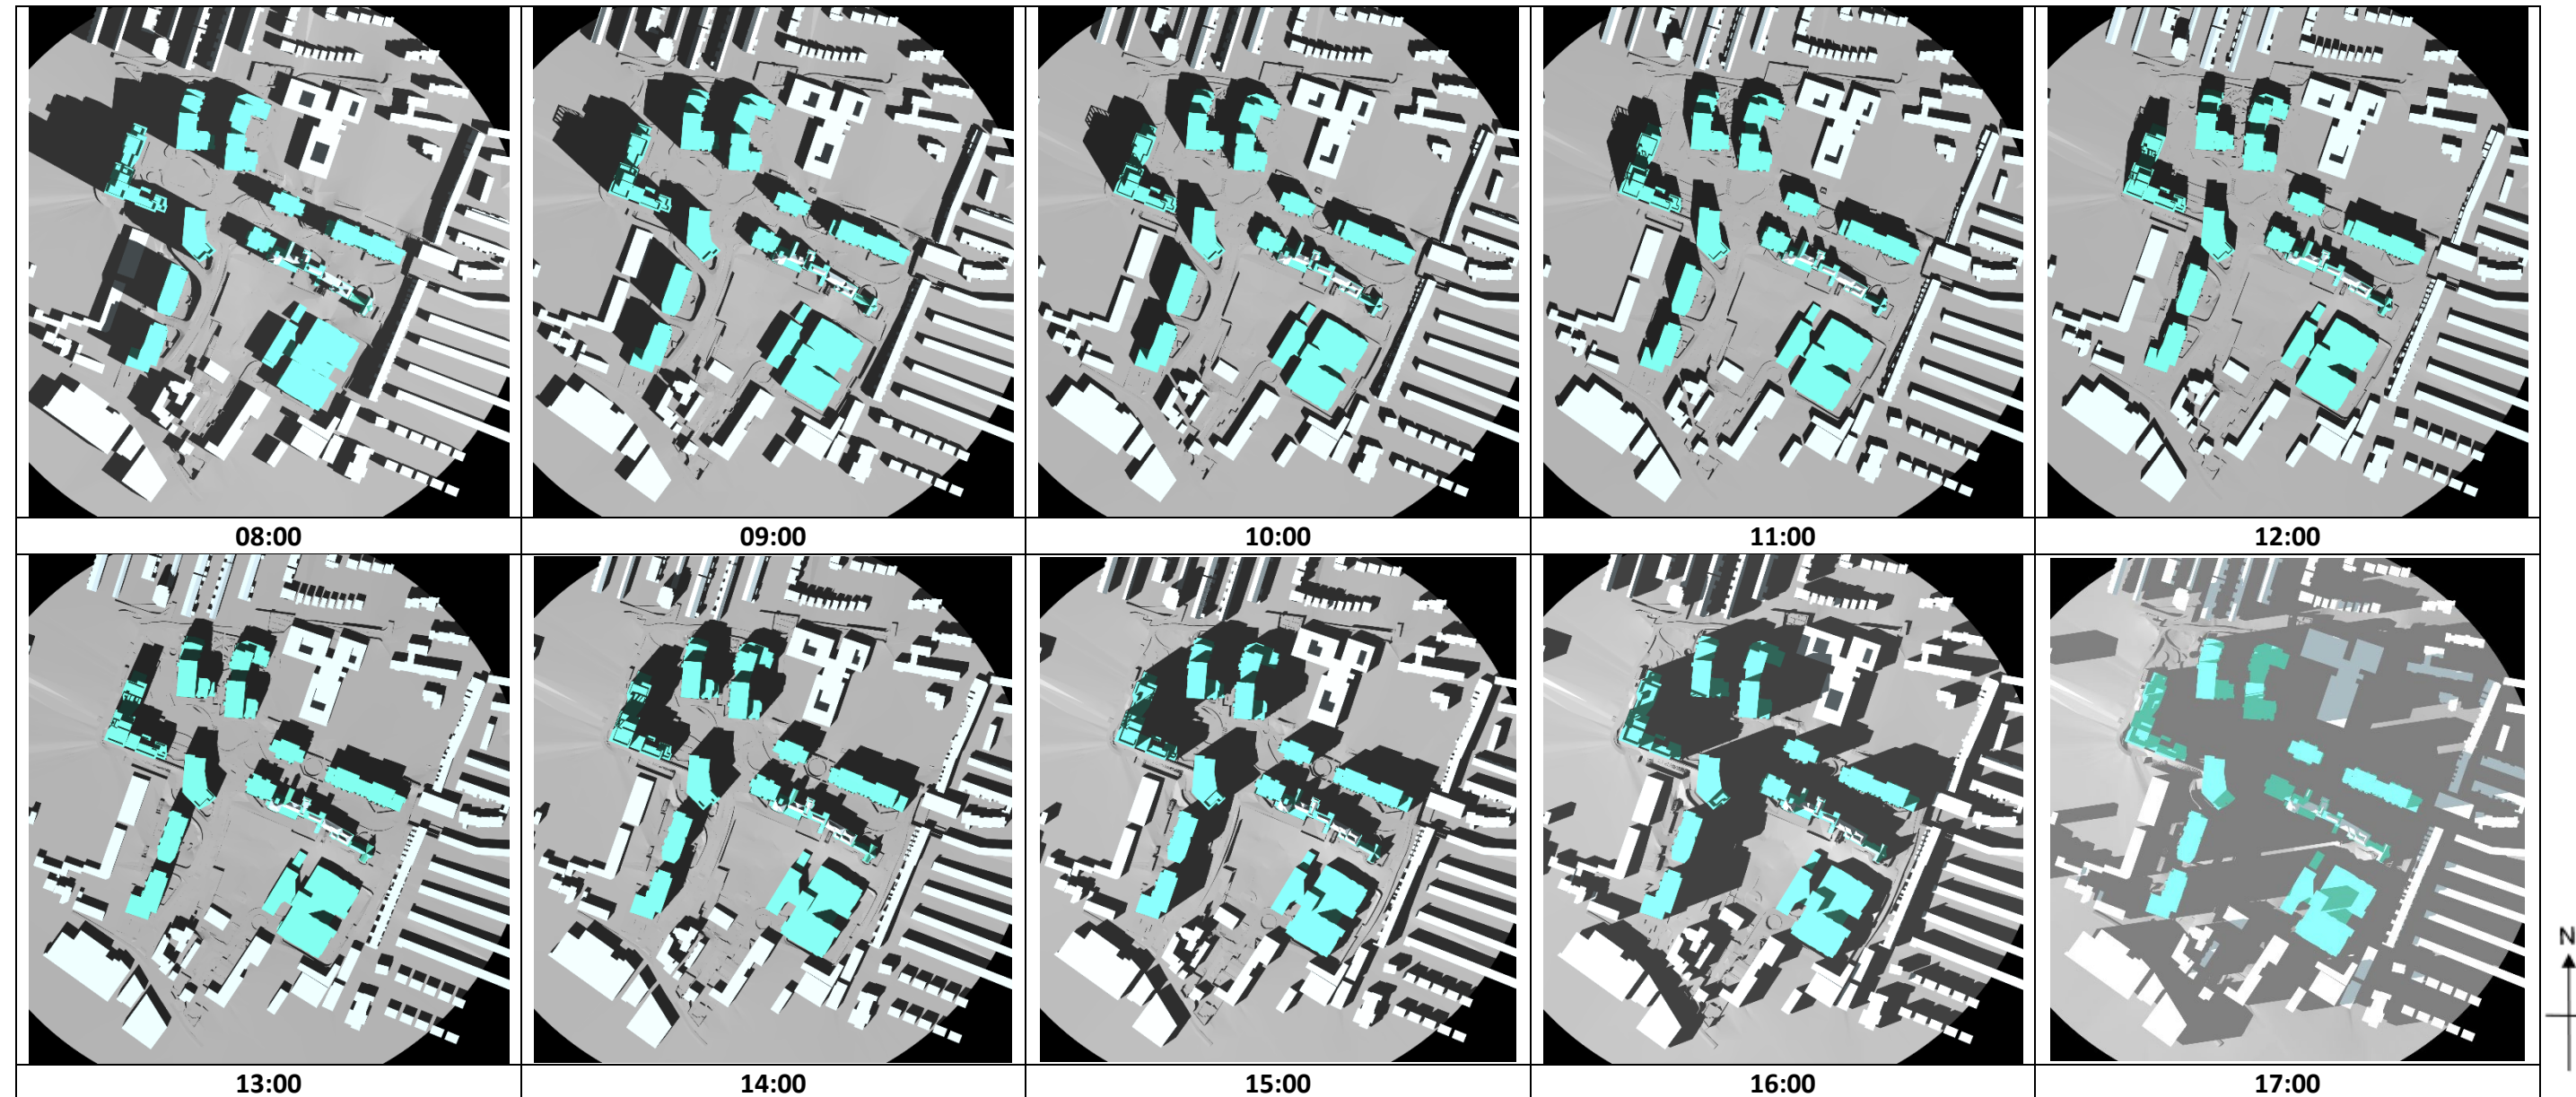
Fig D.1: Sunlight and Site Shading Diagrams - Equinox (March 21st): 08:00-17:00 hrs

The Site Shading diagrams in Fig D.1 illustrate that the proposed housing development is not predicted to cause undue overshadowing on neighbouring developments. Shadows from the proposed development are determined to remain within the confines of the proposed development site. Shading from buildings within the proposed development is not excessive, due to the considered approach taken to the site layout and building heights.

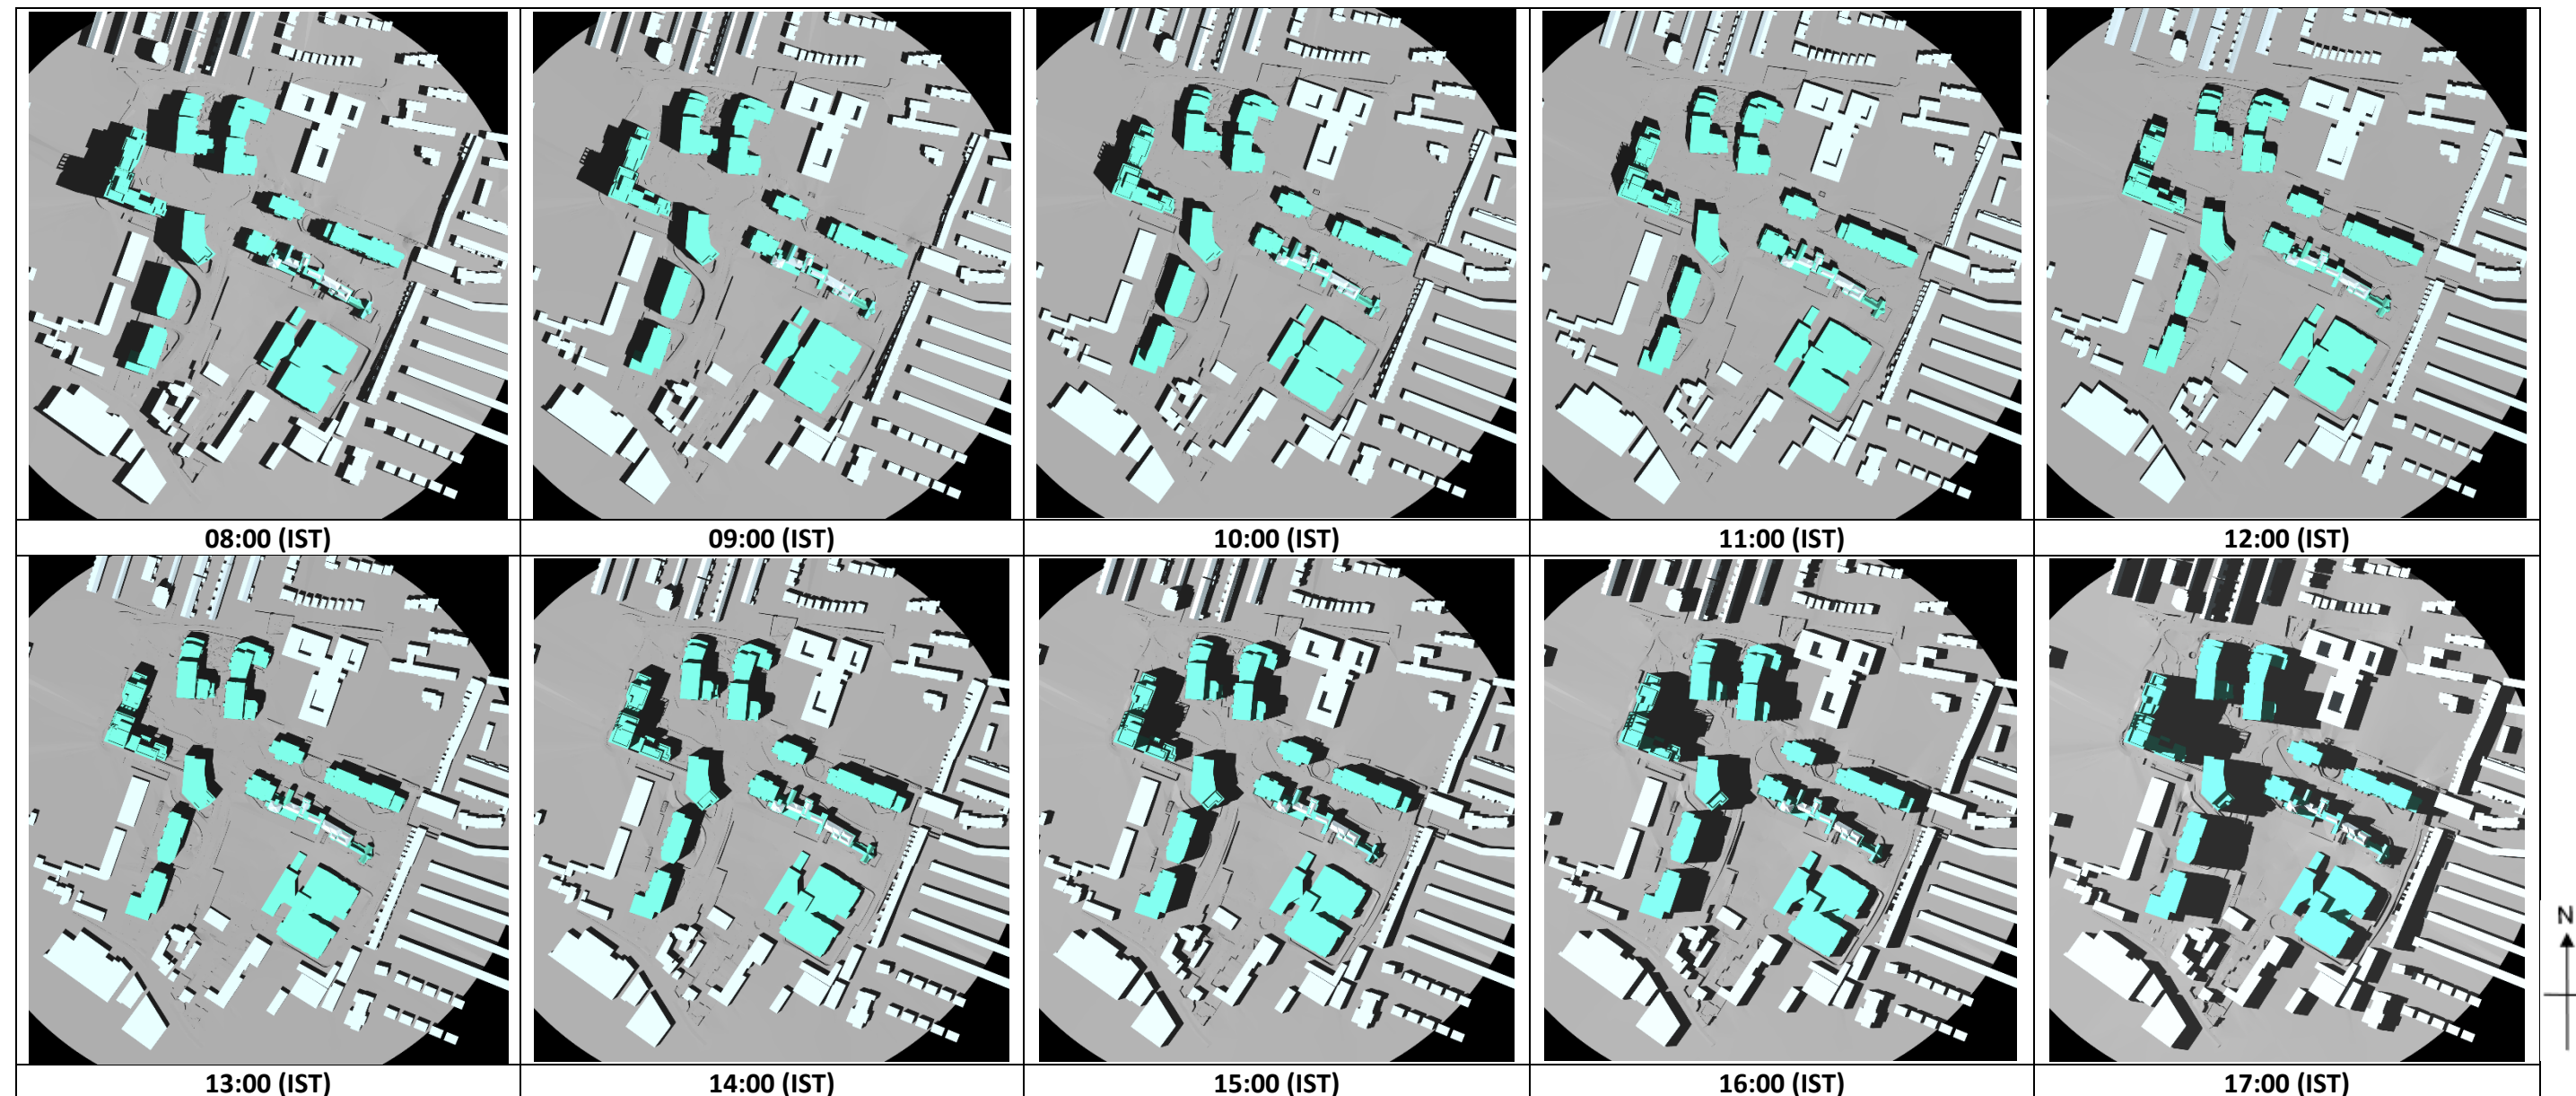
Fig D.2: Sunlight and Site Shading Diagrams - Summer Solstice (June 21st): 08:00-17:00 hrs

Whilst both winter and summer solstices have been included, it should be noted that the statistics of Met Eireann, the Irish Meteorological Service, indicate that the sunniest months in Ireland are May and June. During December, Dublin receives a mean daily duration of 1.7 hours of sunlight out of a potential 7.4 hours sunlight each day (i.e. only 22% of potential sunlight hours). This can be compared with a mean daily duration of 6.4 hours of sunlight out of a potential 16.7 hours each day received by Dublin during June (i.e. 38% of potential sunlight hours). Therefore, impacts caused by overshadowing are generally most noticeable during the summer months and least noticeable during the winter months. Due to the low angle of the sun in mid-winter, the shadow environment in all urban and suburban areas are generally dense tending to make the images confusing and superfluous.

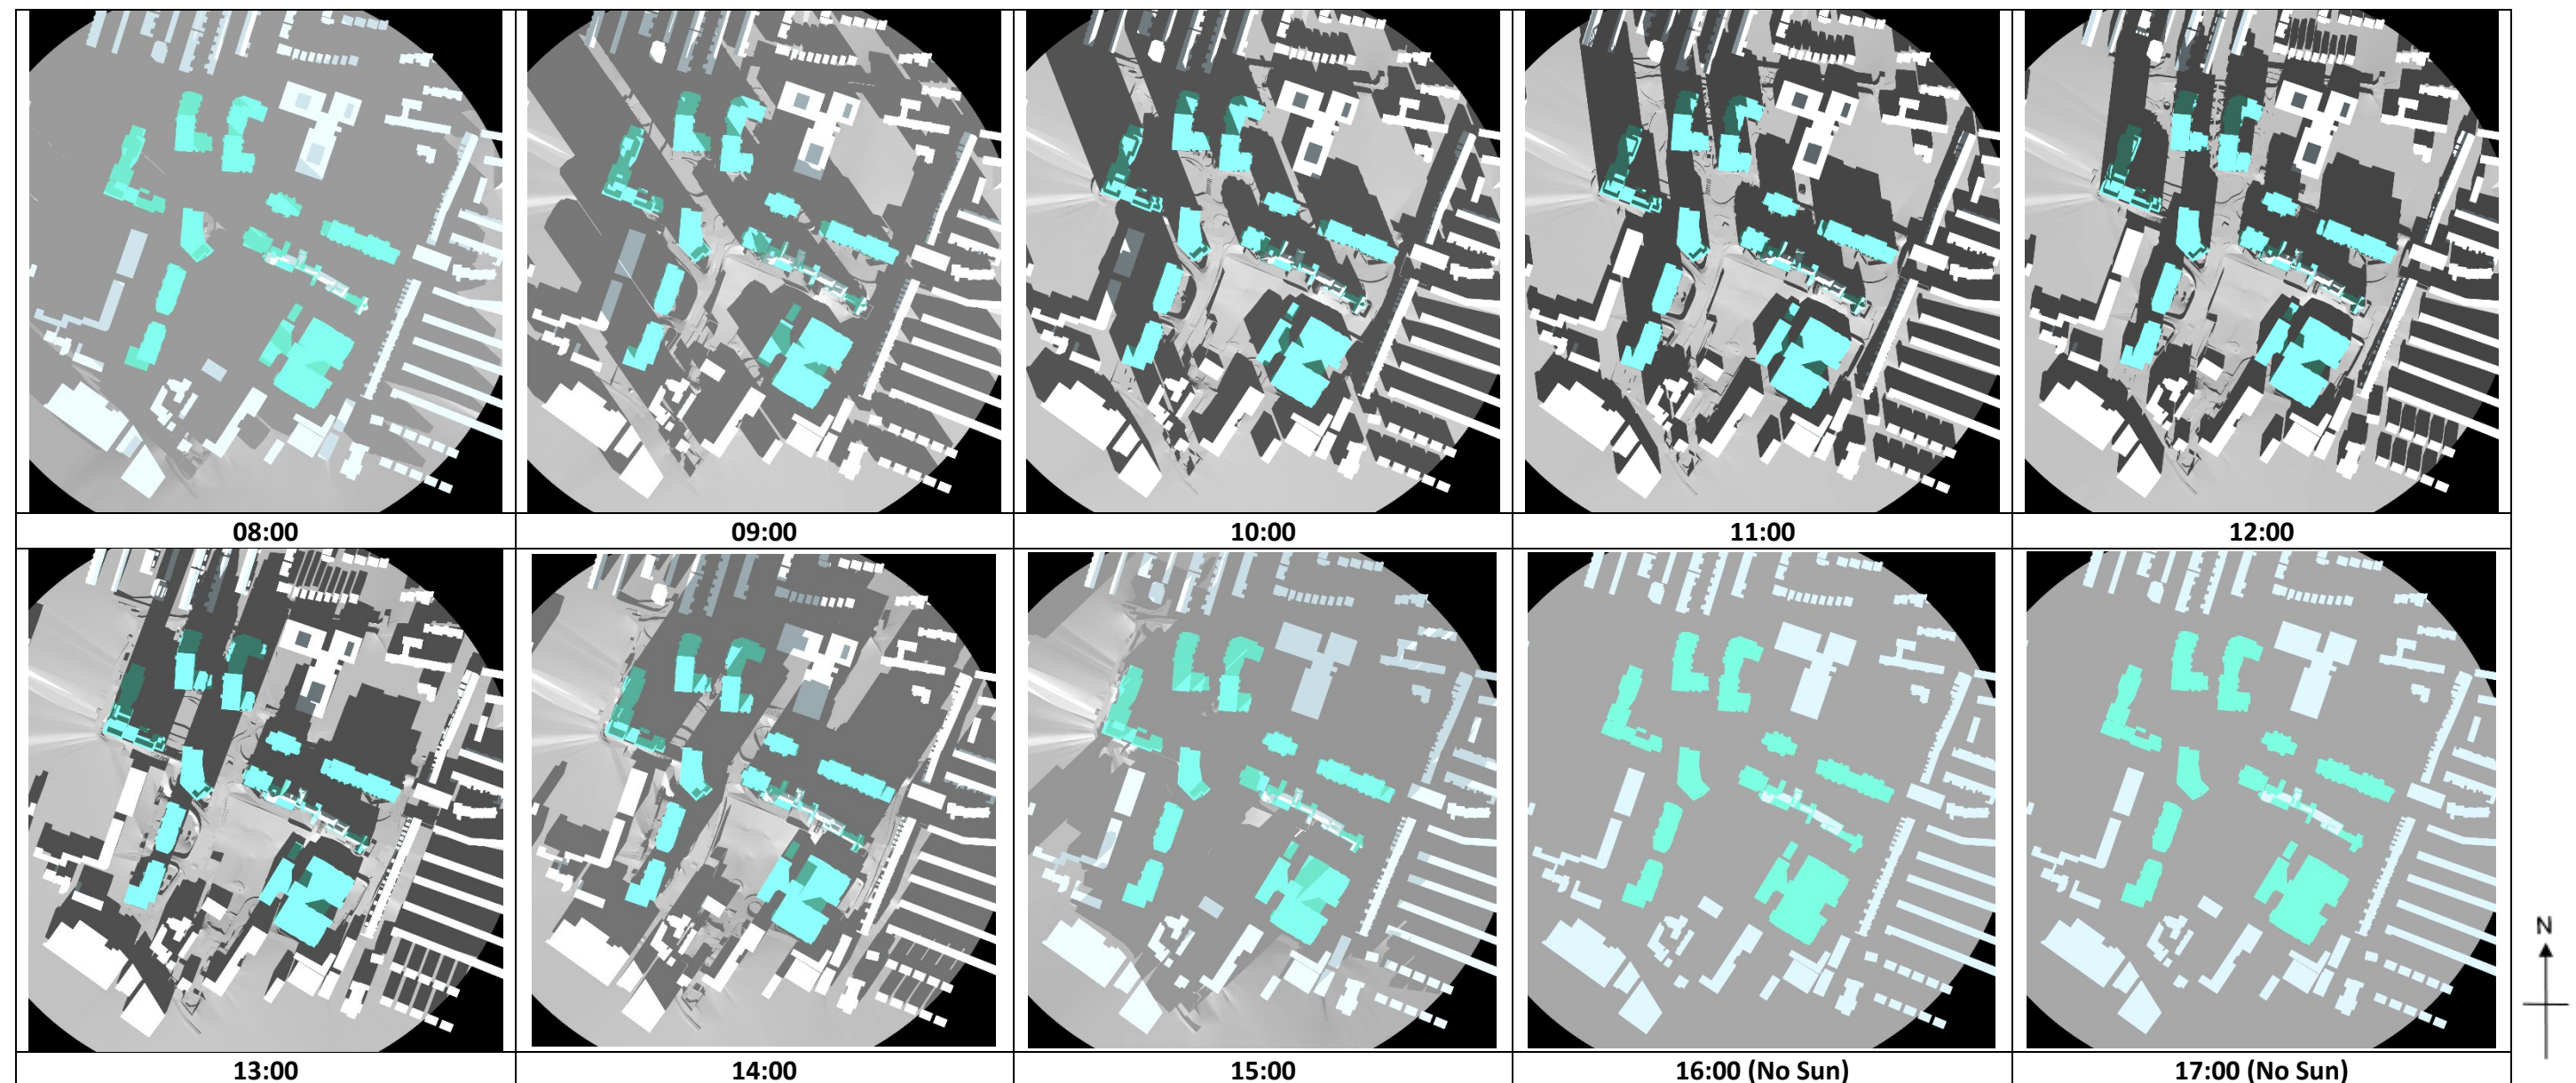
Fig D.3: Sunlight and Site Shading Diagrams - Winter Solstice (December 21st): 08:00-17:00 hrs

Whilst both winter and summer solstices have been included, it should be noted that the statistics of Met Eireann, the Irish Meteorological Service, indicate that the sunniest months in Ireland are May and June. During December, Dublin receives a mean daily duration of 1.7 hours of sunlight out of a potential 7.4 hours sunlight each day (i.e. only 22% of potential sunlight hours). This can be compared with a mean daily duration of 6.4 hours of sunlight out of a potential 16.7 hours each day received by Dublin during June (i.e. 38% of potential sunlight hours). Therefore, impacts caused by overshadowing are generally most noticeable during the summer months and least noticeable during the winter months. Due to the low angle of the sun in mid-winter, the shadow environment in all urban and suburban areas are generally dense tending to make the images confusing and superfluous.
